Docket No. 272 – Development and Management Plan Inspection

Underground Line Watercourse and Railroad Crossings

Date: February 27, 2008

Location: Crossings of Watercourses and Railroads in Segments 3, 4a and 4b

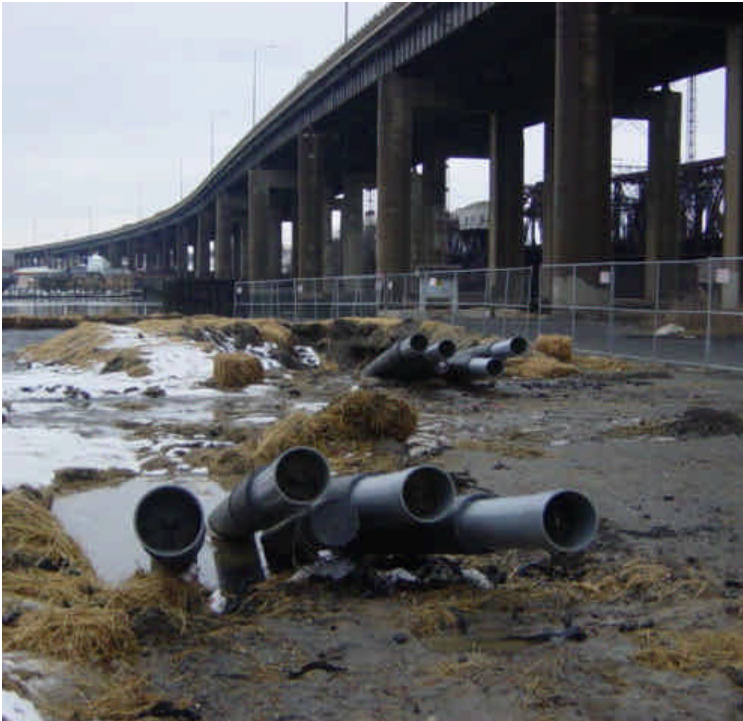
On the east side of the Housatonic River the dirt berms remain between the drill pits (conduits) and the river.

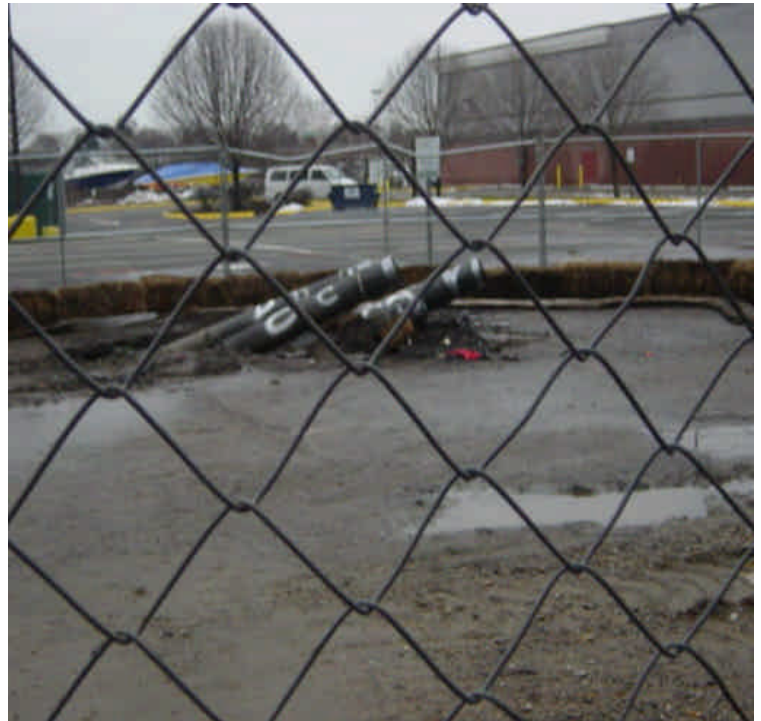
On the west side of the Housatonic River, the drilling pits have been backfilled, with only the conduits left exposed.

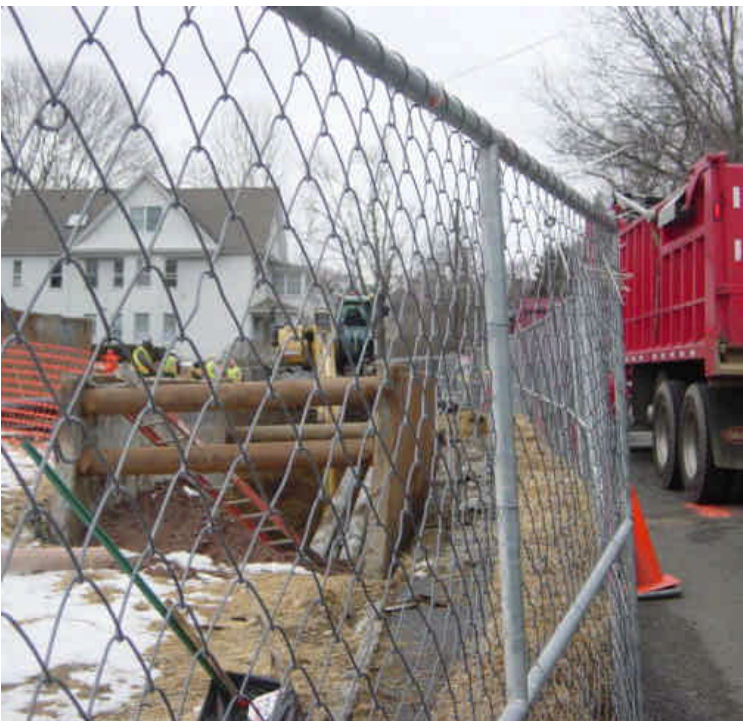
On the west side of the Saugatuck River, the HDD has been Completed and crews are now working on vaults and tie-ins.

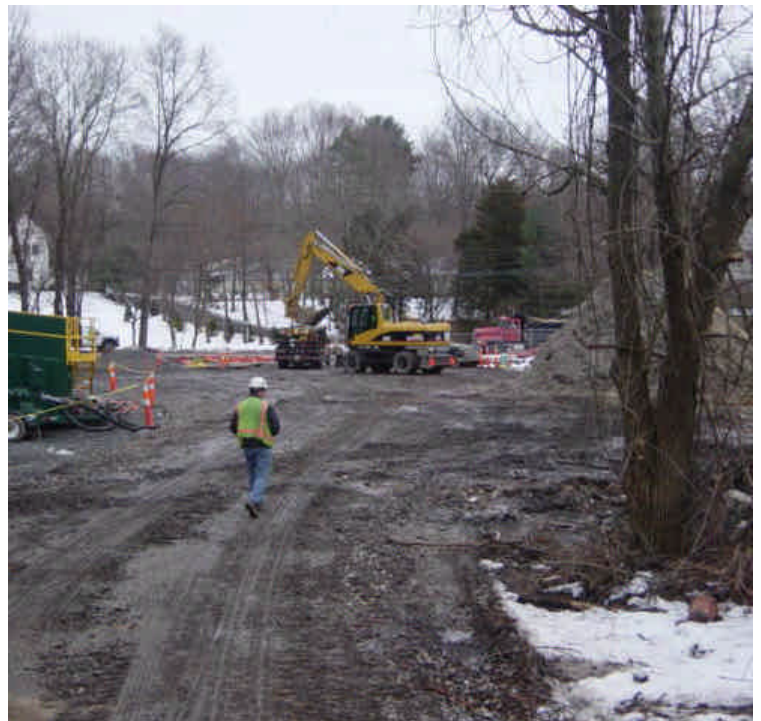
Staging area on the east side of the Saugatuck River was partially restored but is now being utilized by Seg. 4B contractors for the vault installation. Final restoration efforts will need to be coordinated between the contractors.
