Docket No. 272 – Development and Management Plan Inspection

Underground Line Watercourse and Railroad Crossings

Date: March 6, 2008

Location: Crossings of Watercourses and Railroads in Segments 3, 4a and 4b

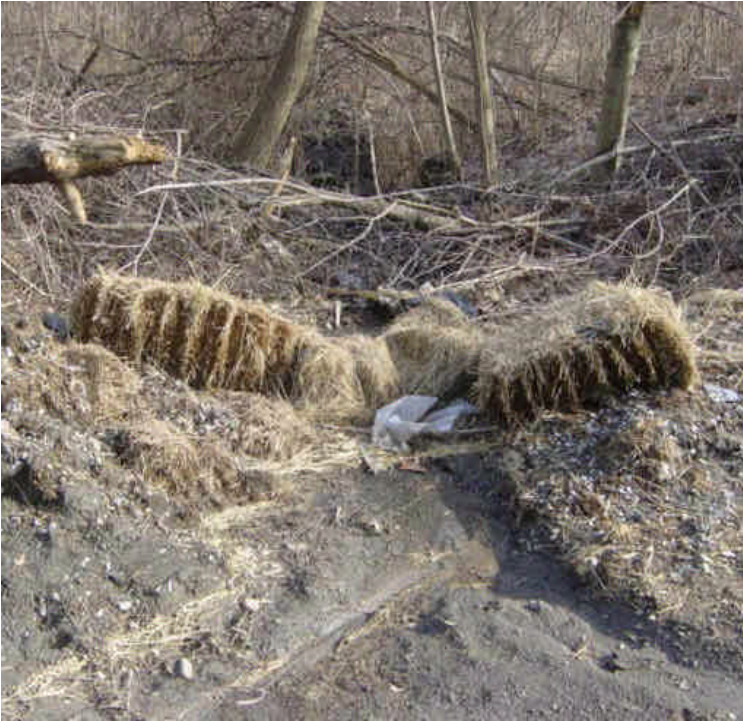
A small channel has eroded near the west side of the staging area on the east side of the Housatonic River. Haybales are in place and are containing most of the sediment, but a minor amount has migrated beyond the haybale barrier.

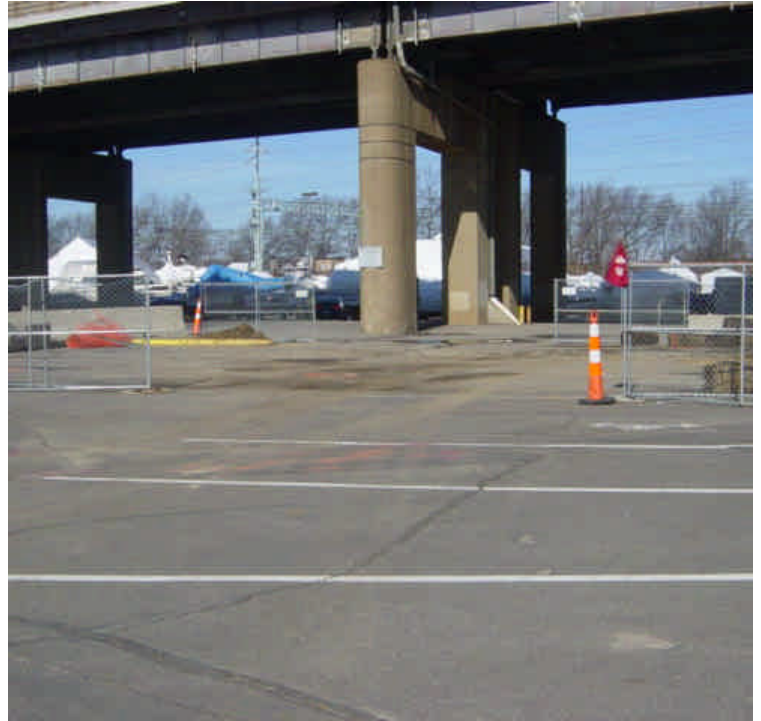
Staging area on the west side of the Housatonic River remains active as crews are working to tie-in the conduits to the existing vault. A minor amount of remnant sediment has accumulated and been tracked over the paved area.

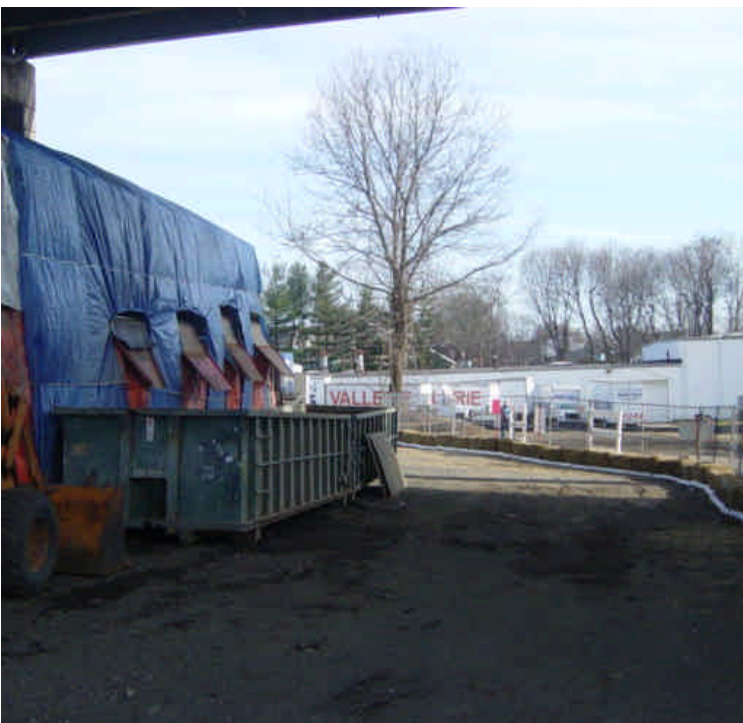
A staging area has been set-up on the south side of the Metro North R.R. in Milford. The staging area has been surrounded by haybales and a filter boom. A temporary access drive has been cut to provide access to the boat launch area. Drilling equipment is being set-up including a bentonite reclamation machine under the I-95 overpass.
