Docket No. 272 – Development and Management Plan Inspection

Underground Line Watercourse and Railroad Crossings

Date: April 10, 2008

Location: Crossings of Watercourses and Railroads in Segments 3, 4a and 4b

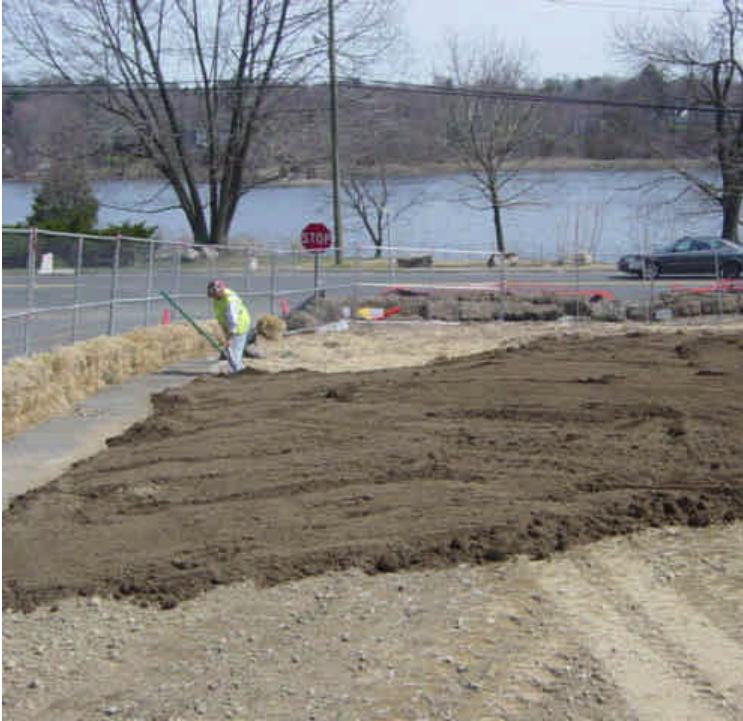
On the west side of the Saugatuck River near sta. #234, topsoil was being spread and the area was being seeded.

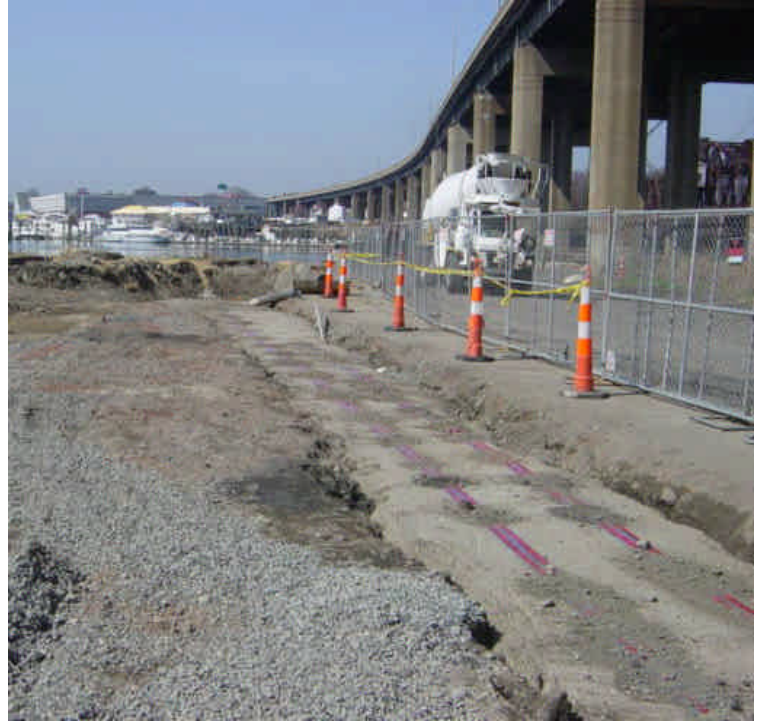
HDD work has been tied-in to the vault near sta. #1015 and the area has been partially backfilled. Final restoration or paving is still scheduled.

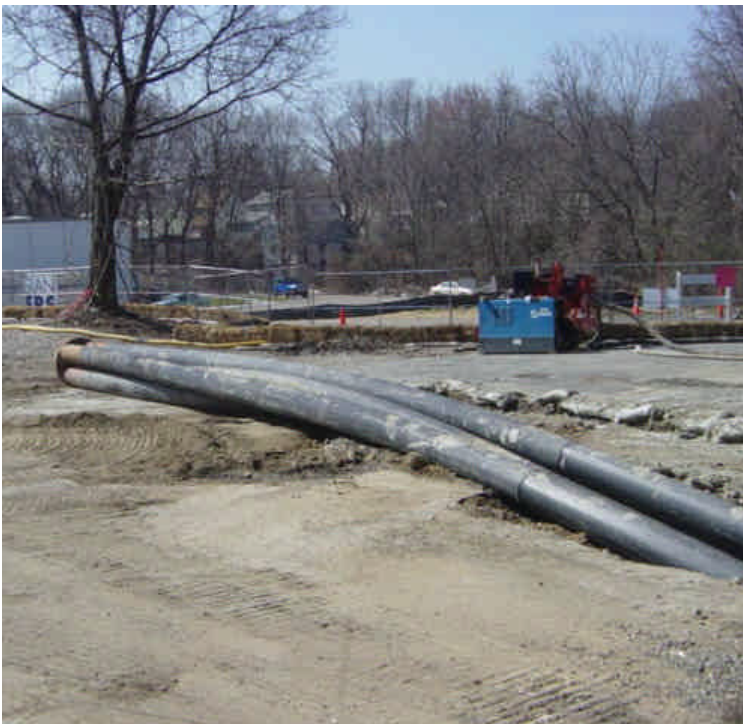
Conduit has been pulled through the first of two borings at the Metro North Railroad Crossing in Milford. A minor amount of slurry material was observed near the perimeter of the staging area, but it was being adequately contained by a haybale barrier.
