Docket No. 272 – Development and Management Plan Inspection

Underground Line Watercourse and Railroad Crossings

Date: April 17, 2008

Location: Crossings of Watercourses and Railroads in Segments 3, 4a and 4b

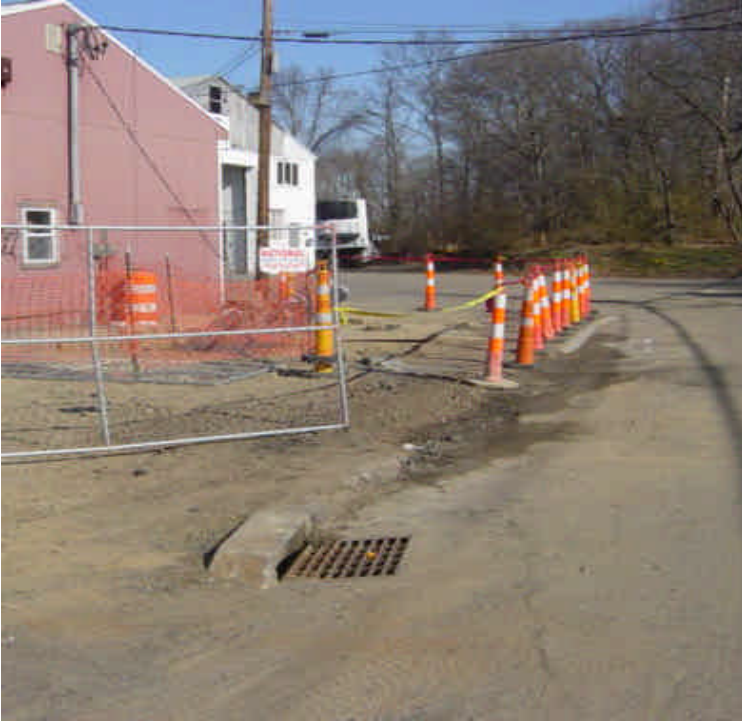
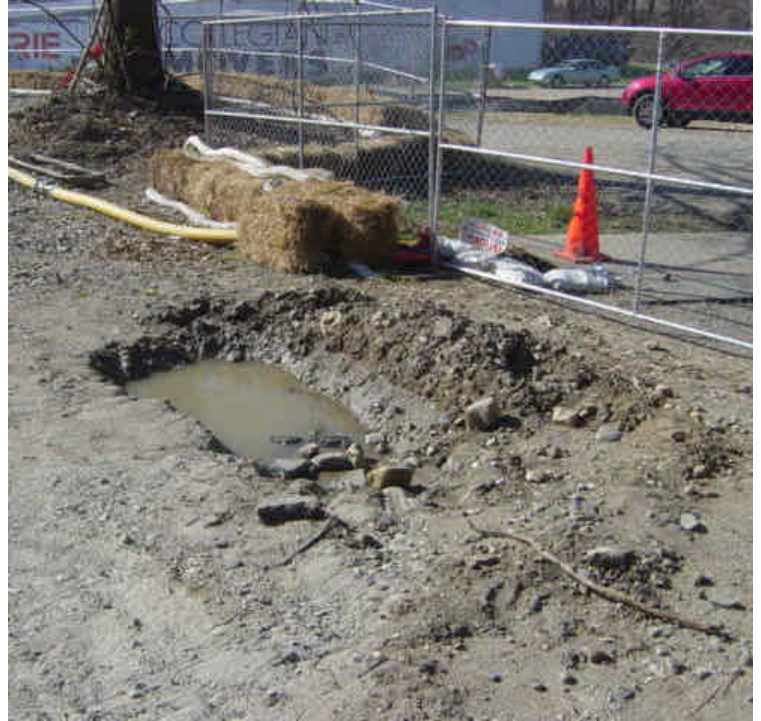
Conduit has been pulled through the first of two borings at the Metro North Railroad Crossing in Milford and there was no activity at the time of the inspection. A minor amount of slurry material was observed along the curb line along Nauagtick Ave. and the adjacent catch basin was not protected. A small pit has been excavated in the staging area but the material appears to be adequately contained at this time.

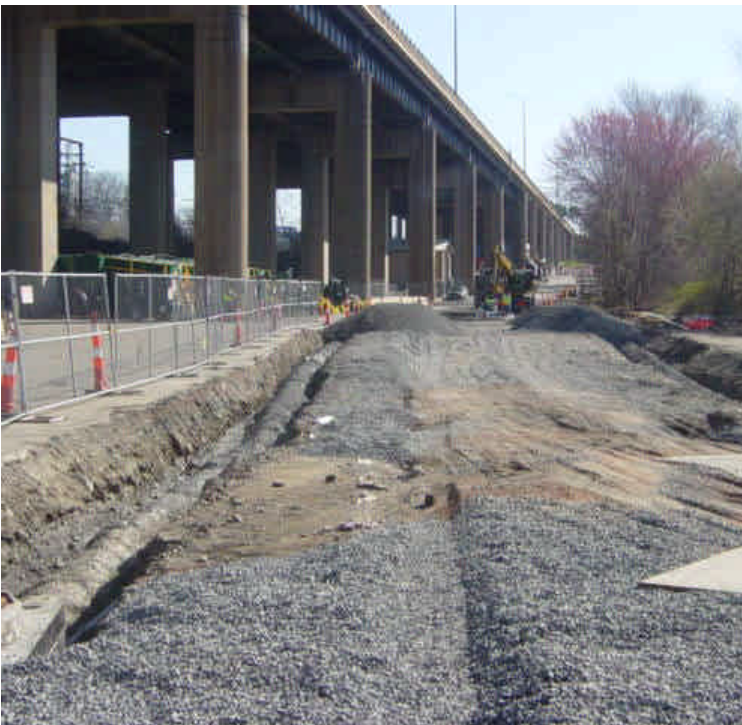
On the east side of the Housatonic River, vault tie-in work is nearing completion. Hand holes were being installed before the area is backfilled completely.

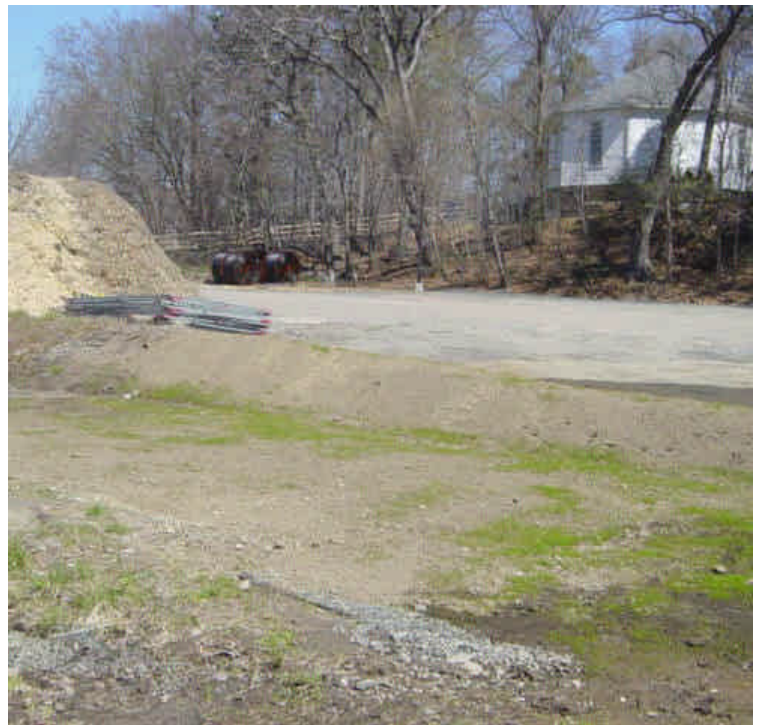
Work is complete on the east side of the Saugatuck River near sta #251. The area is partially restored. Wood chips and chain link fencing remain stockpiled in the staging area. A dirt berm was recently re-graded and grass cover is beginning to grow. Controls may be needed until the area is stable.
