Docket No. 272 - Development and Management Plan Inspection

Underground Line Watercourse and Railroad Crossings

Date: April 24, 2008

Location: <u>Crossings of Watercourses and Railroads in Segments 3, 4a and 4b</u>

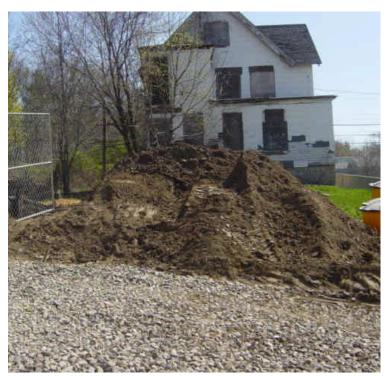
A new temporary access drive has been constructed at the Metro North Railroad crossing in Milford. Stockpiled soil is being stored outside of the controlled area and lacks adequate containment.

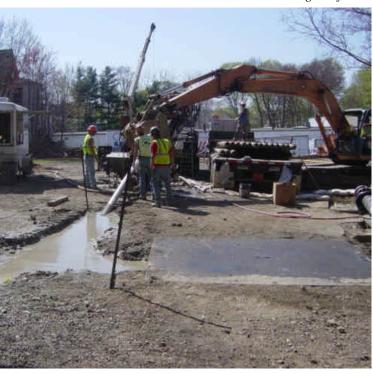
HDD work continues at the Metro North Railroad crossing in Milford. The drilling pit appears to be appropriately sized.

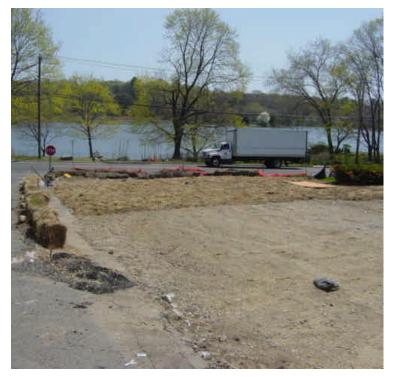
The area near sta. #231-234 has been prepared for paving for several weeks. Seed and mulch were previously spread over the areas of exposed soil that are not slated for paving.

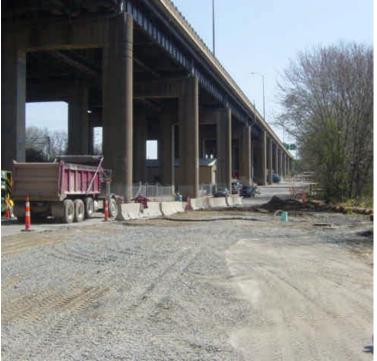
HDD vault tie-in work has been completed on the east side of the Housatonic River and the area has been backfilled in preparation for paving.
