Docket No. 272 – Development and Management Plan Inspection

Underground Line Watercourse and Railroad Crossings

Date: May 1, 2008

Location: Crossings of Watercourses and Railroads in Segments 3, 4a and 4b

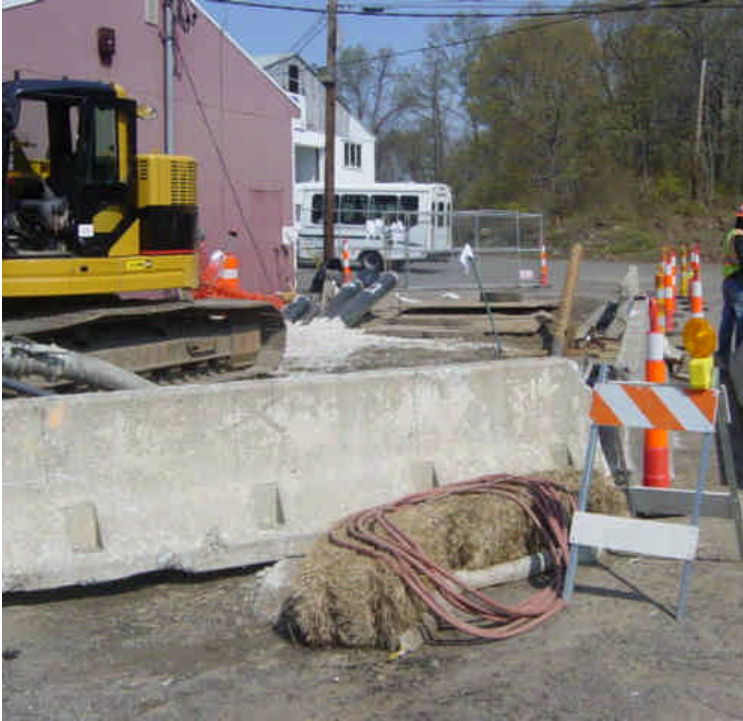
HDD work continues along Naugatuck Ave. The adjacent catch basin has been protected with hay bales and filter booms.

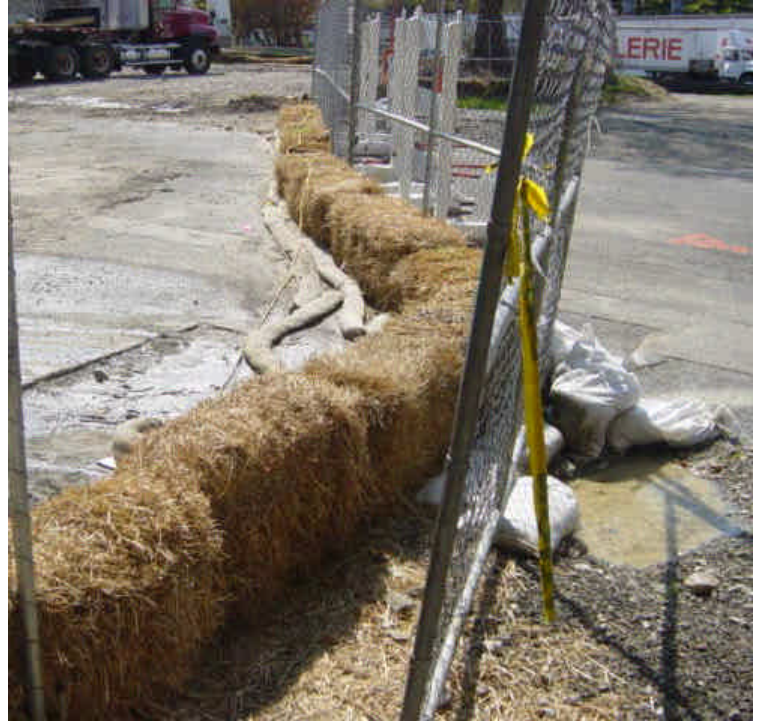
Sediment laden runoff/ slurry material was observed seeping under the hay bale barrier and beyond the fenced perimeter of the work zone in one location. Adequately control this material.

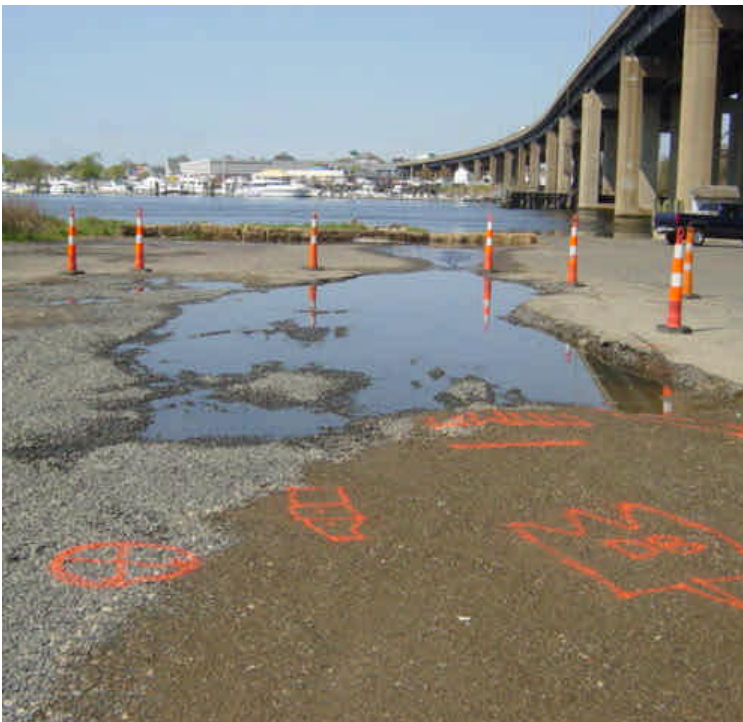
HDD work at the Housatonic River is complete. The drill pits have been backfilled and the west side has been paved. The conduits on the east side were inadvertently crossed during tie-in work and need to be partially excavated and corrected.

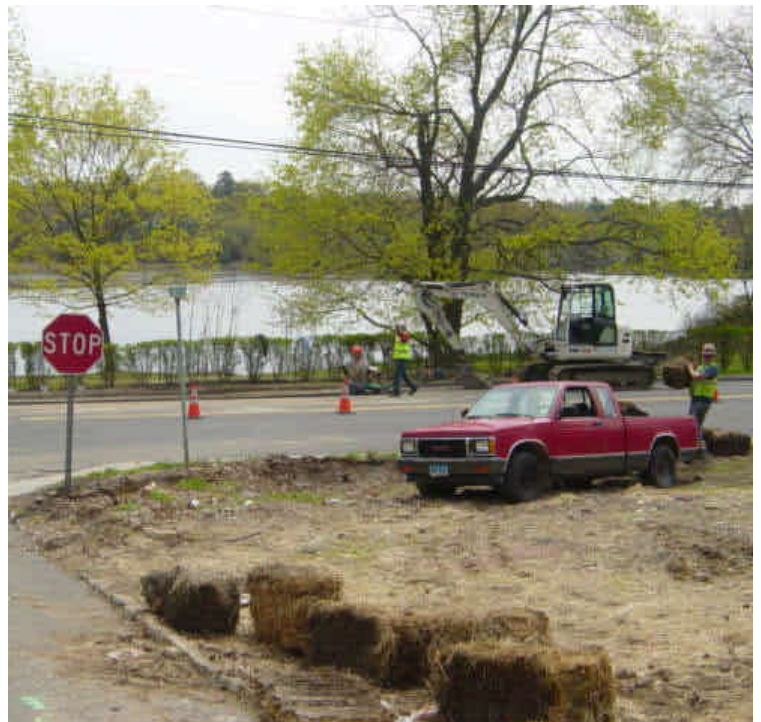
Shrubs previously removed the west side of the river near sta. #235+75 (not per the D&M) have been replaced. Hay bales were also being removed from along Riverside Dr. Continue to monitor until vegetative cover has establish in previously exposed areas.
