**Docket No. 272 – Development and Management Plan Inspection**

**Underground Line Watercourse and Railroad Crossings**

**Date:** May 22, 2008

**Location:** Crossings of Watercourses and Railroads in Segments 3, 4a and 4b

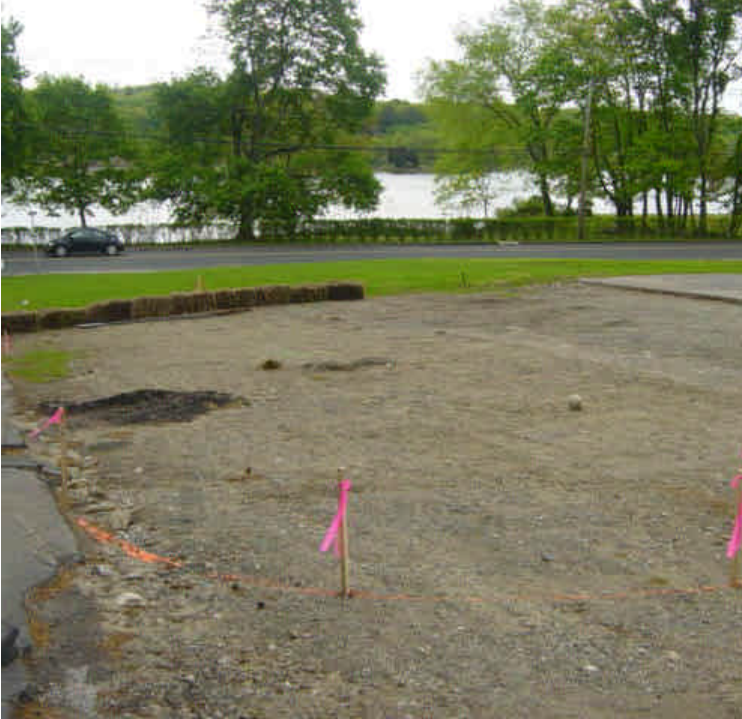
**Staging area on the west side of the Saugatuck River has been partially restored. The area has been staked out in preparation for paving. Paving has been scheduled for a number of weeks but has not yet occurred.**

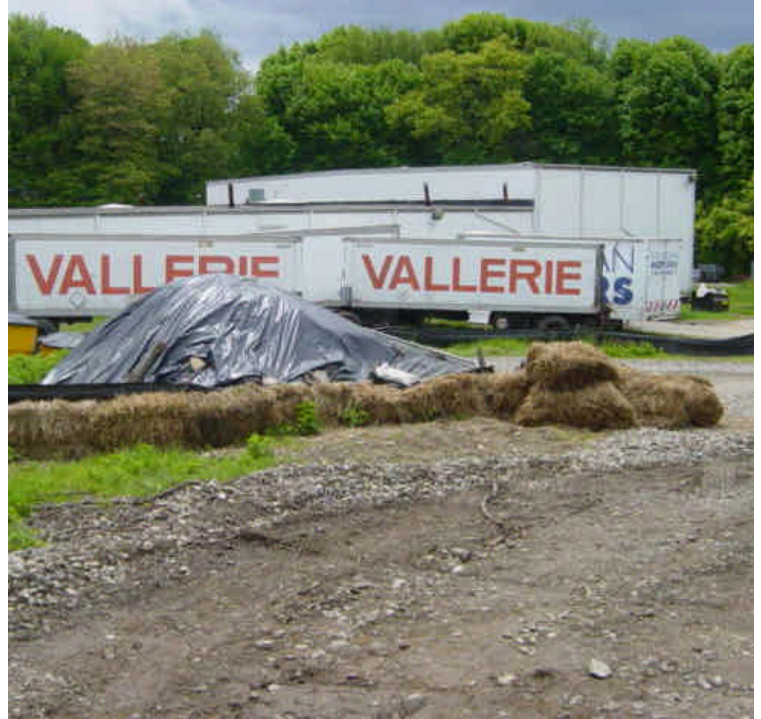
**The soil stockpile located adjacent to the staging area near the Metro North Railroad in Milford has been covered with a tarp for further containment.**

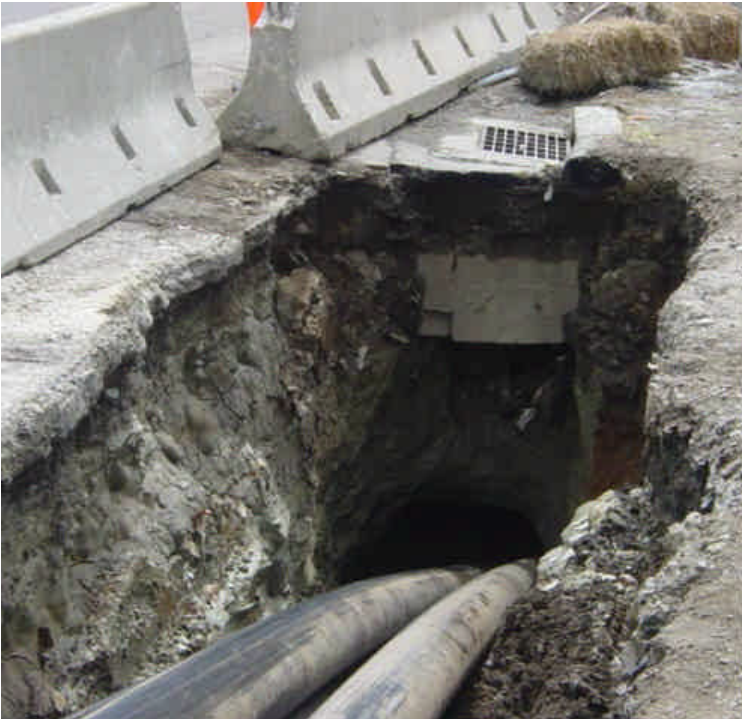
**Conduit was being pulled through the second boring at the Metro North Railroad Crossing in Milford. Catch basin will still need attention.**

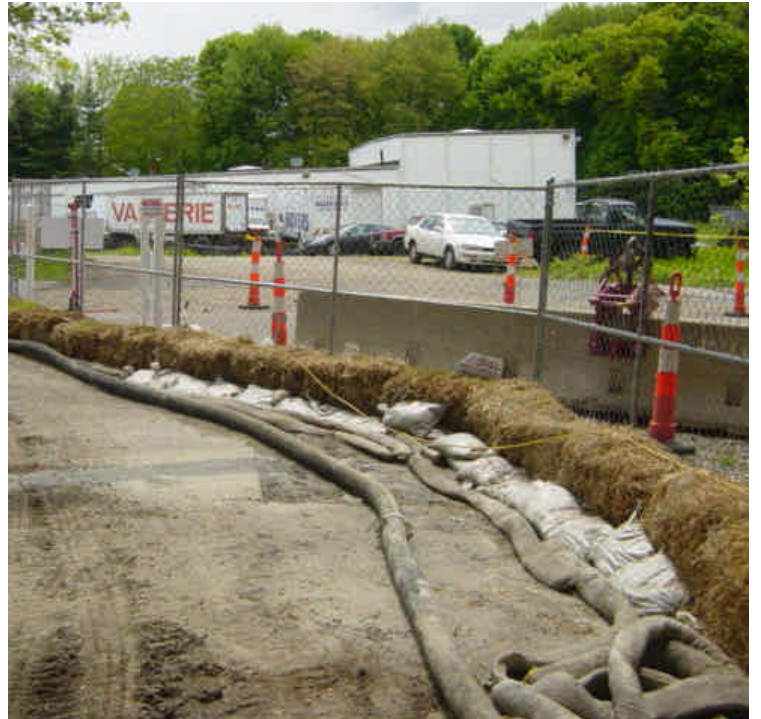
**Perimeter barrier controls remain in place around the staging area at the Metro North Railroad Crossing in Milford. Continue to adjust as necessary.**

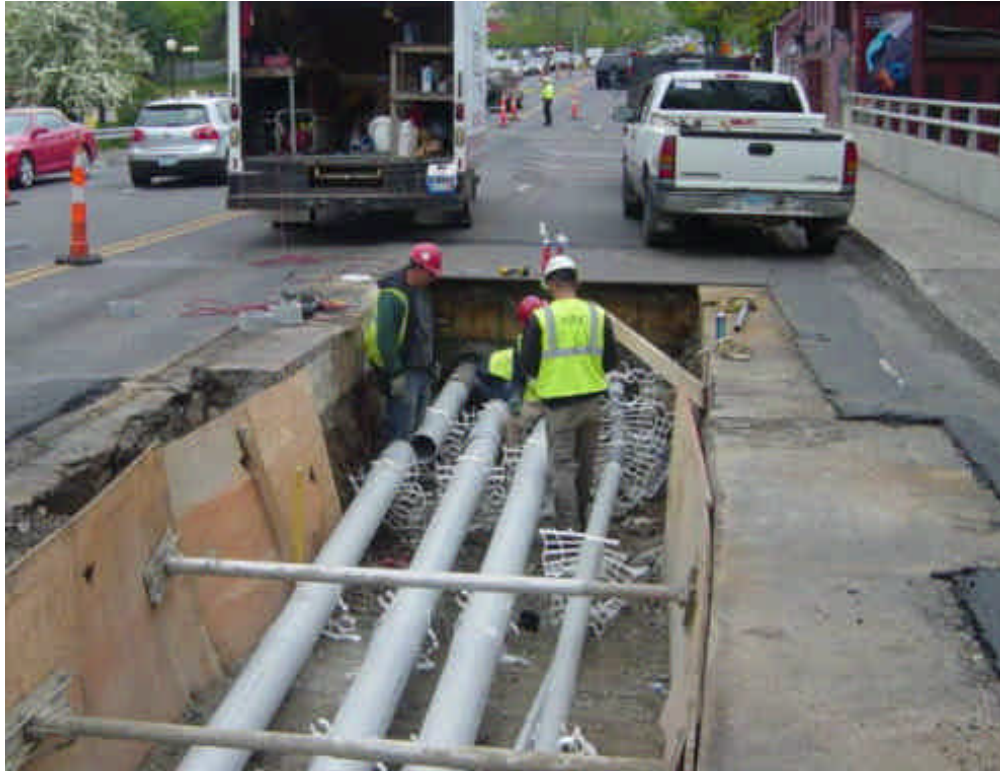
**Electrical contractor was installing conduit banks at sta. #441, connecting/tying-in to the conduit sleeves attached to the bridge deck at Sasco Creek.**
