**Docket No. 272 – Development and Management Plan Inspection**

**Underground Line Watercourse and Railroad Crossings**

**Date:** May 29, 2008

**Location:** Crossings of Watercourses and Railroads in Segments 3, 4a and 4b

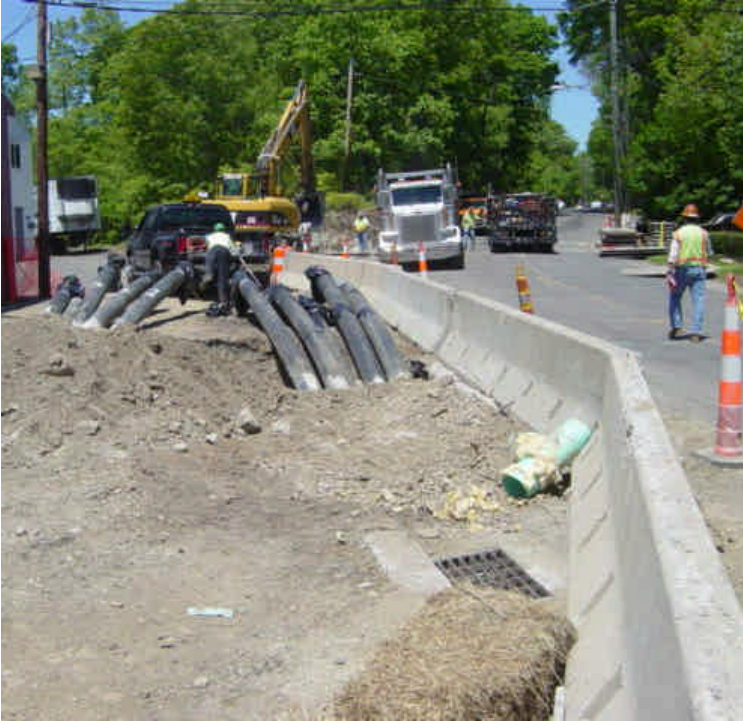
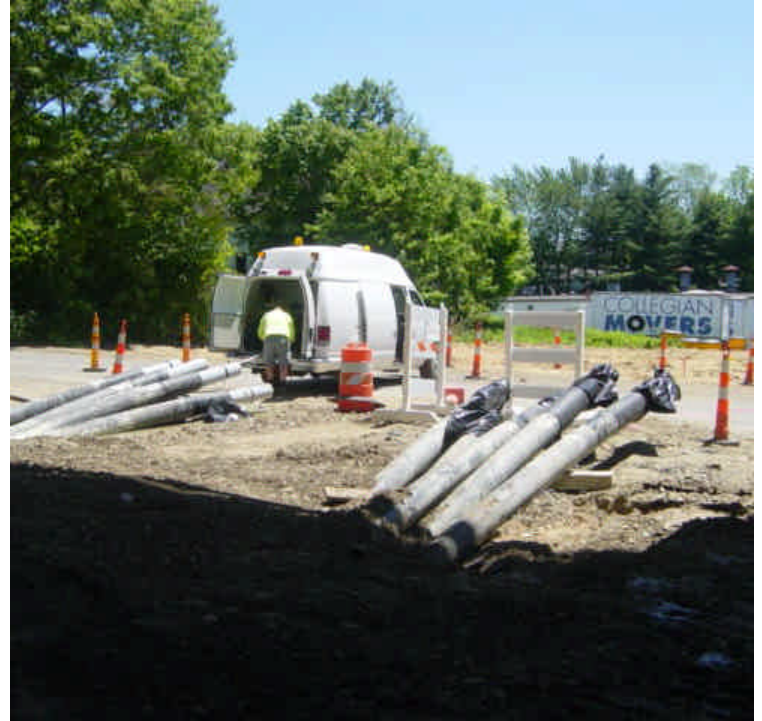
<p><b>Hay bales were removed from around a catch basin near the staging area along Naugatuck Ave. and the basin was no longer protected (since 5/15). Accumulated sediment was also observed along the edge of the roadway and along the concrete barrier curbs. 5/29/08</b></p>	<p><b>If hay bales had to be moved to accommodate work, a silt sack should be installed directly within the grate or the contractor needs to clean the catch basin as soon as work is complete. 5/15-5/29/08 Remove accumulated sediment from the roadway. 5/29/08</b></p>	<p><b>Needs attention.</b></p>
<p><b>Sasco Creek Bridge Attachment Fairfield/Westport</b></p>	<p><b>Work to attach the conduit bank to the bridge deck appears to have been completed. 5/29/08</b></p>	<p><b>Ensure that controls are in place to catch/contain any debris from falling into the river as indicated in the D&amp;M plan. 5/29/08</b></p>	<p><b>Continue to monitor.</b></p>

**Metro North RR: Conduit has been pulled through the second boring and the drill pits have been partially backfilled. Electrical contractors were on site proofing the lines. The catch basin on the north side remains unprotected.**

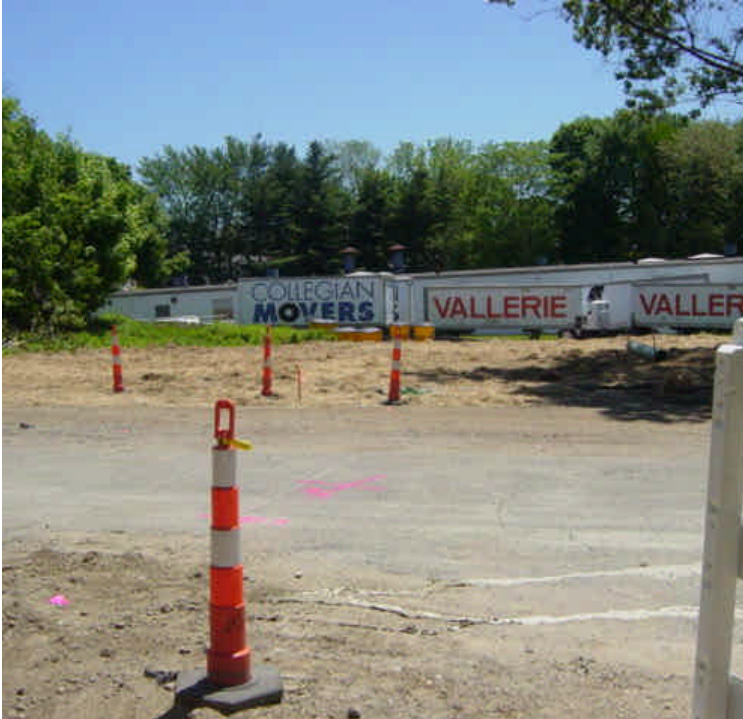
**The area near the access drive to the boat ramp where the drilling rig was previously located has been partially restored. Hay mulch has been spread to stabilize the area.**

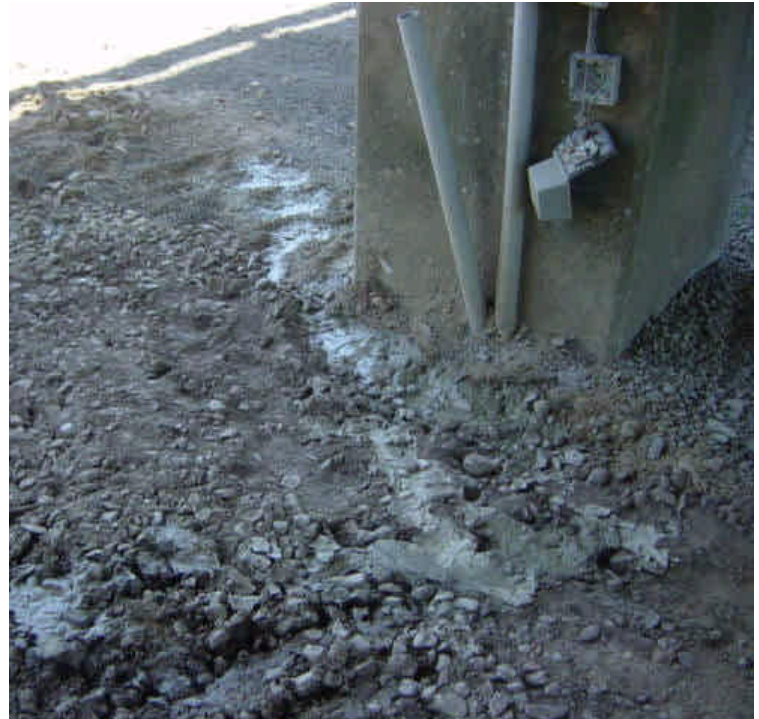
**A minor amount of residual drill slurry was observed near the base of bridge foundation.**
