Docket No. 272 – Development and Management Plan Inspection

Underground Line Watercourse and Railroad Crossings

Date: June 12, 2008

Location: Crossings of Watercourses and Railroads in Segments 3, 4a and 4b

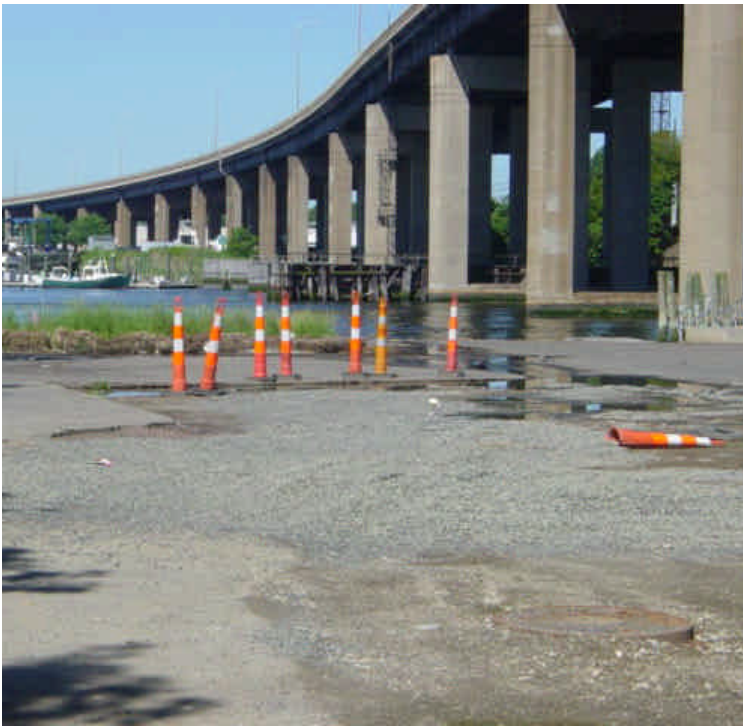
Hay bales remain along the east bank of the Housatonic River, and the area is ready to be paved. The surface should be stabilized as soon as possible as this area appears to have the potential to be inundated.

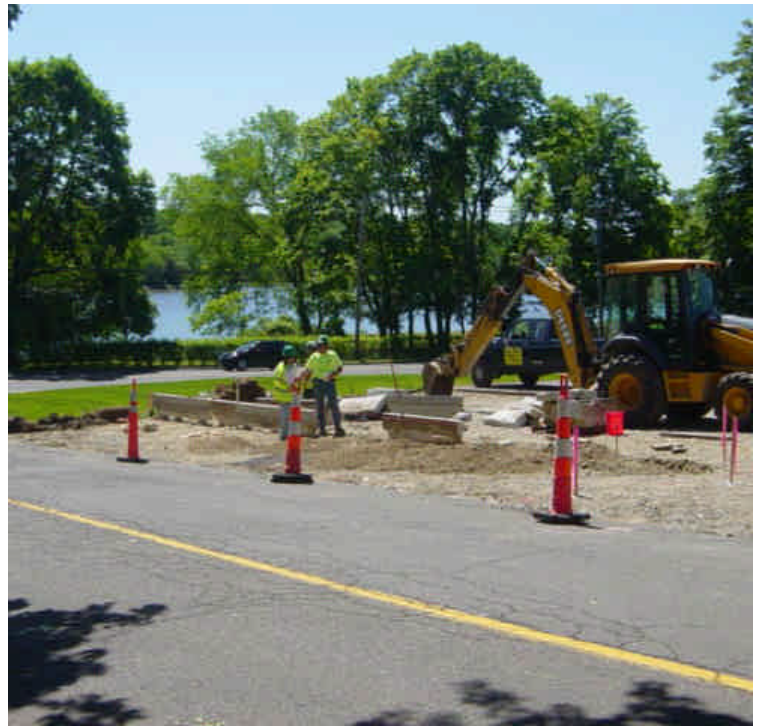
On the west side of the Saugatuck River, the portions of the work area that were restored are vegetated. The adjacent area is still waiting to be paved. Stone curbing was being set and electrical contractors were on site pulling cable.

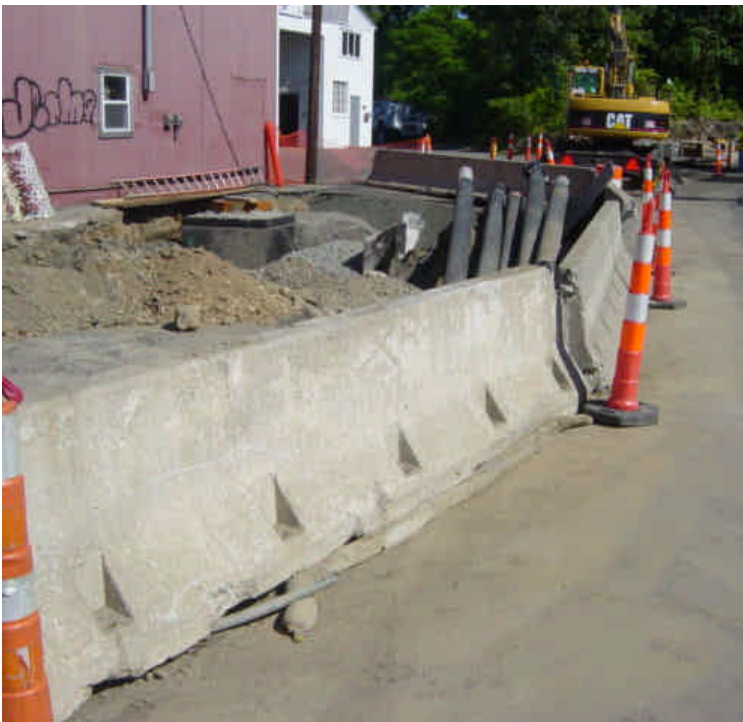
Tie-in work for one of the two circuits has been completed on the north side of the Metro North R.R. Crossing. Accumulated sediment has been swept from along the edge of the roadway. A filter boom has been installed along the edge of the barrier curb to filter runoff.

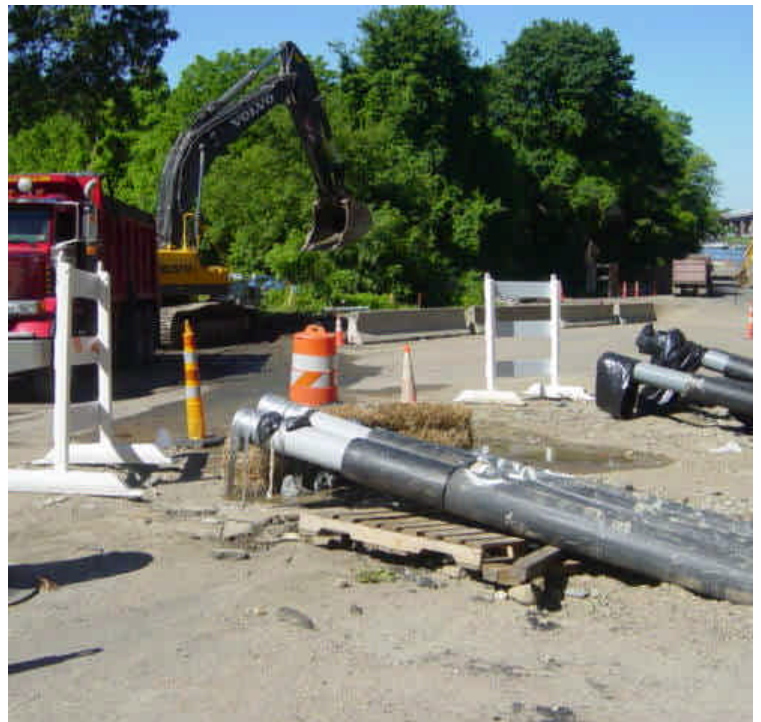
The staging area on the south side of the Metro North R.R. Crossing has been demobilized and the perimeter controls have been removed. Hay bales remain in one location near the drill pit where a minor amount of groundwater was observed seeping under the barrier. The runoff was generally clean and was flowing back towards the adjacent trench work.
