**Docket No. 272 – Development and Management Plan Inspection**

**The Connecticut Light and Power Company Certificate of Environmental Compatibility and Public Need for the construction of a new 345-kV electric transmission line and associated facilities between Scovill Rock Switching Station in Middletown and Norwalk Substation in Norwalk, Connecticut, including reconstruction of portions of existing 115-kV and 345-kV electric transmission line, the construction of Beseck Switching Station in Wallingford, East Devon Substation in Milford, (and Singer Substation in Bridgeport), modifications at Scovill Rock Switching Station and Norwalk Substation, and the reconfiguration of certain interconnections.**

**Underground Line Watercourse and Railroad Crossings**

**Date:** June 27, 2008

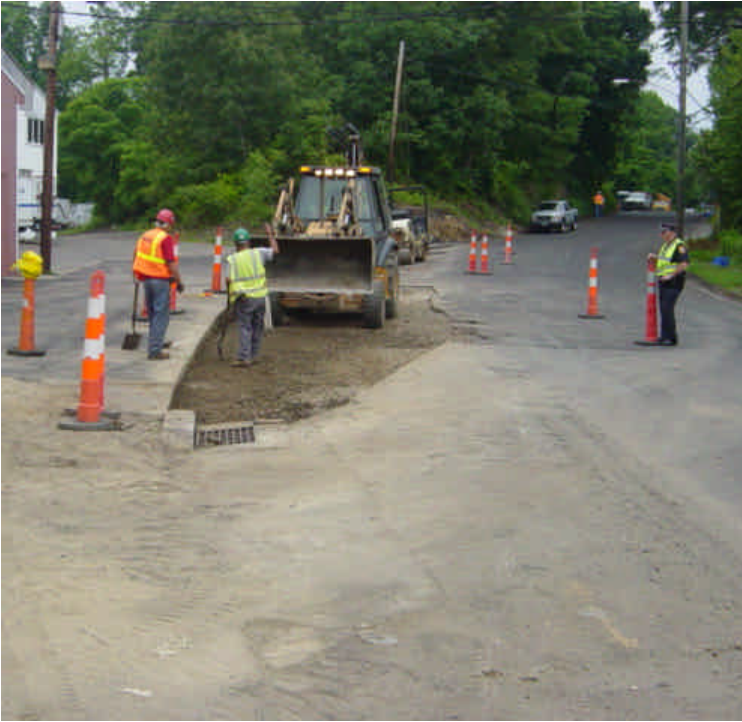
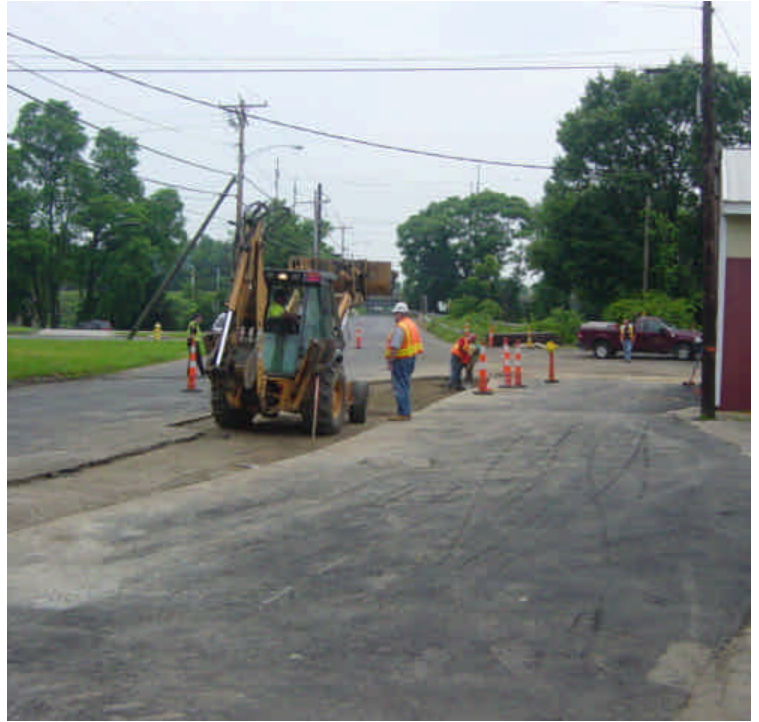
**HDD work at the Metro North R.R. is complete. The circuits have been tied in on the north side. The roadway has been partially paved except for a small area which was being regraded to ensure proper drainage. Sediment has accumulated near the end of the driveway adjacent to the catch basin which did not have controls in place.**

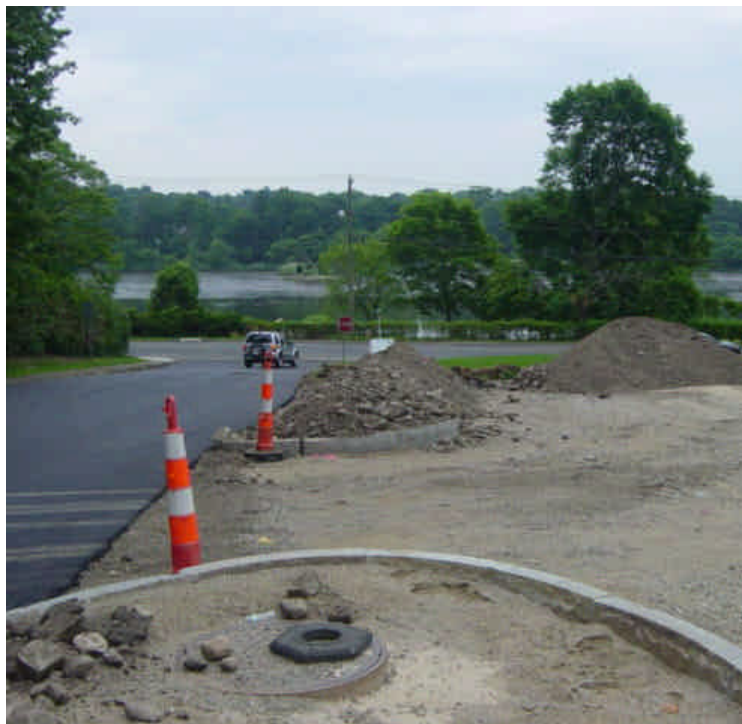
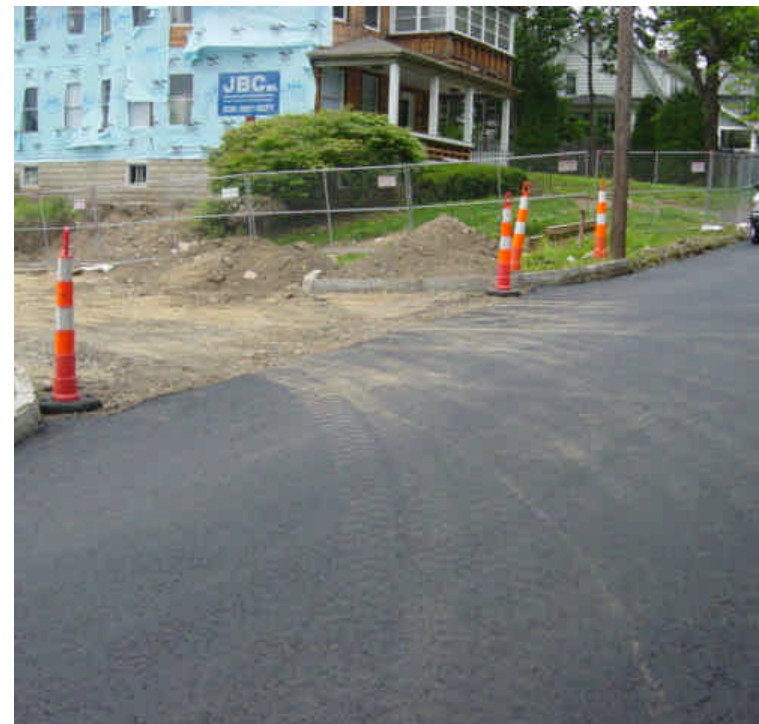
**On the west side of the Saugatuck River, the portions of the work area that were restored are vegetated. The adjacent area is still waiting to be paved. Stone curbing has been set and soil has been stockpiled in these areas. Minor tracking was observed on Lincoln St. Accumulated sediment at the intersection of Lincoln St. and Riverside Ave. has been swept. This area has been scheduled for pavement for several months.**

<b>Vault Openings and Trench Construction Saugatuck River</b>	<b>HDD work on the Saugatuck River is complete. Final restoration/ surface treatment is still required on the west side. 6/27/08</b>	<b>Monitor and maintain sediment and erosion controls. Contractors plan to pave the west side soon. 3/20-6/27/08</b>	<b>NA</b>
