Docket No. 272 – Development and Management Plan Inspection

Underground Line Watercourse and Railroad Crossings

Date: July 2, 2008

Location: Crossings of Watercourses and Railroads in Segments 3, 4a and 4b

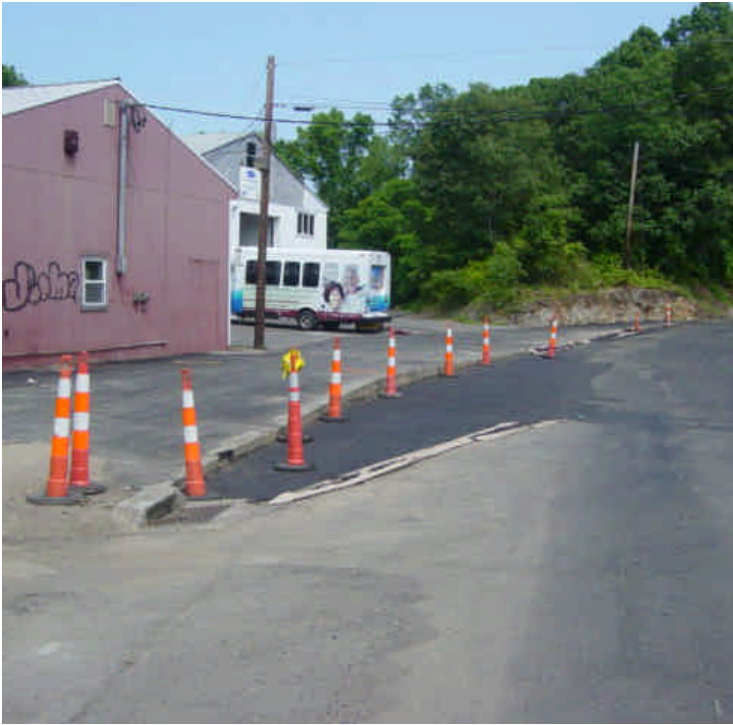
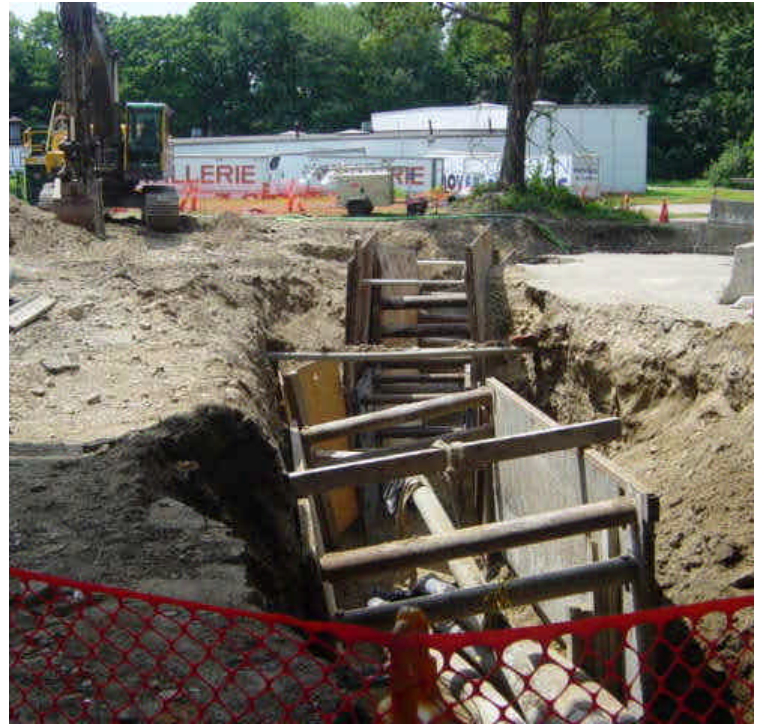
HDD work at the Metro North R.R. is complete. The circuits have been tied in on the north side. The roadway has been paved. A small area was re-graded to promote drainage. Accumulated sediment appears to have been swept near the end of the driveway adjacent to the catch basin.

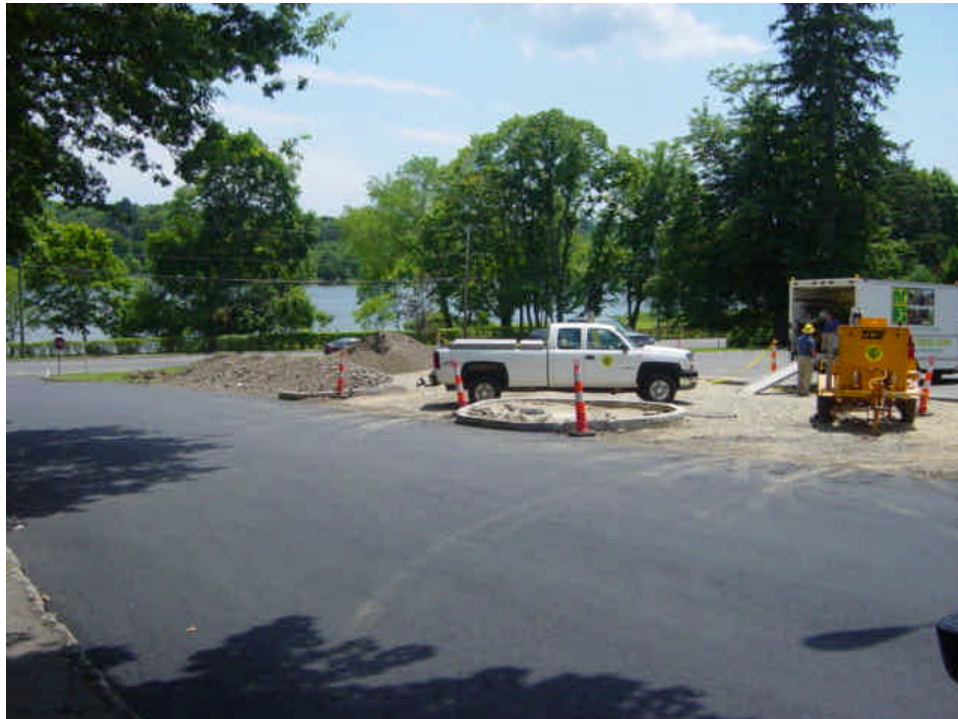
On the west side of the Saugatuck River, the staging area is still waiting to be paved. Stone curbing has been set and soil has been stockpiled in these areas. Minor tracking was observed on Lincoln St. New River Electric was on-site.
