Docket No. 272 – Development and Management Plan Inspection

Underground Line Watercourse and Railroad Crossings

Date: July 17, 2008

Location: Crossings of Watercourses and Railroads in Segments 3, 4a and 4b

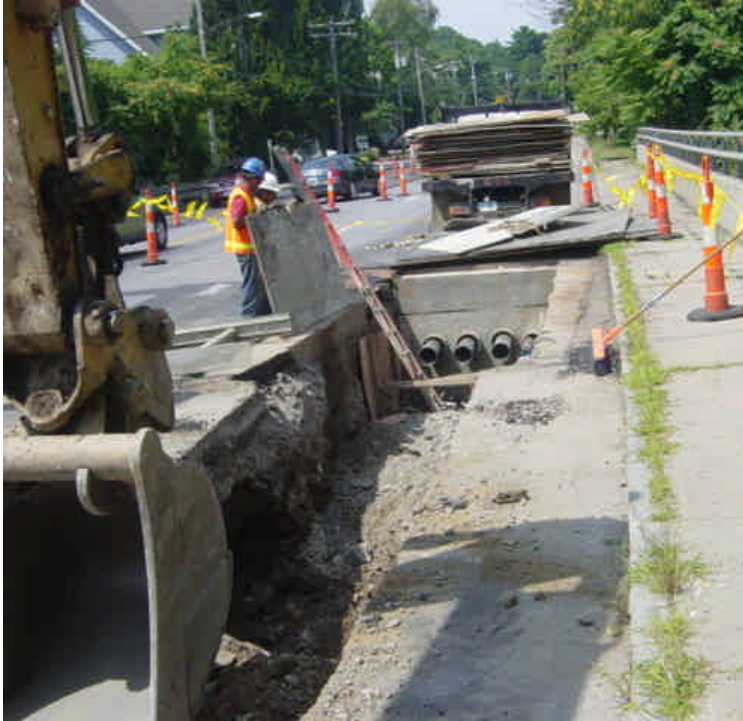
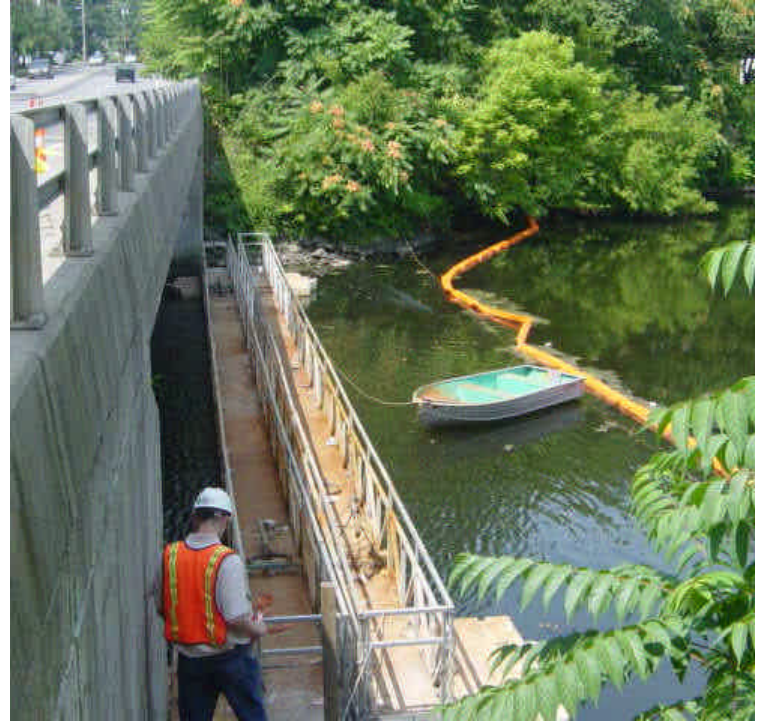
<p>Mill River (Southport Harbor) Bridge Attachment</p>	<p>Conduit tie-in work on the bridge deck was occurring at the time of</p>	<p>Ensure that controls are in place to catch/contain any debris from falling into the</p>	<p>Continue to monitor.</p>

Areas of Inspection	Observation	Recommended Action	Corrected Action
Fairfield	inspection. A filter barrier was observed within the river channel. 7/17/08	river as indicated in the D&M plan. A7/17/08	
Inland Wetland and Watercourse encroachment and mitigation	<p>The HDD of the Saugatuck River and associated wetlands in Westport is complete. Final restoration efforts continue. 7/17/08</p> <p>The HDD of the Housatonic River and associated wetlands in Stratford and Milford is complete. Final restoration and tie-in efforts continue. 7/17/08</p>	<p>None. 7/17/08</p> <p>The drill work was completed well with the approved monitoring plan provided in the D&M plan 7/17/08</p>	<p>NA</p> <p>NA</p>
Staging, Storage, and Parking Areas Housatonic River	Restoration efforts are on hold on the east side until the final tie-in work at the nearby Metro North HDD site is complete so that all of the restoration work can be completed at once. 7/17/08	Contain all material within the established limits of work zone and clean and restore the areas appropriately. See Erosion Control section for more details. 7/17/08	Continue to monitor.

Tie-in work was occurring at the Mill River (Southport Harbor) Bridge Attachment. Work did not appear to impact the River. A filter barrier is in place in the channel.

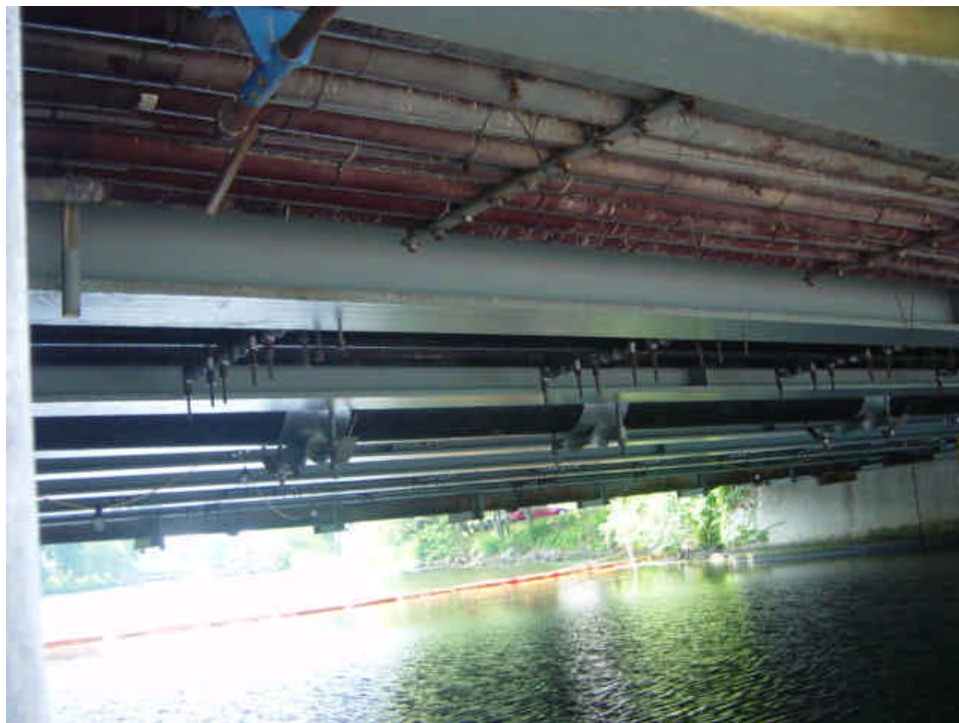
Conduit has been attached to the bridge over the Mill River (Southport Harbor).
