**Docket No. 272 – Development and Management Plan Inspection**

**Underground Line Watercourse and Railroad Crossings**

**Date:** August 21, 2008

**Location:** Crossings of Watercourses and Railroads in Segments 3, 4a and 4b

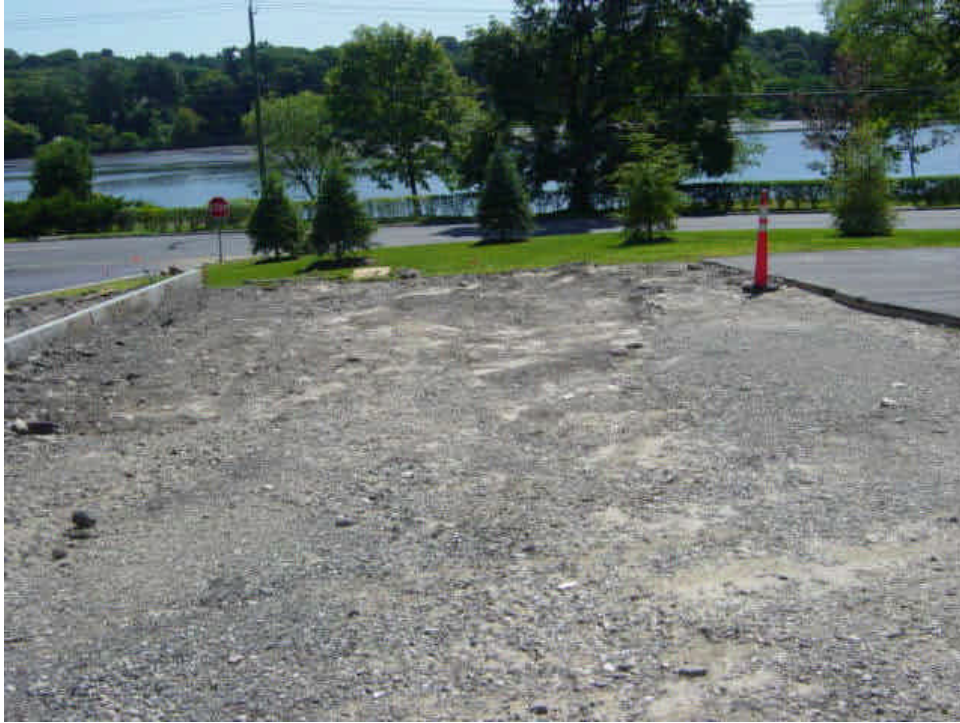
**On the west side of the Saugatuck River, portions of the work area have re-vegetated. The adjacent area is still waiting to be paved (since 3/20) with the potential for run-off.**

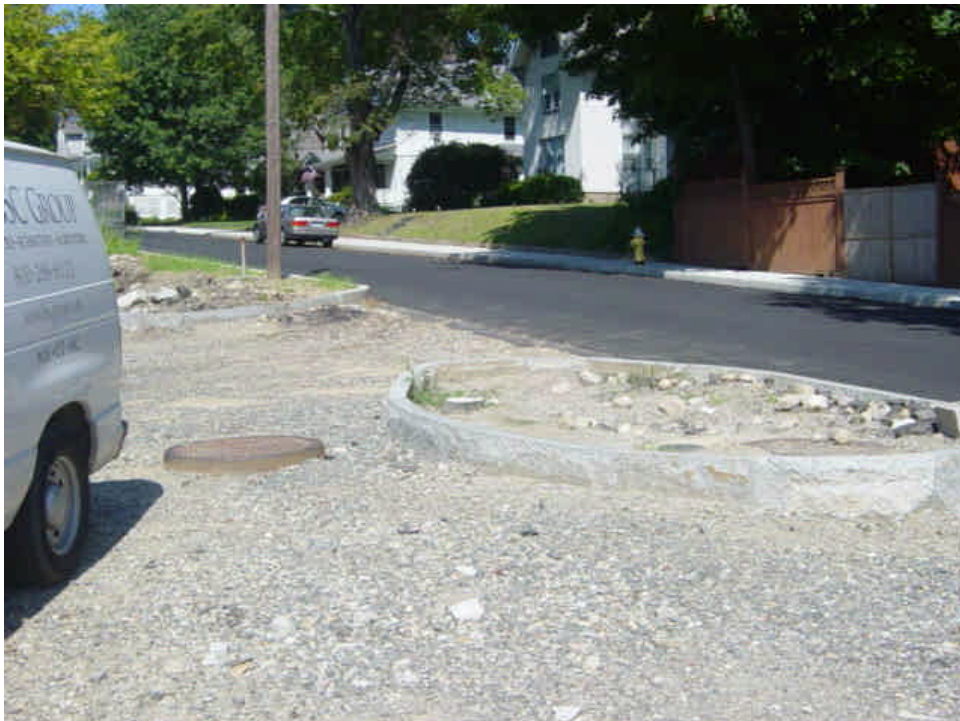
**On the west side of the Saugatuck River stone curbing has been set and soil has been spread in some areas. Final surfacing is needed here as soon as possible.**
