Docket No. 272 – Development and Management Plan Inspection

The Connecticut Light and Power Company Certificate of Environmental Compatibility and Public Need for the construction of a new 345-kV electric transmission line and associated facilities between Scovill Rock Switching Station in Middletown and Norwalk Substation in Norwalk, Connecticut, including reconstruction of portions of existing 115-kV and 345-kV electric transmission line, the construction of Beseck Switching Station in Wallingford, East Devon Substation in Milford, (and Singer Substation in Bridgeport), modifications at Scovill Rock Switching Station and Norwalk Substation, and the reconfiguration of certain interconnections.

Underground Line Watercourse and Railroad Crossings

Date: September 5, 2008

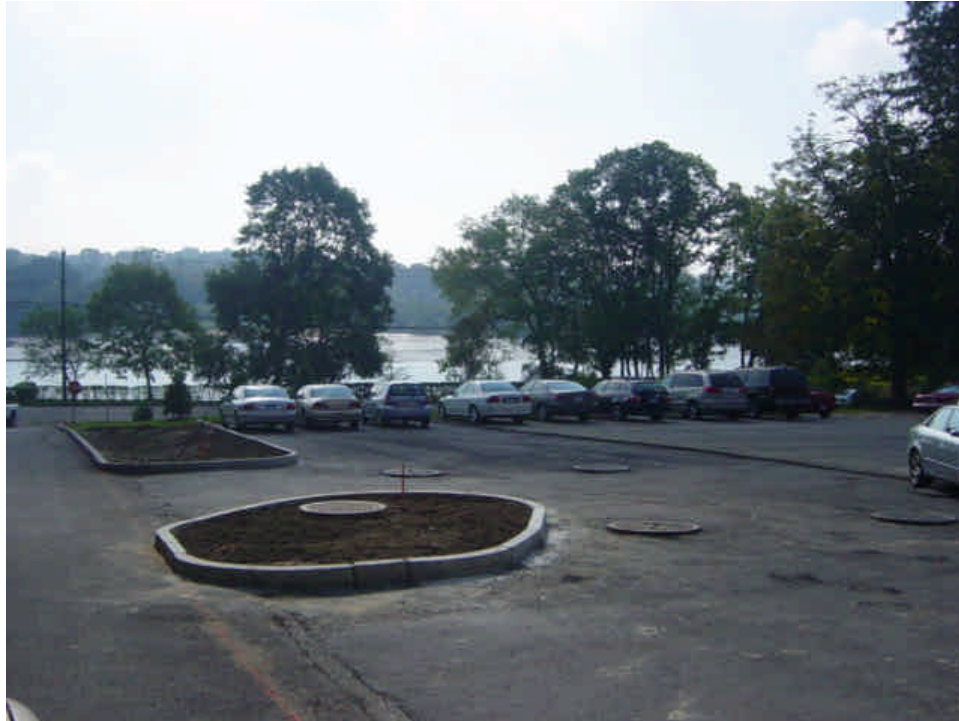
On the west side of the Saugatuck River, stone curbing has been reset and the parking lot received a base coat of pavement.

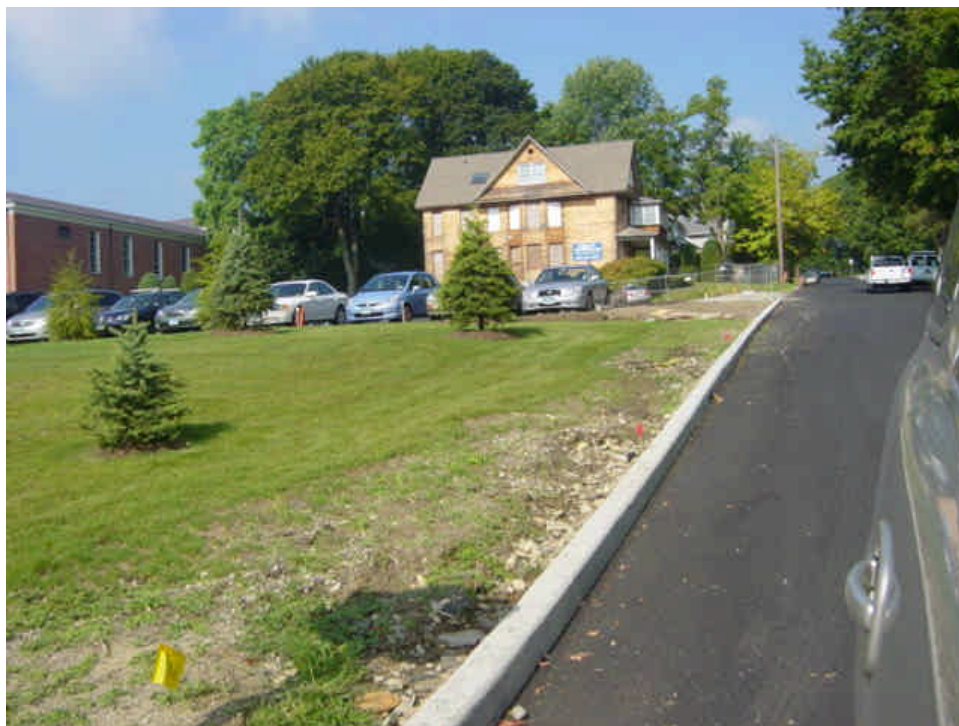
On the west side of the Saugatuck River, curbing has been reset along Lincoln Street. Continue to stabilize the soil located immediately adjacent with grass cover.
