Docket No. 272 - Development and Management Plan Inspection

Underground Line Watercourse and Railroad Crossings

Date: September 12, 2008

Location: Crossings of Watercourses and Railroads in Segments 3, 4a and 4b

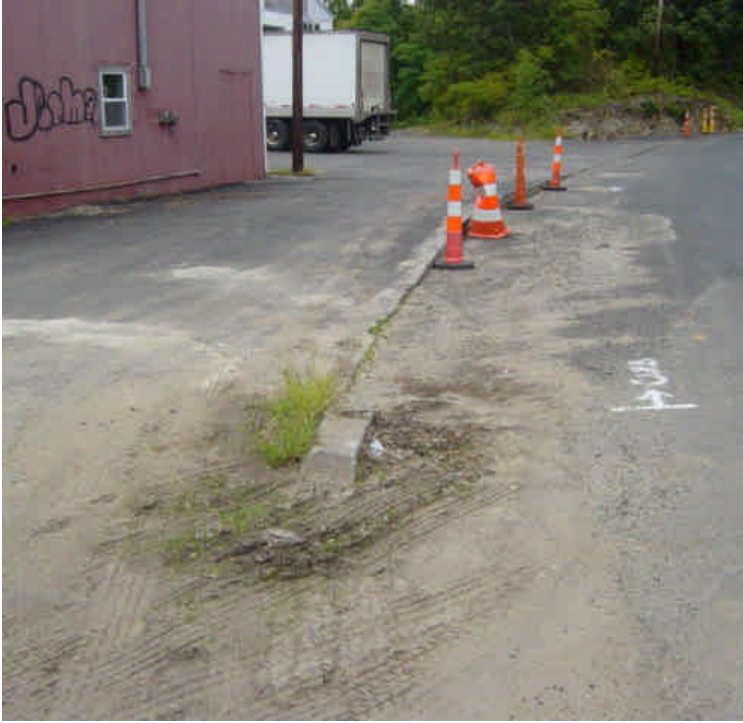
Sediment was observed along the curb line near the Metro North HDD staging area off of Naugatuck Ave. This material may not be project related.

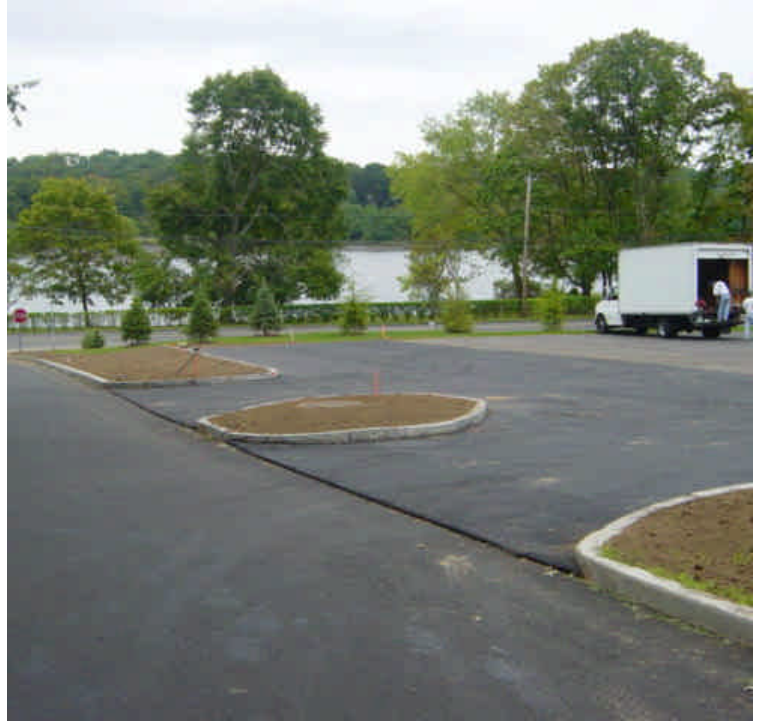
Parking lot near sta. #234 has been repaved and the island areas appear to have been seeded. Provide mulch to prevent exposure to erosion.

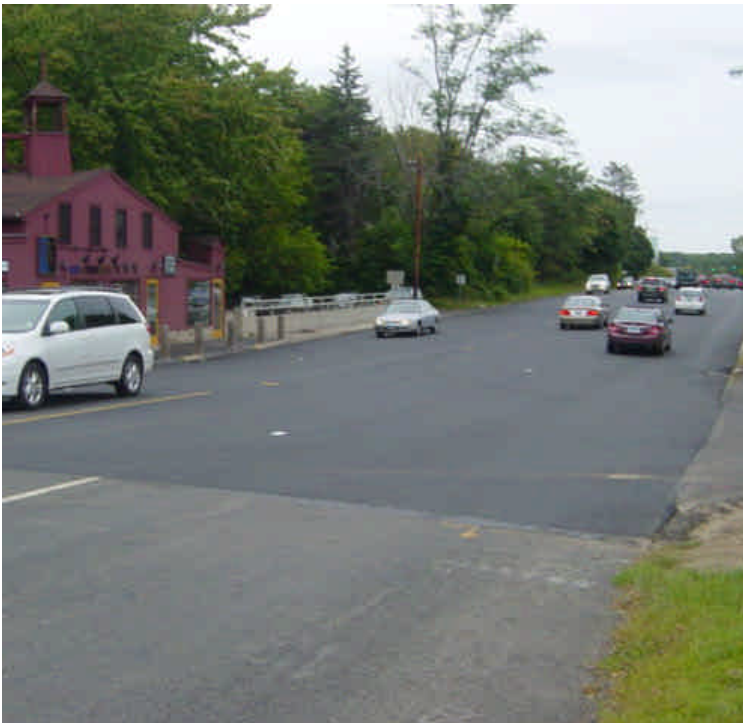
Pavement has been restored in the areas of both bridge attachments (sta. #433-434 & #512-513).
