Docket No. 272 – Development and Management Plan Inspection

Underground Line Watercourse and Railroad Crossings

Date: October 16, 2008

Location: Crossings of Watercourses and Railroads in Segments 3, 4a and 4b

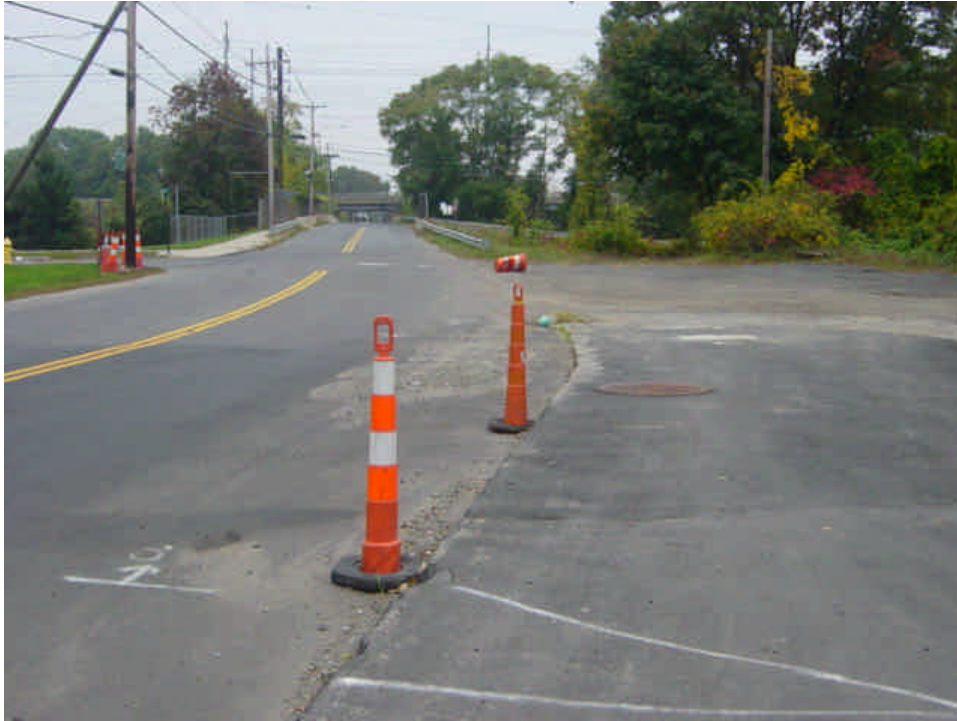
Areas of Inspection	Observation	Recommended Action	Corrected Action
	<p>temporary access road, which provided access to the boat launch. 10/16/08</p> <p>Hay bales were removed from around a catch basin near the staging area along Naugatuck Ave. A minor amount sediment and sand appeared to have entered the adjacent catch basin. (since 5/15). Some sediment was still noted on the roadway but may not be project related. 10/16/08</p>	<p>10/16/08</p> <p>The catch basin may need to be cleaned once work is complete. Continue to sweep roadway as necessary. 10/16/08</p>	<p>Catch basin still needs attention.</p>
<p>Inland Wetland and Watercourse encroachment and mitigation</p>	<p>The HDD work has been completed and affected resource areas have been restored. 10/16/08</p>	<p>None. 10/16/08</p>	<p>NA</p>
<p>Staging, Storage, and Parking Areas Metro North R.R. - Milford</p>	<p>The south staging area has been restored while additional efforts are still needed on the north side. 10/16/08</p>	<p>Continue to monitor the area. See Erosion Control section for more details. 10/16/08</p>	<p>Needs additional restoration.</p>

Staging area for the Metro North Railroad HDD along Naugatuck Ave remains unchanged from the previous week. Sediment and sand remains in and around the catch basin. The catch basin needs to be cleaned out.
