Docket No. 272 – Development and Management Plan Inspection

East Devon Substation Inspection

Date: March 19 & 23, 2007

Location: East Devon Substation

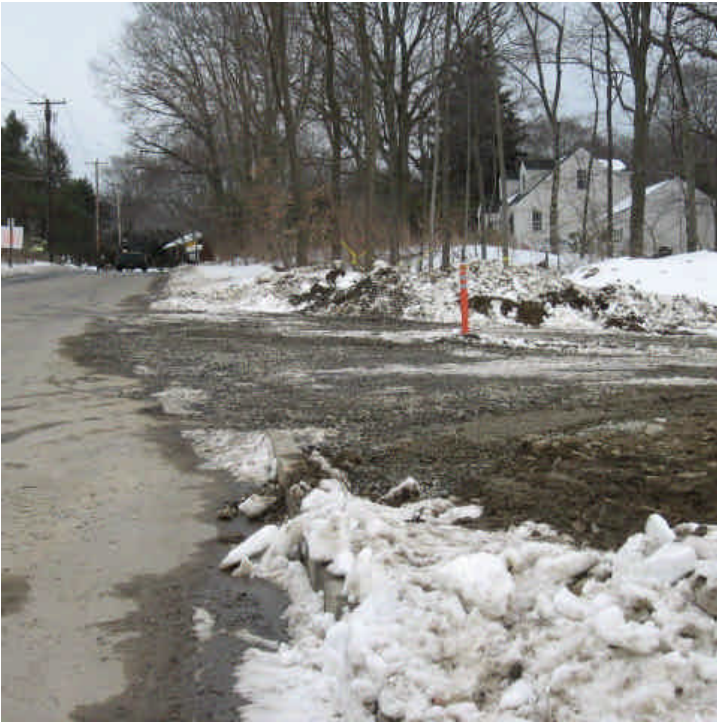
Shelland Street (new location) was very muddy at the time of inspection and some sediment tracking was noted on Plains Rd. 3/19/07.

Areas of Inspection	Observation	Recommended Action	Corrected Action
Access Roads and Adjacent Roadways	Work associated with the relocation of Shelland St continues to the east of the existing overhead ROW. Raised catch basins (CBs) are noted in the area but are non-operational at this time. 3/23/07	Continue to monitor and add controls as necessary. 3/23/07.	Not Applicable (NA)
	Access points are noted and roadways are being constructed in two locations off Plains Rd and at the relocated Shelland St. 3/23/07	Continue to monitor for sediment tracking and construct stone access pads at the entrances to reduce tracking. 3/23/07	NA
	On 3/19/07, sediment tracking was noted on Plains Rd. at all access points. A significant swath of mud was noted at the western access. By 3/23/07, it appeared that attempts had been made to sweep the roadway.	Continue to monitor for sediment tracking and sweep the roadway on a regular basis. 3/23/07	The roadway appears to have been swept by 3/23/07 in response to the 3/19 inspection.

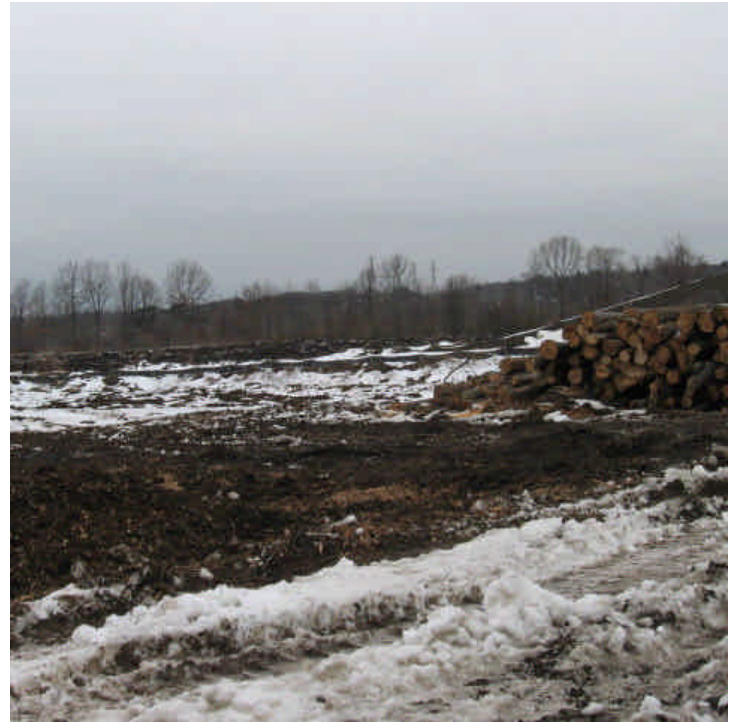
View of the clearing at the East Devon Substation site. 3/19/07.

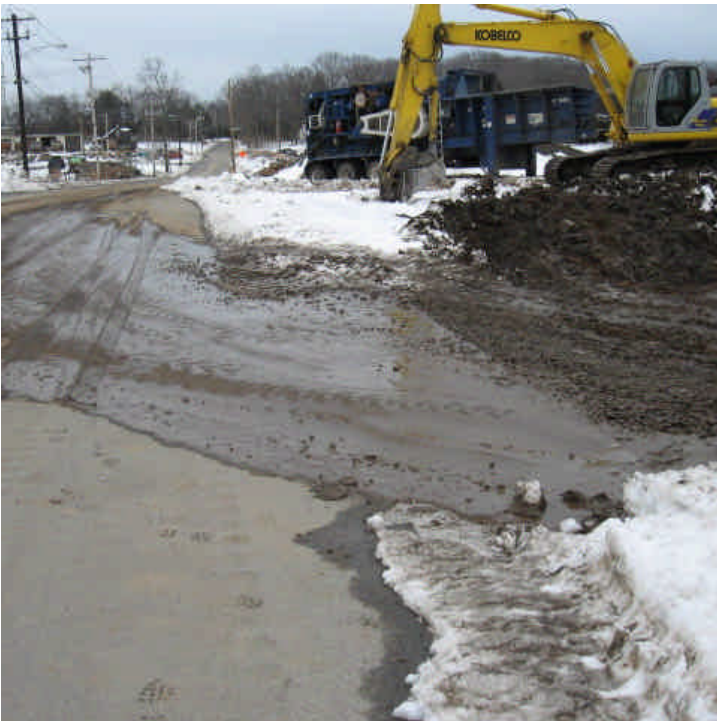
A significant amount of mud was being tracked into the roadway at the western construction entrance off Plains Road. 3/19/07.

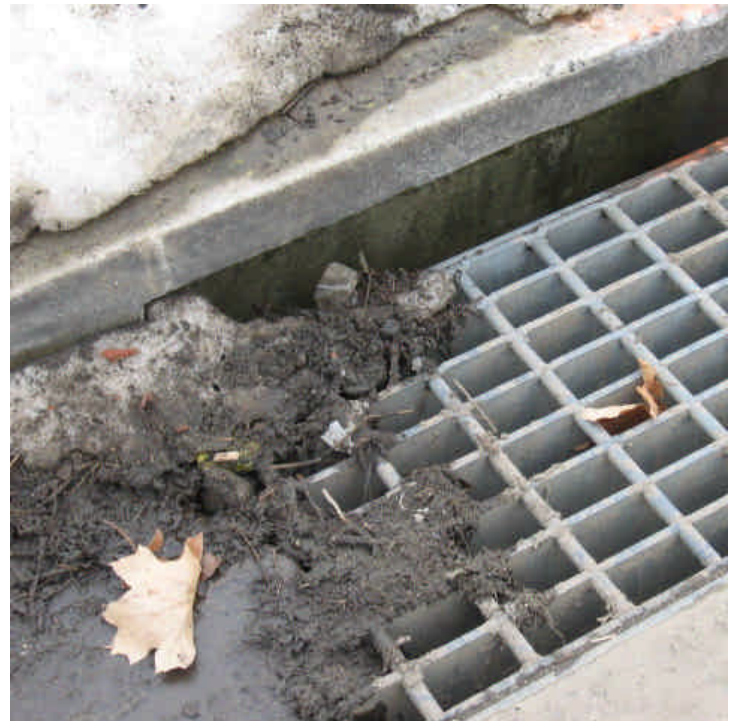
“Silt saks” (or similar) were not observed within the CBs along Plains Rd. in the vicinity of the constructed access roads on 3/19/07. However, silt	Continue to monitor and maintain as necessary. See Erosion Control Section for more detail. 3/23/07.	CB controls were in place on 3/23/07 in response to the 3/19 inspection.

The catch basins along Plains Road were not protected with silt sacks or similar. Curb drop inlet protection was also not provided. 3/19/07.

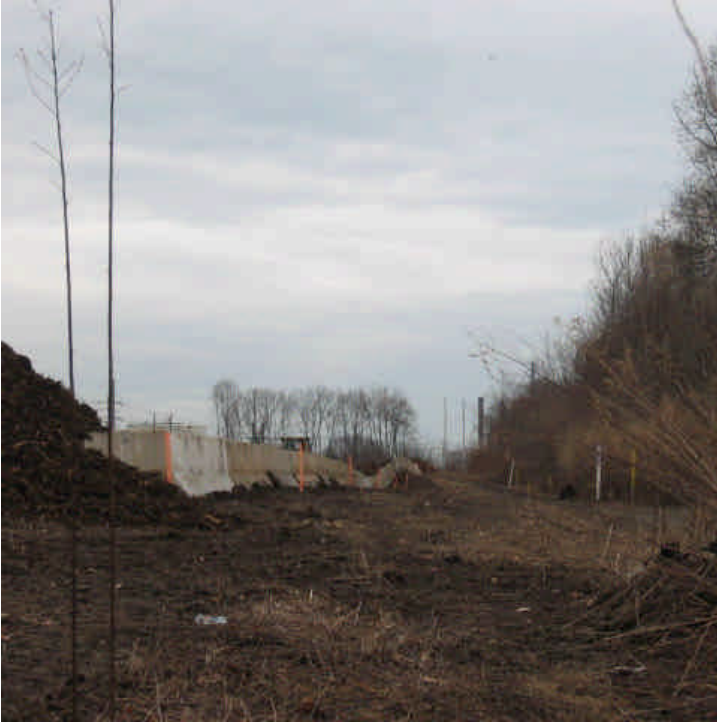
Jersey barriers were in place along the western boundary of the substation site. 3/23/07.

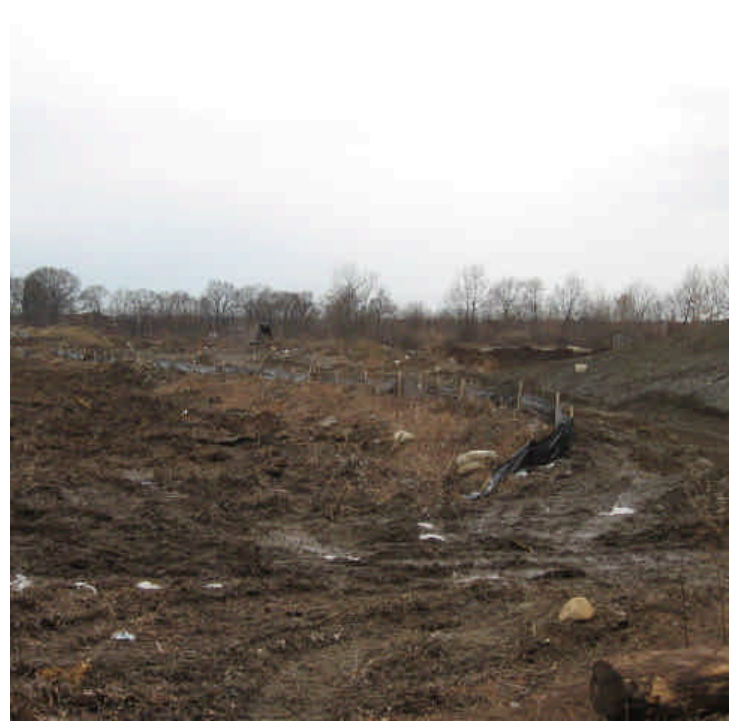
View of the ongoing clearing and grading activities. 3/23/07.

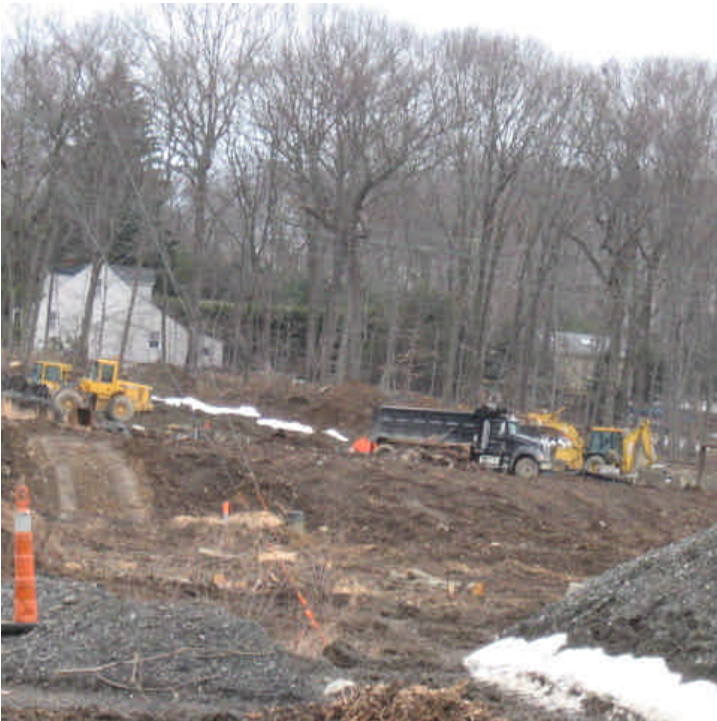
Work associated with the relocation of Shelland Street continues. 3/23/07.

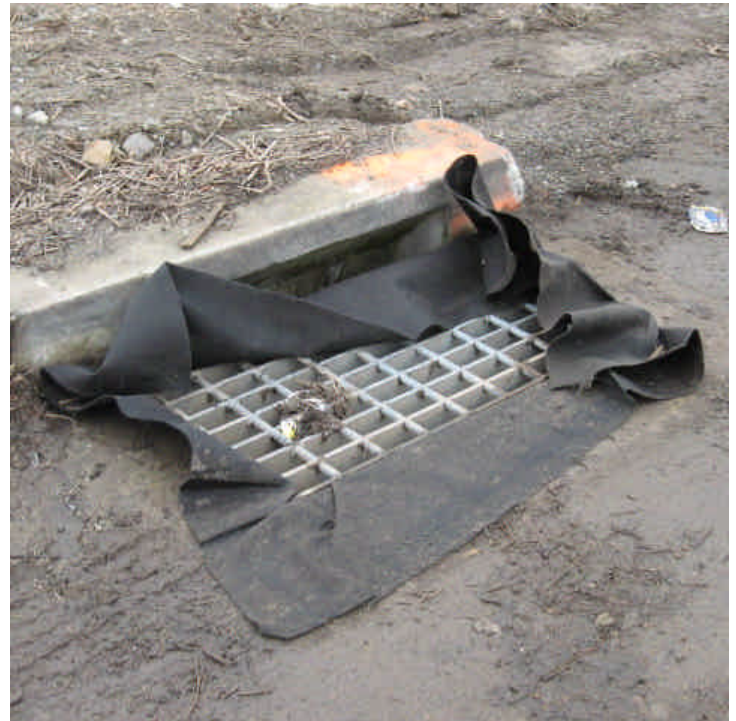
Silt saks were installed within the catch basins along Plains Road. Fabric was pulled over the curb inlets in some locations. 3/23/07.
