Docket No. 272 – Development and Management Plan Inspection

Segment 2b Inspection

Date: March 19 & 23, 2007

Location: Segment 2b – Cheshire/Hamden Town Line to East Devon Substation

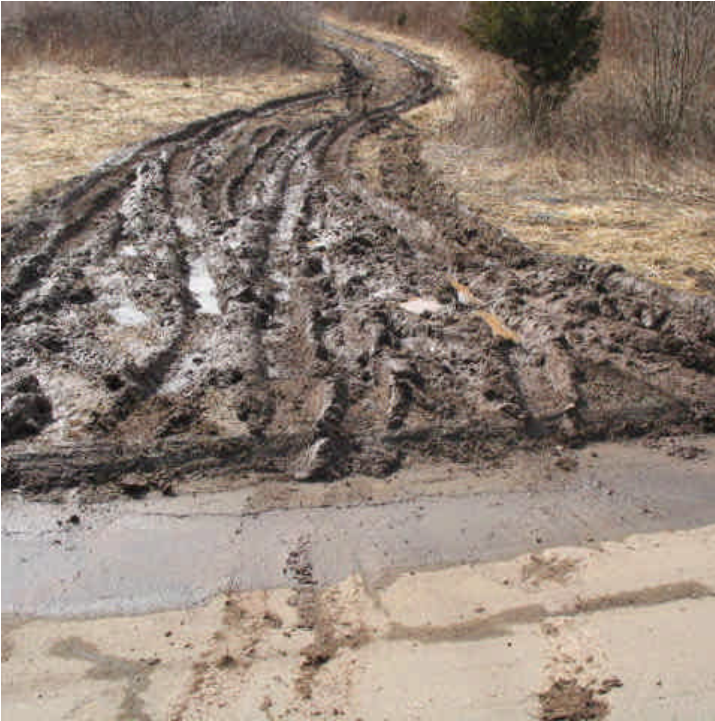
Old Lane Rd (Hamden): The entrance to the overhead ROW access road was very muddy this week. Sediment tracking was noted within the roadway. 3/13/07

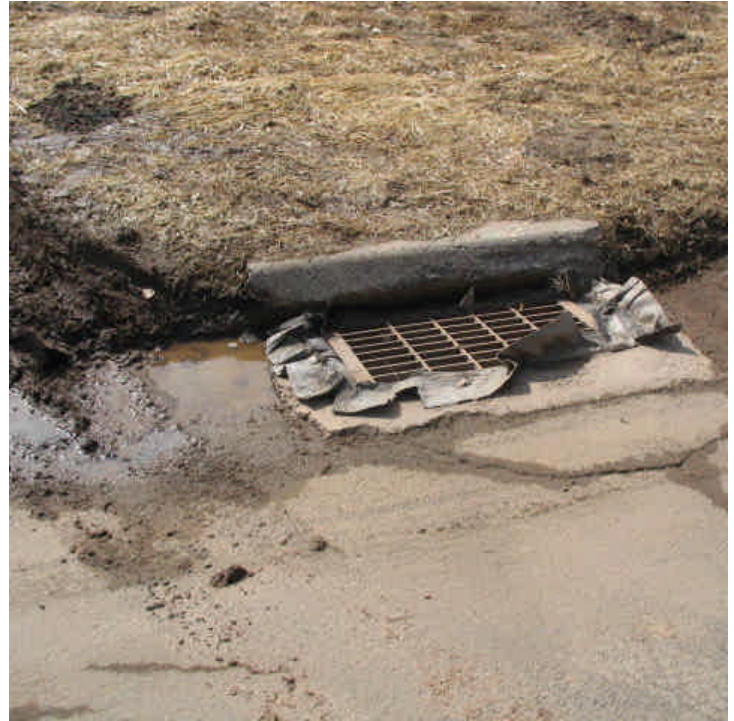
Old Lane Rd: The catch basin adjacent to the ROW access road is still receiving turbid runoff from the overhead ROW. There is no curb drop inlet protection here. 3/13/07.

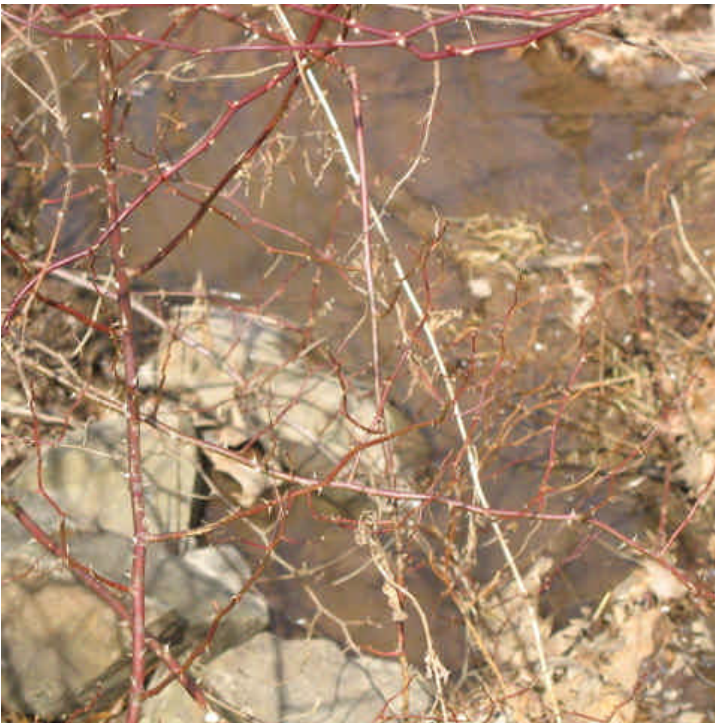
Old Lane Rd: Turbid water was noted within the adjacent, receiving wetland again this week. 3/13/07

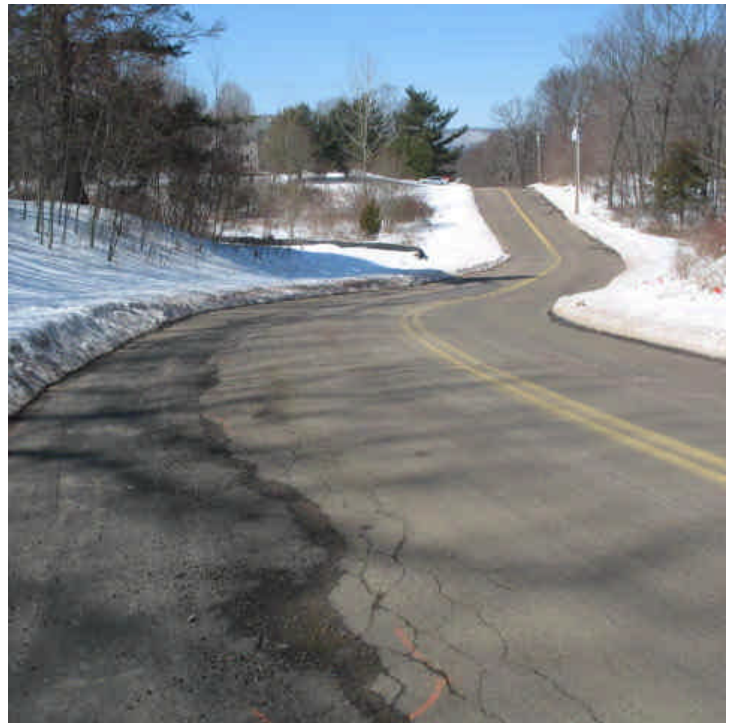
Old Lane Rd: No active work was noted within the roadway. Trenches have been backfilled and patched. 3/20/07.

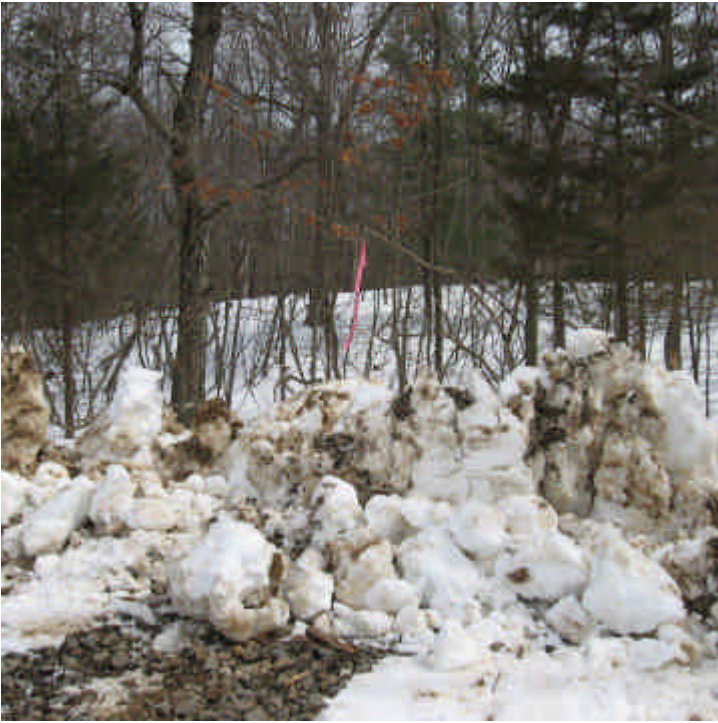
Cow Path Lane (Woodbridge): Snow, along with some sediment was piled near the wetland edge due to plowing activities. 3/19/07

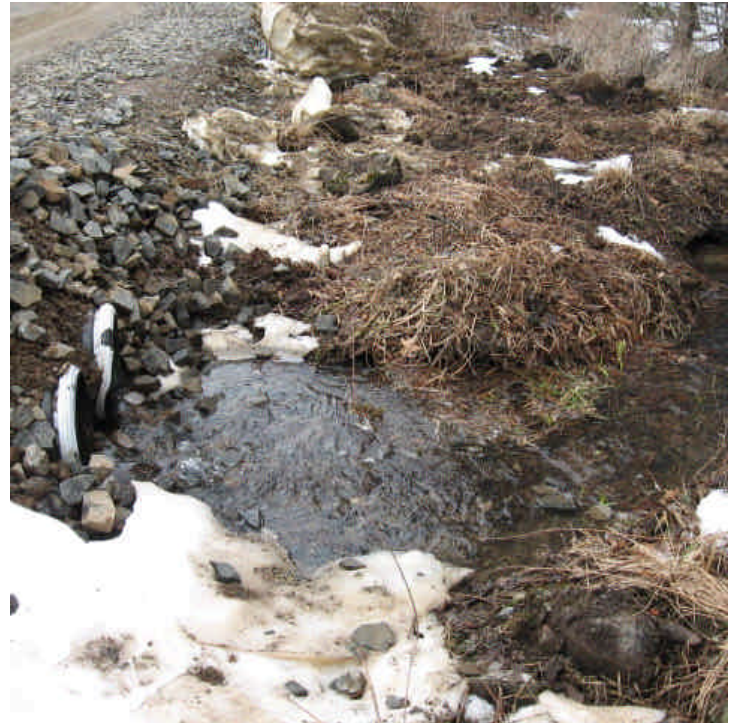
Cow Path Lane: Water flowing from the outlet pipe at the first crossing was free of sediment. 3/23/07

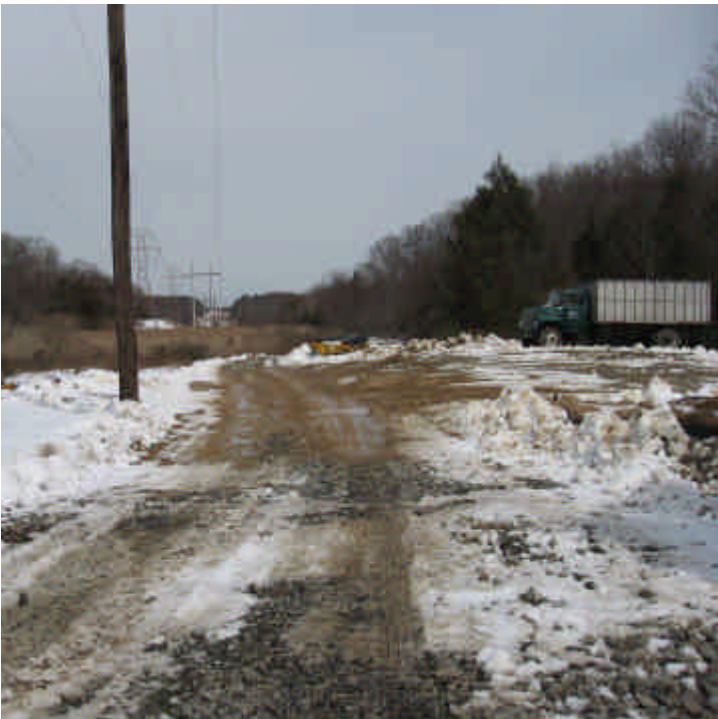
Cow Path Lane: A truck and sanitary facility were noted adjacent to wetland areas on either side of the ROW. Work space is limited here but attempt to provide storage away from wetlands. 3/19/07

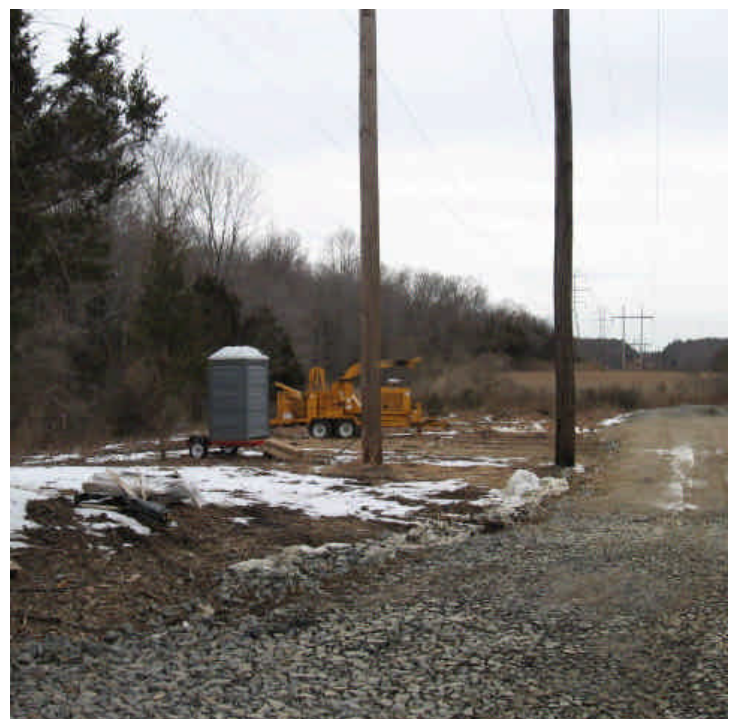
Cow Path Lane: The truck was no longer present on 3/23/07. An effort has been made to re-locate the sanitary facility, but due to limited work space and wetland configuration, options are limited.

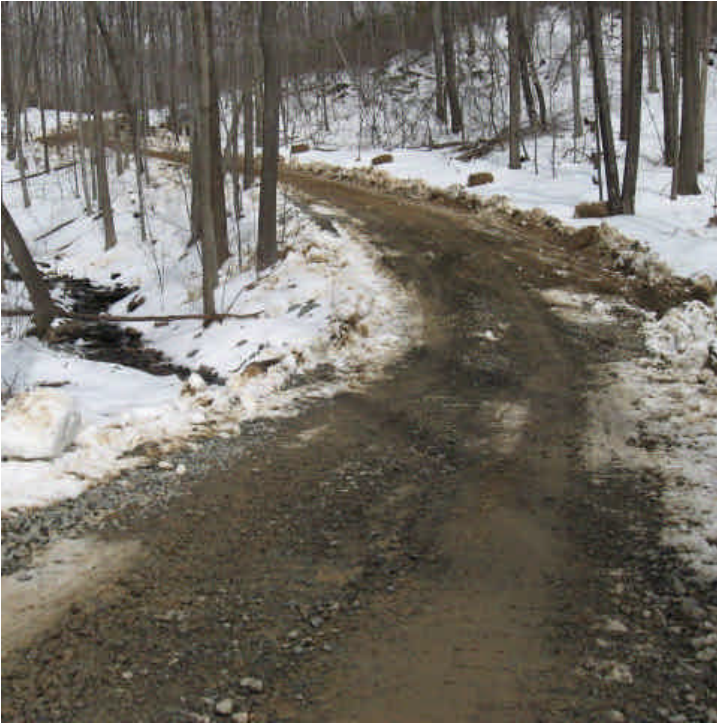
Cow Path Lane: View of the access road at the stream crossing on 3/19/07

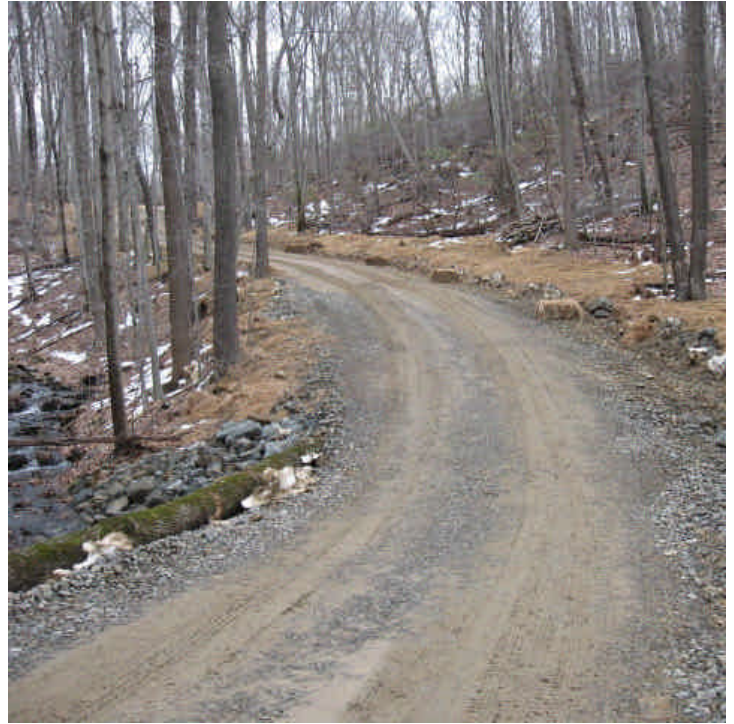
Cow Path Lane: View of the access road at the stream crossing on 3/23/07. Haybale check dams were in place along the access road and mulch had been applied to the disturbed slopes.

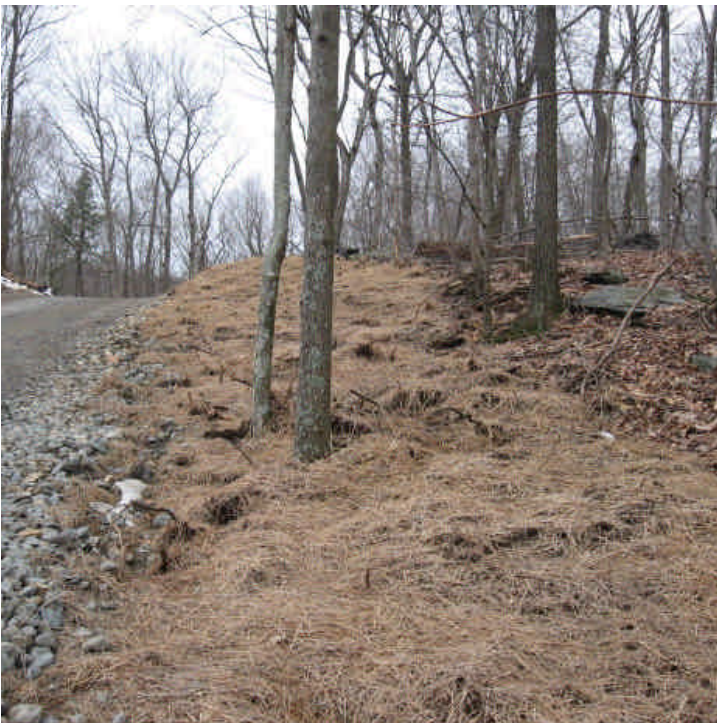
Cow Path Lane: Mulch was applied to the side slopes of the access road near the stream crossing 3/23/07.

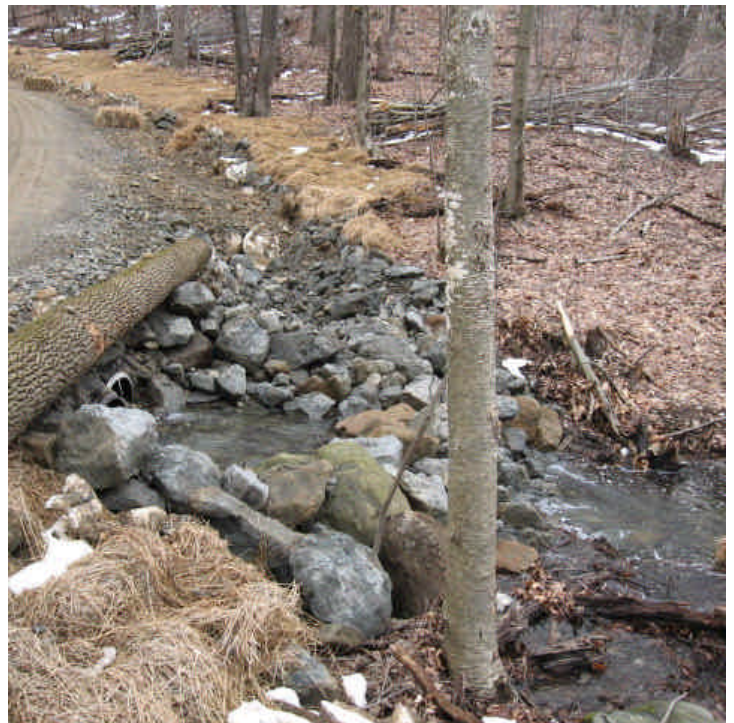
Cow Path Lane: View of the stream outlet on 3/23/07. A stone sediment trap was constructed at the culvert outlet and haybale check dams were installed downgradient.

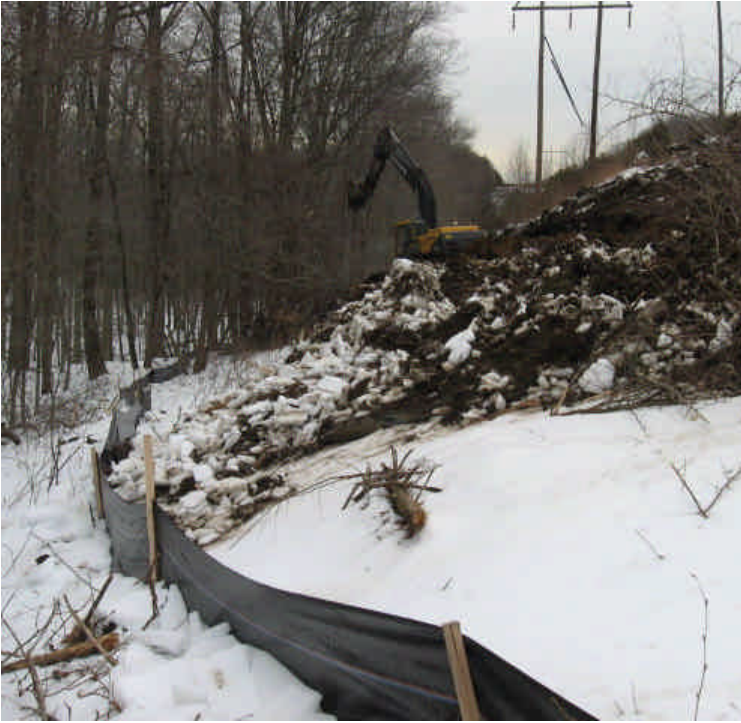
Cow Path Lane: Grading for pads resulted in some temp. soil stockpiling. Sediment and cleared snow were piled against the silt fence and had the potential to overwhelm the controls on 3/19/07.

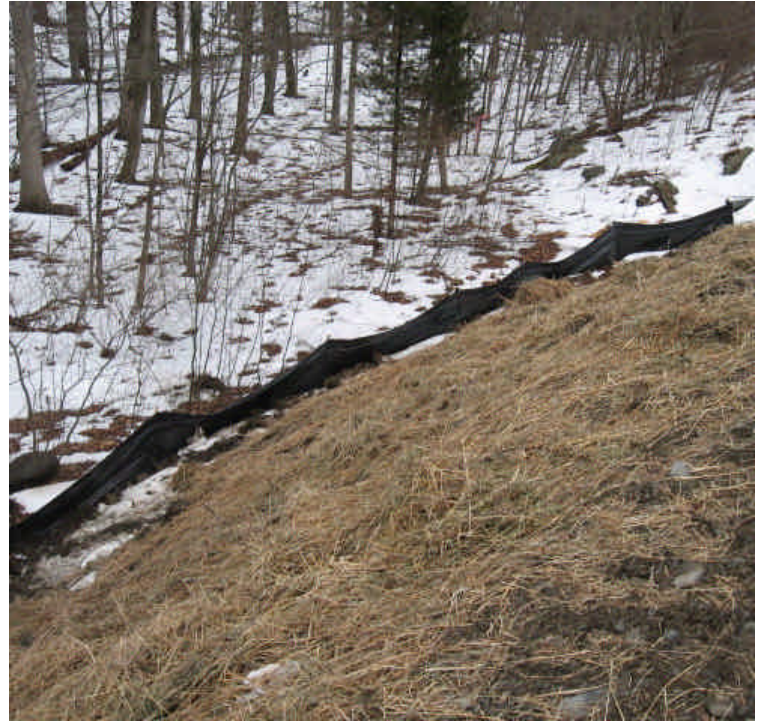
Cow Path Lane: Mulch was applied to the graded side slopes and silt fence remains in place by 3/23/07. The stream is located downgradient.

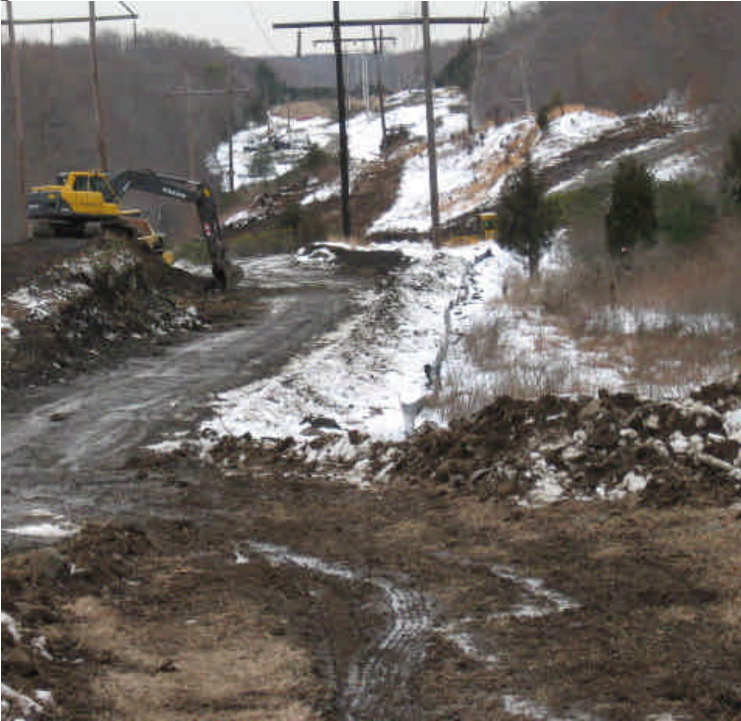
Cow Path Lane: Overall view of the activity within the ROW on 3/19/07. Major grading and soil movement was occurring to construct pads for structures.

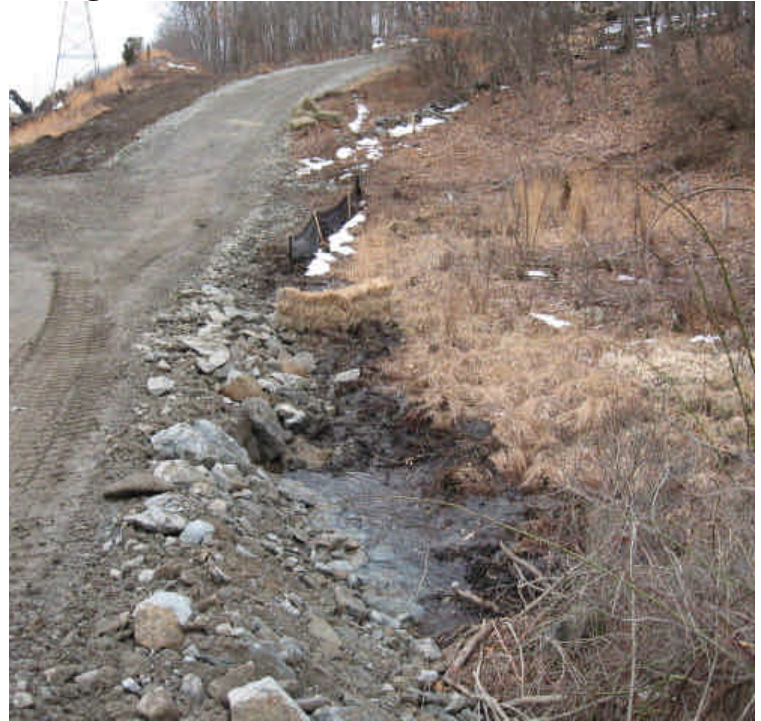
Check dams had been installed along the swale to a stream crossing. Controls were suggested on 3/19/07 and installed by 3/23/07. Continue to monitor and add controls as necessary.

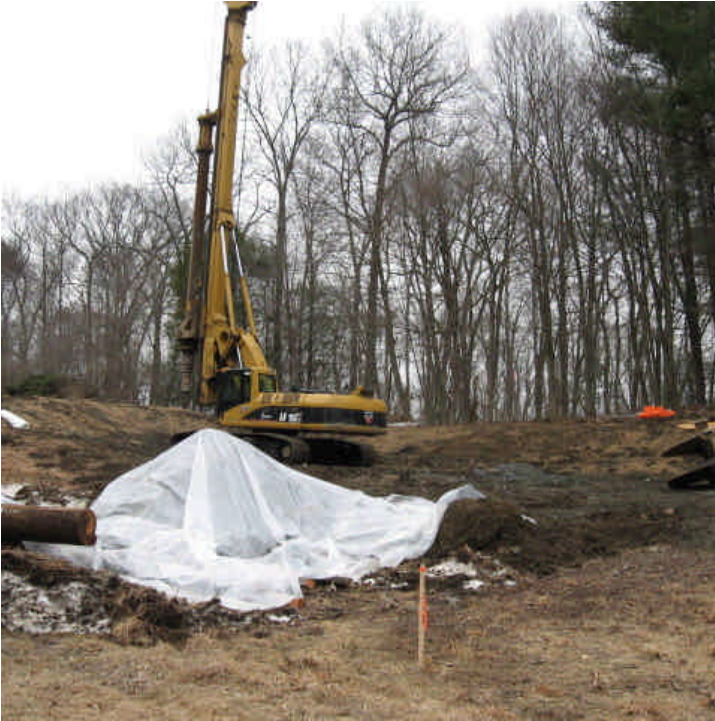
SCRWA, Morris to Dillon St (Woodbridge): Drilling has begun for structures #3950 A&B. 3/23/07.

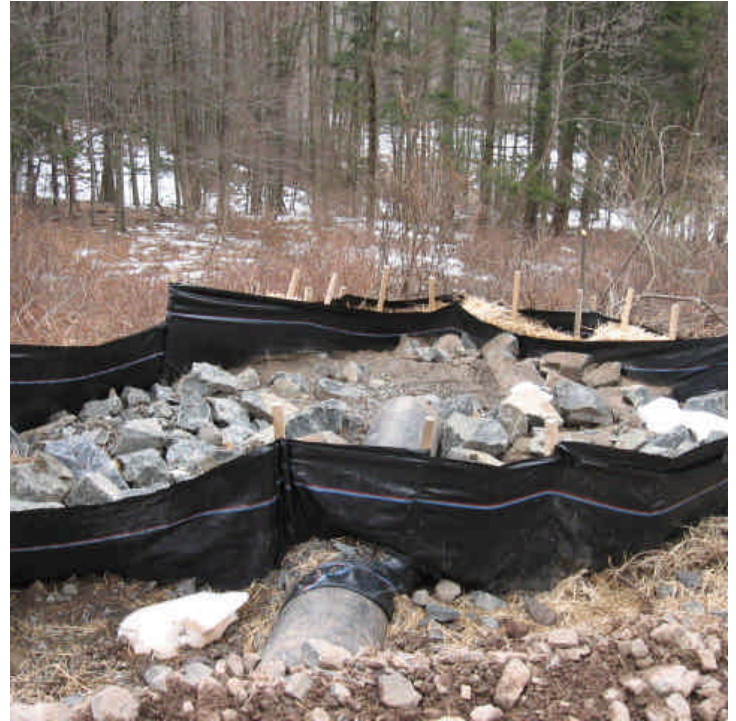
SCRWA, Morris to Dillon St: Erosion controls remain intact along the access roads, culvert location, and throughout the ROW. Sediment has built up in the stone trap at the culvert outlet. 3/23/07.

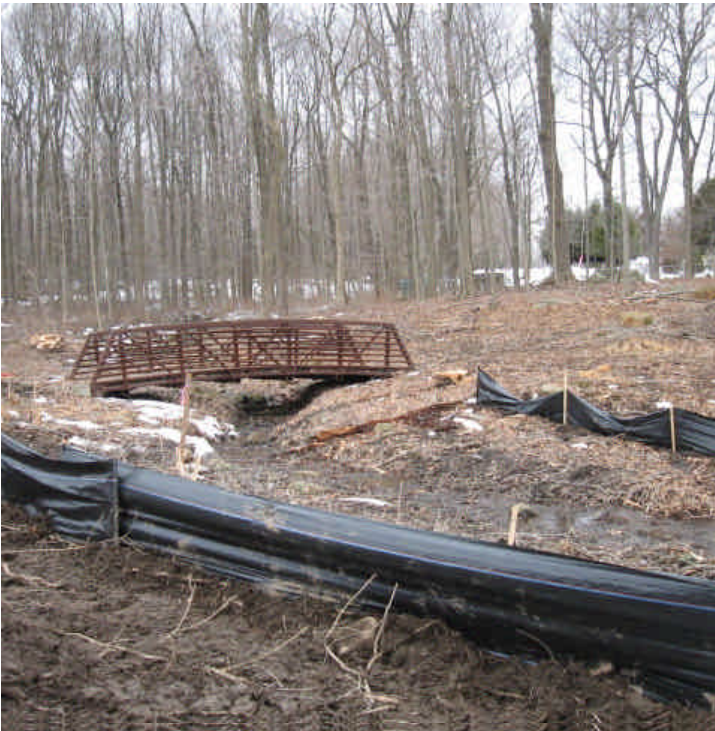
JCC Bypass (Woodbridge): Clearing activities appear to be complete in this area. Silt fence was in place along the stream. 3/23/07.

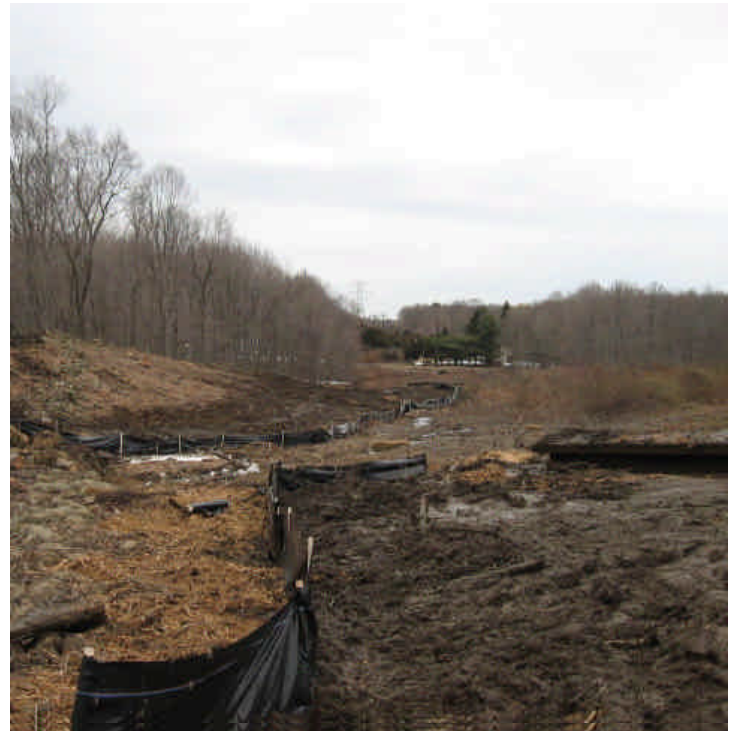
JCC Bypass: Silt fence was in place along the majority of the wetland area and was being extended at the time of inspection. 3/23/07

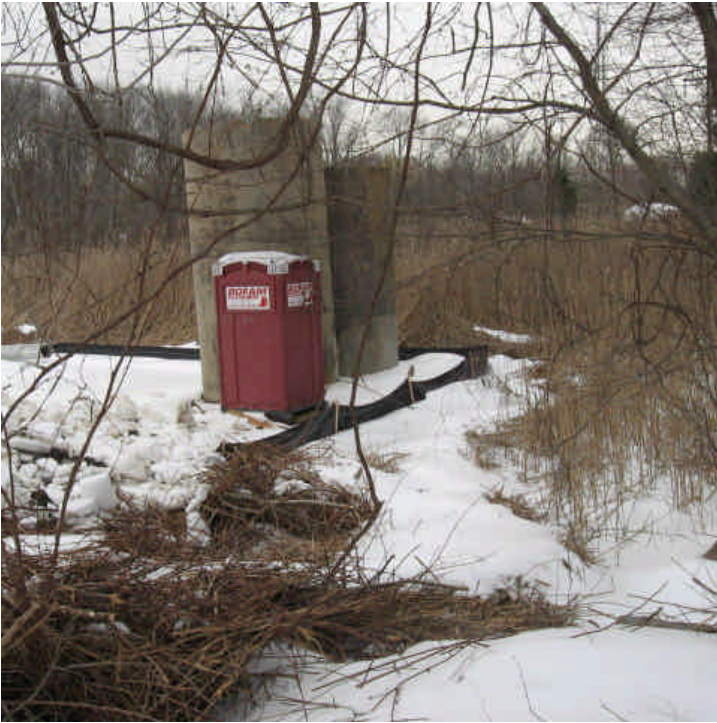
Hunting Hill Rd (Orange): A sanitary facility was noted within the wetland on the timber mats at the foundation drill site on 3/19/07.

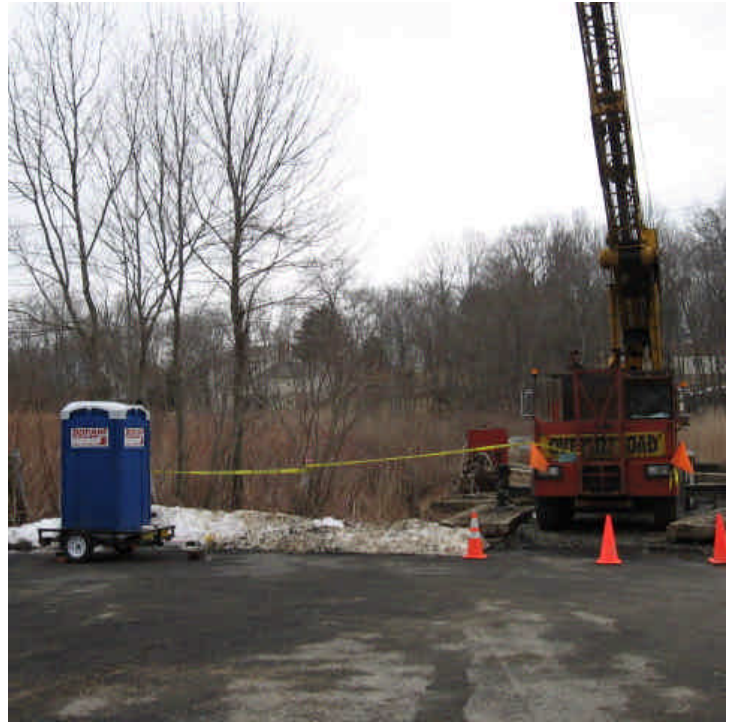
Hunting Hill Rd: Drilling equipment was being stored on a small upland area, adjacent to the wetland. The sanitary facility was removed from the wetland by 3/23/07. Workspace is limited here.

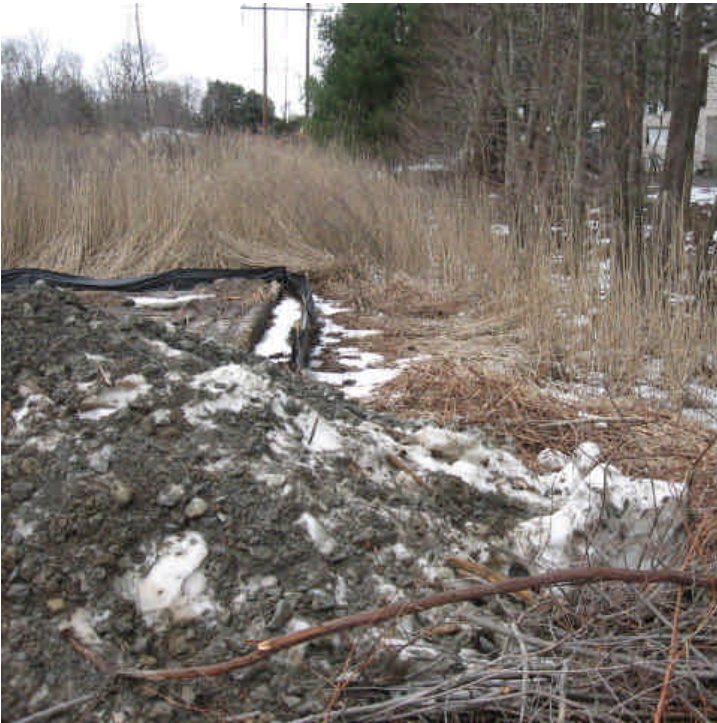
Hunting Hill Rd: Snow/sediment was piled on top of the silt fence and into the wetlands off the timber mats here. 3/23/07.

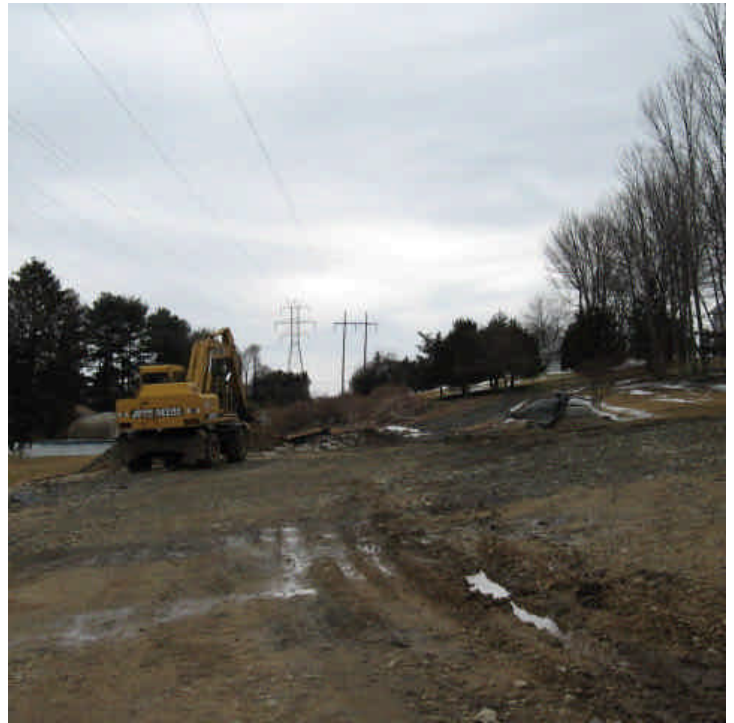
Hunting Hill Place (Orange): Foundation drilling/pouring appears to be complete. 3/23/07

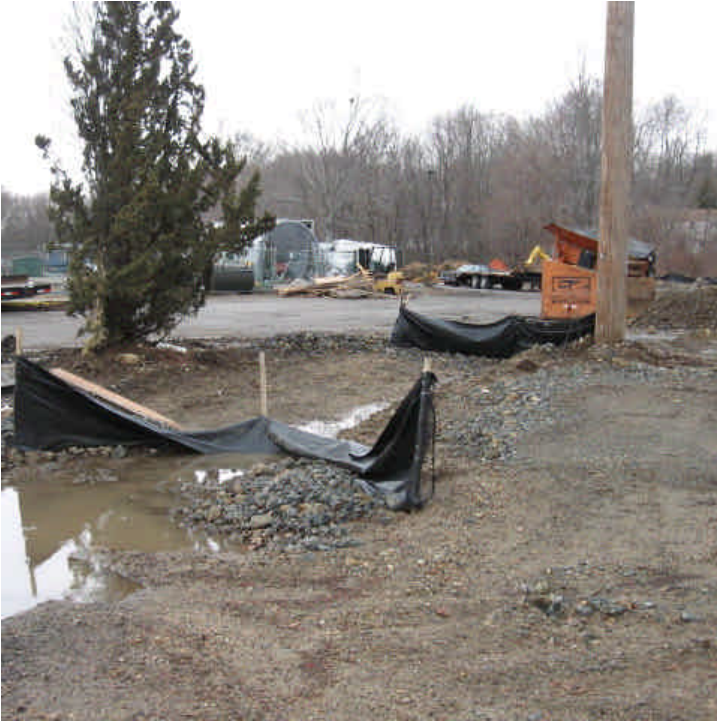
Route 121 (Milford): It appears the check dams were repaired but recent snow fall has damaged the silt fence again in this area. 3/23/07

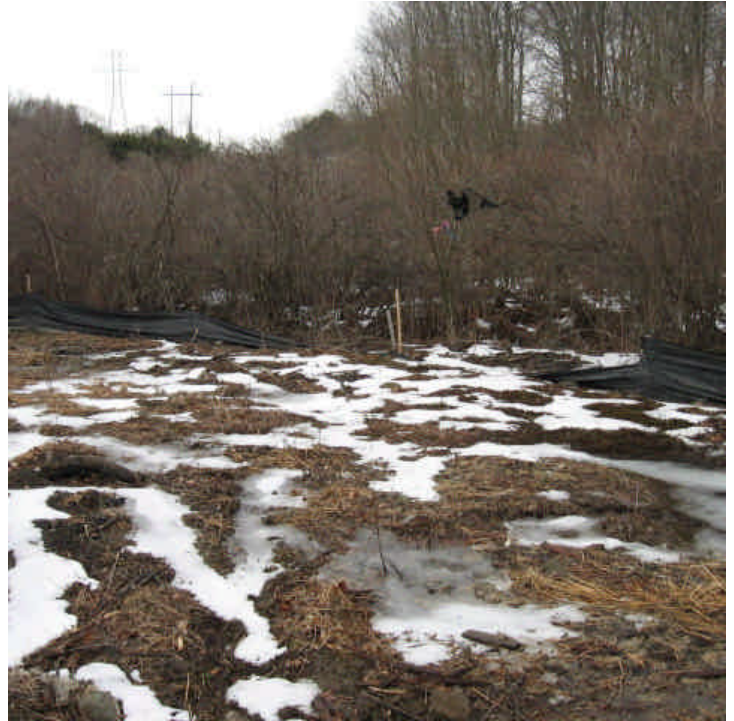
Route 121: It appears that the silt fence near the stockpile was repaired, but damaged by recent snow fall. 3/23/07.

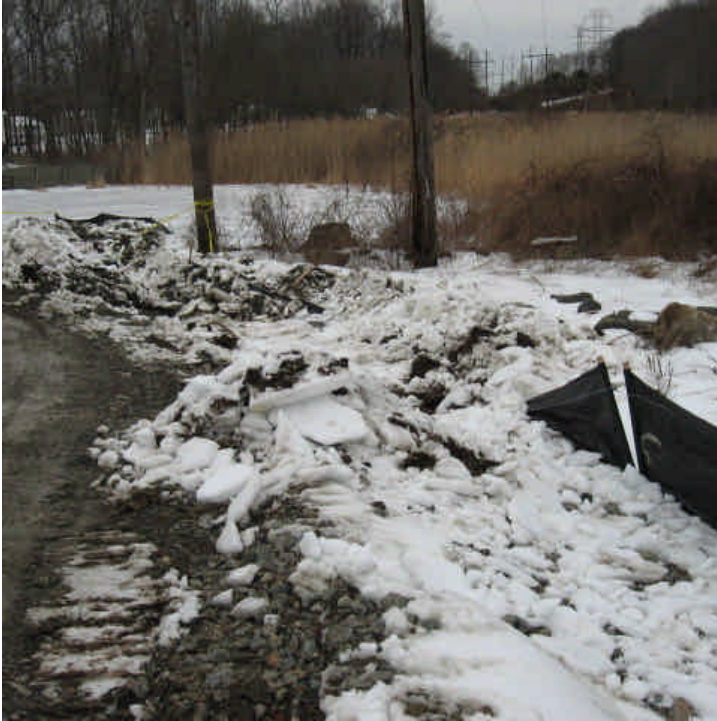
Whealers Farm Road (Milford): Snow was plowed over the silt fence off Wheelers Farm (west) on 3/19/07

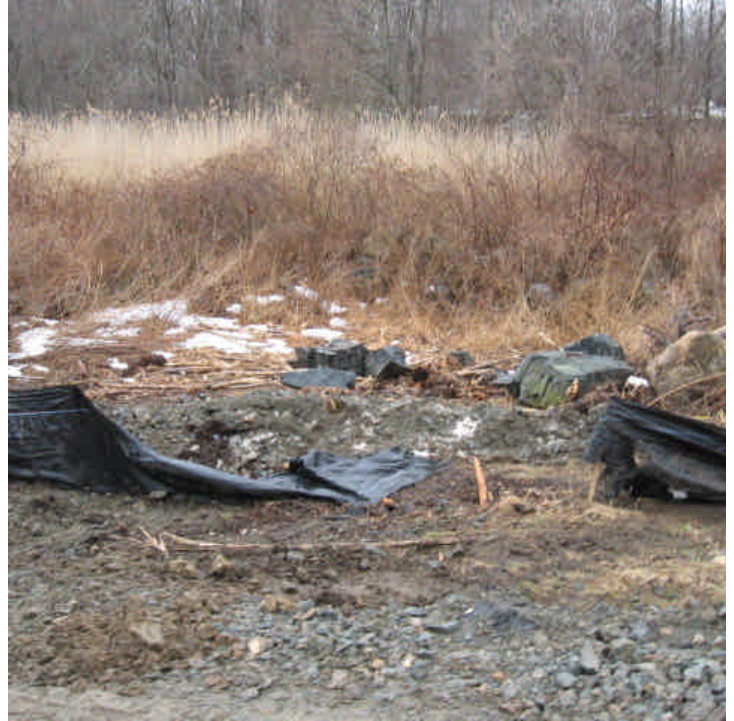
Whealers Farm Road: Silt fence remains damaged and is covered with sediment from plowing activities on 3/23/07. The small sediment pile should be carefully removed and place back on the work side of the fen
