Docket No. 272 – Development and Management Plan Inspection

Underground Line Watercourse and Railroad Crossings

Date: November 1, 2007

Location: Crossings of Watercourses and Railroads in Segments 3, 4a and 4b

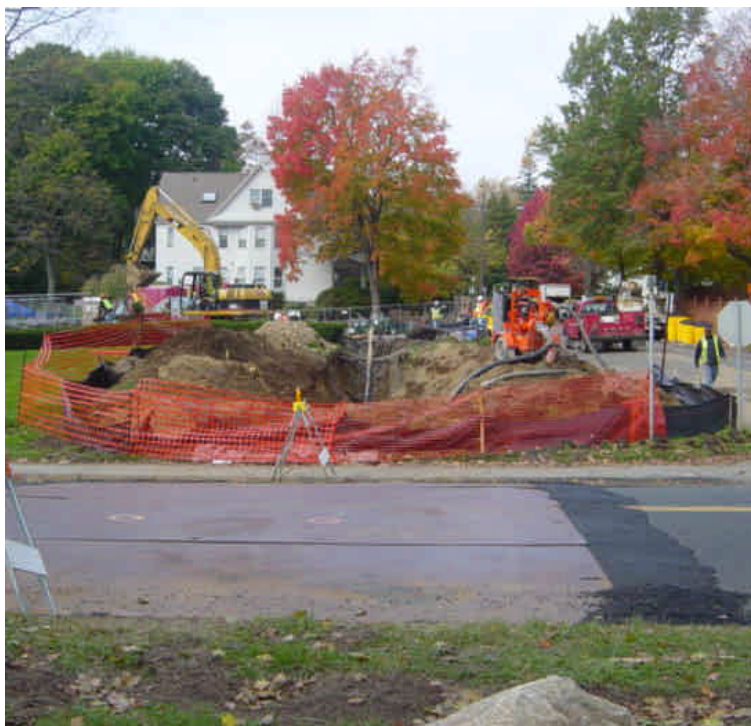
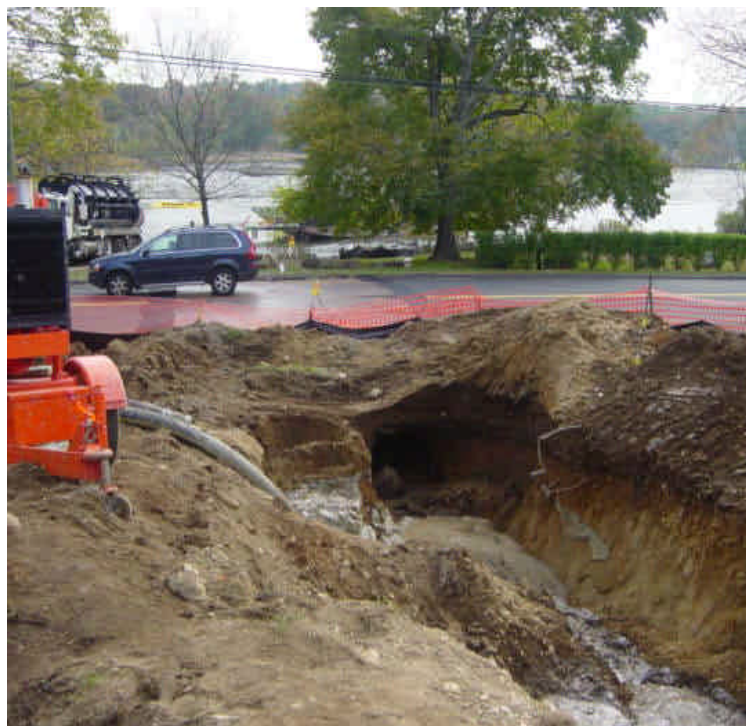
On the west side of the Saugatuck river, Lincoln St. has been closed as conduit sections are being staged and fused together as crews prepare for the conduit pull. The drilling/recycling pit has been expanded as additional soil continues to slough into the pit. Steel plates have been proactively installed along Riverside Avenue to distribute vehicle loads over the boring.

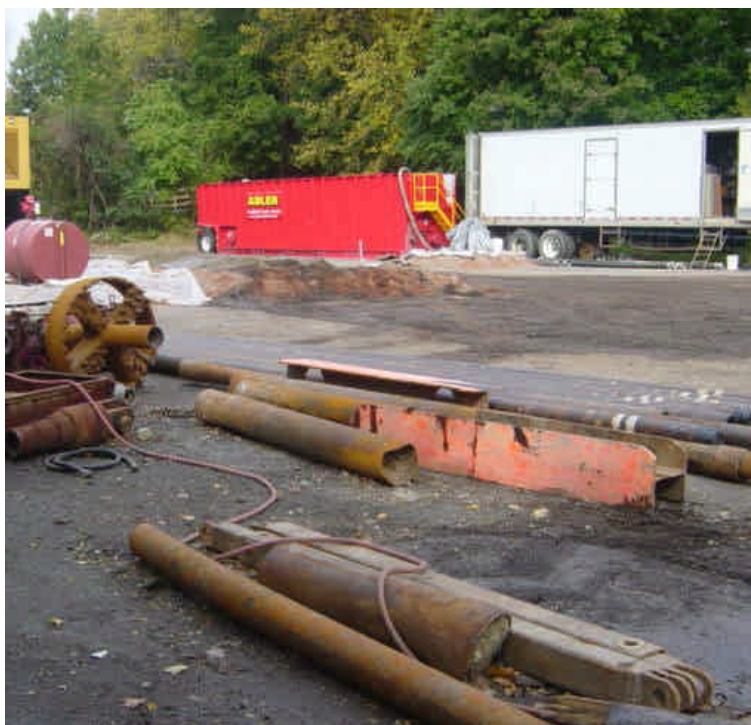
The staging area on the east side of the river remains fairly stable. Silt fence around the perimeter of the yard and around the drilling pit need attention.

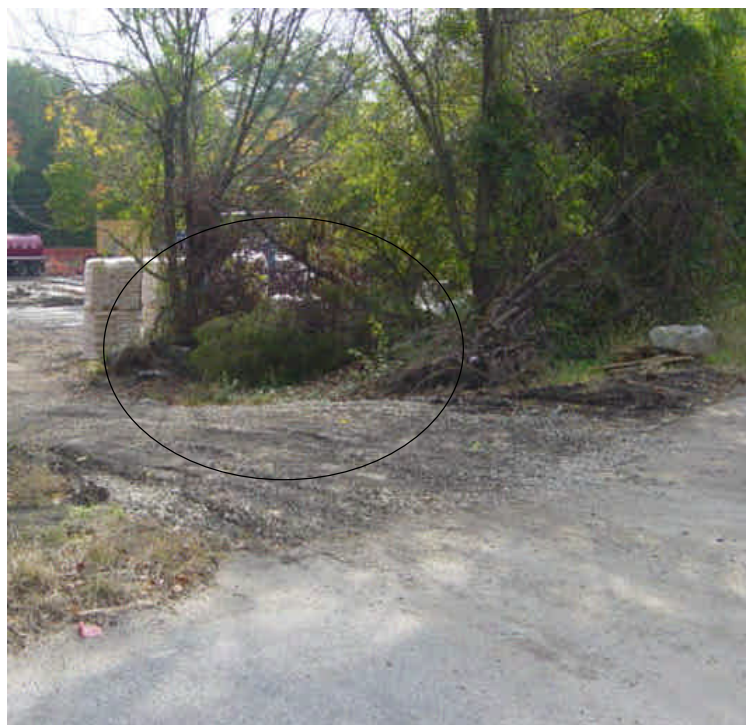
Tracking was previously observed at the entrance to the staging area on the east side of the river. The stone entrance has been refreshed but previously tracked sediment remains in the parking lot area.
