Docket No. 272 – Development and Management Plan Inspection

Underground Line Watercourse and Railroad Crossings

Date: November 8, 2007

Location: Crossings of Watercourses and Railroads in Segments 3, 4a and 4b

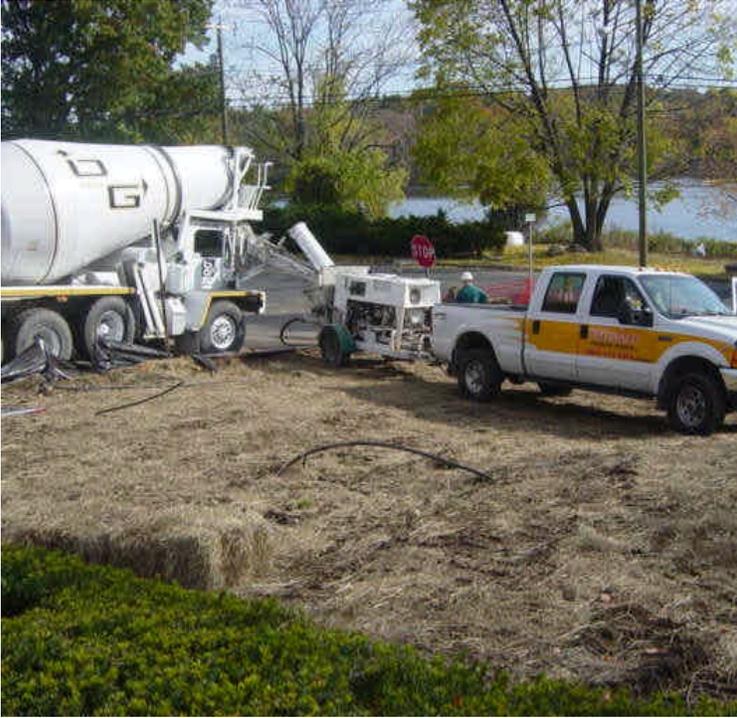
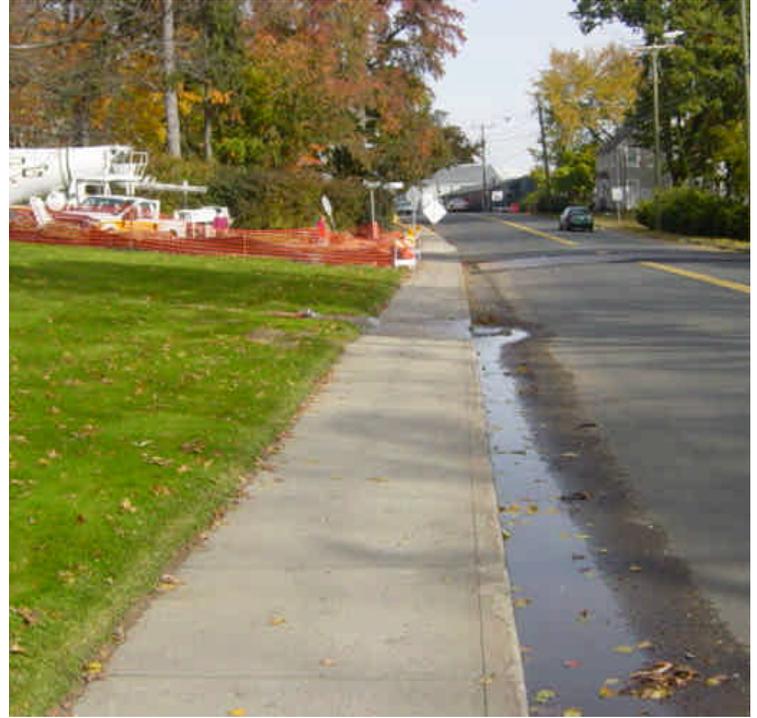
On the west side of the Saugatuck river, the drilling pit has been backfilled and the area has been stabilized with hay mulch. Flowable fill is being pumped into the boring (left). A frac tank on the west side staging area was being drained. The discharge was being directed into a protected catch basin. However, debris in the silt sack was causing the water to flow downstream to an unprotected catch basin (right).

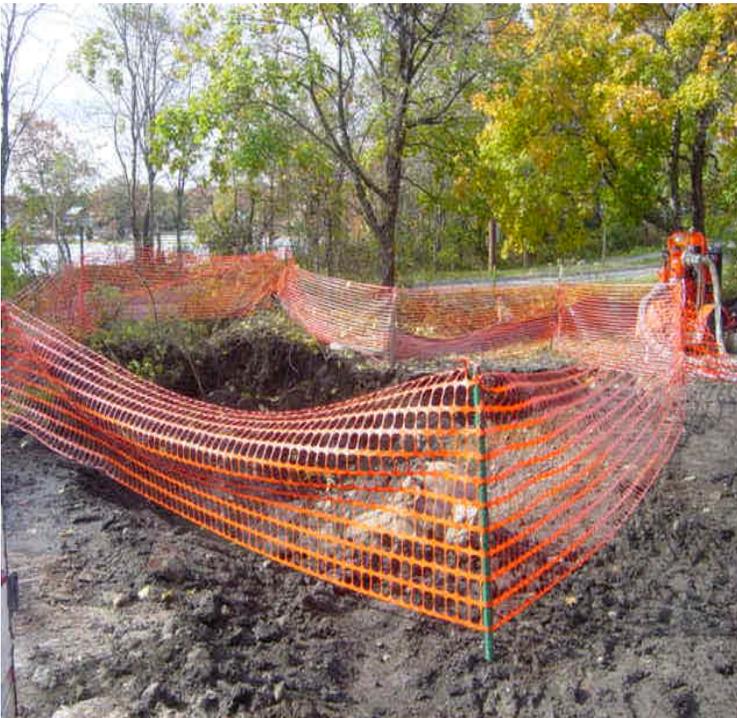
The staging area on the east side of the river remains fairly stable. Silt fence has been partially removed from around the drilling pit. Drilling activities related to the first hole have been completed. The area where the silt fence was removed appears to be stable.

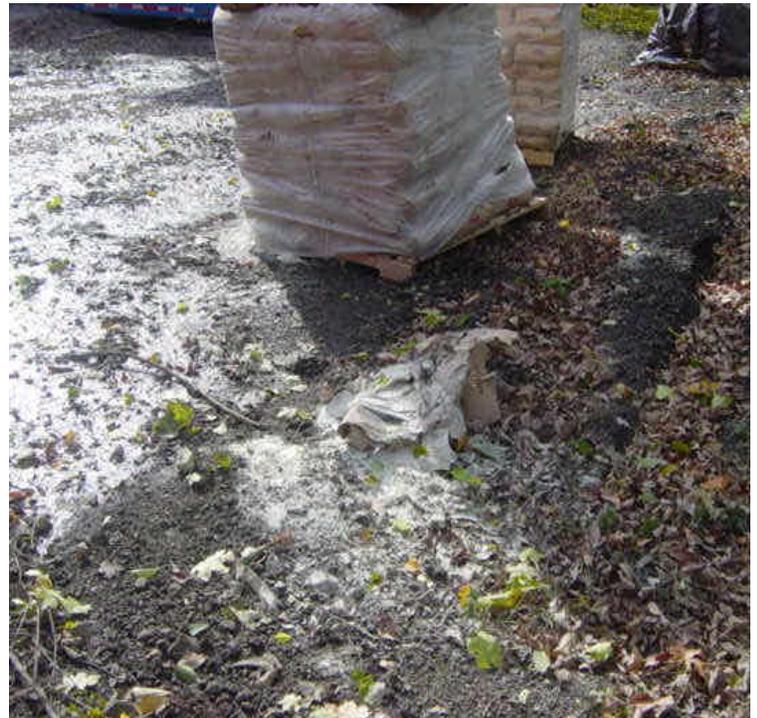
Several bags of Max-Gel were torn and had spilled on the ground near the entrance to the staging area.
