Docket No. 272 – Development and Management Plan Inspection

Underground Line Watercourse and Railroad Crossings

Date: October 4, 2007

Location: Crossings of Watercourses and Railroads in Segments 3, 4a and 4b

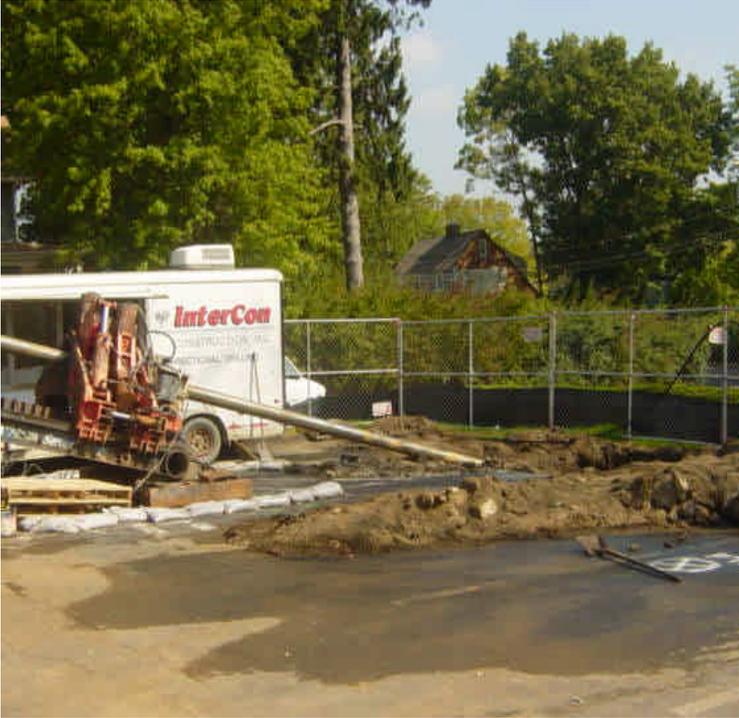
View of the drill positioned in the staging area on the west side of the of the Saugatuck River.

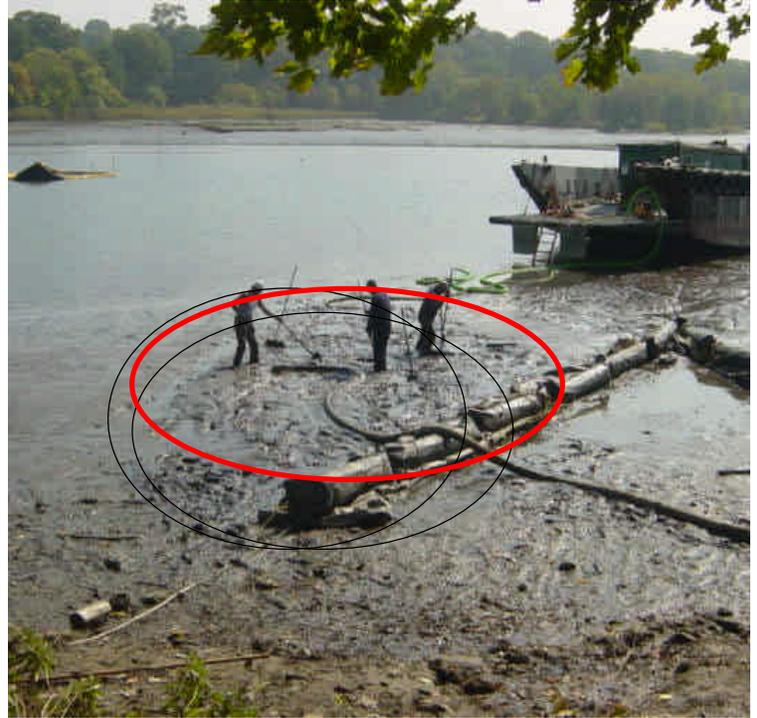
<p>Inland Wetland and Watercourse encroachment and mitigation</p>	<p>The currently active portion of the project consists of the watercourse crossing of the Saugatuck River and associated wetlands in Westport. 10/04/07</p> <p>A frac-out (accidental release) of drilling fluid was observed in the Saugatuck River near the west bank in the mudflats during low tide. Crews had stopped drilling activities as specified in the D&M Plan to place booms around the area. They were actively vacuuming up the slurry and the time of inspection and appeared to have it contained. DEP and OLISP were contacted as required. 10/04/07</p>	<p>Continue to implement the approved monitoring plan for the crossing of the Saugatuck River provided in the D&M plan in order to avoid impacts to the resource areas. 10/04/07</p> <p>Continue to monitor carefully for drilling fluid releases and continue to address as specified in the monitoring plan provided in the D&M. Contractors have been monitoring pressure and making regular visual inspections in the river. 10/04/07</p>	<p>NA</p> <p>Regular inspections are occurring leading to the discovery and appropriate clean-up of a frac-out. DEP was informed.</p>

Areas of Inspection	Observation	Recommended Action	Corrected Action
	a clean up crew was removing drilling fluid from a frac-out in the mudflats near the west bank of the river. 10/04/07	appropriately and treated according to the groundwater handling plan as reference in the D&M. 10/04/07	
Blasting	No blasting has been proposed. 10/04/07	None 10/04/07	NA
Spills and Material Storage	<p>Reserve spill cleanup materials/kits were observed in the staging area. 10/04/07</p> <p>Two 55-gallon drums located in the staging area on the east side of the river were being stored without secondary containment. 10/04/07</p>	<p>Continue to bring spill kits to active work sites. 10/04/07</p> <p>It is recommended that 100% secondary containment is provided for any fuels, oils, paints, solvents, or other hazardous materials stored on-site due to the overall sensitive nature of the area. 10/04/07</p>	<p>NA</p> <p>Needs attention.</p>

Crews were working to clean-up drilling fluid from a recent frac-out on the mud flats near the west bank Saugatuck River. The circle roughly depicts the extent of the darker colored spill against the mud.

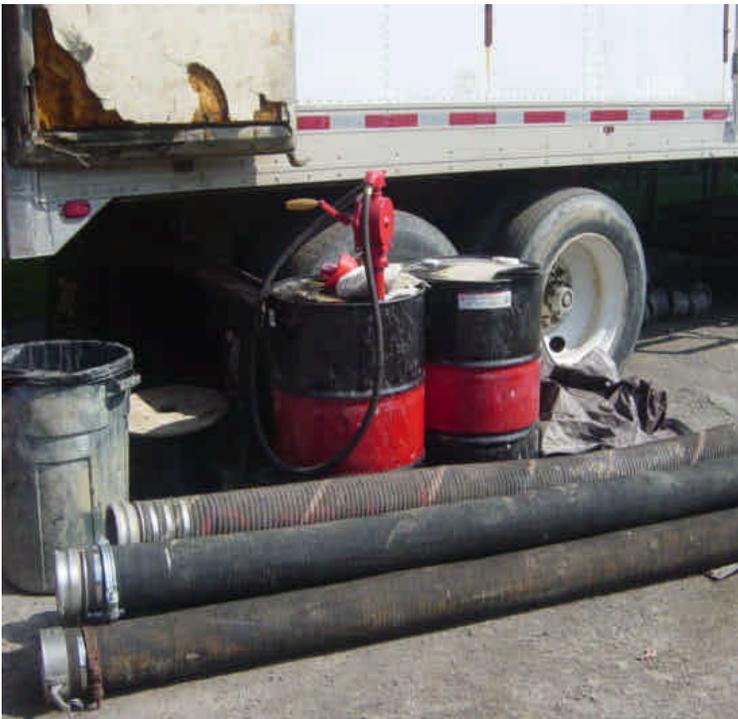
Two 55-gallon drums located in the staging area on the east side of the river were being stored without secondary containment. This is recommended due to the overall sensitivity of the area.

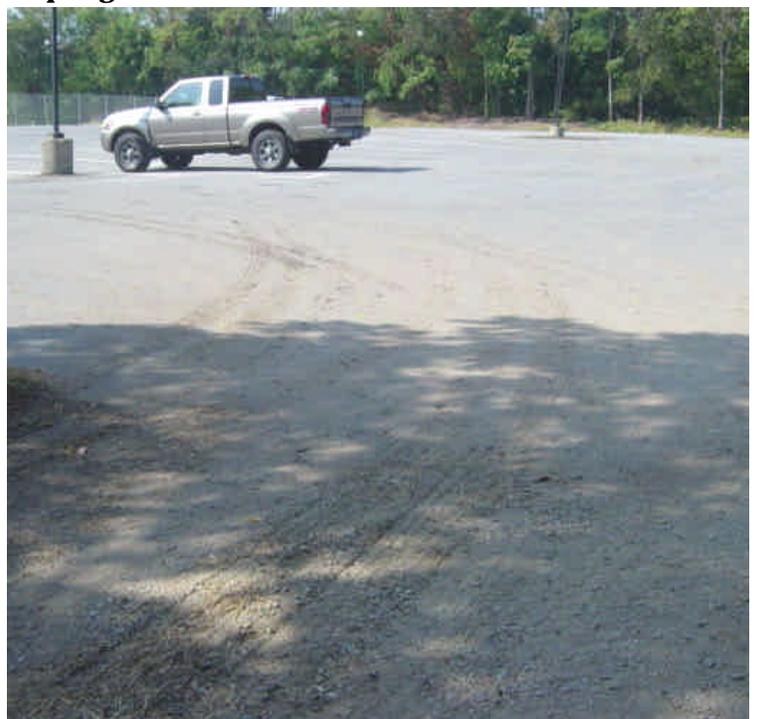
Areas of Inspection	Observation	Recommended Action	Corrected Action
Access Roads and Adjacent Roadways	A stone construction entrance is in place at the access to the staging area on the east side of the Saugatuck River. The entrance is accessed from the paved parking area off of Imperial Ave. Minor sediment tracking was observed, but limited to the paved parking lot area 10/04/07	Continue to maintain construction entrance to reduce sediment migration from the work area. Sweep the parking lot and area as necessary. 10/04/07	NA at this time but needs regular attention.
Vault Openings and Trench Construction	Crews were actively working on the Horizontal Directional Drill (HDD) between vault #14 to vault #15 under the Saugatuck River. The drill set-up was recently moved to the west side of the river. Work was temporarily stopped to address a recent frac-out near the west bank of the river. Crews were actively cleaning the area 10/04/07	See Inland Wetlands Section for additional details. 10/04/07	NA

A stone construction entrance is in place at the access to the staging area on the east side of the Saugatuck River. Minor tracking was observed, but limited to the paved parking lot area.
