**Docket No. 272 – Development and Management Plan Inspection**

**The Connecticut Light and Power Company Certificate of Environmental Compatibility and Public Need for the construction of a new 345-kV electric transmission line and associated facilities between Scovill Rock Switching Station in Middletown and Norwalk Substation in Norwalk, Connecticut, including reconstruction of portions of existing 115-kV and 345-kV electric transmission line, the construction of Beseck Switching Station in Wallingford, East Devon Substation in Milford, (and Singer Substation in Bridgeport), modifications at Scovill Rock Switching Station and Norwalk Substation, and the reconfiguration of certain interconnections.**

**Underground Line Watercourse and Railroad Crossings**

**Date:** October 11, 2007

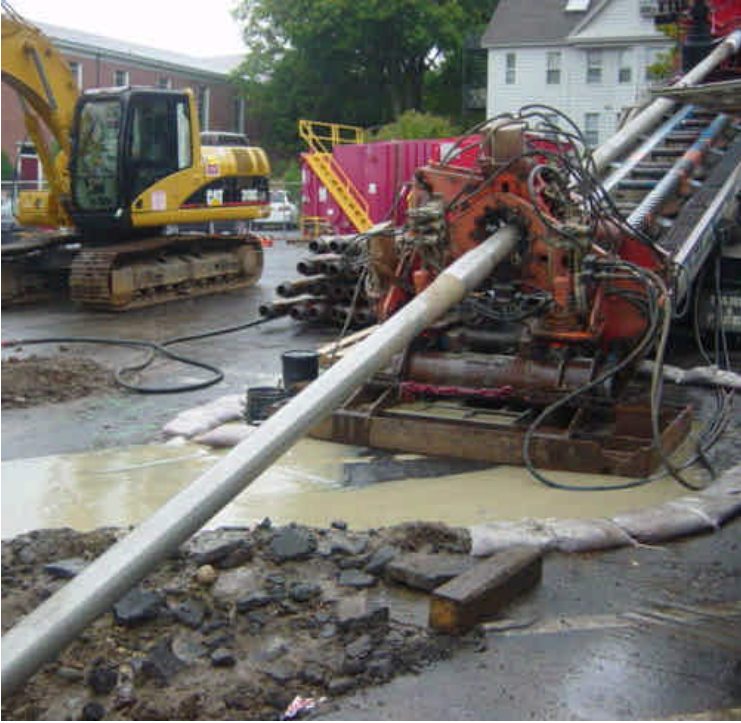
**View of the drilling rig positioned in the staging area on the west side of the Saugatuck River. Drilling fluid is being properly contained.**

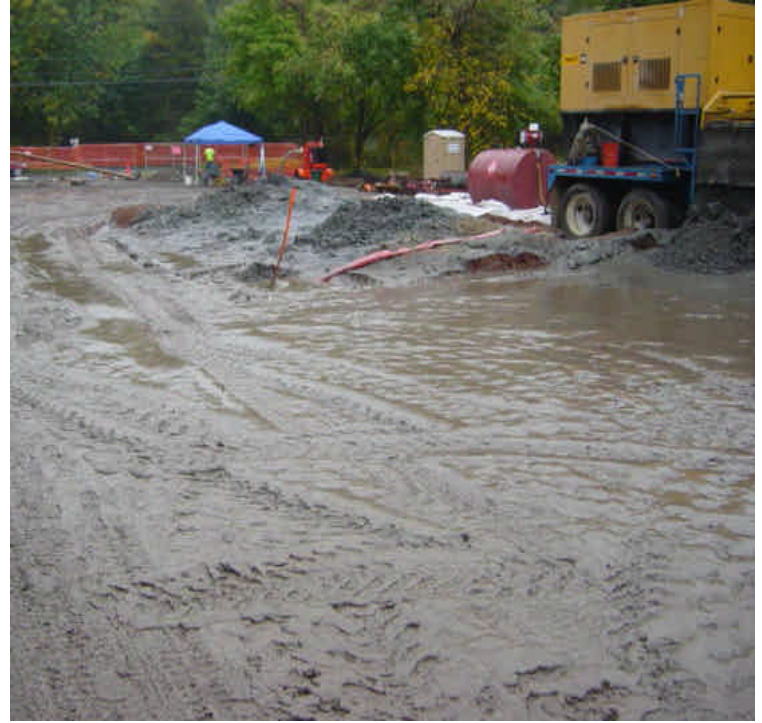
Areas of Inspection	Observation	Recommended Action	Corrected Action
	<p>reclamation/ recycling machine, used to separate bentonite clay from the soil is set-up within the staging area on the east side of the river. The staging yard was becoming very muddy due to the rainy conditions and bentonite reclamation, but the area was adequately contained. Sediment tracking was not an issue. 10/11/07</p>	<p>for sediment tracking sweep parking lot/ roadway as necessary. Minimize vehicle traffic in the staging area when feasible. 10/11/07</p>	
<p><b>Soils</b></p>	<p>Soils are exposed as part of the drill set-up and excavation. Drilling slurry (bentonite clay) is used in the process. 10/11/07</p> <p>The drilling pit within the east side staging yard currently appears to be adequately sized for receiving drilling slurry. A small amount of material appeared to have splashed out of the pit beyond the silt fence limits. 10/11/07</p>	<p>Soils appear to be handled appropriately. Monitor for dust as previously indicated. 10/11/07</p> <p>Continue to monitor the amount of slurry in relation to the size of the pit to ensure adequate storage capacity. Also consider impacts from future storm events and run-off. Use caution to prevent drilling fluid from splashing out of the pit and beyond the controlled limits of the yard. 10/11/07</p>	<p>NA</p> <p>Requires regular attention and monitoring.</p>

**Staging area on the east side of the Saugatuck River was becoming very muddy as a result of the bentonite reclamation combined with the rain. The area was being adequately maintained and tracking was not an issue.**

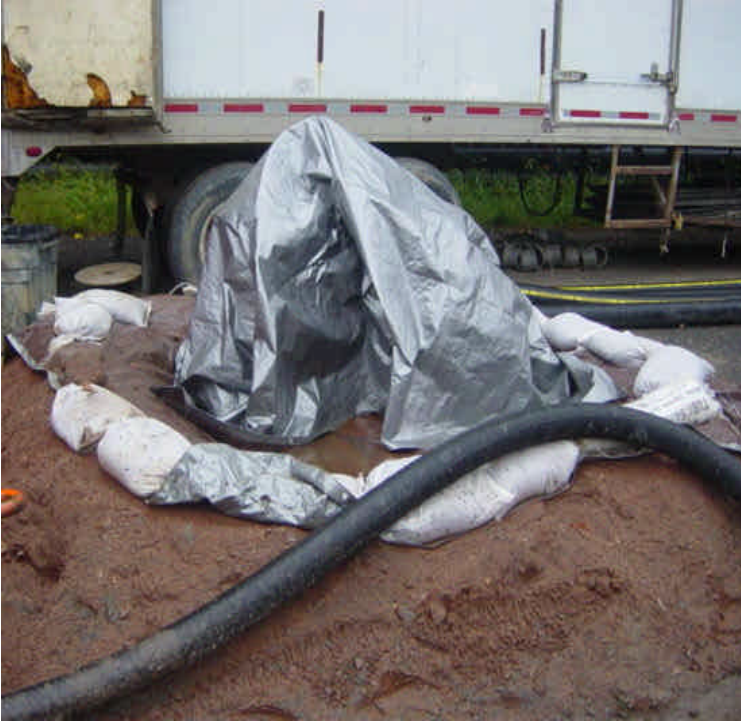
**Secondary containment has been provided for two 55-gallon drums located in the staging area on the east side of the river**

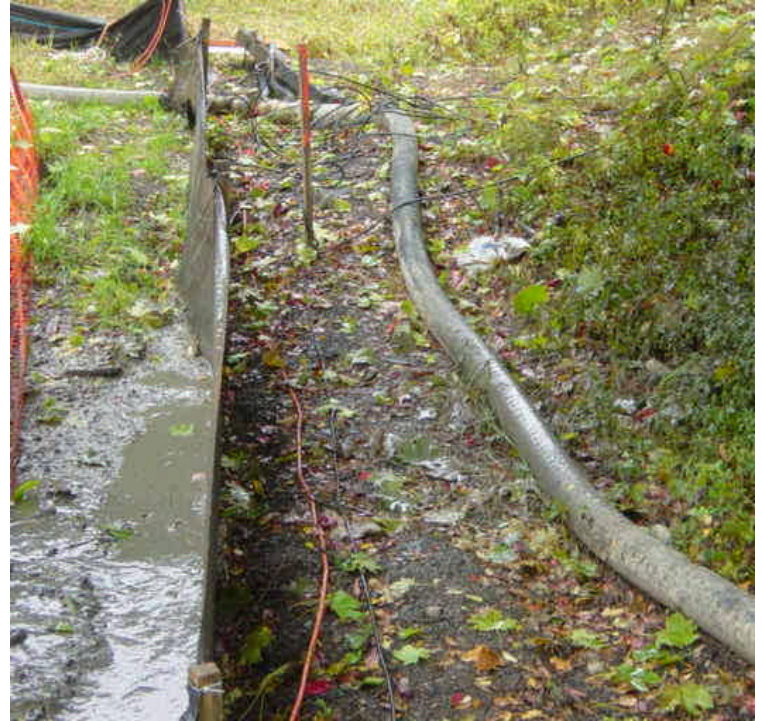
**The perimeter silt fence appears to be adequately sized and positioned to contain the drilling slurry return and recycling pits on the east side of the river. However, some of the drilling fluid appears to have migrated out of the pit, against the fence. A small amount splashed beyond the controls.**
