**Docket No. 272 – Development and Management Plan Inspection**

**Underground Line Watercourse and Railroad Crossings**

**Date:** October 18, 2007

**Location:** Crossings of Watercourses and Railroads in Segments 3, 4a and 4b

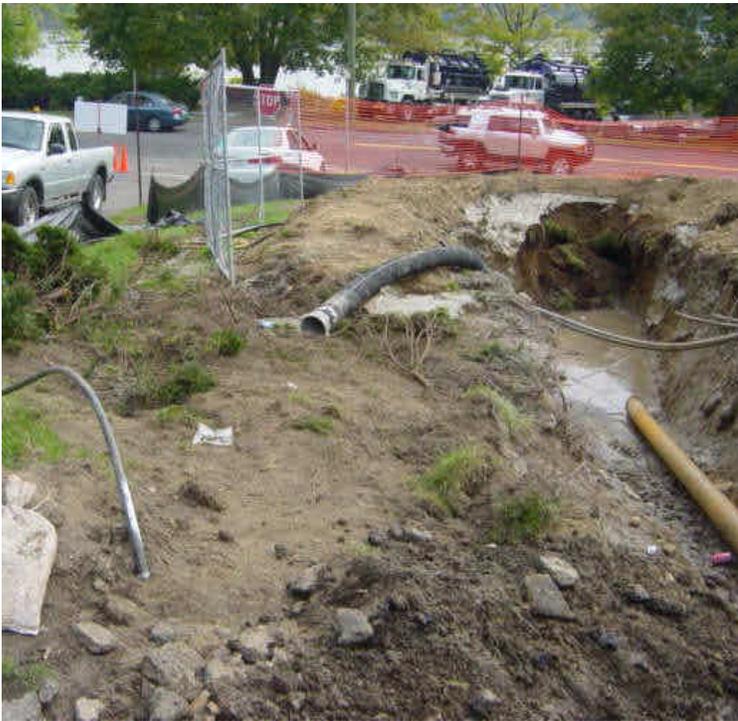
<p>Vegetative clearing (including trees to save or danger trees noted)</p>	<p>A row of hedges/shrubs was removed from the west side of the river near</p>	<p>Re-establish removed vegetation when feasible or confirm removal with</p>	<p>Needs evaluation/ confirmation.</p>

**View of staging area on the west side of the Saugatuck River. Silt fence along Lincoln St. need to be repaired and toed-in. Shrubs have been removed which were not specifically marked with a note for clearing on the 4/5/07 revised version of the D&M Plan.**

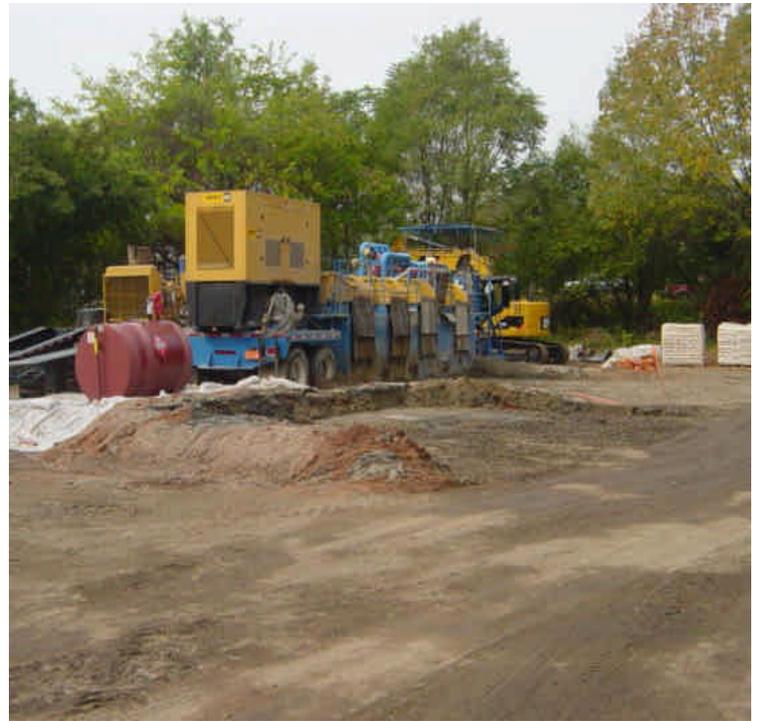
**The bentonite reclamation equipment located in the staging area on the east side of the Saugatuck River is well contained. Secondary containment has also been provided for the temporary fuel tank.**

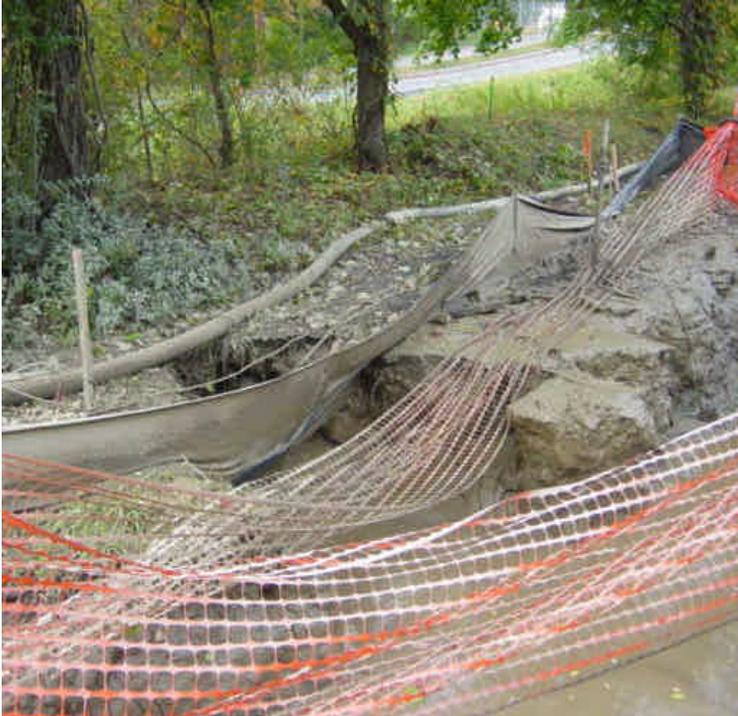
<p>Soils</p>	<p>Soils are exposed as part of the drill set-up and excavation. Drilling slurry (bentonite clay) is used in the process. 10/18/07</p> <p>The drilling pit within the east side staging yard appears to have been recently enlarged, possibly due to the soil along the walls sloughing off into the pit. The pit appears to be adequately sized for receiving drilling slurry. 10/18/07</p>	<p>Soils appear to be handled appropriately. Monitor for dust as previously indicated. 10/18/07</p> <p>Continue to monitor the amount of slurry in relation to the size of the pit to ensure adequate storage capacity. Also consider impacts from future storm events and run-off. Use caution to prevent drilling fluid from splashing out of the pit and beyond the controlled limits of the yard. 10/18/07</p>	<p>NA</p> <p>Requires regular attention and monitoring</p>
<p>State species of concern, threatened and endangered species.</p>	<p>According to the D&amp;M plan, state-listed species are not located in this work area</p>	<p>None.</p>	<p>NA</p>

**The drilling pit within the east side staging area appears to have been recently enlarged, possibly due to the soil along the walls sloughing off into the pit. Adjust and extend the silt fence to fully encompass the drilling fluid return and recycling pits.**

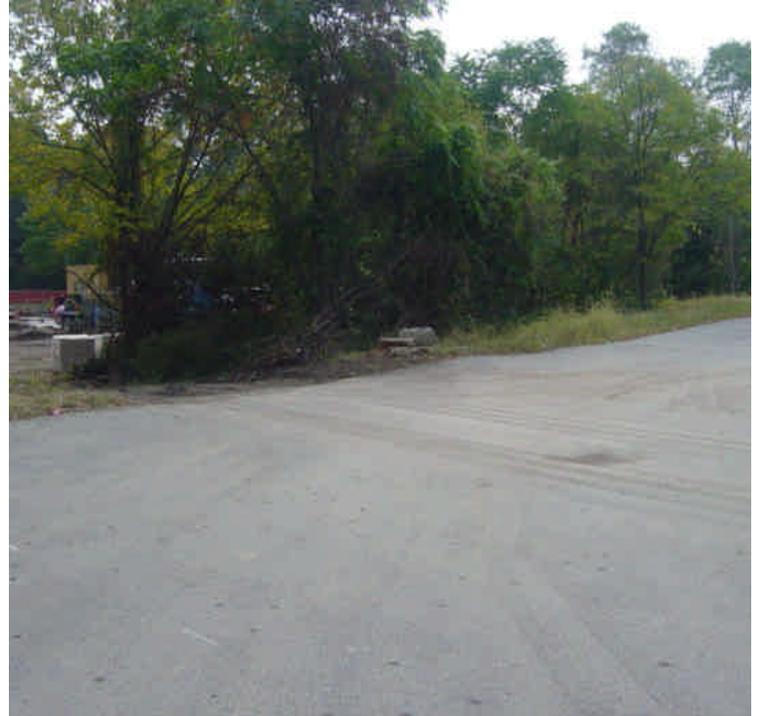
**Some sediment tracking was evident near the entrance to the staging area on the east side of the river, but was limited to the parking lot.**
