Docket No. 272 – Development and Management Plan Inspection

Underground Line Watercourse and Railroad Crossings

Date: October 25, 2007

Location: Crossings of Watercourses and Railroads in Segments 3, 4a and 4b

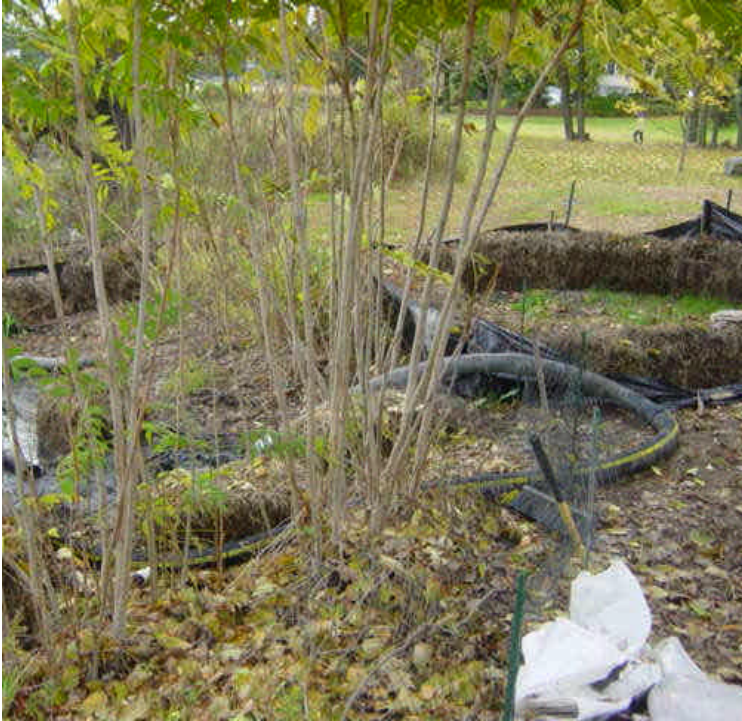
View of haybale filtering/dewatering area on the west side of the Saugatuck River. Pumped material is discharged into this area filter out the water; so that the remaining sediment and bentonite can be placed into the vac trucks for disposal.

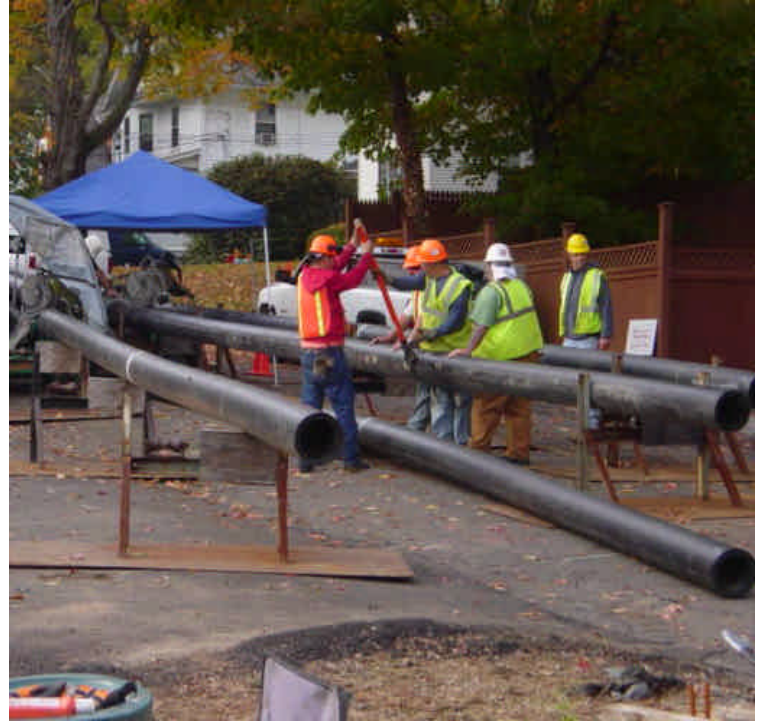
On the west side of the river, Lincoln St. has been closed off and conduit sections were being staged and fused together.

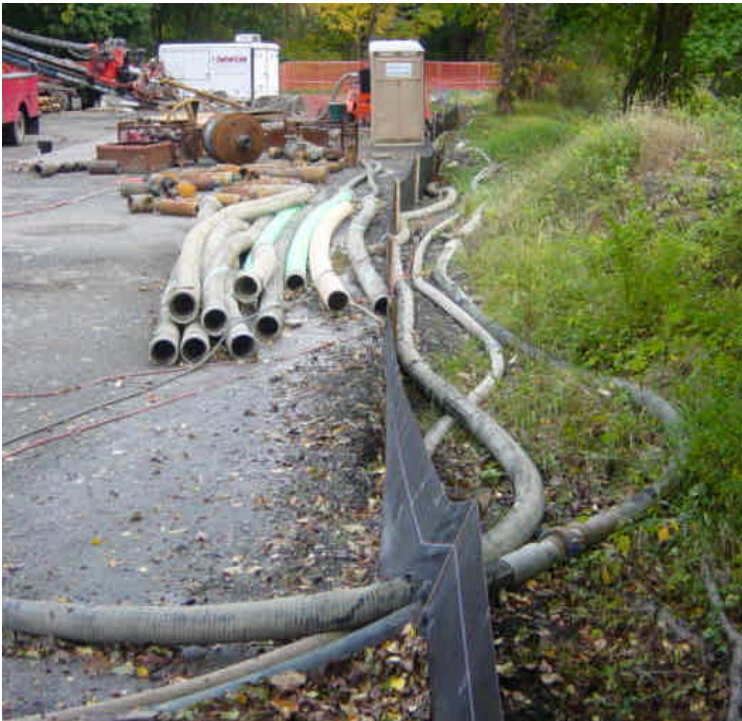
On the east side of the river, several hoses are being used in the HDD operation and are located outside of the contained, silt fenced limits of the staging area. Relocate hoses within the staging area to whenever feasible and construct forked (Y) stakes to prop hoses over the perimeter controls when necessary.

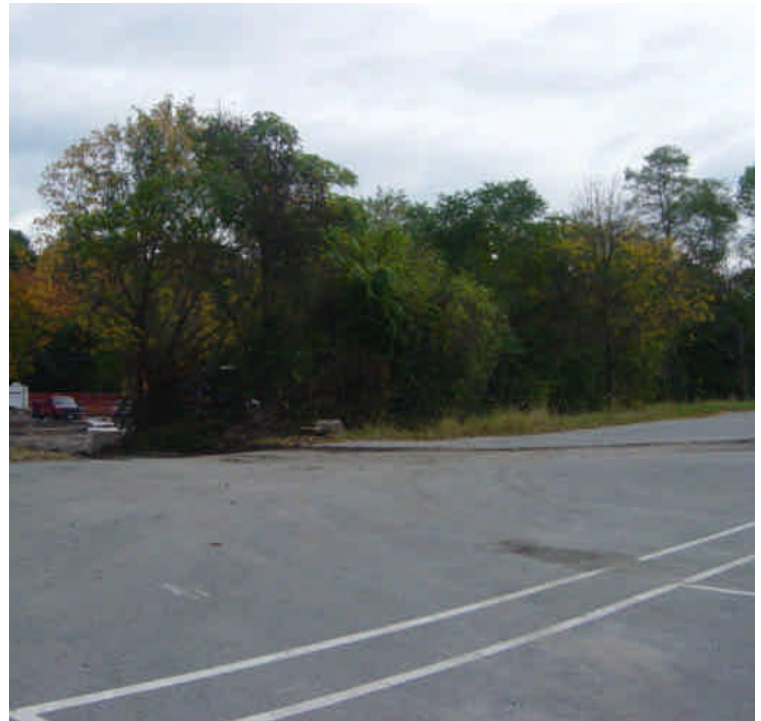
Some tracking was evident near the entrance to the staging area on the east side of the river, but was limited to the parking lot
