Re: **Petition No. 1178 – Fusion Solar Center, LLC – Environmental Monitoring Reports and Daily Site Observation Form Report No. 3**

**ENVIRONMENTAL MONITORING**  
**DAILY SITE OBSERVATION FORM**

**Report No. 3**

Project: DEPCOM Power, Fusion Solar Center  
Address: Potash Hill Road, Sprague, Connecticut

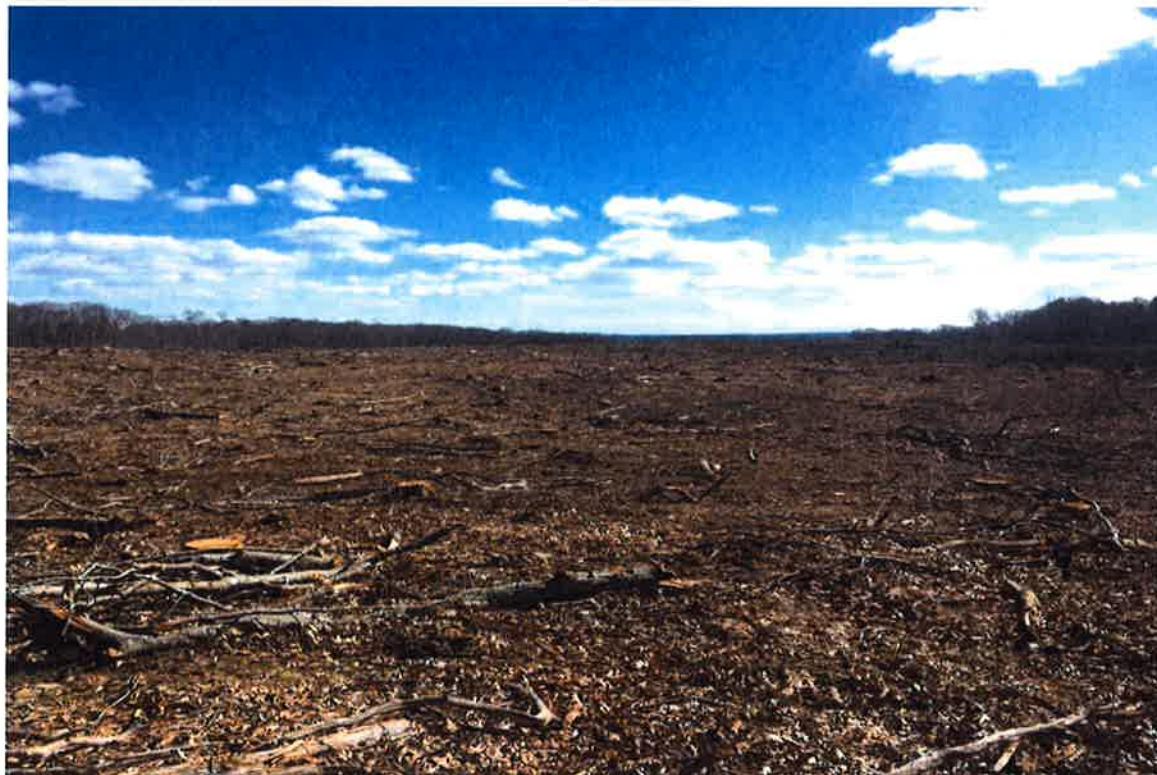
Photo 1: View of northern end of the project area looking south.

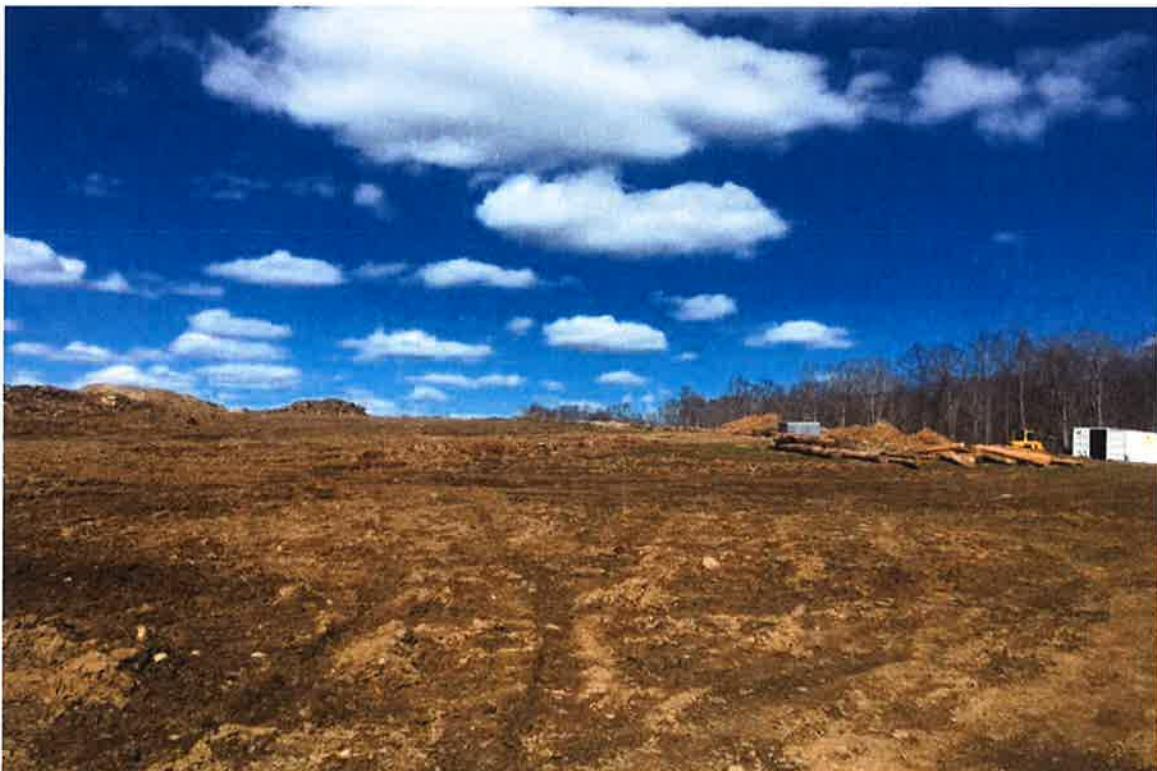
Photo 2: View of southeast project area looking north.

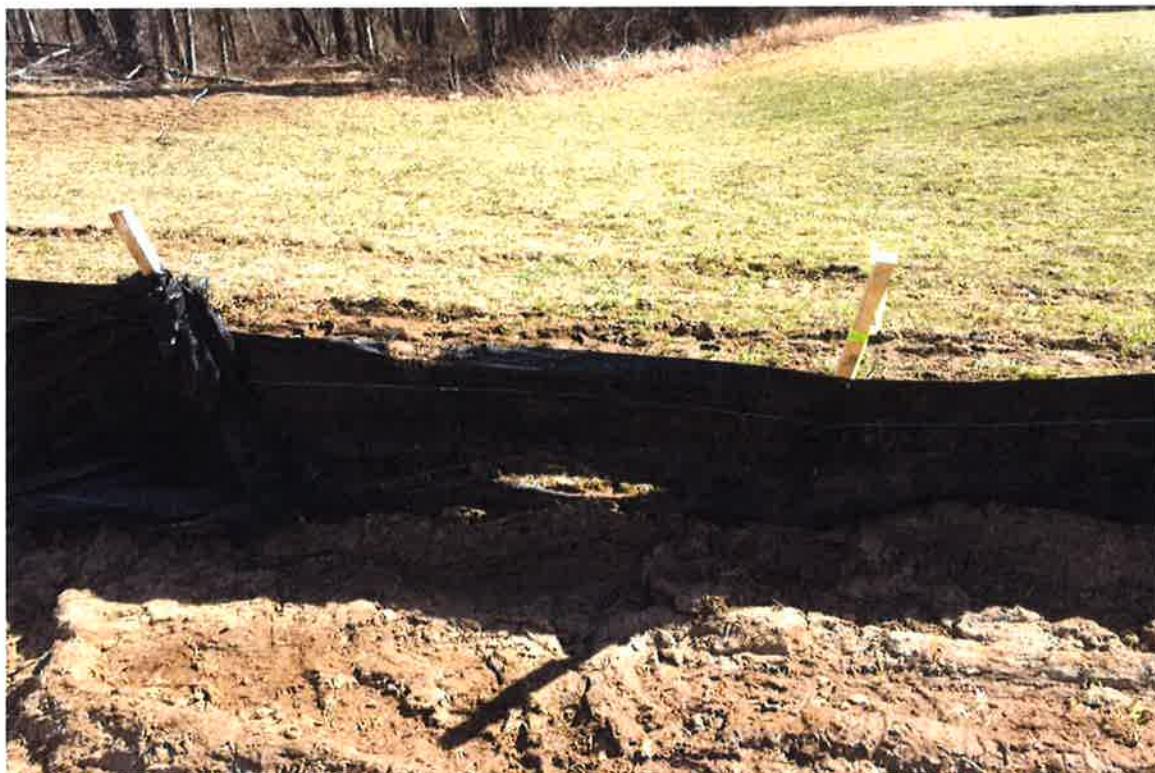
Photo 3: View of CA#4 silt fence hole/gap.

3/3/17 – APT discussed CA #4, 5 & 6 with Chance Combs, DEPCOM. Mr. Combs indicated to APT that corrective actions were already scheduled for the western side of the project on Friday (3/3) afternoon and all corrective actions would be completed on Monday (3/6). Tree clearing activities have been completed for the entire project. Temporary sediment traps are currently under construction.

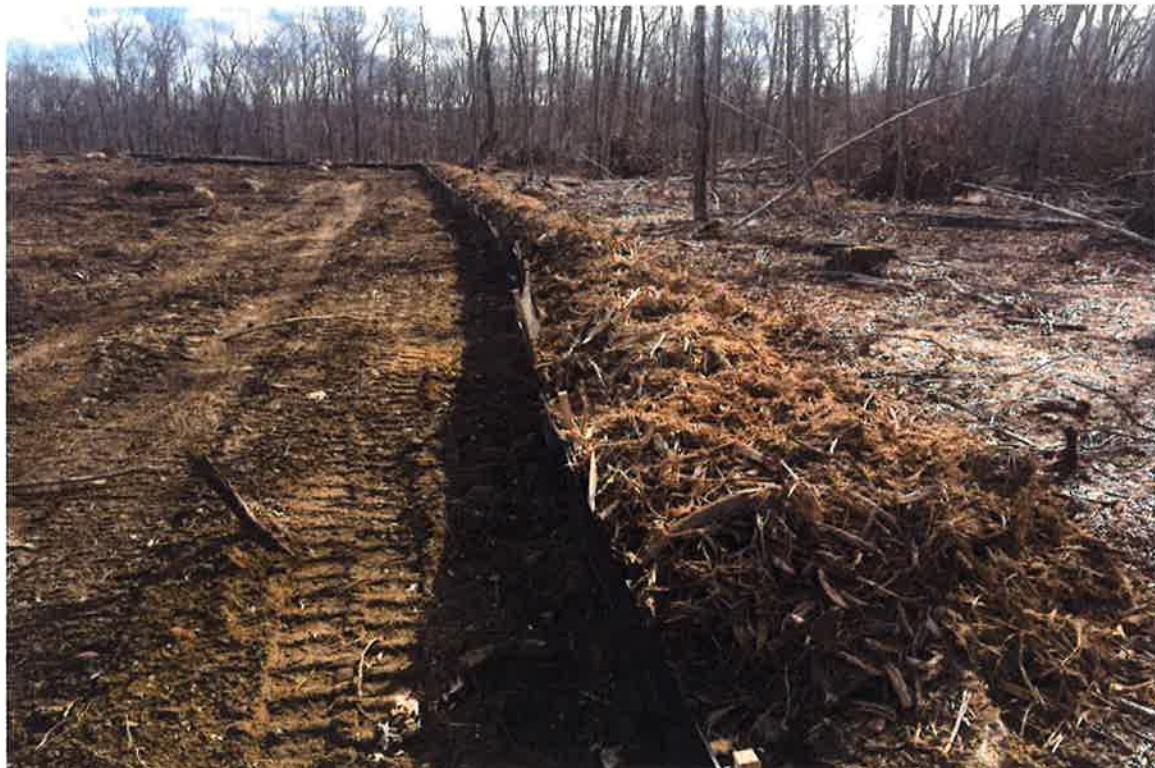
Photo 4: View of CA#5 where wood chips backing silt fence are pushed up to top. Wood chips need to be pushed away from silt fence to not allow herpetofauna migration into work zone.

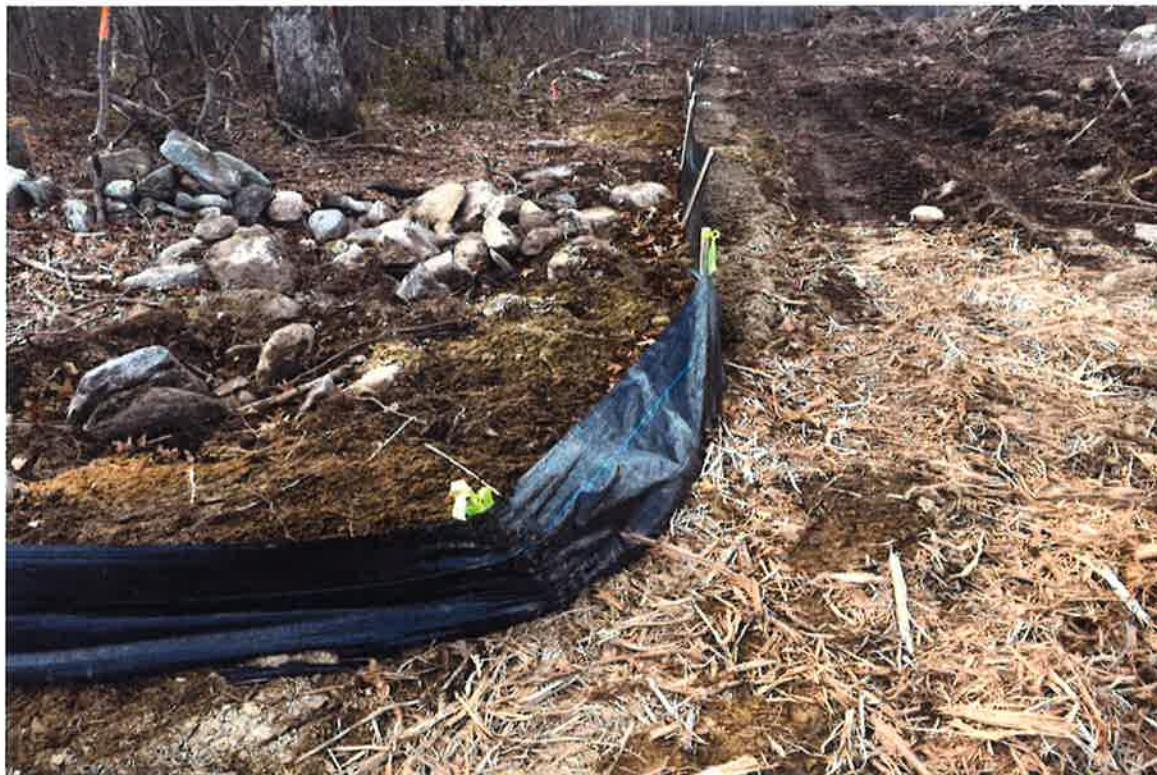
Corrective Action #1 - Brush/logs in wetlands in southeast portion of property.	1/20/17
Corrective Action #2 – Eastern project limits of installed silt fence had 4 breaches (small holes) identified and flagged with orange tape.	2/14/17
Corrective Action #3 – Southern portion of silt fence needs 3 CA; one breach (small hole), one 10-foot section needs to be trenched in and corner near construction road needs repair – 10' section collapsed.	2/14/17
Corrective Action #4 – numerous areas of silt fence have separated from staking or ripped resulting in sagging and disconnected silt fencing needing repair. These tears in the silt fence have also resulting in two gaps/holes.	
Corrective Action #5 – Several areas where wood chip backing to silt fence is pushed up to the top of the silt fence. Wood chips need to be pushed away from silt fence to not allow herpetofauna migration into work zone.	
Corrective Action #6 – one area of insufficient silt fence height due to sagging.

Photo 5: View of CA #6, area of insufficient silt fence height due to sagging.

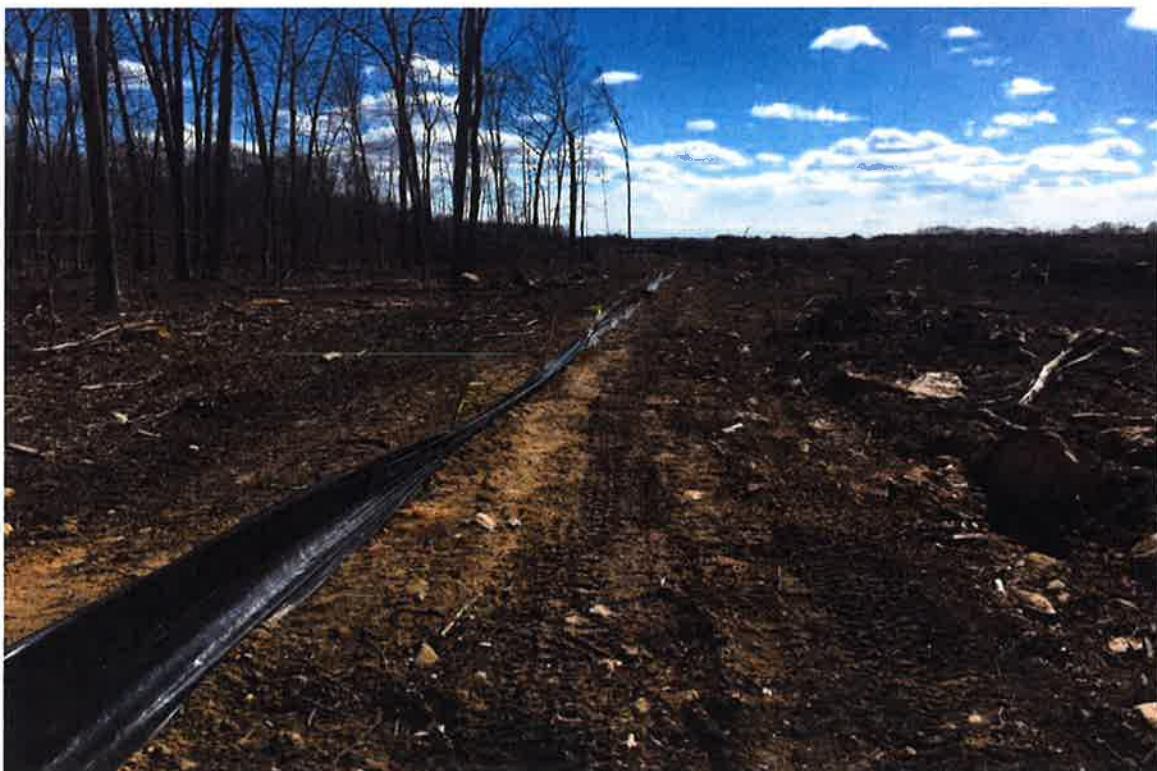
Photo 6: View of CA #6 where silt fence has ripped off staking.
