Re: **Petition No. 1178 – Fusion Solar Center, LLC – Environmental Monitoring Daily Site Observation Form Report No. 10**

ENVIRONMENTAL MONITORING
DAILY SITE OBSERVATION FORM

Report No. 10

Project: DEPCOM Power, Fusion Solar Center
 Address: Potash Hill Road, Sprague, Connecticut

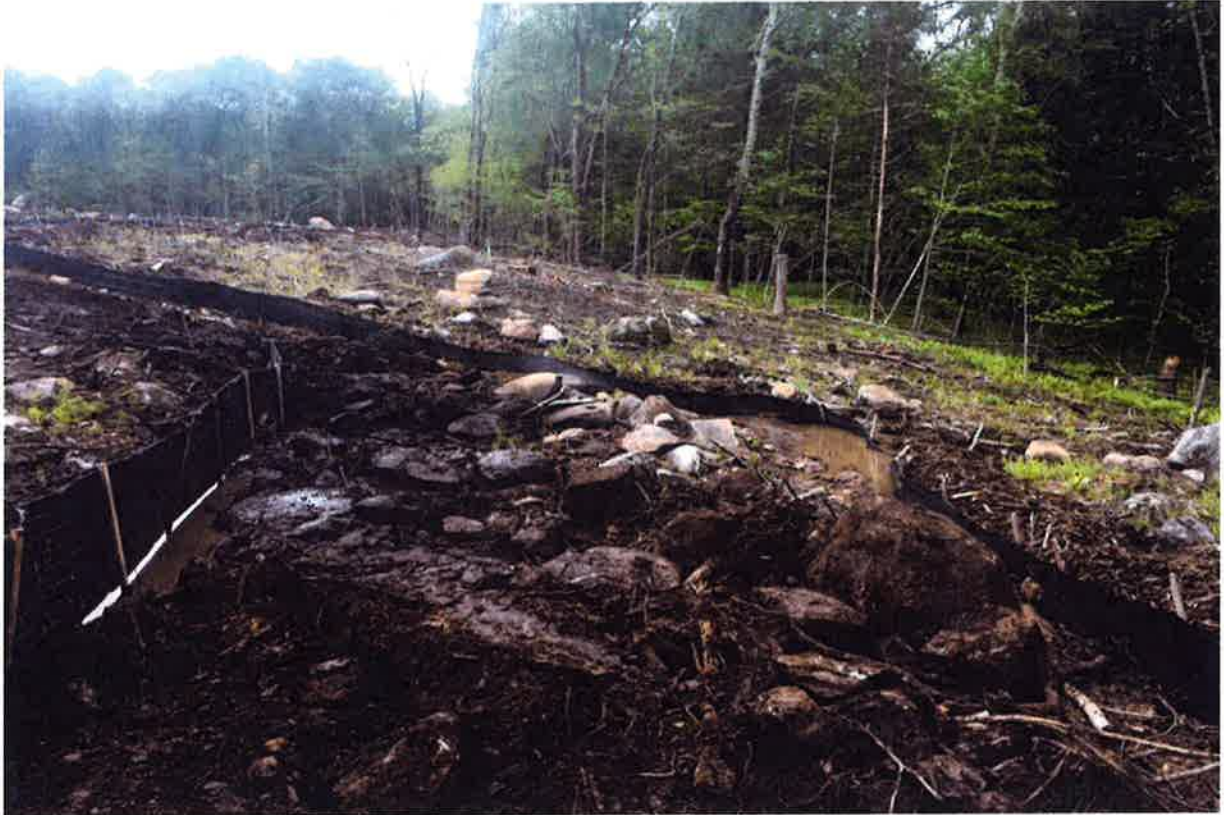
<p>Corrective Action #8 – Two areas identified where gaps in silt fence formed underneath due to focused erosion from stormwater flows. Small sediment release in uplands with little risk of migration off-site or into wetlands.</p> <p>Note: All sediment traps should be reevaluated to ensure that they have been constructed to specifications and that drainage areas specified are being captured by each basin. This may improve conditions at discharge points leading to CA #8. Several sediment traps have been reconstructed, work ongoing.</p>	<p>Original areas repaired by 5/15/17</p> <p>Same locations resulted in silt fence failure requiring repair. Consider adding additional reinforcement to these locations (haybale backing, straw wattle check dams, diversion channels etc.). Repairs underway, not completed yet.</p>
<p>Corrective Action #9 – SB-2 and SB-3 not retaining volume due to low flow outlet pipe not closing, blocked entry to temporarily allow for basin to fill up and outlet via armored outlet or skimmer outfall.</p>	<p>5/15/17</p>

Photo 1: View of CA #8, looking south.

5/15/17 – Water observed leaving site was of lower volume/velocity with fewer suspended sediments than noted during previous inspections. All repairs from 5/8/17 were addressed with previous action items reoccurring on 5/15/17. Corrective Action #8 continues to be an issue, recommend reinforcing silt fence. All sediment basins and traps should be reevaluated to ensure they are functioning and built properly.

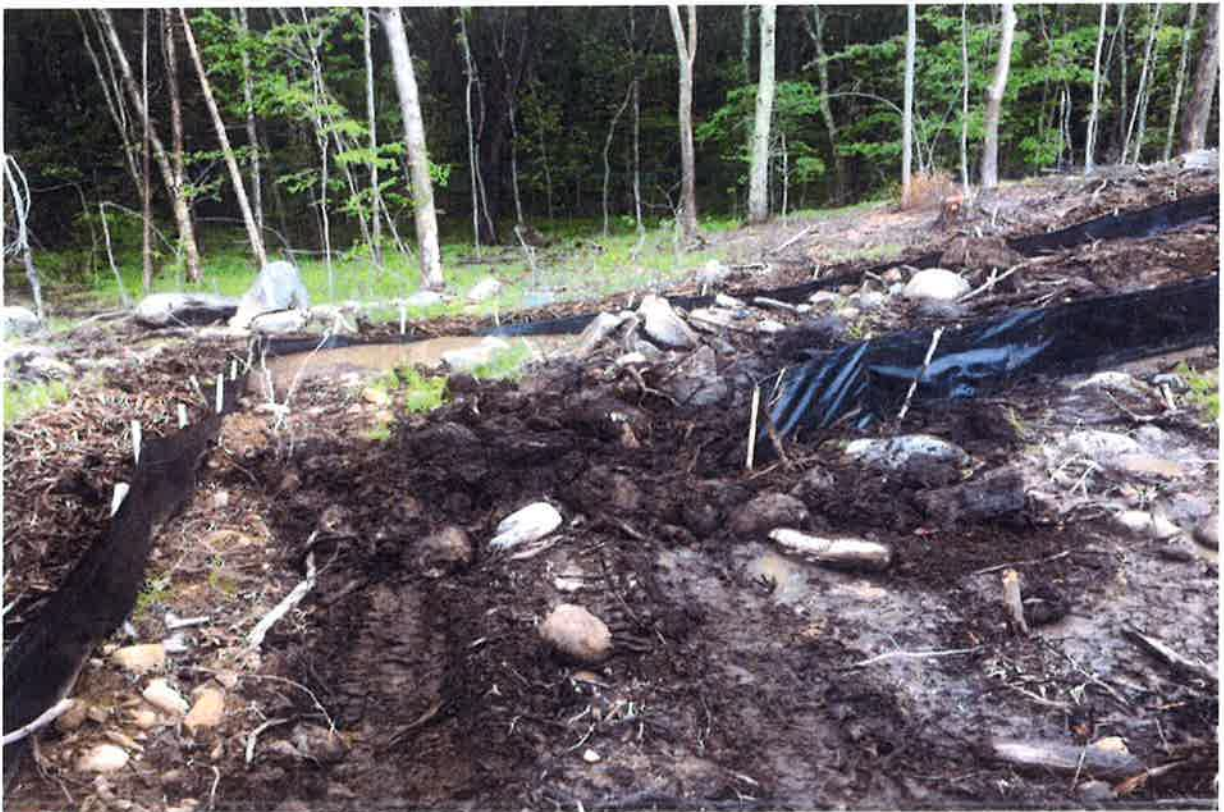
Photo 2: View of CA #8, looking west.

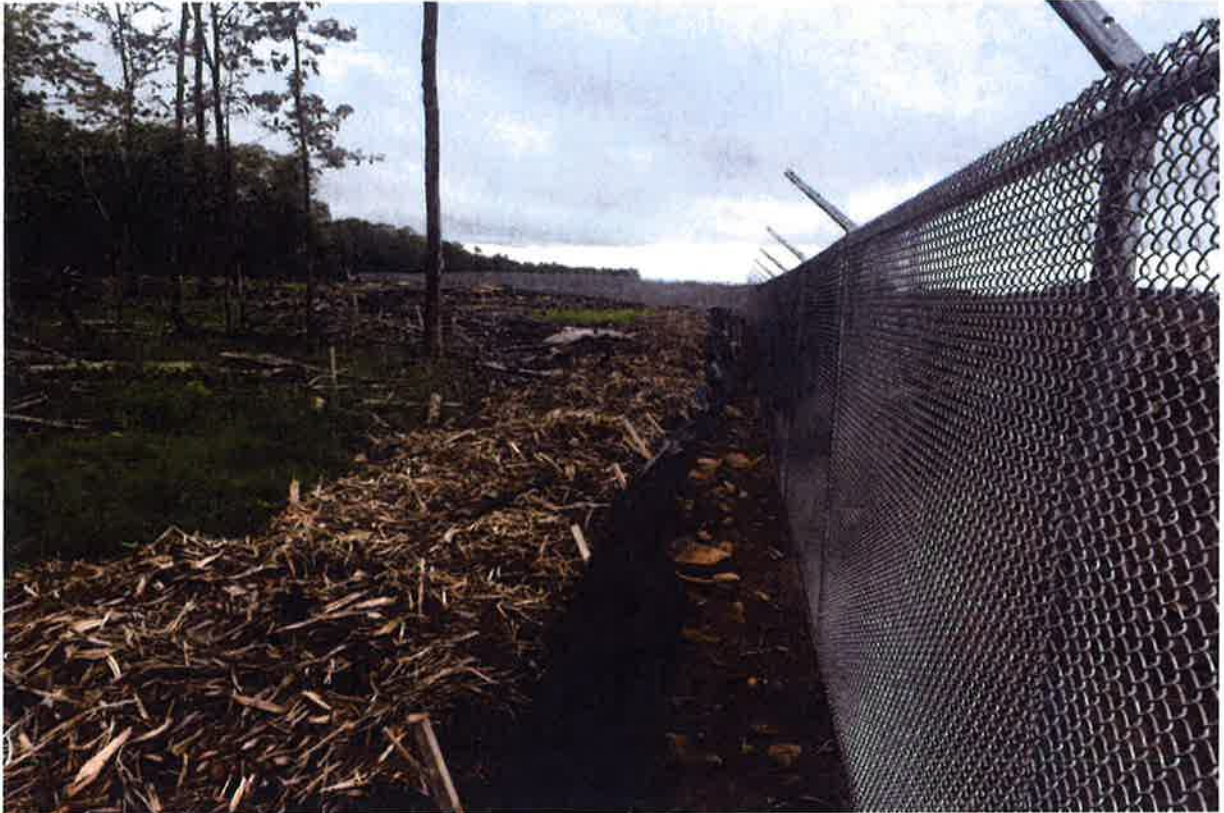
<p>Corrective Action #10 – add new armored swale in southwest project corner to protect outlet flows from SB-3, add check dams to all problem drainage/diversion channels (maintain after each rain storm).</p>	<p>5/15/17</p>
<p>Corrective Action #11 – silt fence in several areas needs to be repaired, cleaned or stakes replaced.</p>	<p>All repairs noted previously completed 5/15/17</p> <p>Several new areas, some created due to damage from permanent fence install, ongoing.</p>
<p>Project Modification Requested:</p>	
<p>Extra work space requested <input type="checkbox"/></p> <p>Change to work area <input type="checkbox"/></p> <p>Change to stormwater feature <input type="checkbox"/></p> <p>Description of Modification: N/A</p>	
<p>Notes:</p>

Photo 3: View of silt fence knocked over during permanent fence install (CA #11), looking south.

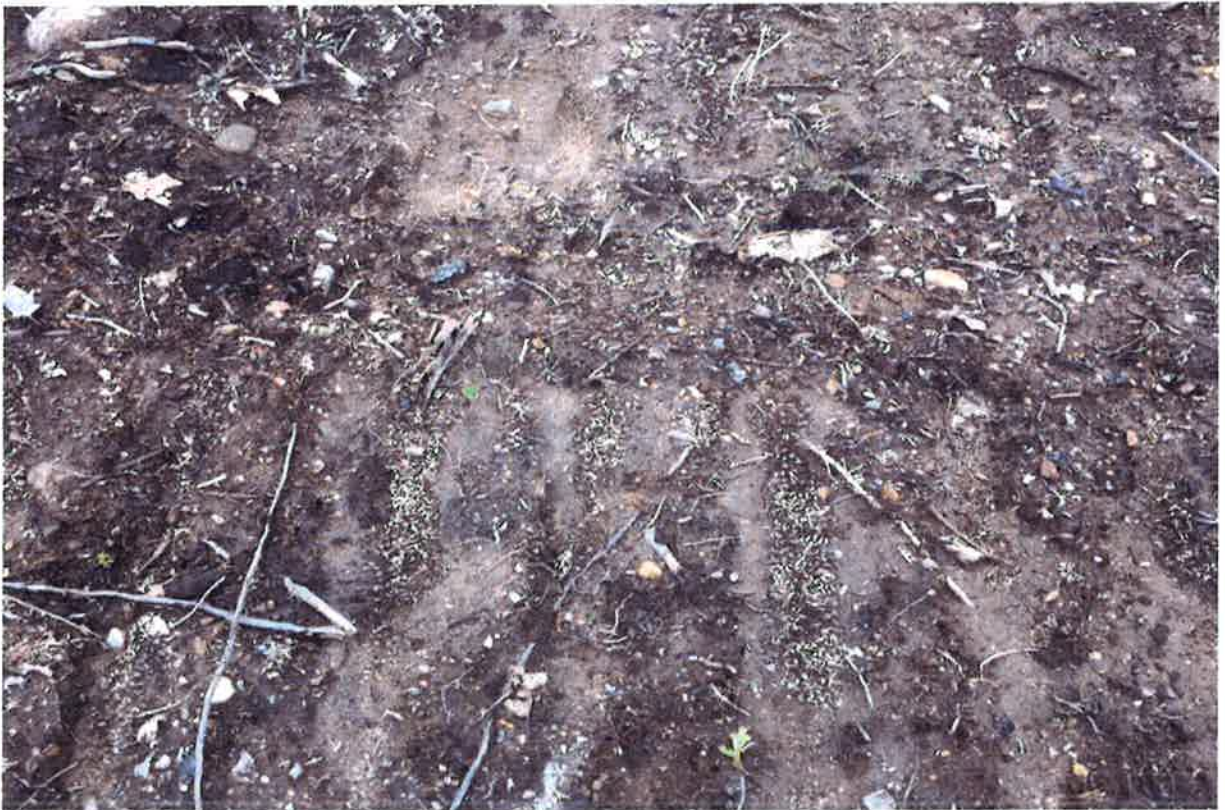
5/26/17 – Seed has been distributed throughout the project area to provide some surface stabilization. Water leaving site (including drainage from SB-3 outfall) has few suspended sediments. Permanent chain-link fence install is still ongoing. Sediment trap reconstruction is currently ongoing. Several areas noted where rill erosion paths are focusing water to silt fence corners. Some silt build up has occurred in these silt fence corners. These areas should be closely monitored after each rain event to remove built-up silt and make any necessary repair or reinforcements.

Photo 4: Close-up view of seeding.

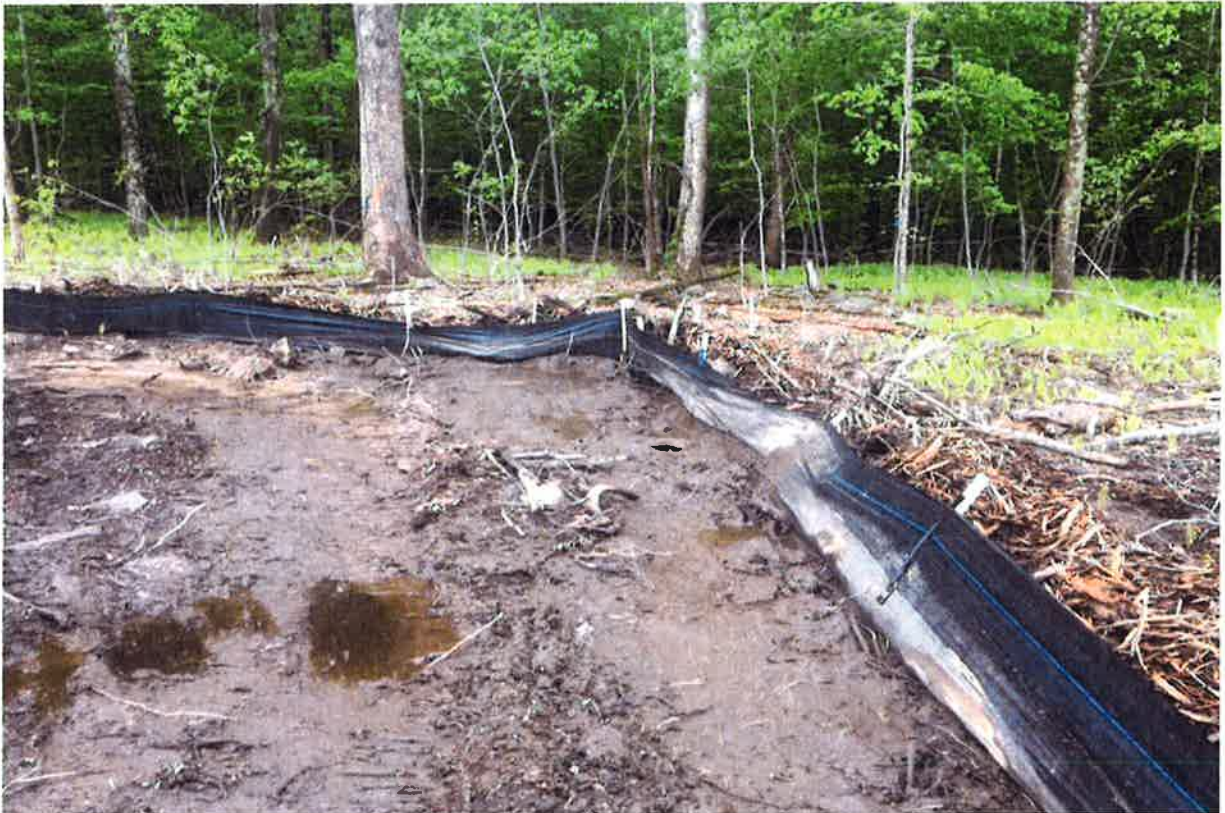
Photo 5: View of silt fence corner noted needing clean-out looking southwest.

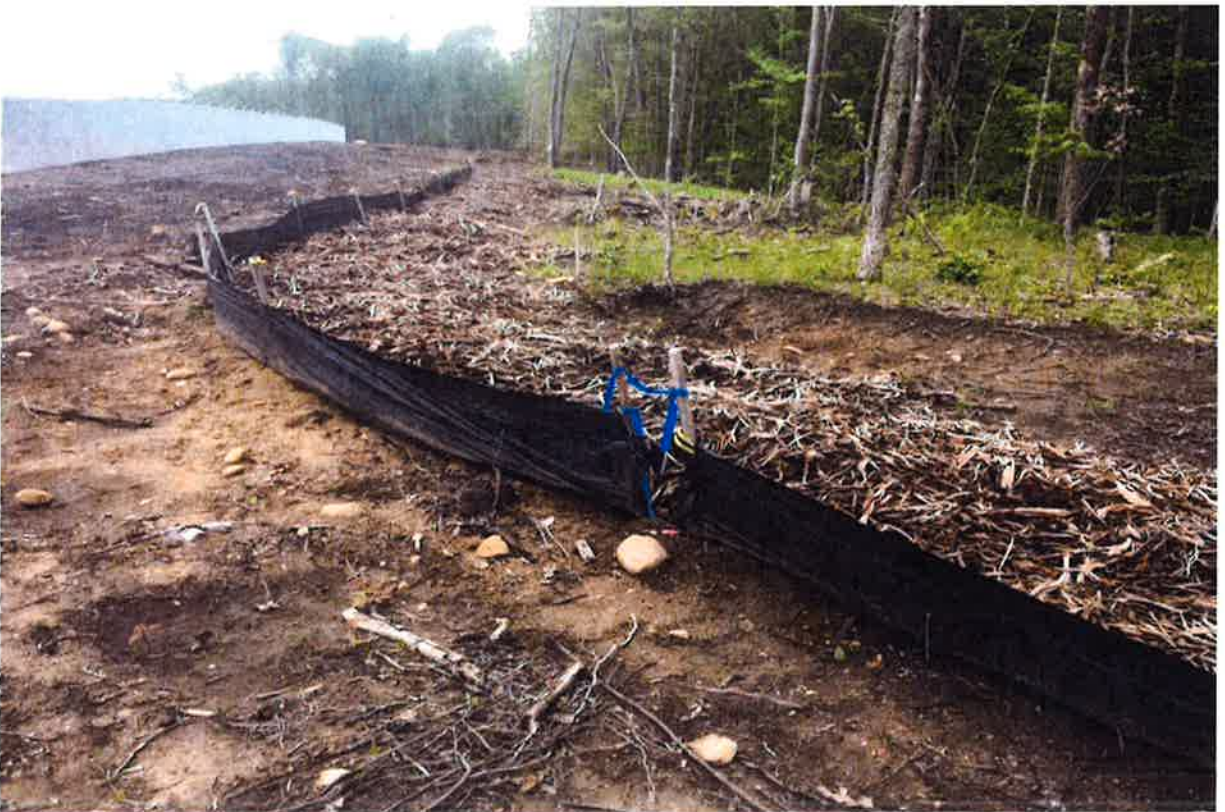
Photo 6: View of gap in silt fence (CA #11), looking northeast.

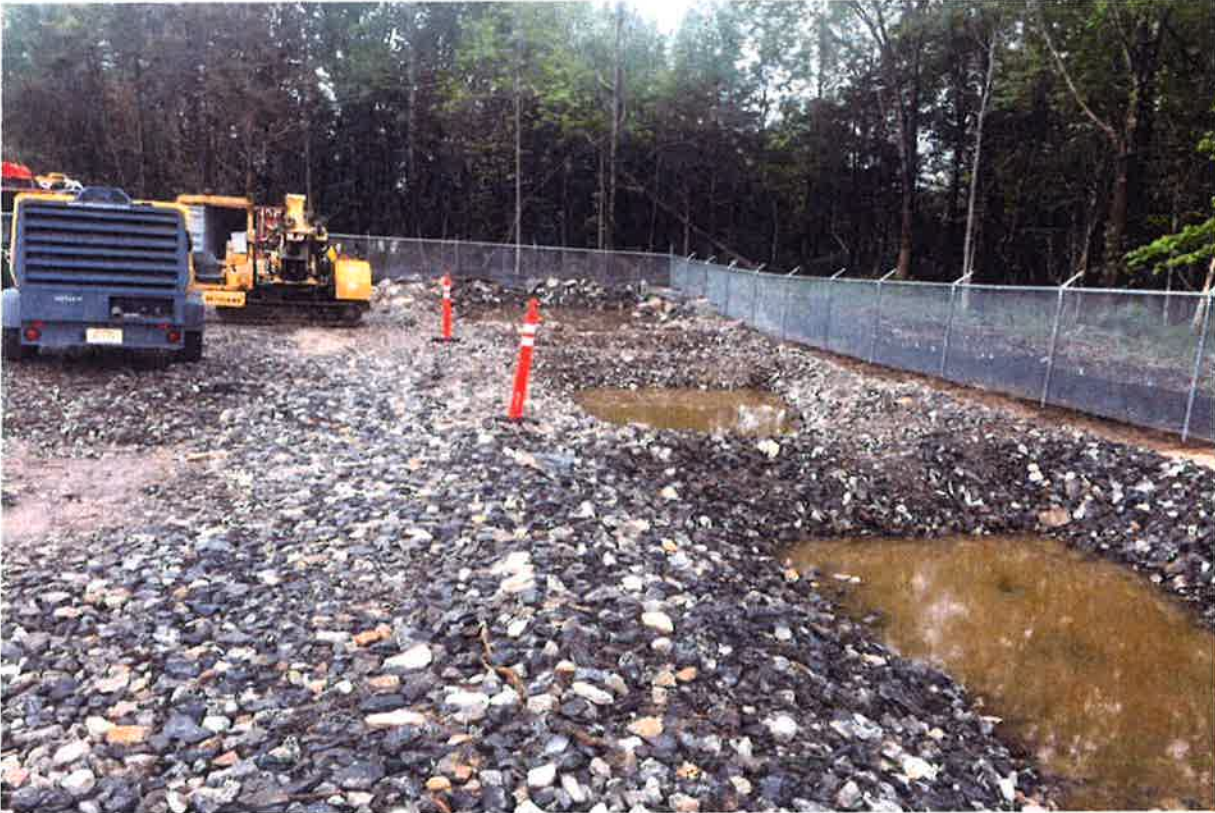
Photo 7: View of drainage swale from SB-3 looking south.

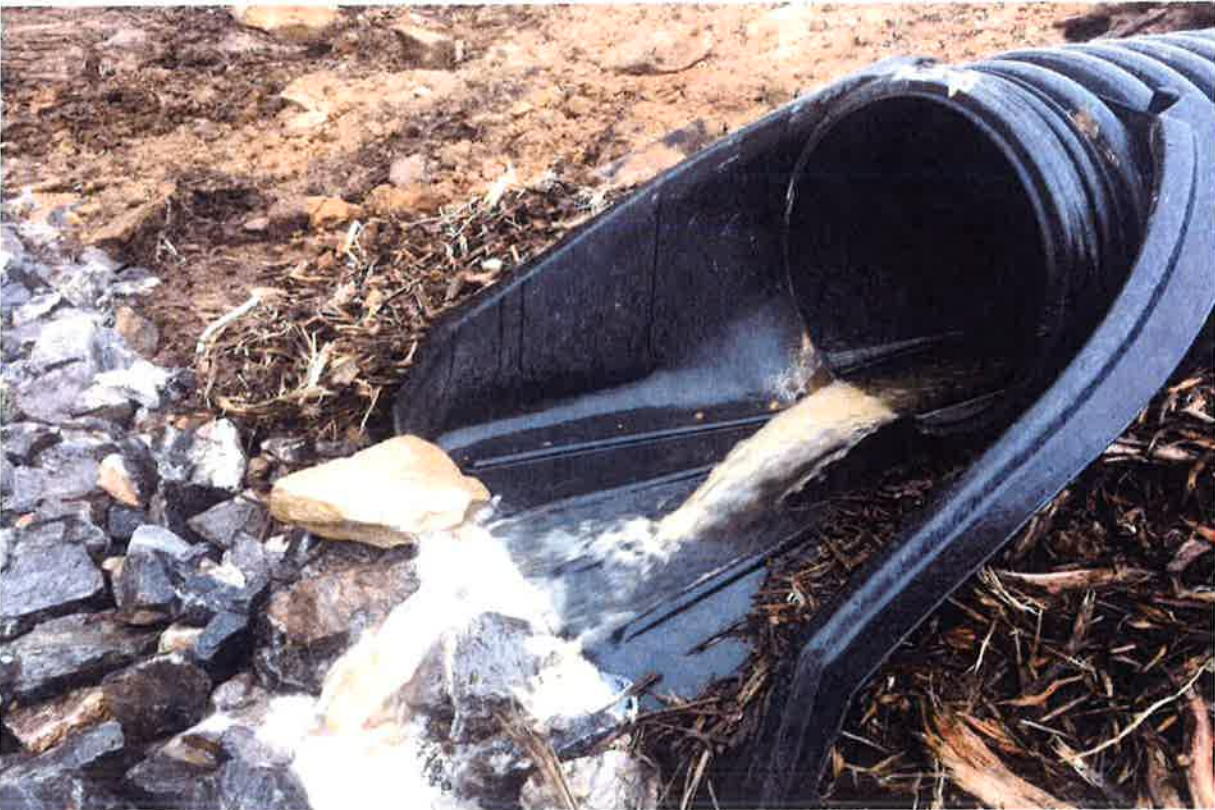
Photo 8: View of outlet from SB-3.

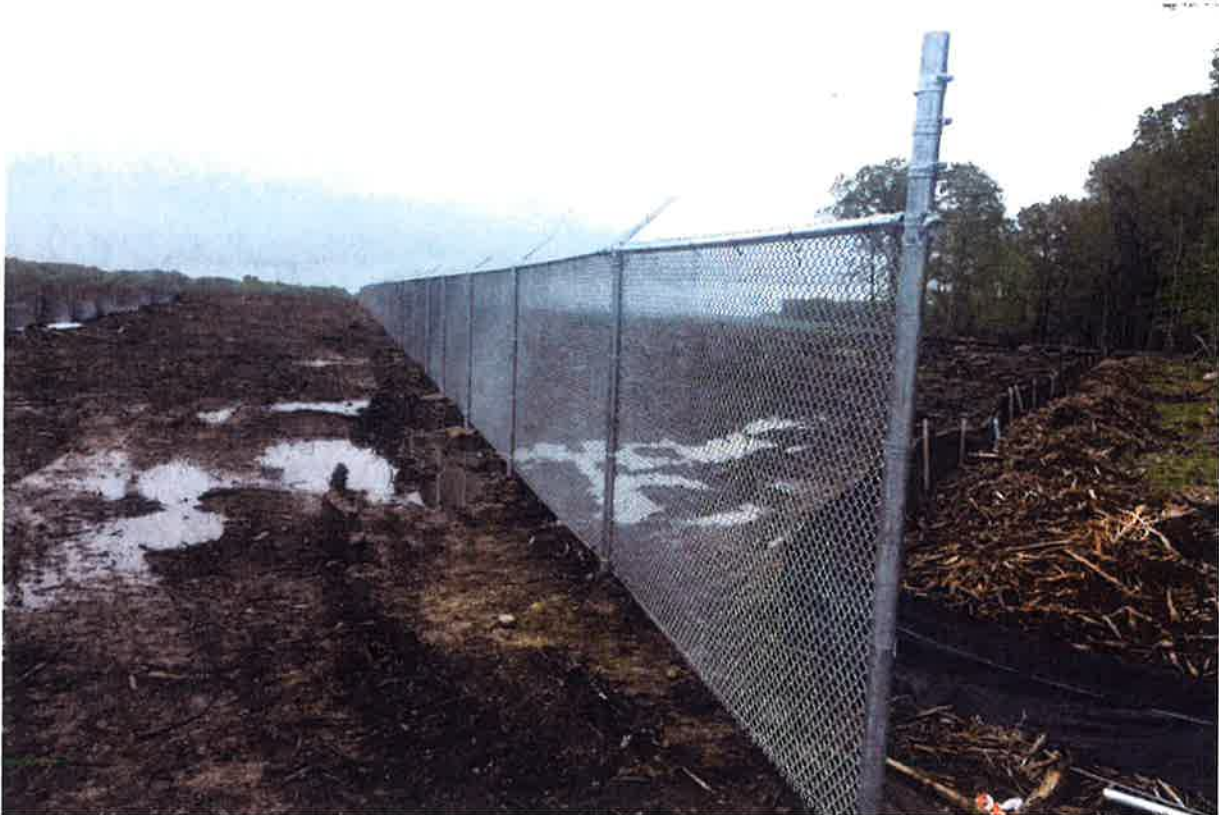
Photo 9: View of permanent fence installed looking south.

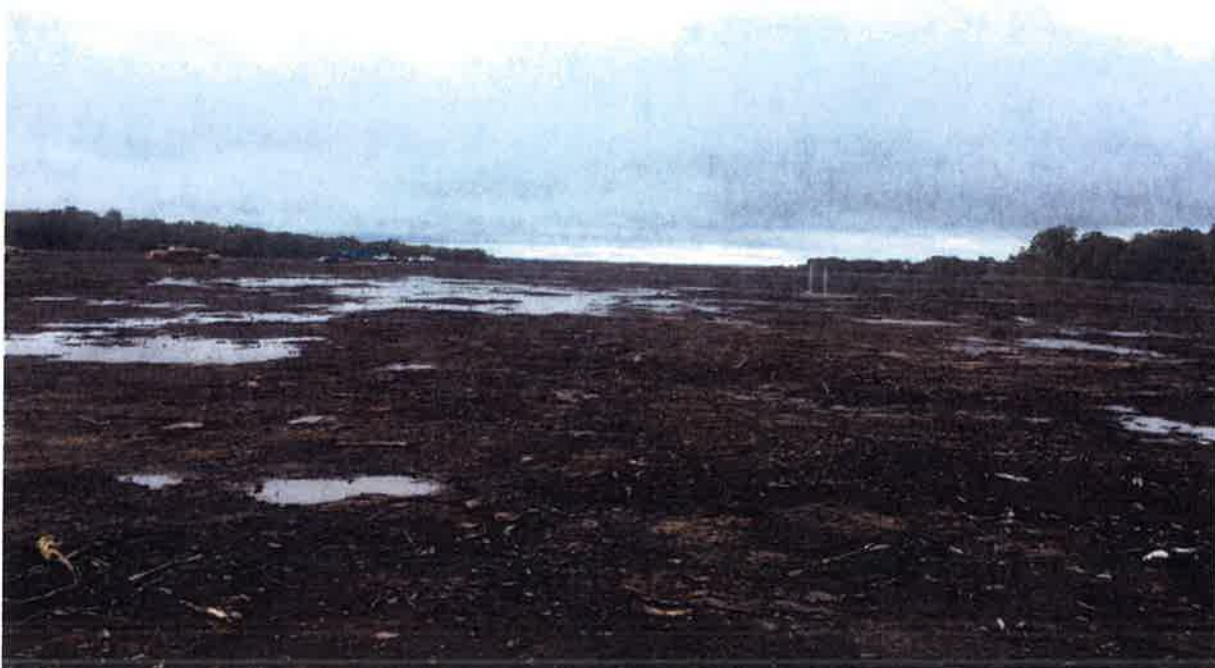
Photo 10: View of project area looking south.
