Re: **Petition No. 1178 – Fusion Solar Center, LLC – Environmental Monitoring Daily Site Observation Form Report Nos. 11 and 12**

ENVIRONMENTAL MONITORING
DAILY SITE OBSERVATION FORM

Report No. 11

Project: DEPCOM Power, Fusion Solar Center
Address: Potash Hill Road, Sprague, Connecticut

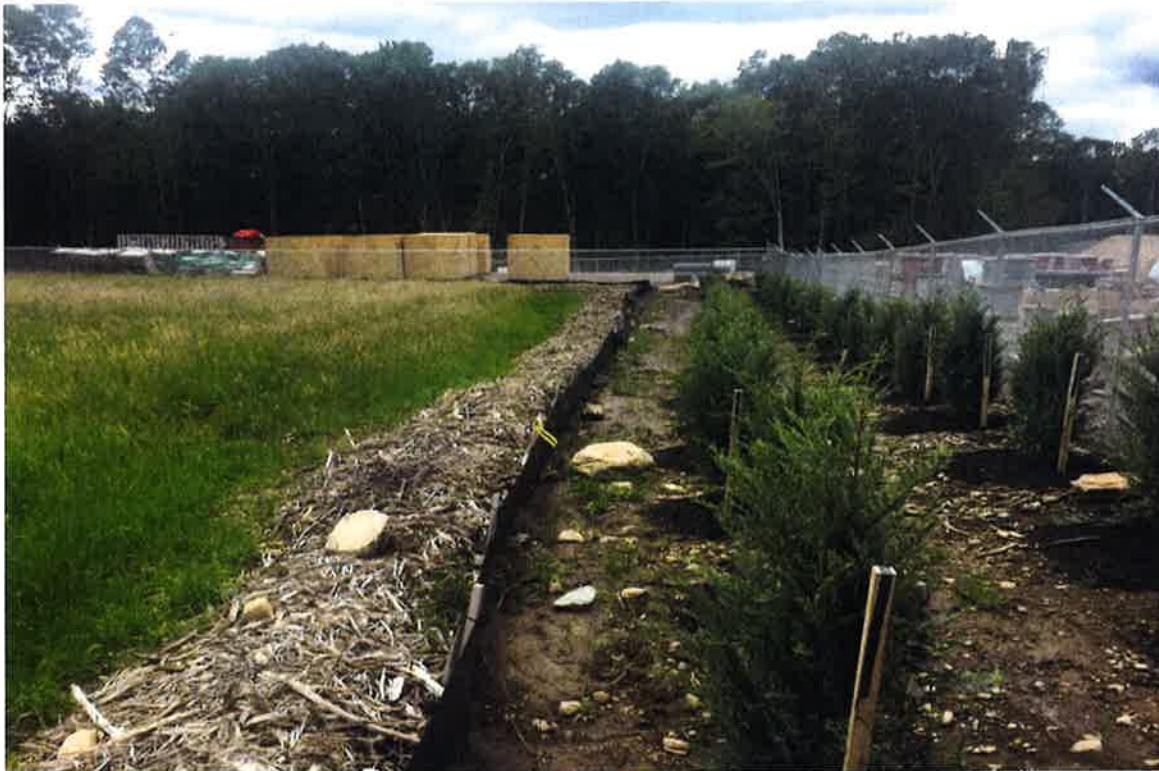
Photo 1: View of perimeter area south of laydown yard looking west.

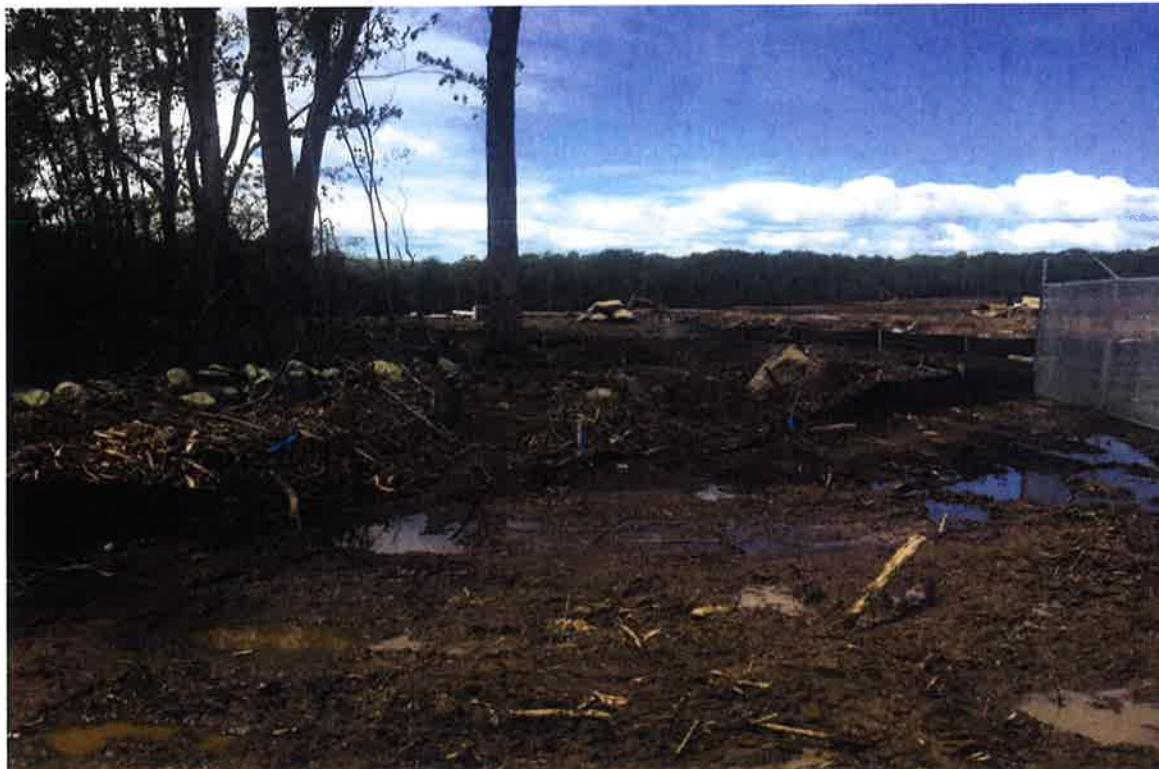
<p>Corrective Action #11 – silt fence in several areas needs to be repaired, cleaned or stakes replaced.</p>	<p>All repairs noted previously completed 5/15/17 Several new areas identified, some created due to damage from permanent fence install. Repairs are ongoing.</p>
<p>Project Modification Requested:</p> <p>Extra work space requested <input type="checkbox"/></p> <p>Change to work area <input type="checkbox"/></p> <p>Change to stormwater feature <input type="checkbox"/></p>	
<p>Description of Modification: N/A</p>

Photo 2: View of silt fence needing repair (CA #11), looking north.

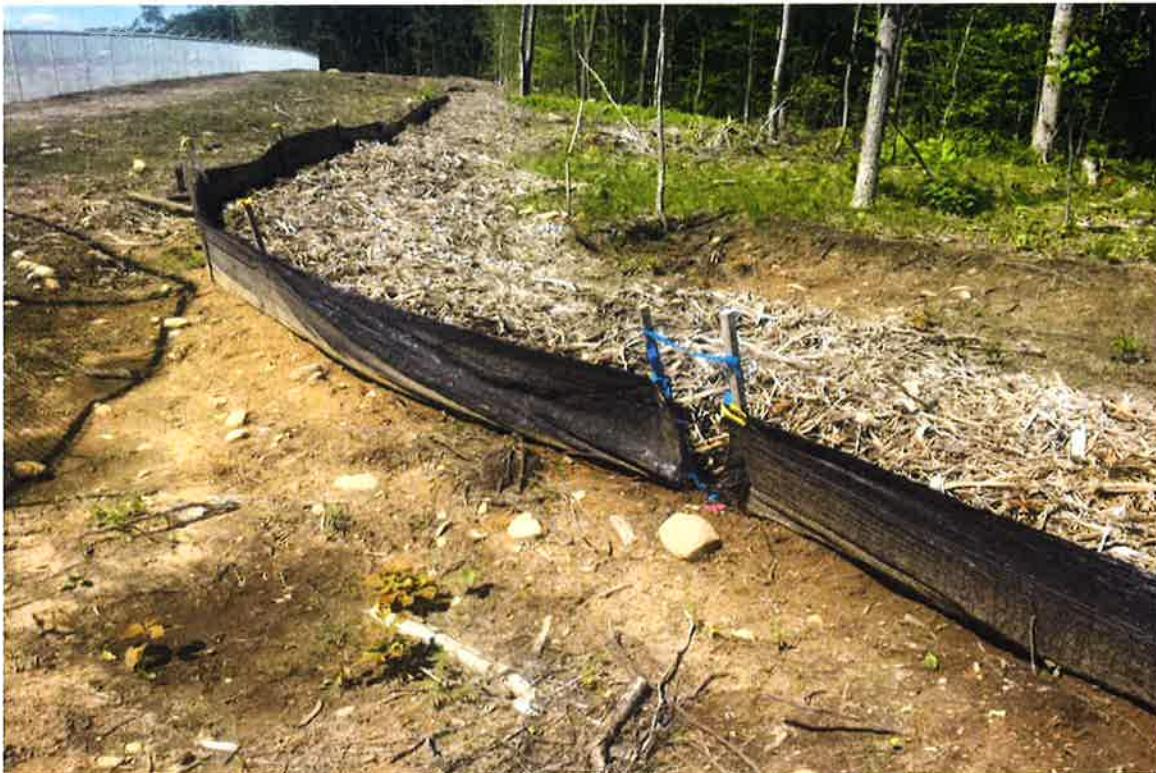
Photo 3: View of gap in silt fence (CA #11) requiring repair.

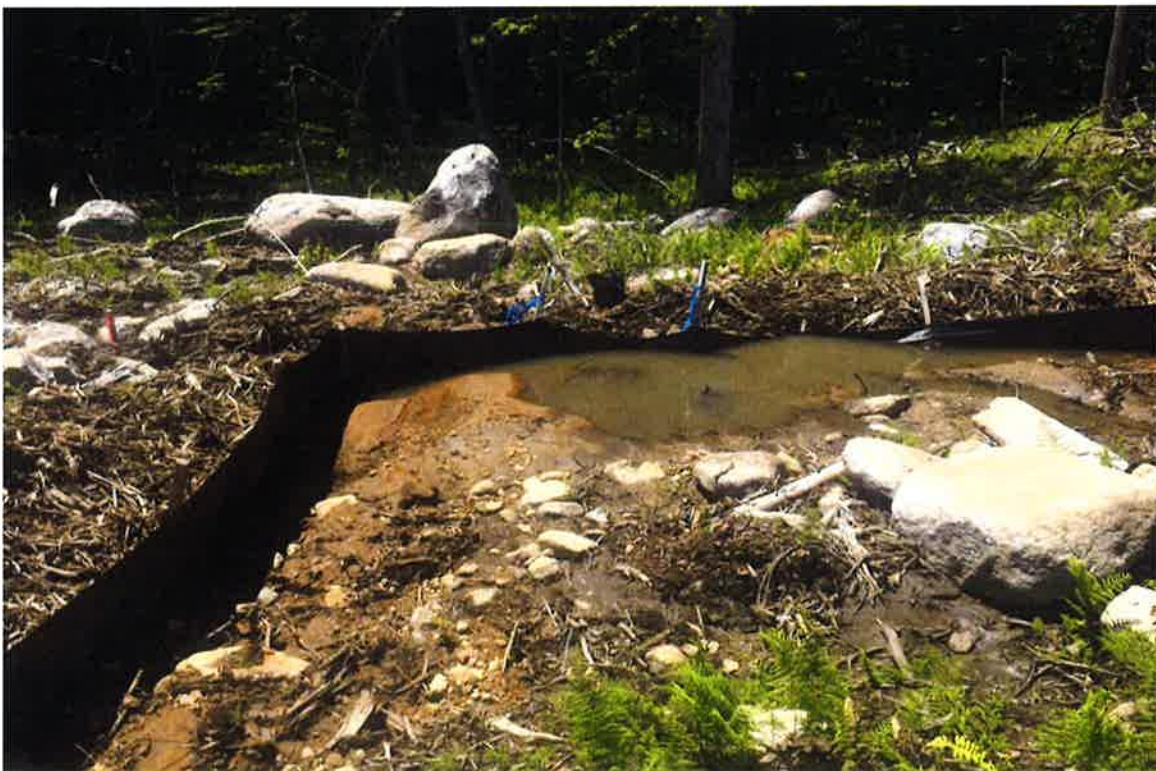
<p>Corrective Action #8 – One area identified where gaps in silt fence formed underneath due to focused erosion from stormwater flows. Small sediment release in uplands with little risk of migration off-site or into wetlands.</p>	<p>Original areas repaired by 5/15/17 Same locations resulted in silt fence failure requiring repair. Additional reinforcement controls added to this area including reinforced silt fence has not been completed. Repairs underway, not completed yet, ongoing.</p>
<p>Corrective Action #9 – SB-2 and SB-3 not retaining volume due to low flow outlet pipe not closing, blocked entry to temporarily allow for basin to fill up and outlet via armored outlet or skimmer outfall.</p>	<p>5/15/17</p>
<p>Corrective Action #10 – add new armored swale in southwest project corner to protect outlet flows from SB-3, add check dams to all problem drainage/diversion channels (maintain after each rain storm).</p>	<p>5/15/17</p>

Photo 4: View of continued problem area (CA #8) in northwest corner looking west.

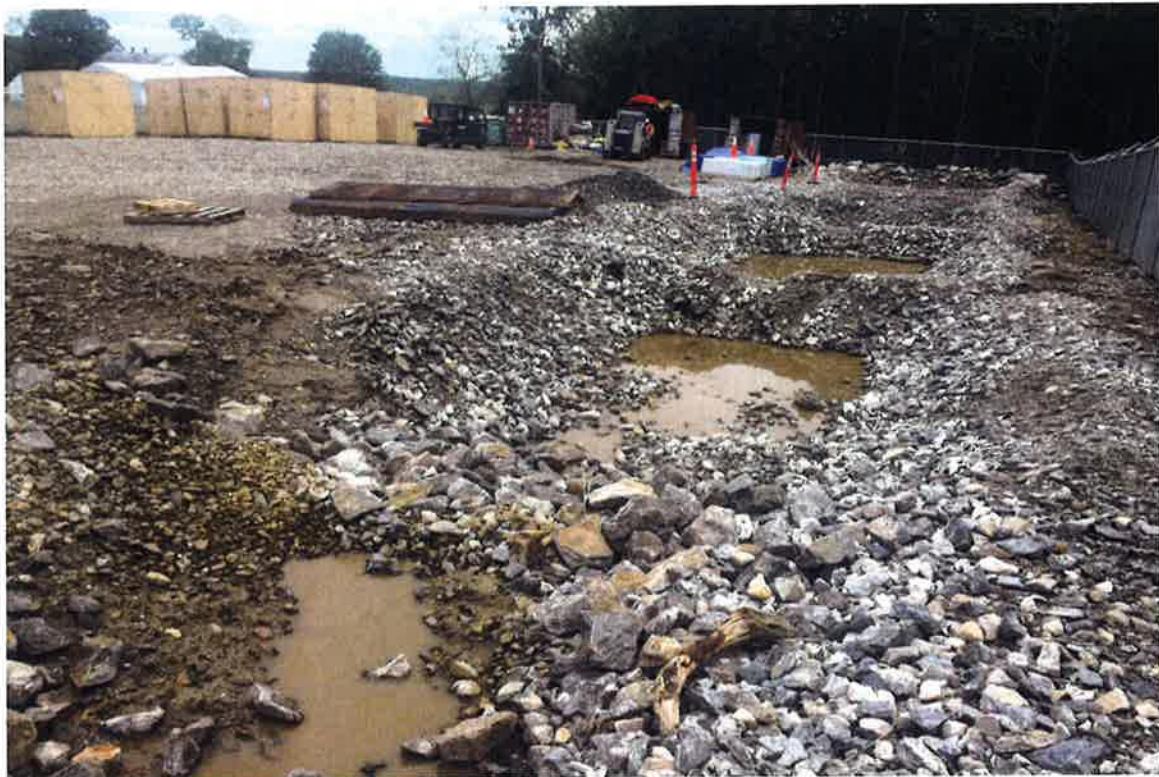
Photo 5: View of SB-3 outfall looking south.

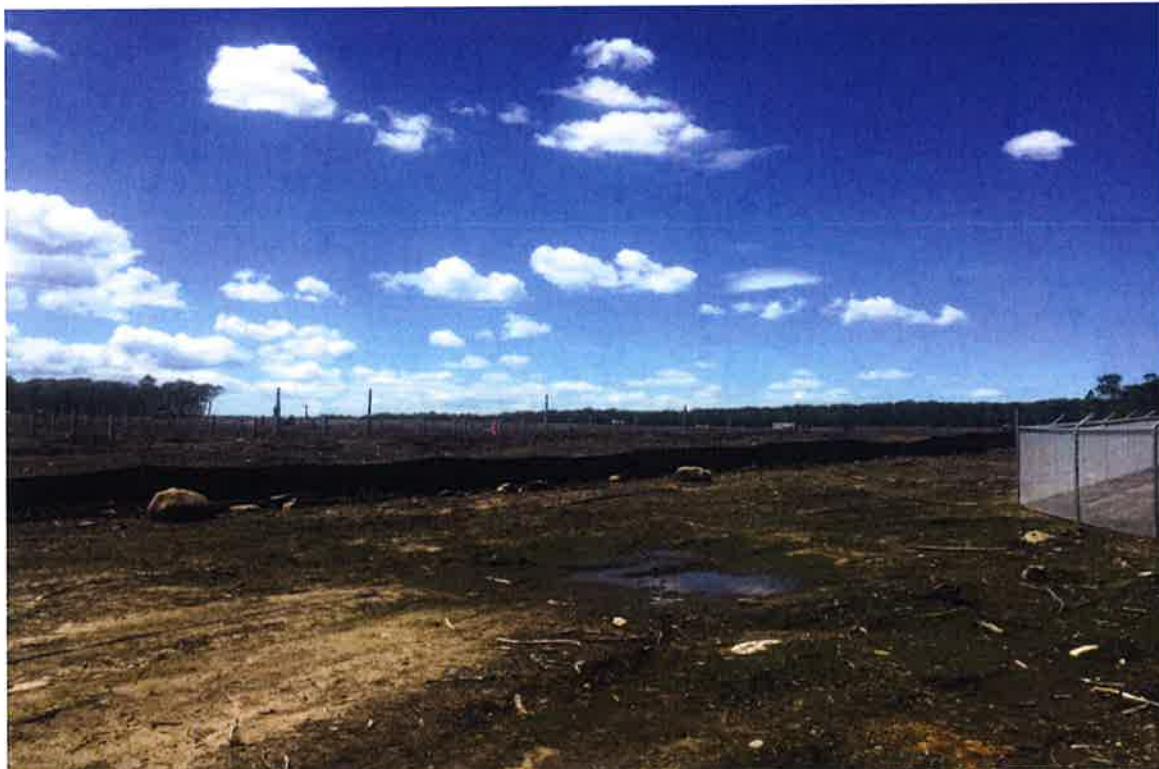
Photo 6: View of Project Area looking southeast.

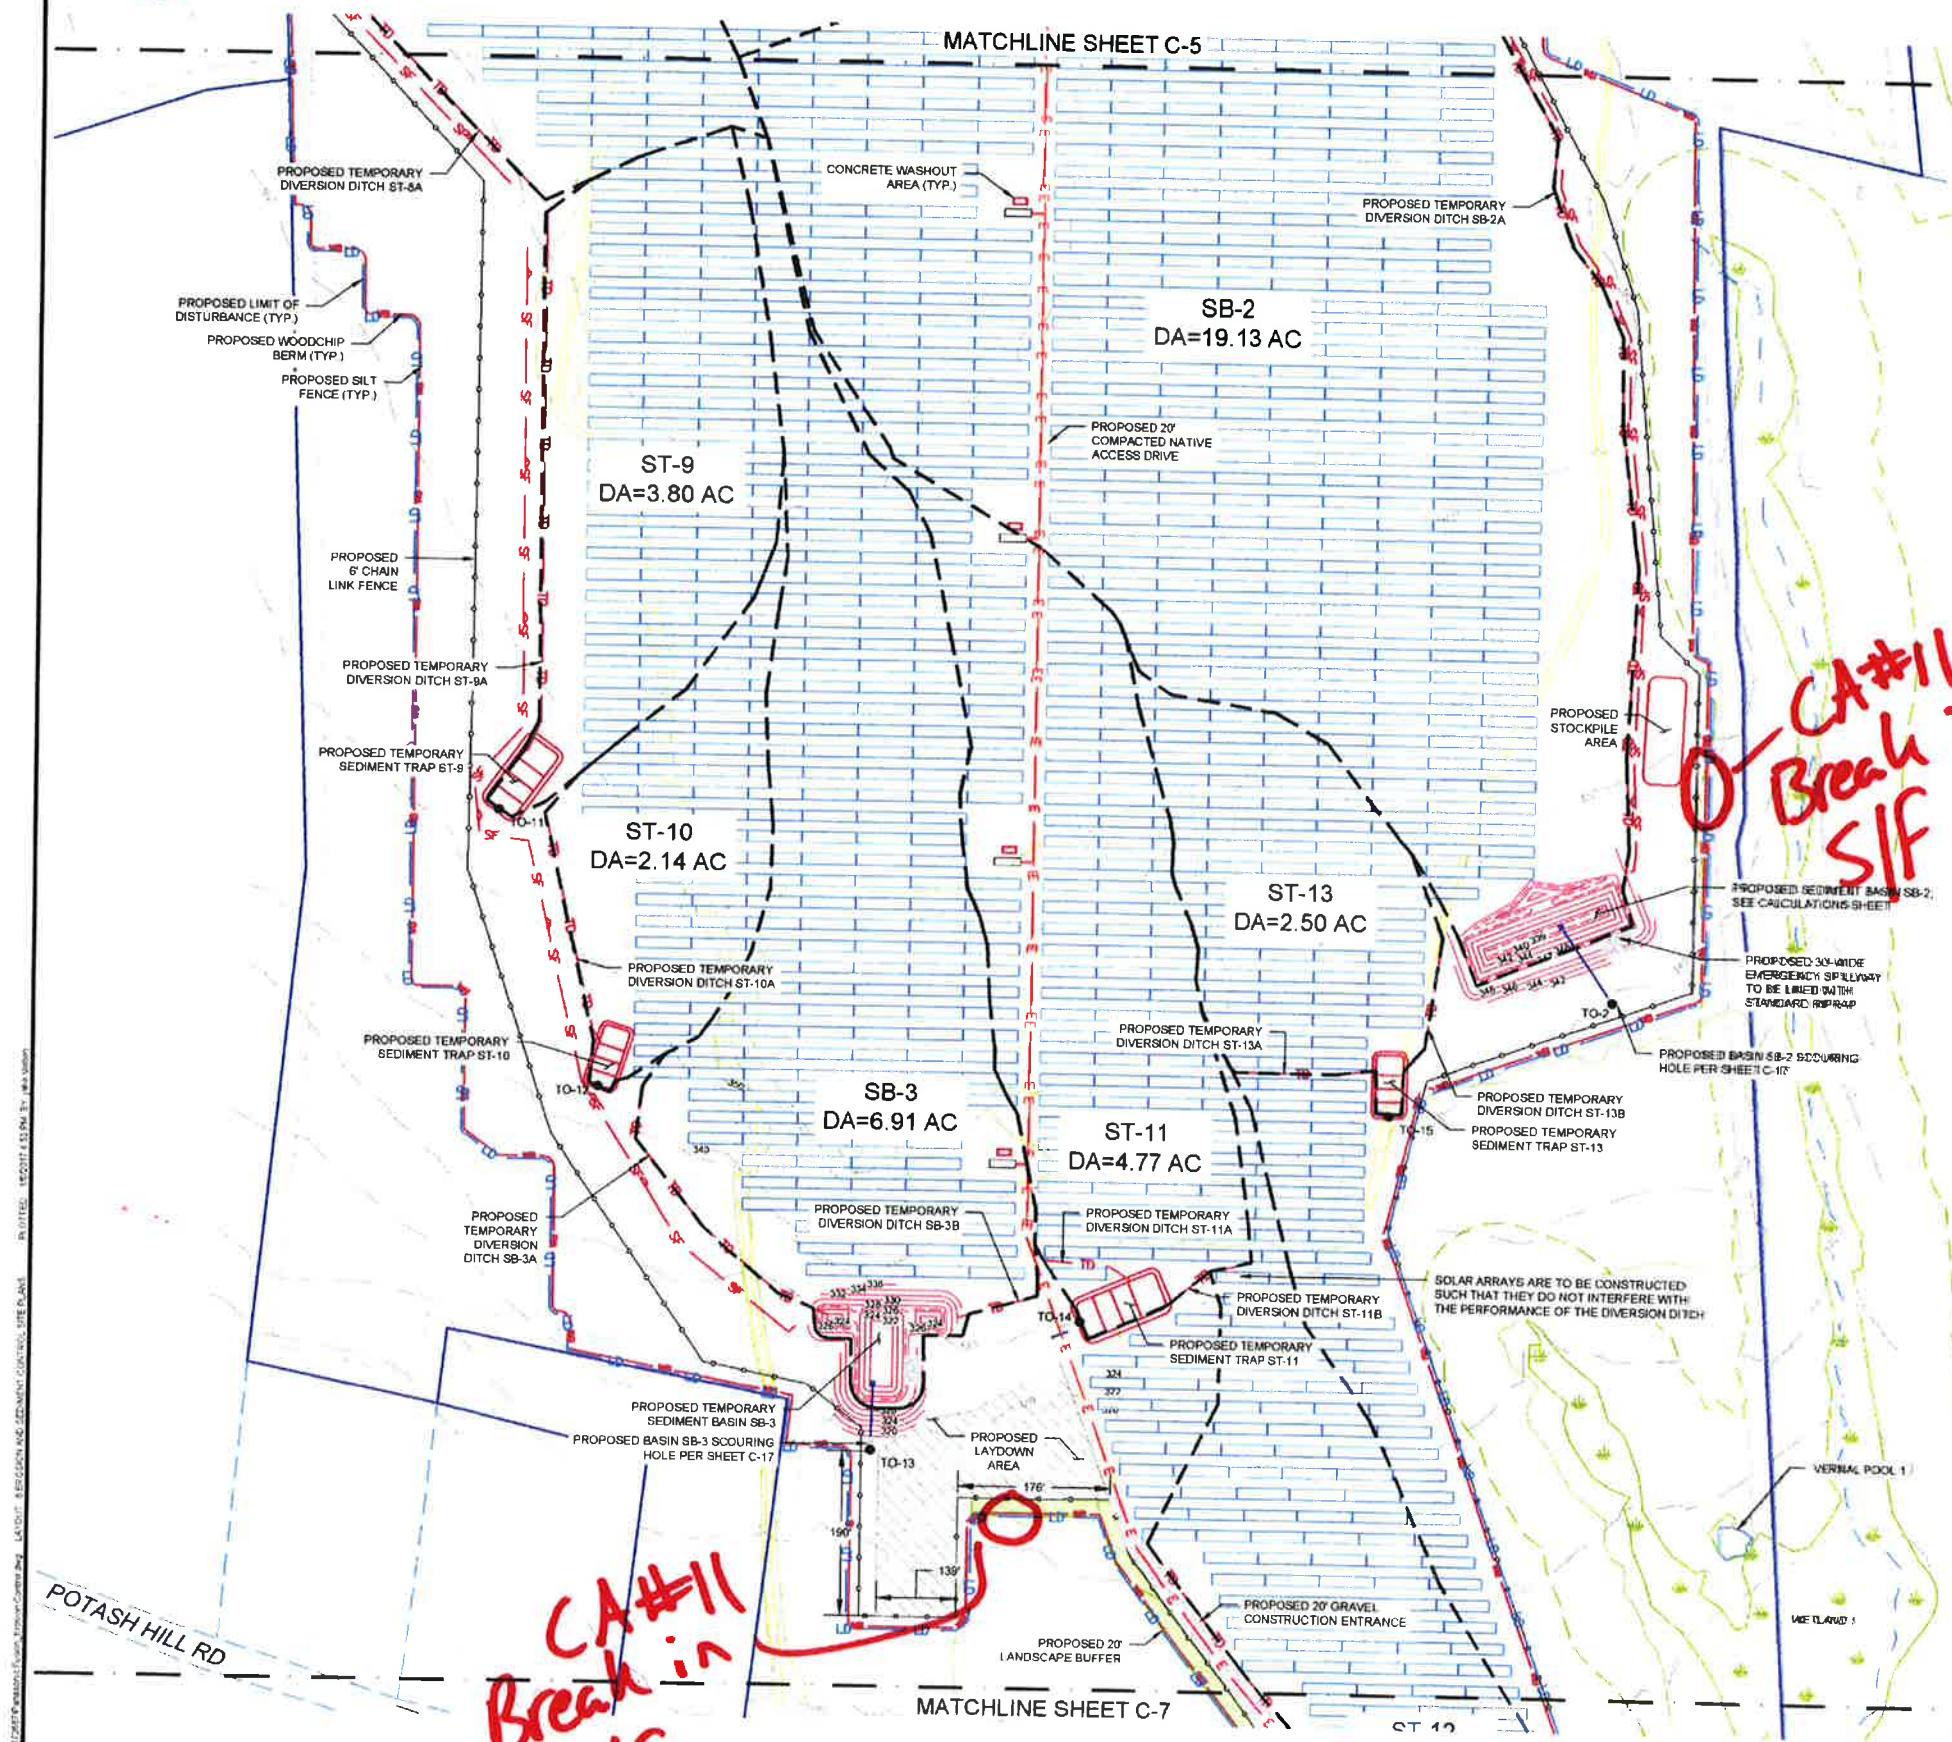
SKETCH MAP - 6/7/17

CA#11
Re

✓ CA #8- large amount of sediment build-up; S/F install incomplete

CA -
Break SI

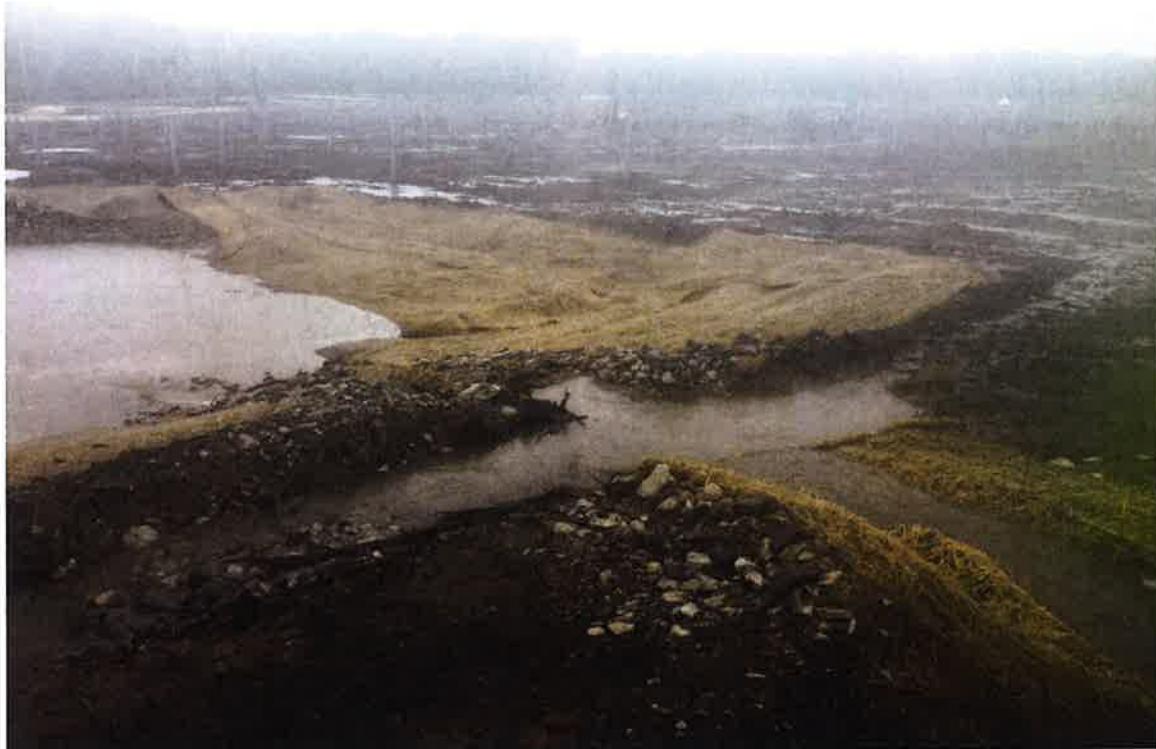
7/7/17 – Diversion ditches leading to ST-7 and ST-8 have not been graded to allow free drainage into the basins. Water is diverting from the ditches around the basins. Consider re-grading inlet to allow for free drainage. All water leaving the site that was observed during the inspection is generally free of suspended sediments. Side areas of the project that have been seeded are starting to germinate with vegetation.

Photo 1: View of ST-7 (description of activity found in Report Notes) looking north.

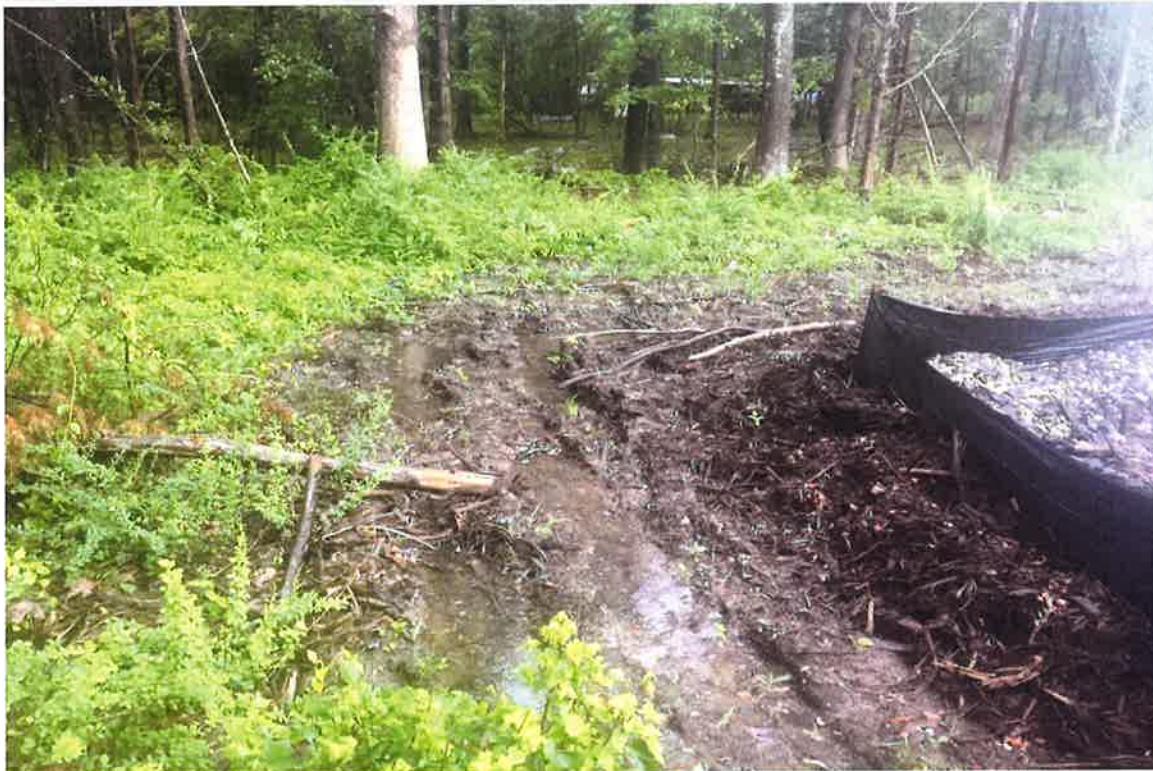
Photo 2: View of southwest project corner south of SB-3 outfall, looking west.

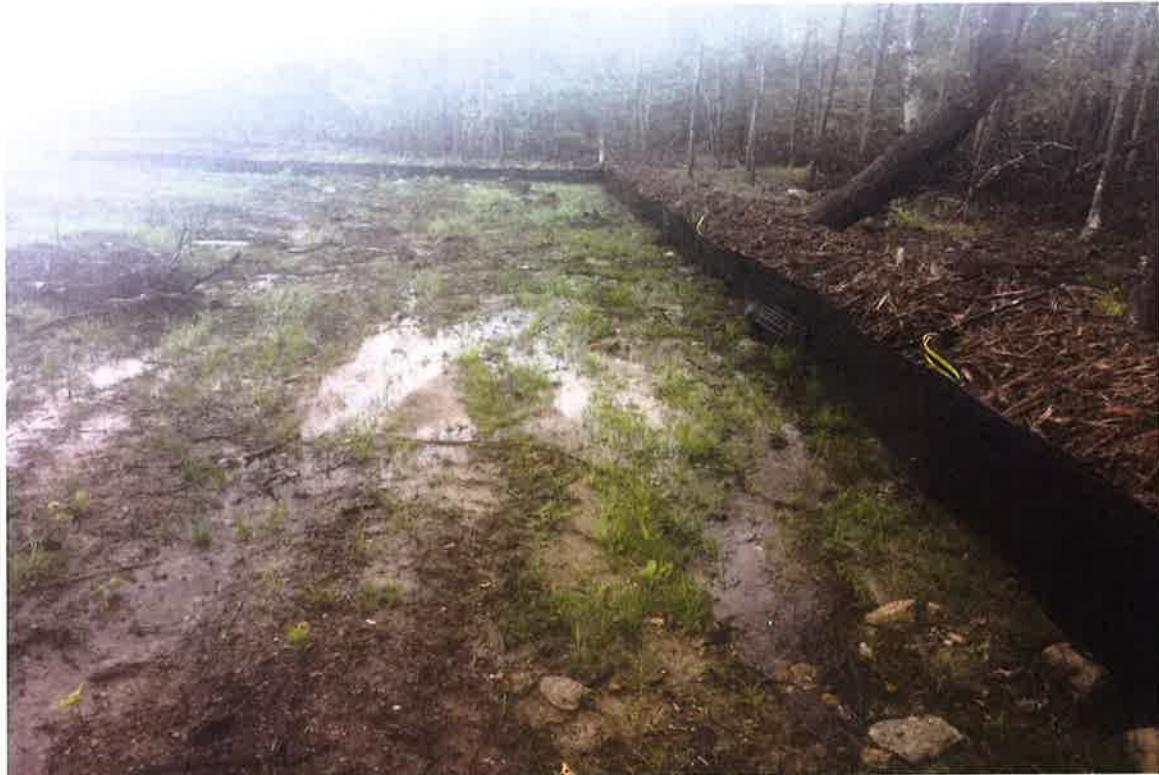
Photo 3: View of silt fence edge on western project boundary looking south.

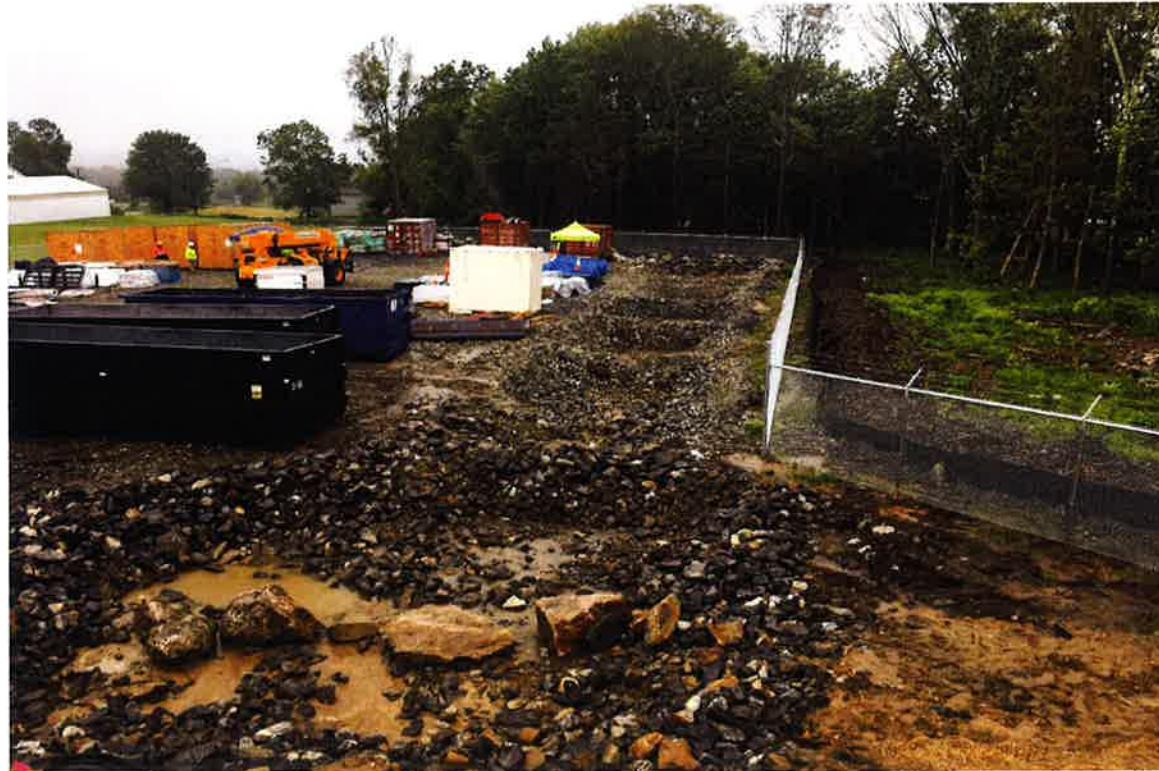
Photo 4: View of SB-3 outfall looking south.

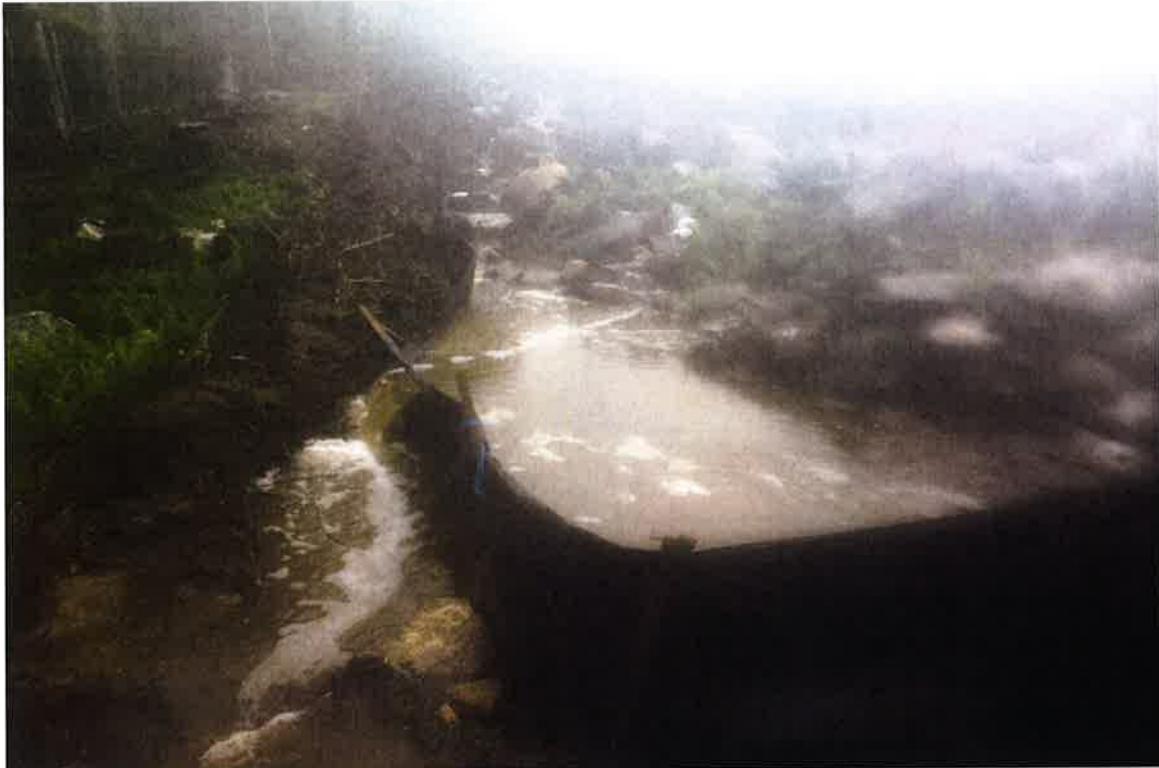
Corrective Action #8 – One area identified where gaps in silt fence formed underneath due to focused erosion from stormwater flows. Small sediment release in uplands with little risk of migration off-site or into wetlands.	Original areas repaired by 5/15/17
Corrective Action #9 – SB-2 and SB-3 not retaining volume due to low flow outlet pipe not closing, blocked entry to temporarily allow for basin to fill up and outlet via armored outlet or skimmer outfall.	5/15/17
Corrective Action #10 – add new armored swale in southwest project corner to protect outlet flows from SB-3, add check dams to all problem drainage/diversion channels (maintain after each rain storm).	5/15/17
Corrective Action #11 – silt fence in several areas needs to be repaired, cleaned or stakes replaced.	All repairs noted previously on 5/15/17 completed by 7/7/17. No additional areas noted (beyond those identified in CA #12)

Photo 5: View of CA #8 with overtopping stormwater looking north.

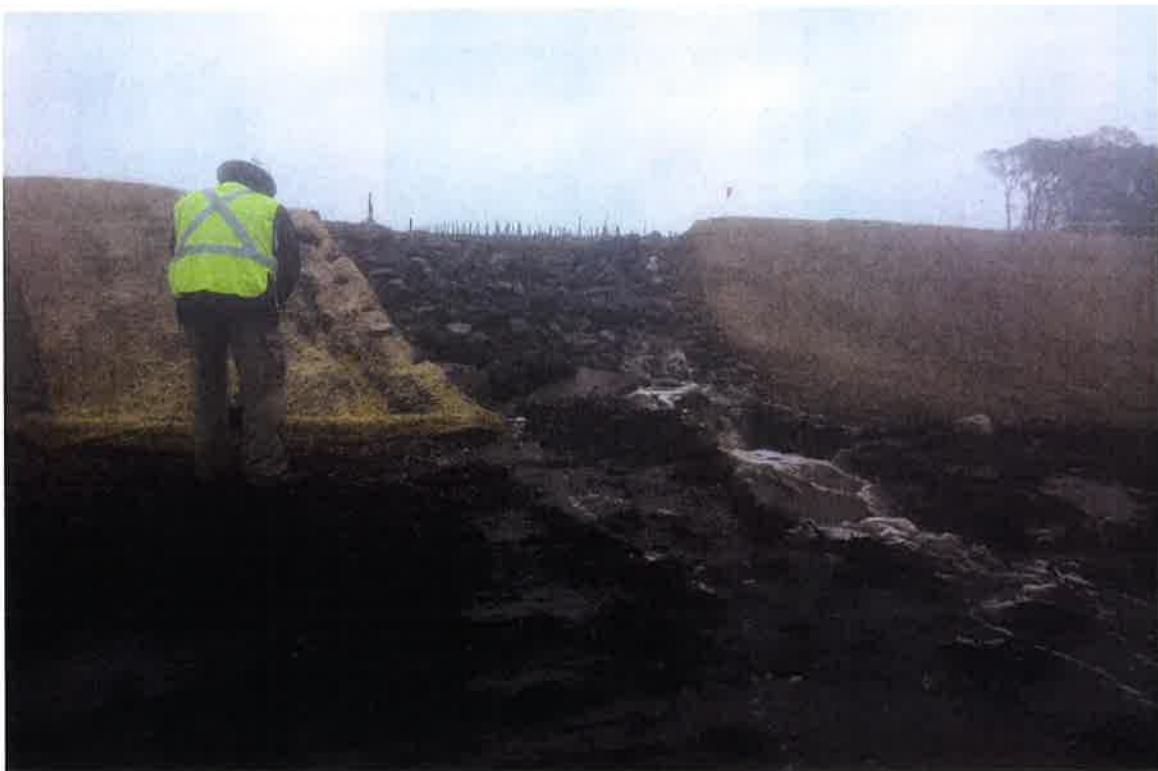
Photo 6: View of TO-8 outfall looking east.

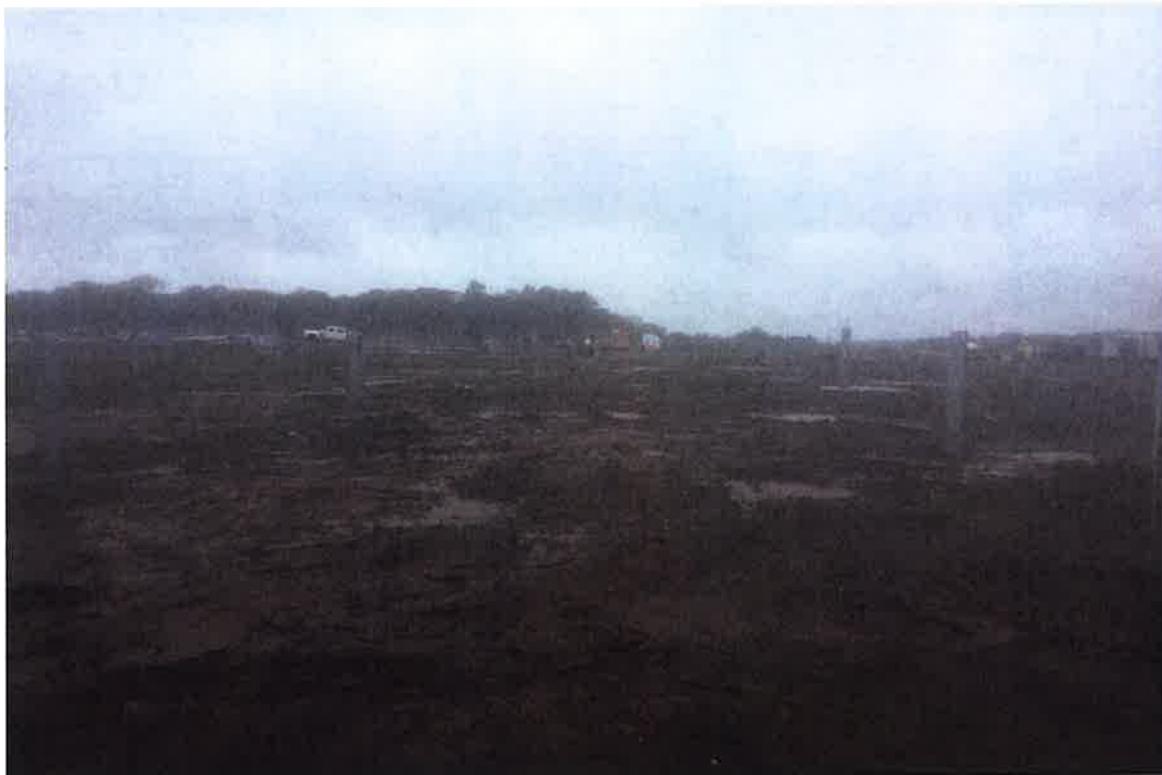
Photo 7: View center project area looking east.

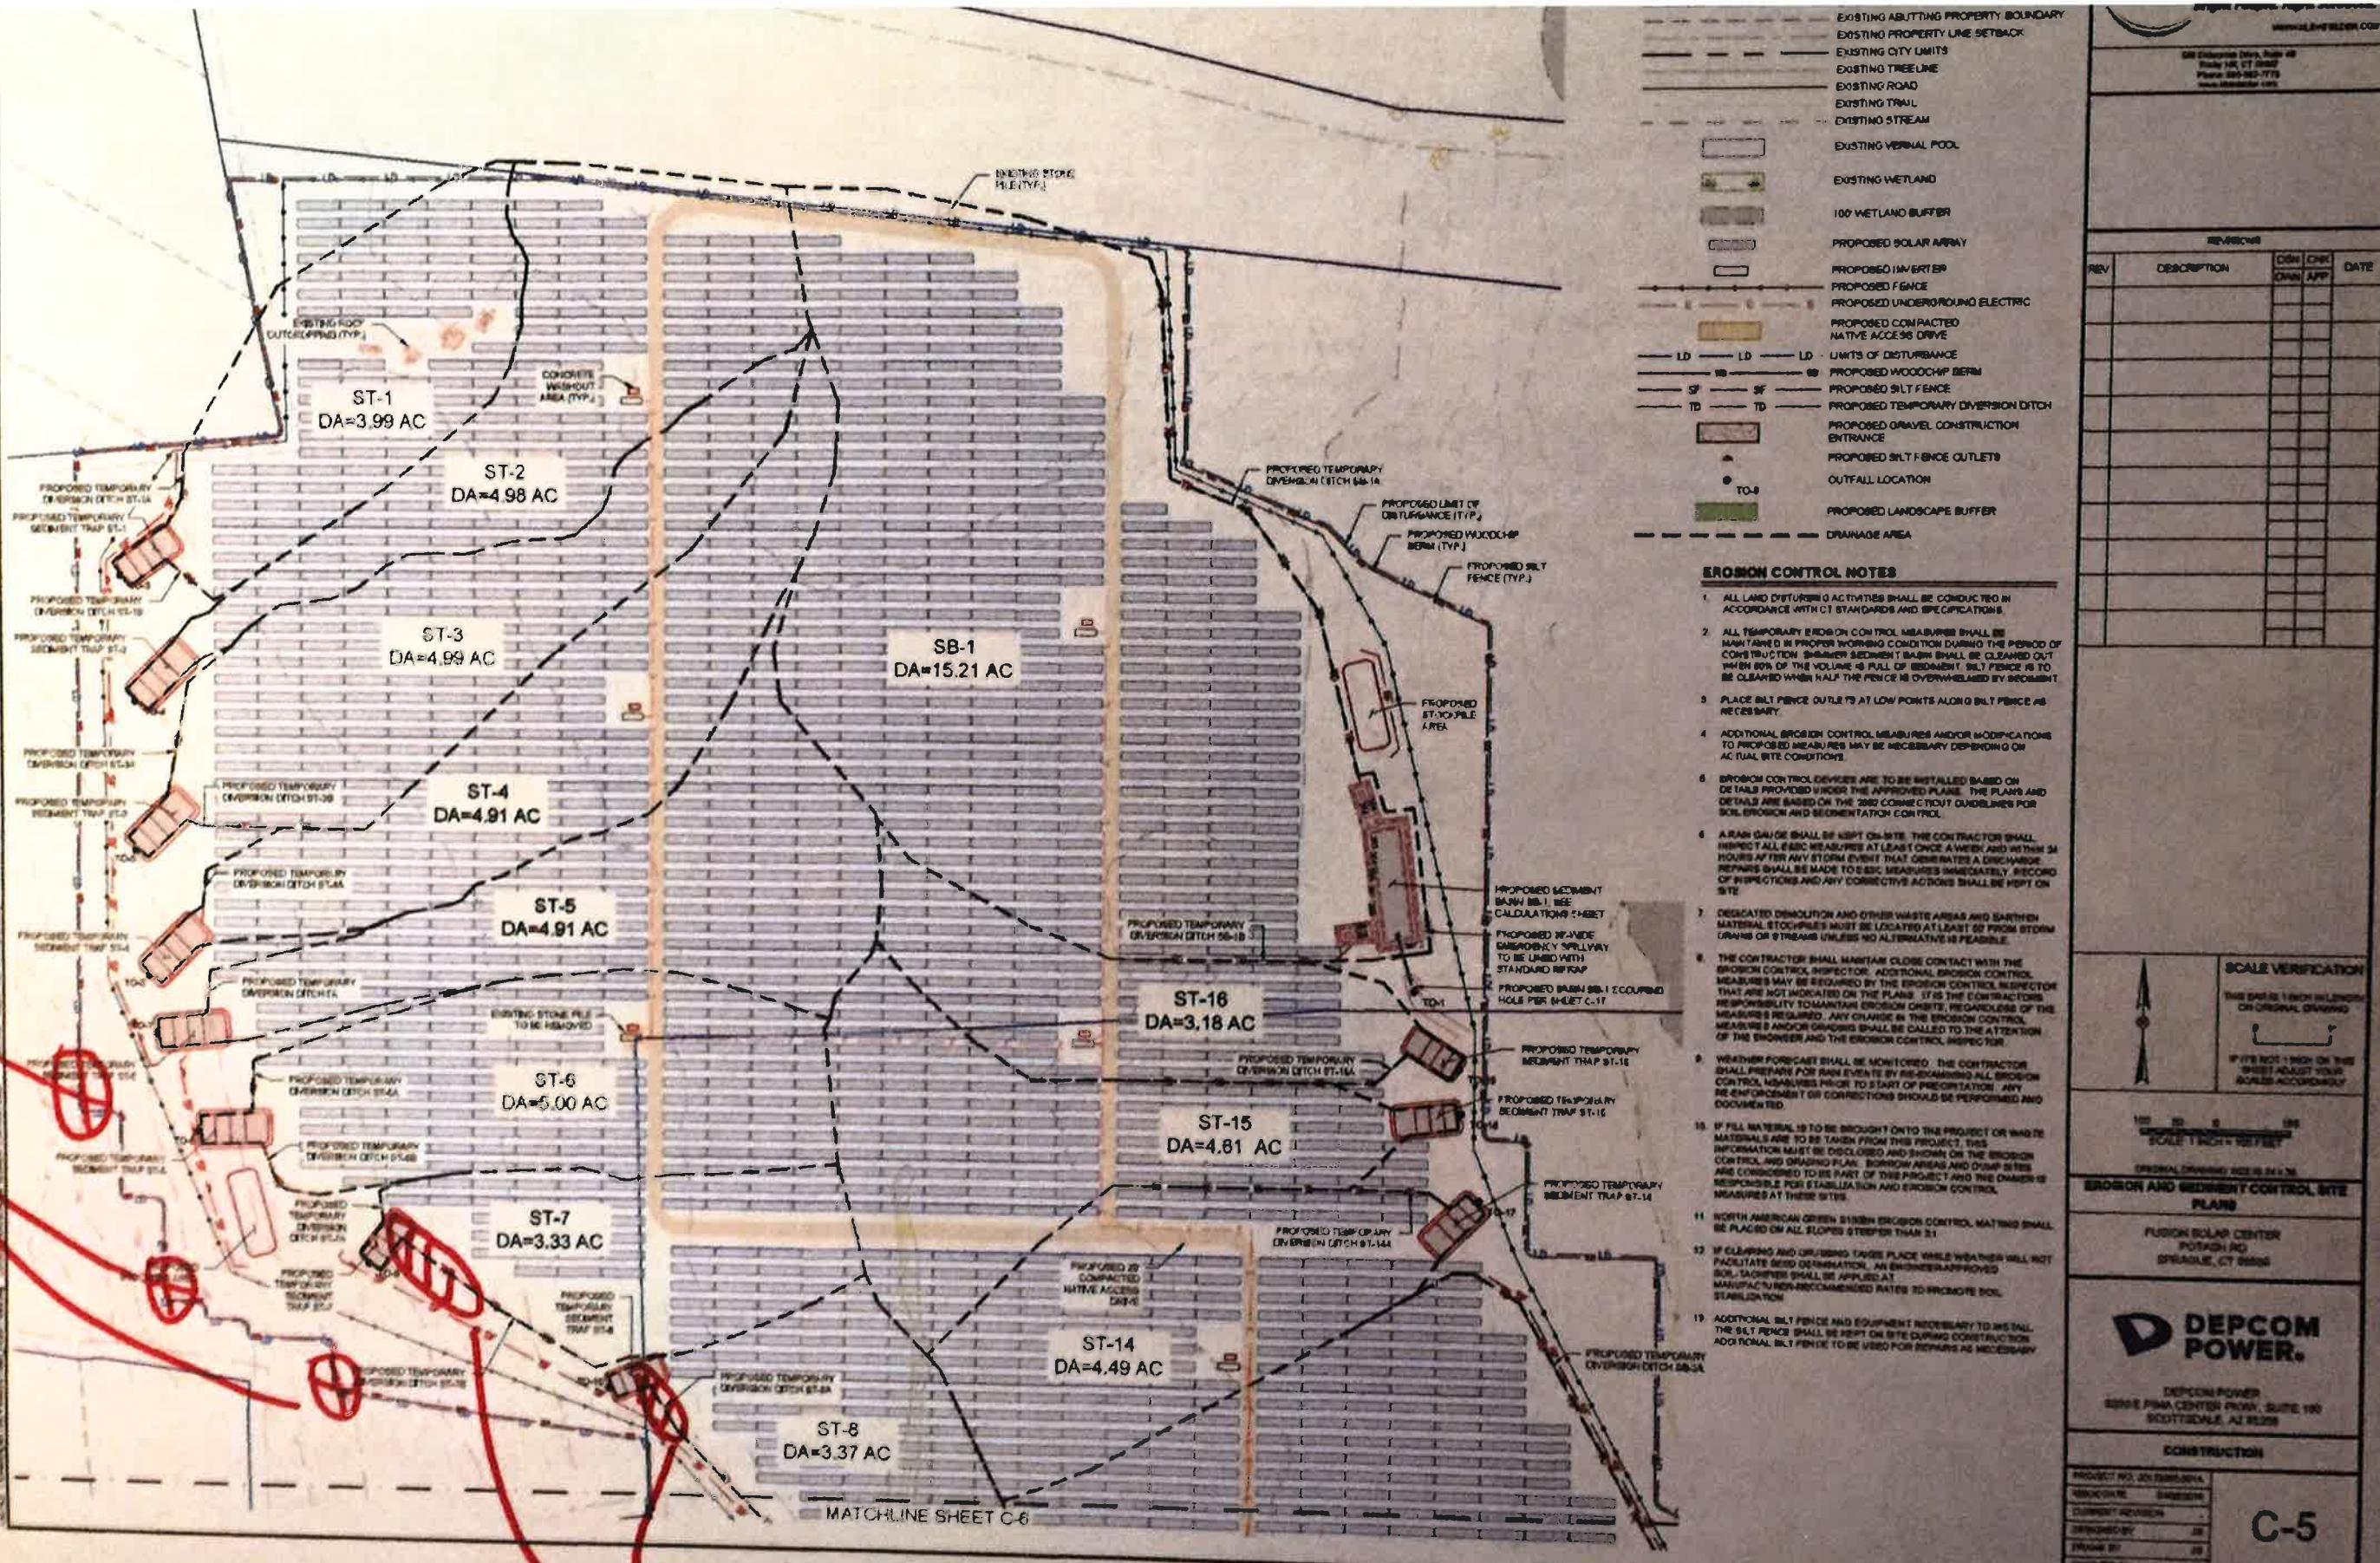
Note: Diversion ditch drainage not entirely
draining to basin - Consider regrading
