Re: **Petition No. 1178 – Fusion Solar Center, LLC – Environmental Monitoring Daily Site Observation Form – Report No. 13**

**ENVIRONMENTAL MONITORING**  
**DAILY SITE OBSERVATION FORM**

**Report No. 13**

Project: DEPCOM Power, Fusion Solar Center  
Address: Potash Hill Road, Sprague, Connecticut

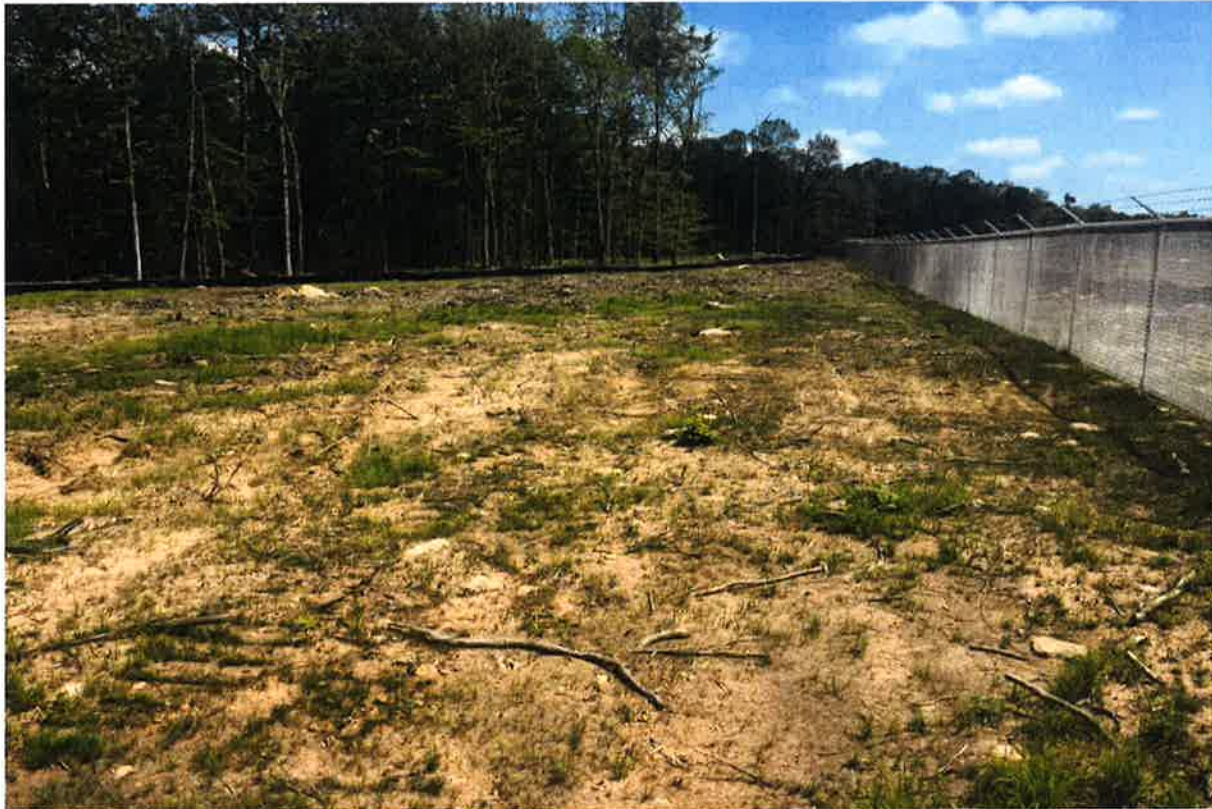
Photo 1: View of typical project perimeter looking north.

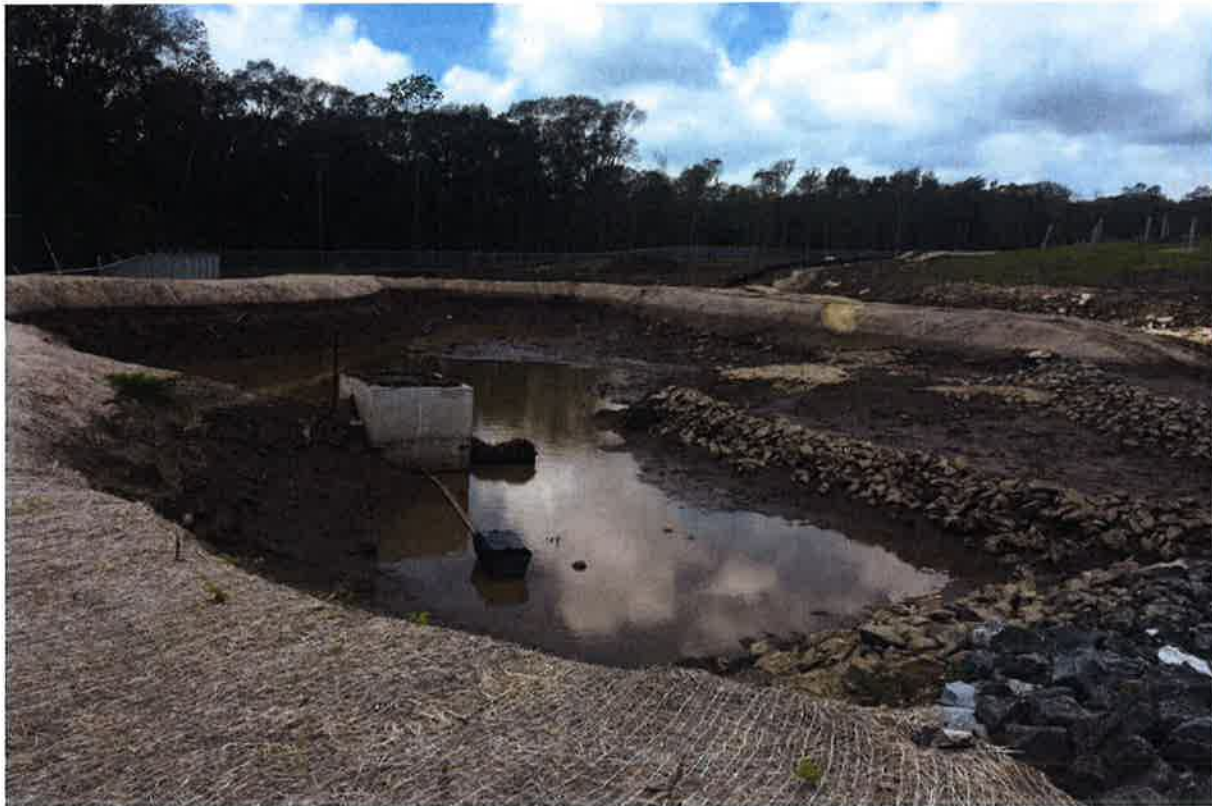
Photo 2: View of SB-3, looking west.

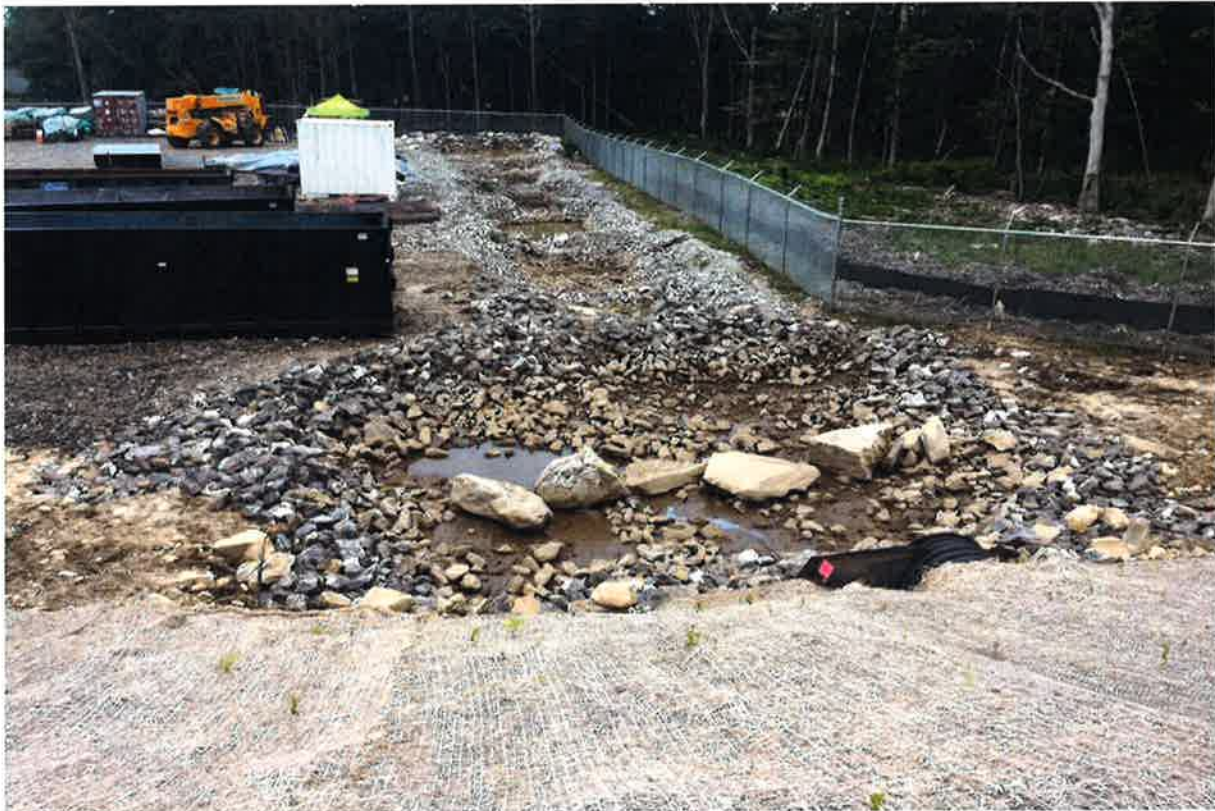
7/18/17 – Stabilize all areas between LOD & Solar Array limits that are at final grades. Clear out SB's, ST's and diversion ditches of accumulated sediments. Diversion ditches from ST-7 and ST-8 have been regraded to allow free drainage into basins. Outfall system from SB-3 needs repairs, sidewalls have failed at several locations.

Photo 3: View of outlet from SB-3, looking south.

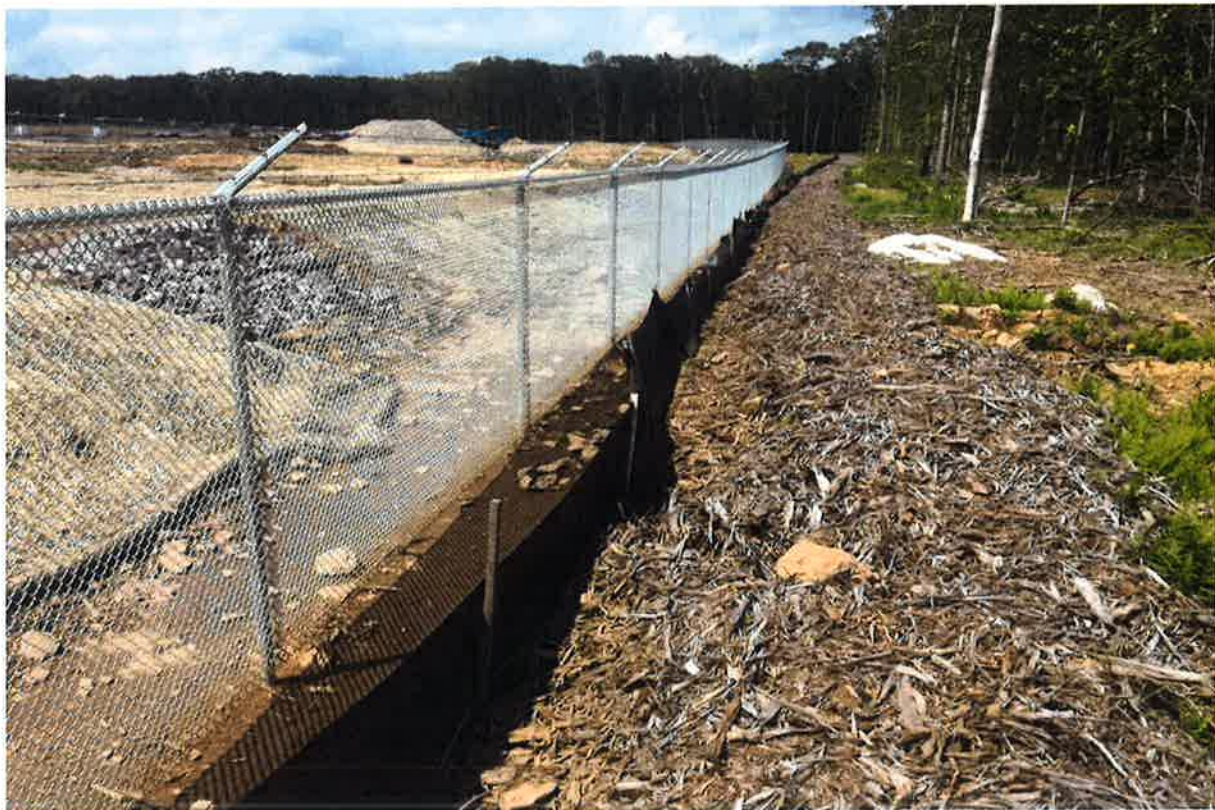
Photo 4: View of silt fence line repaired, looking north.

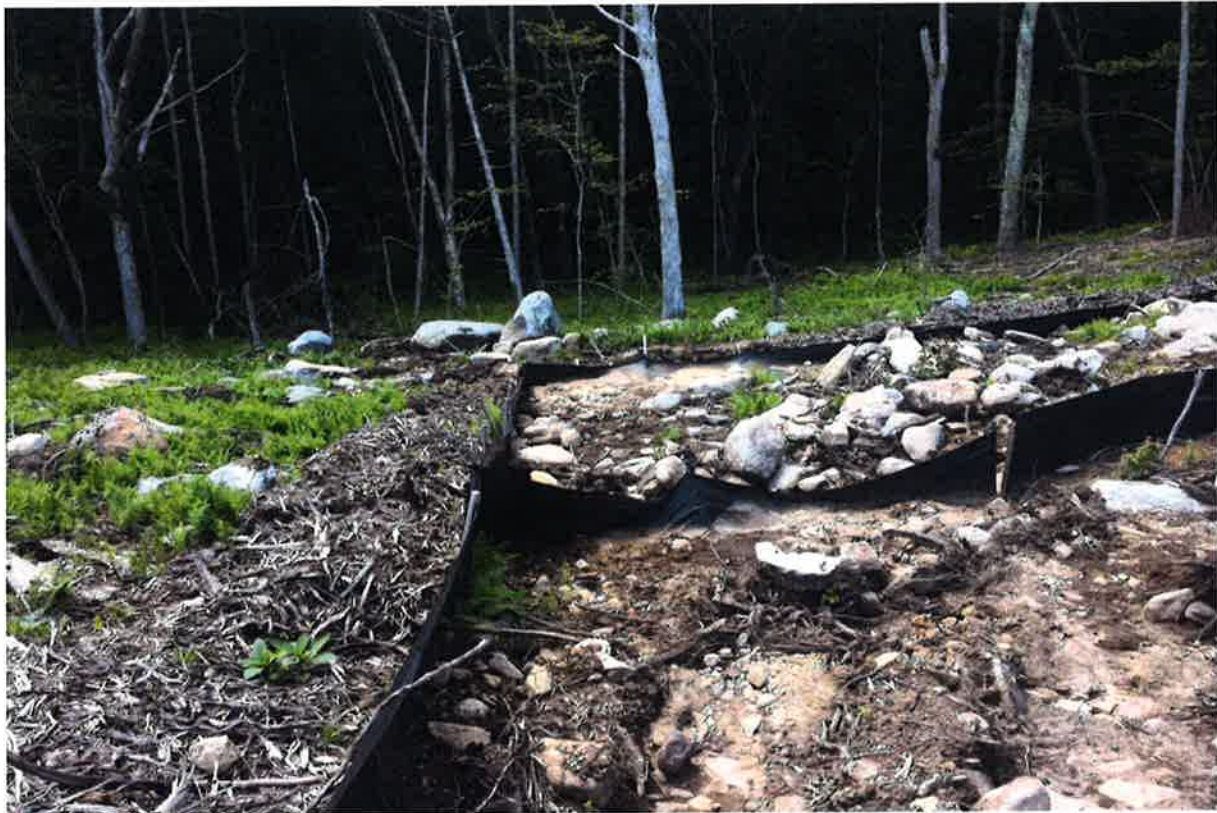
Corrective Action #12 – three areas identified where high-water volumes have knocked over silt fence and resulted in large accumulation of sediment in front of the silt fencing. Consider cleaning out any sediment build-up in front of these silt fence locations, repair silt fence, and reinforce as needed. Erosion paths noted at one location, suggest altering this flow path.	Several areas identified where silt fence has overtopped and silt fence buildup should be removed, repaired, silt fence should be reinforced where needed for future rain events.
<b>Project Modification Requested:</b>	
Extra work space requested <input type="checkbox"/> Change to work area <input type="checkbox"/> Change to stormwater feature <input type="checkbox"/>	
Description of Modification: N/A	
<b>Notes:</b>	
1/17/17 – construction entrance road with anti-tracking pad installed; land clearing activities 50-60% complete; initial grubbing started in southeast end of project in preparation of silt fence installation (to begin 1/18/17); minor brush pile with logs placed in wetlands in southeast portion of property by property owner - materials properly removed by DEPCOM Power on 1/20/17.  2/3/2017 - A majority of the project area has been cleared. A small patch in the northern end of the project remains to be cleared. Silt fence has been installed in most of the project limits minus the northern limits of the project.  2/14/17 – Received notification from Victor Menor, DEPCOM, that corrective actions #2 and #3 were made prior to heavy snow storm on February 9, 2017; APT will verify areas during next inspection.  3/3/17 – APT discussed CA #4, 5 & 6 with Chance Combs, DEPCOM. Mr. Combs indicated to APT that corrective actions were already scheduled for the western side of the project on Friday (3/3) afternoon and all corrective actions would be completed on Monday (3/6). Tree clearing activities have been completed for the entire project. Temporary sediment traps are currently under construction.

Photo 5: View of CA #12 consisting of silt build-up and silt fence failure, looking west.

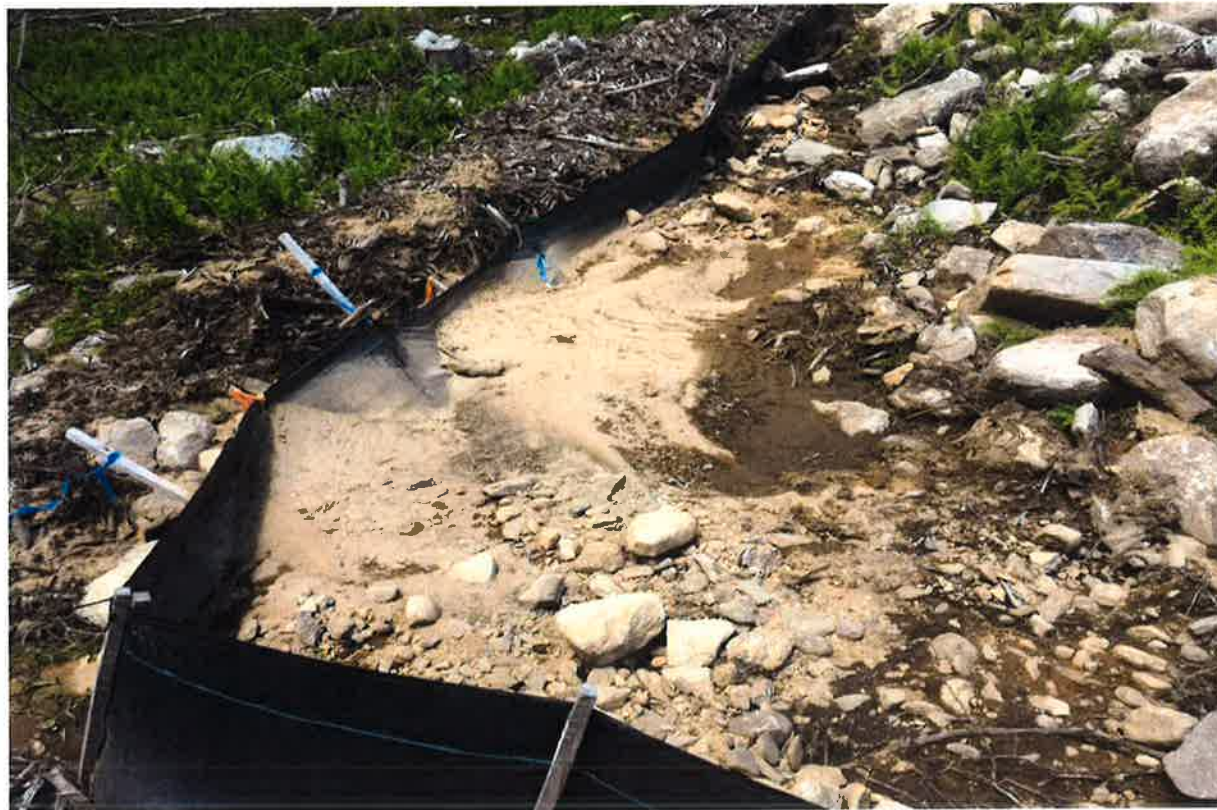
Photo 6: View of CA #12 (silt build-up), looking west.

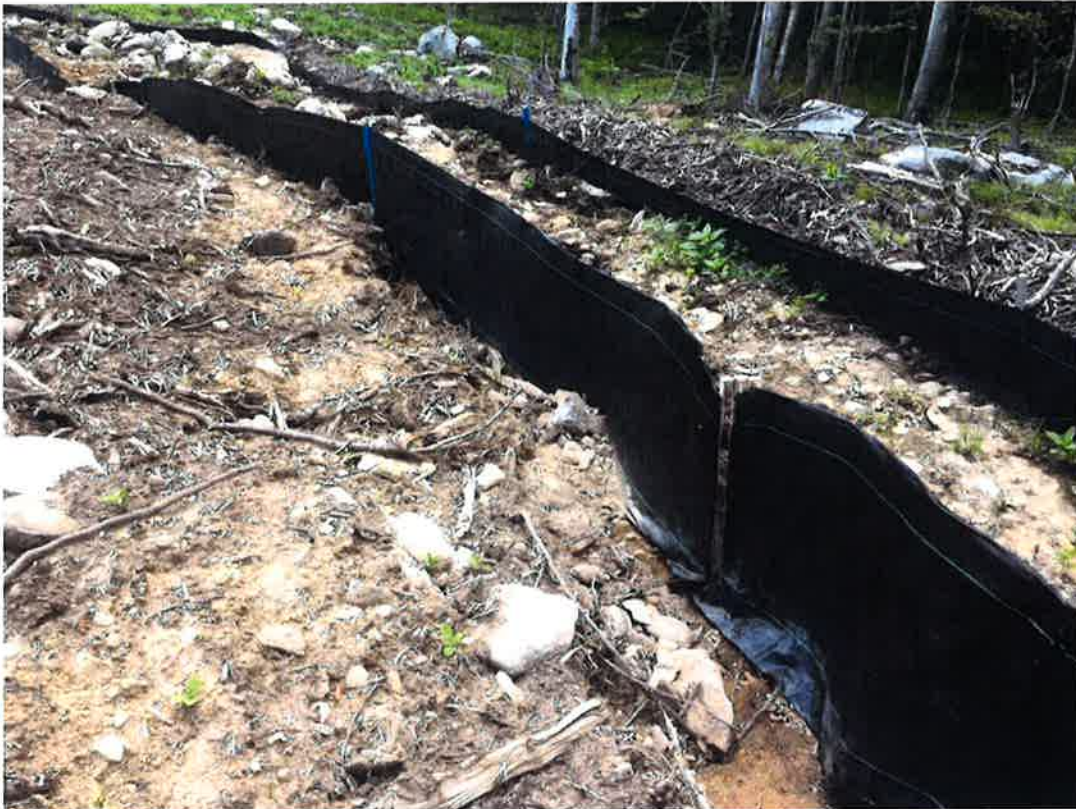
Photo 7: View of CA #12 and areas adjacent to silt fence draining to CA #12, looking southwest.

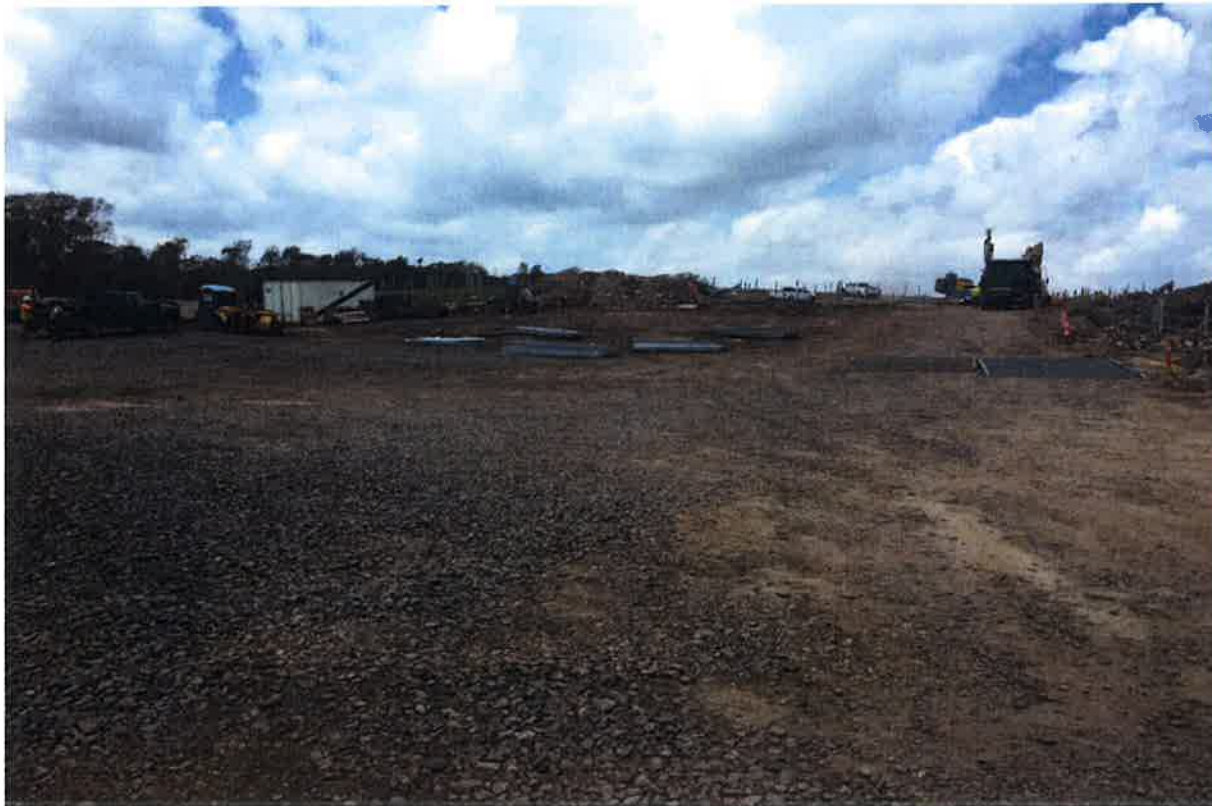
Photo 8: View of laydown yard, looking north.
