Re: **Petition No. 1178 – Fusion Solar Center, LLC – Environmental Monitoring Daily Site Observation Form – Report No. 14**

ENVIRONMENTAL MONITORING
DAILY SITE OBSERVATION FORM

Report No. 14

Project: DEPCOM Power, Fusion Solar Center
 Address: Potash Hill Road, Sprague, Connecticut

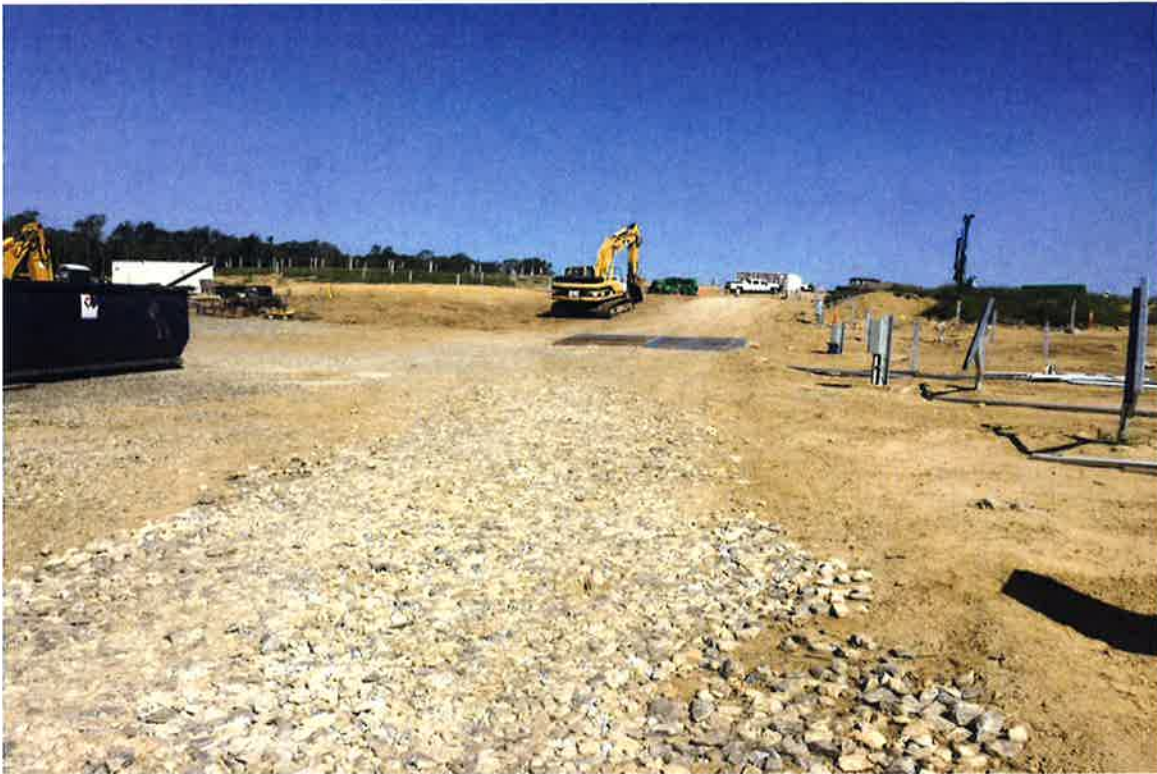
Photo 1: View of access road looking north.

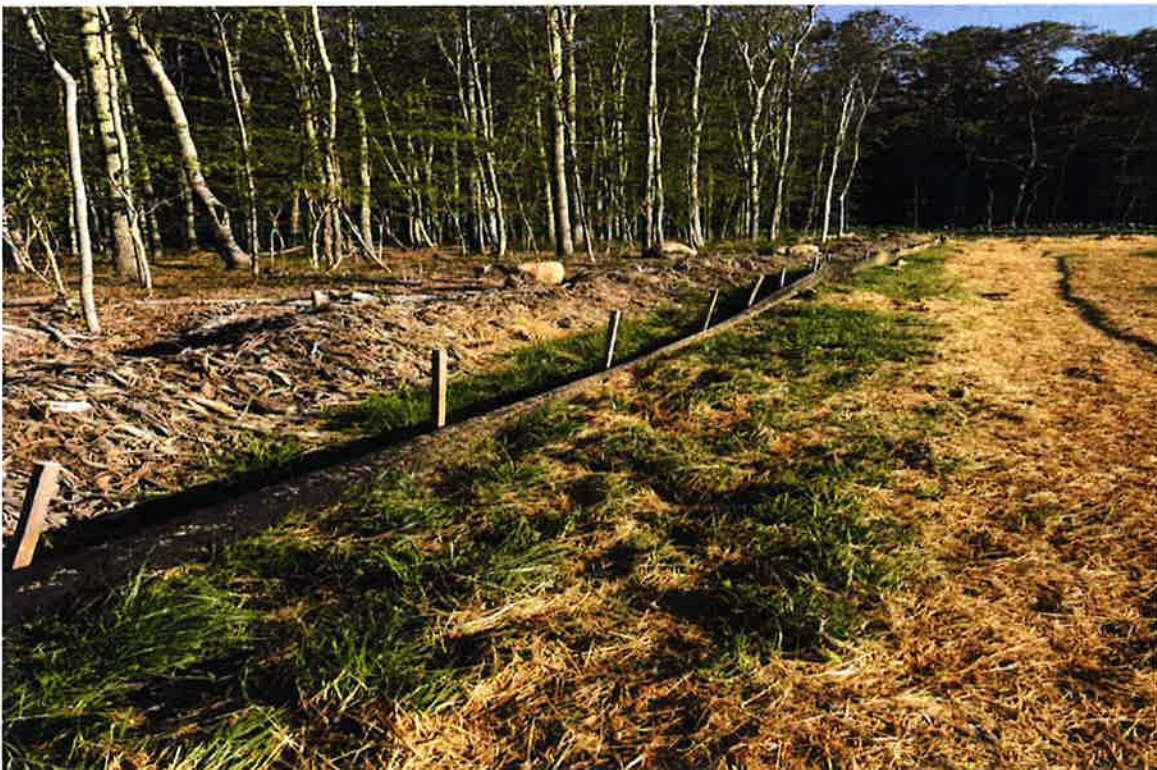
Photo 2: View silt fencing knocked down in northwest corner looking north.

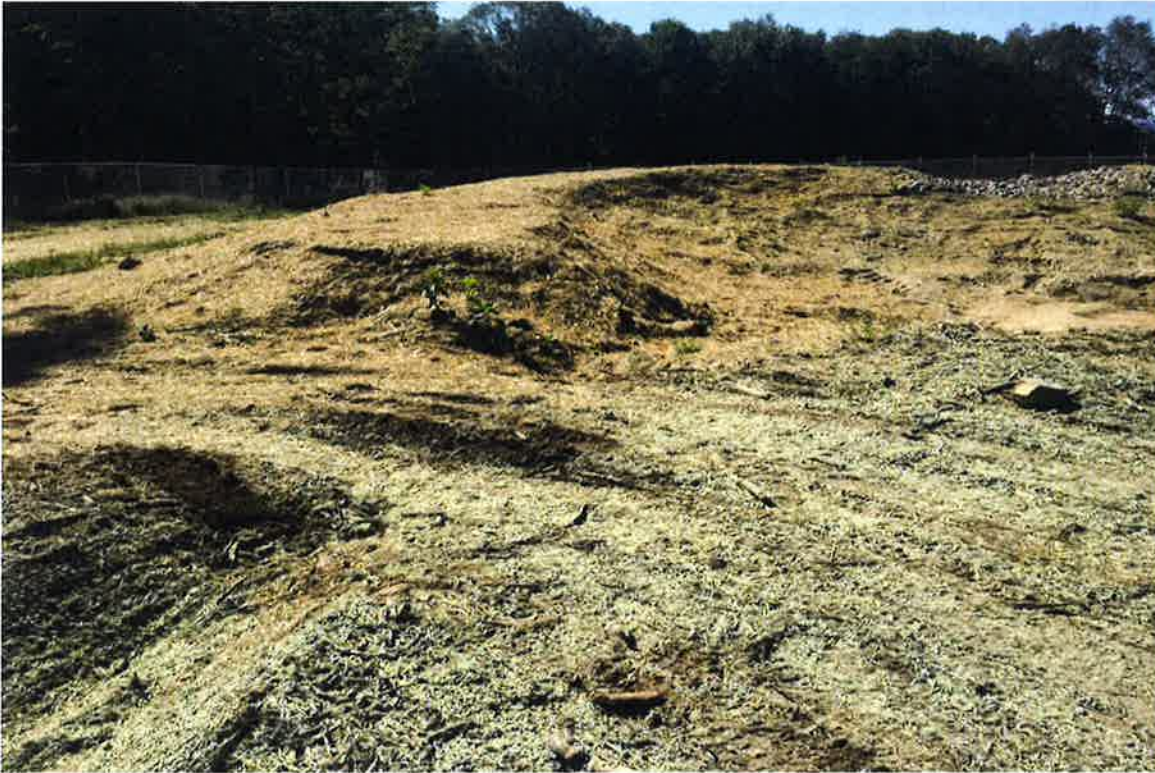
Photo 3: View of temporary diversion ditch to SB-2 tracked through and filled in.

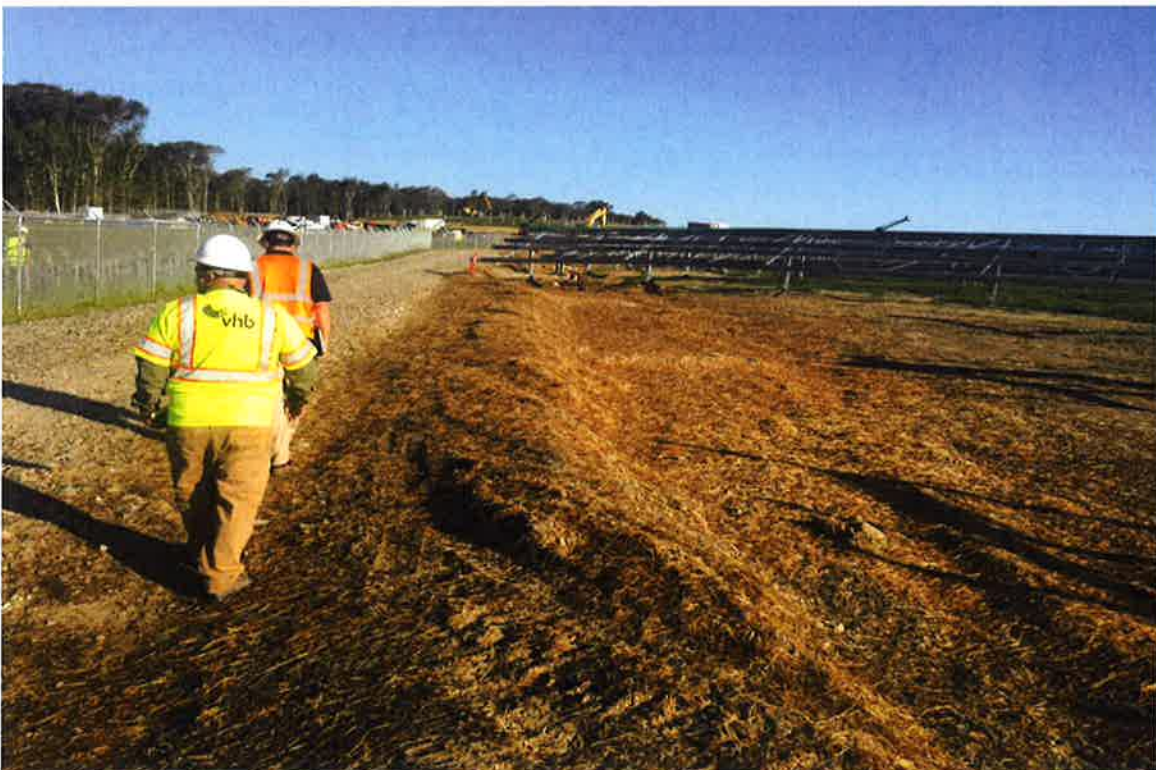
Photo 4: View of temporary drainage ditch along access entrance looking north.

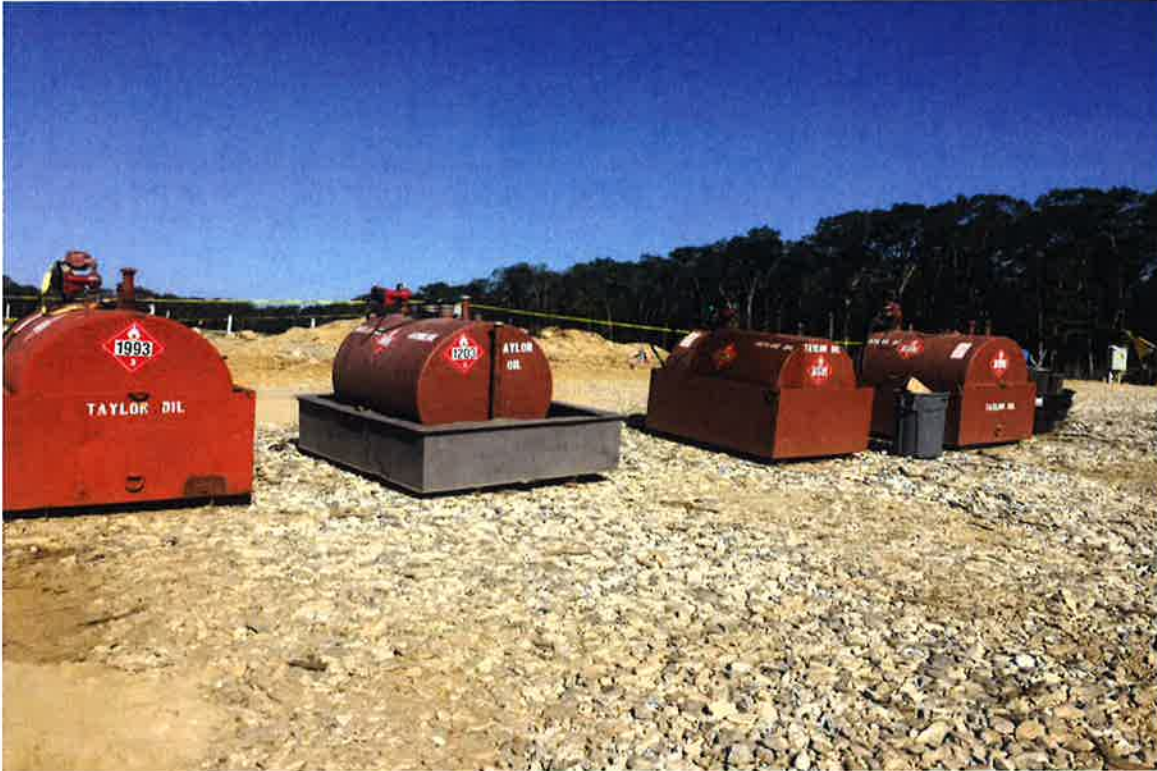
Photo 5: View of fuel storage.

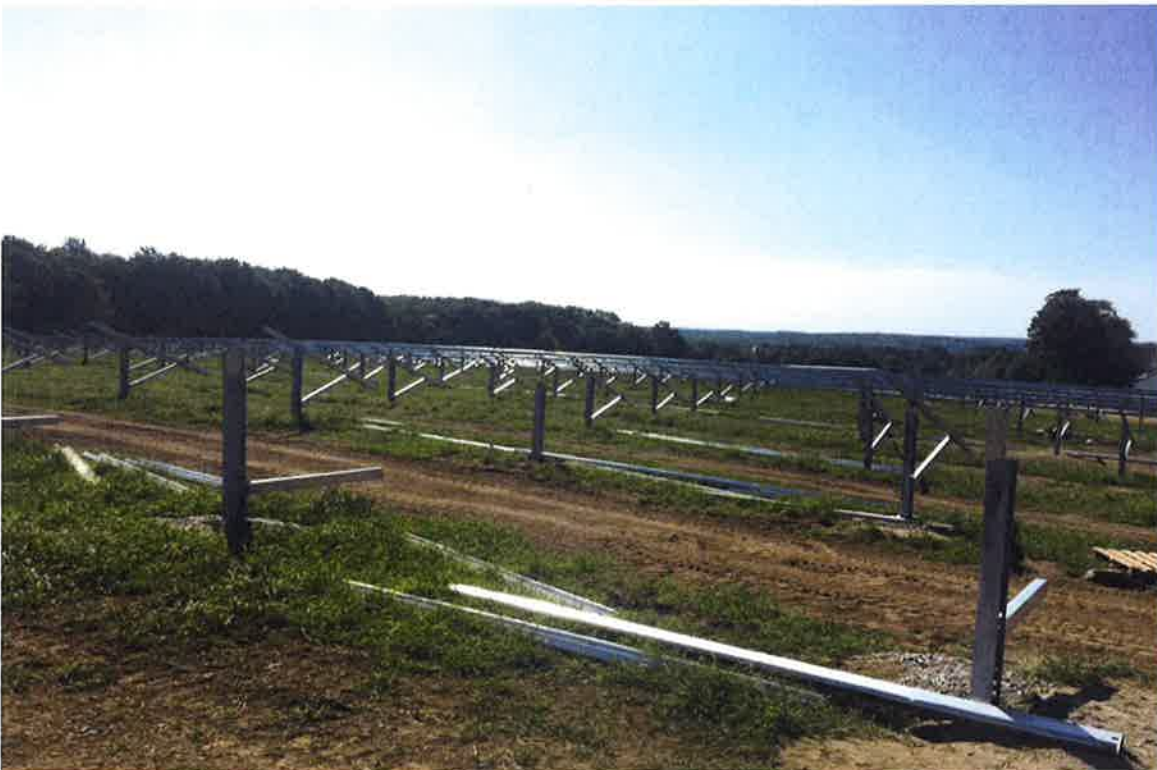
Photo 6: View of typical racking activities looking south.

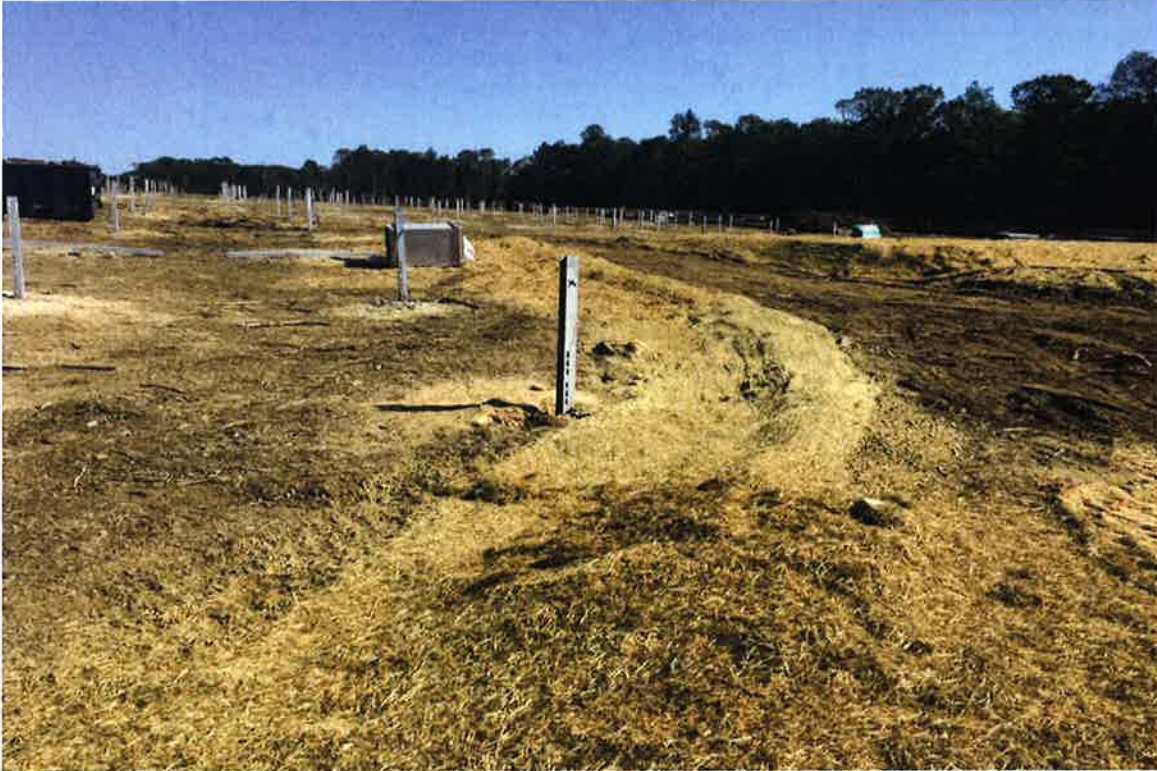
Photo 7: View of recently installed temporary diversion ditch to ST-13 looking north.

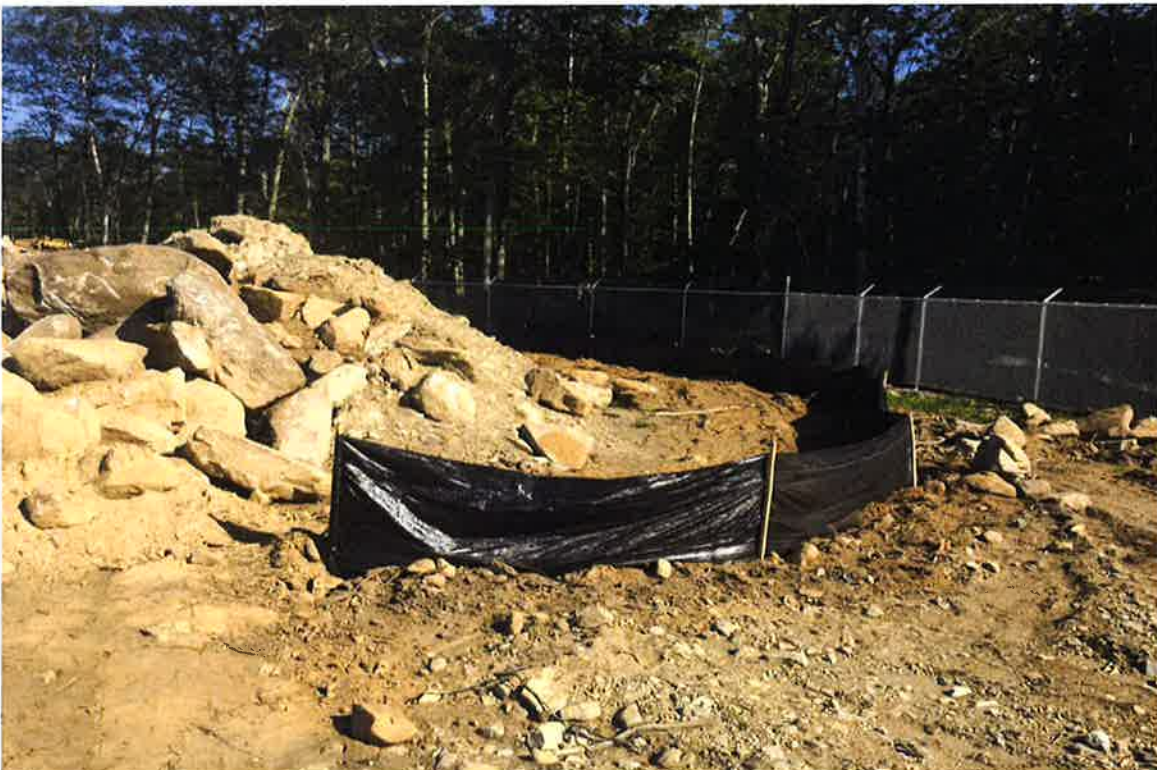
Photo 8: View of protected soil stockpile.

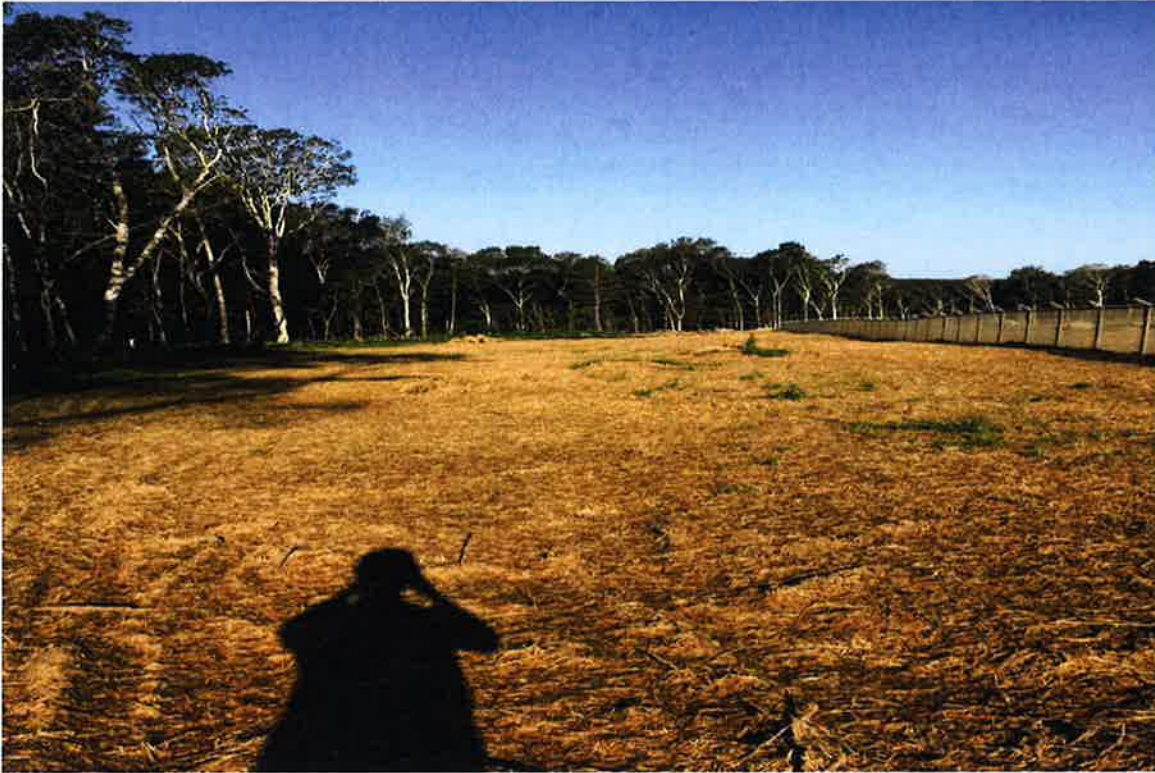
Photo 9: View of stabilized project peripheries areas looking north.

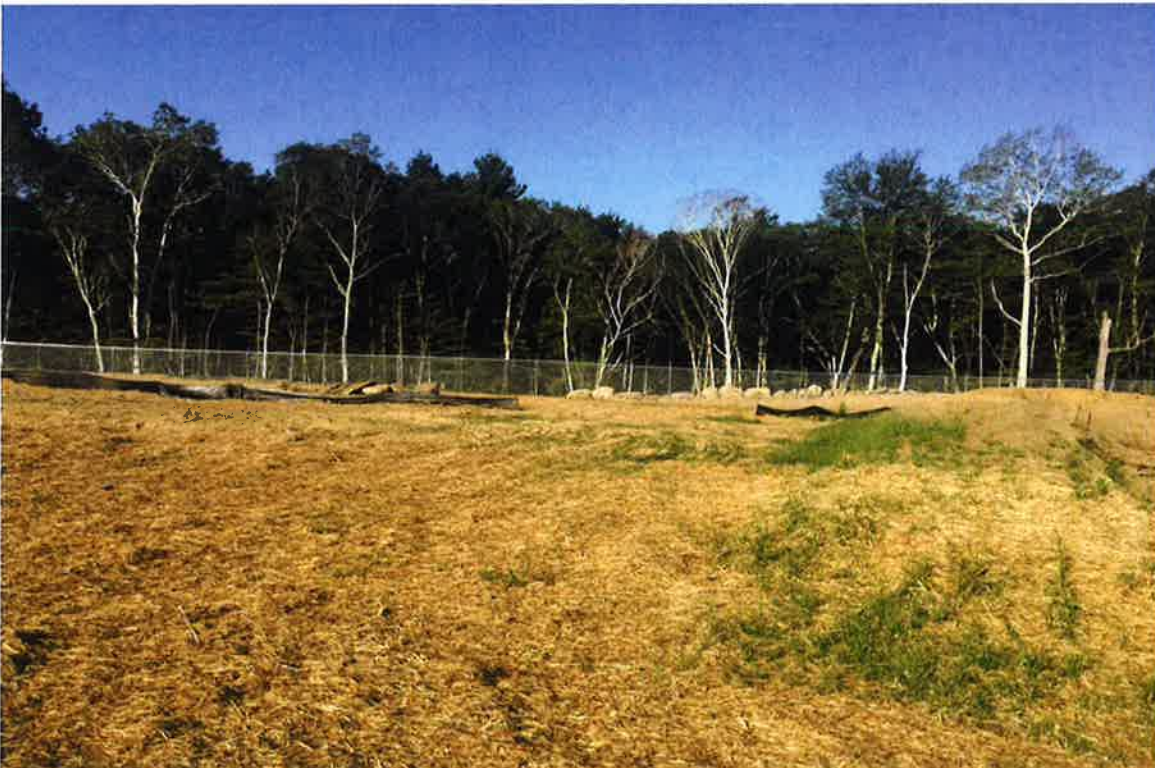
Photo 10: View of silt fence gap to be repaired.

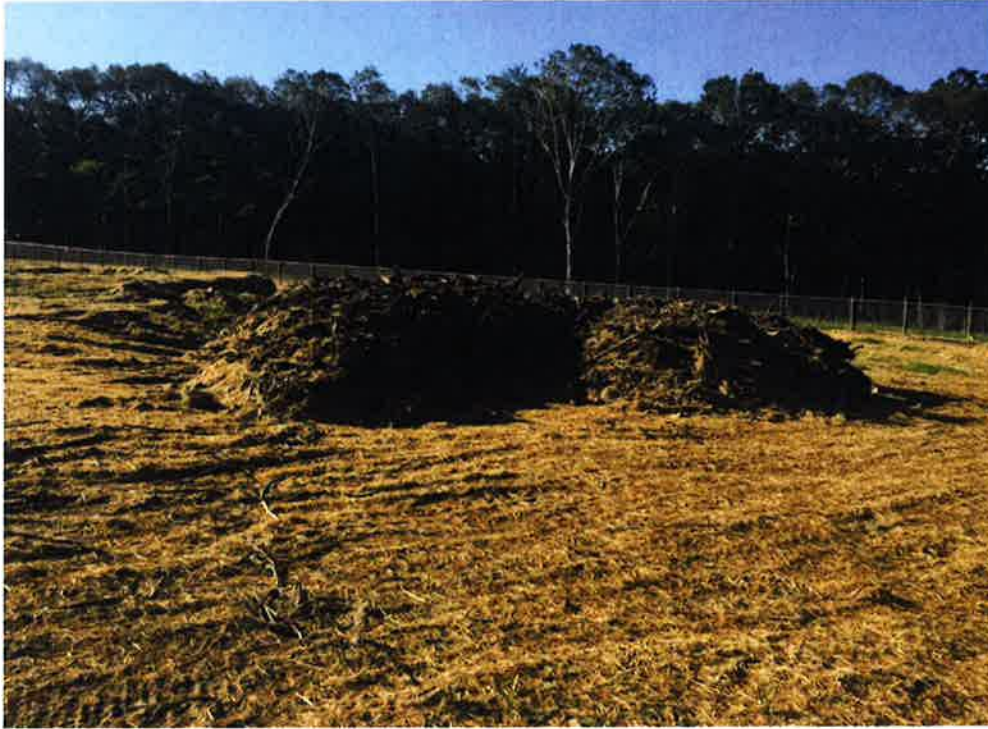
Photo 11: View of stockpile unprotected.
