Re: **Petition No. 1178 – Fusion Solar Center, LLC – Environmental Monitoring Daily Site Observation Form – Report No. 16**

ENVIRONMENTAL MONITORING
DAILY SITE OBSERVATION FORM

Report No. 16

Project: DEPCOM Power, Fusion Solar Center
Address: Potash Hill Road, Sprague, Connecticut

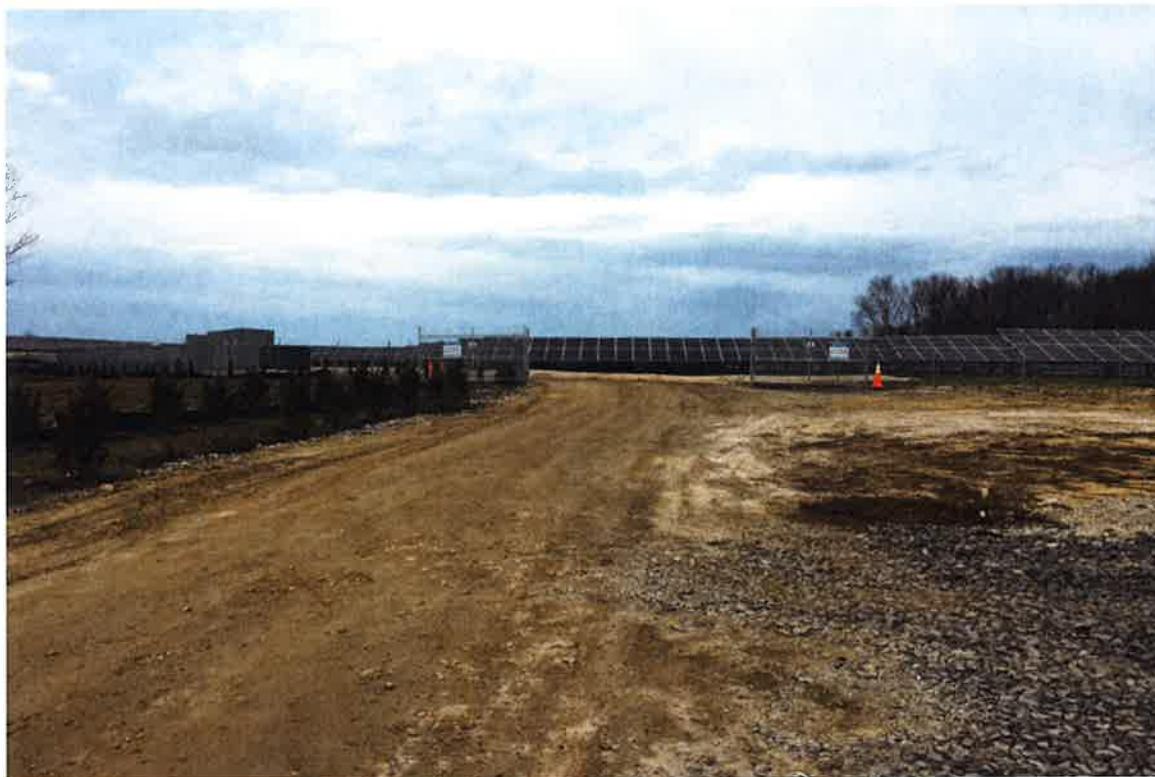
Photo 1: View of access road entrance looking north.

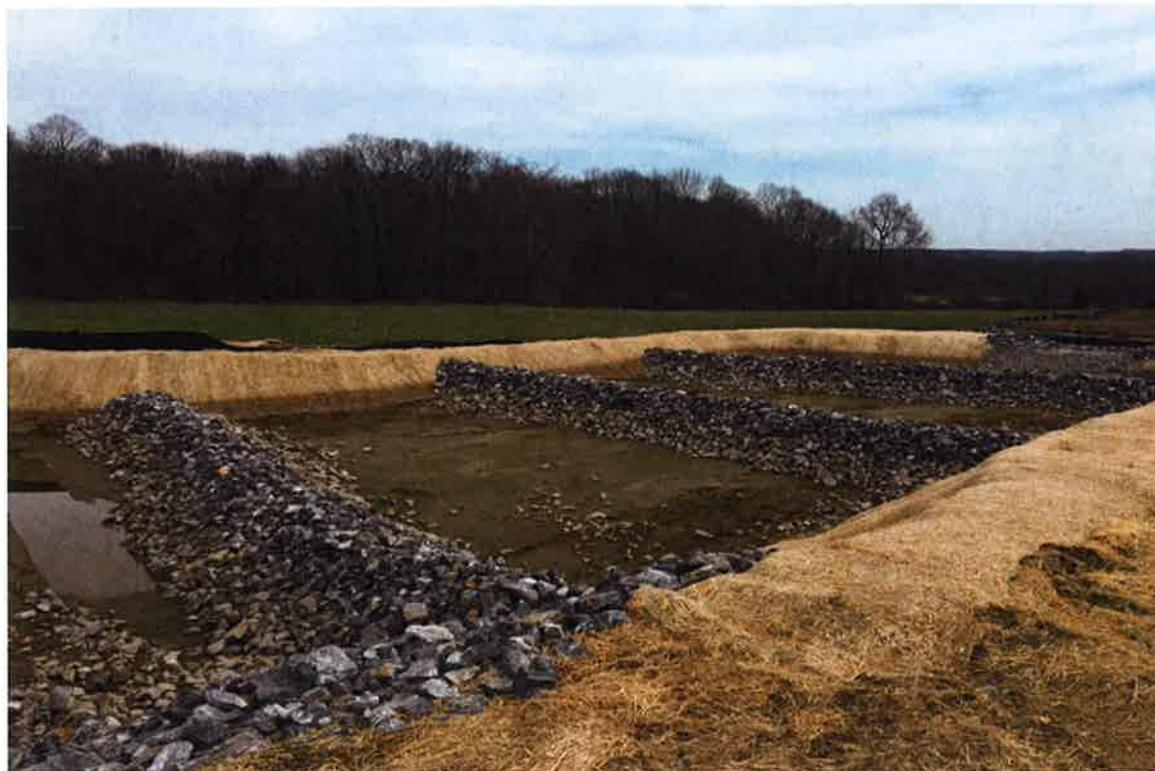
Photo 2: View of a typical sediment basin.

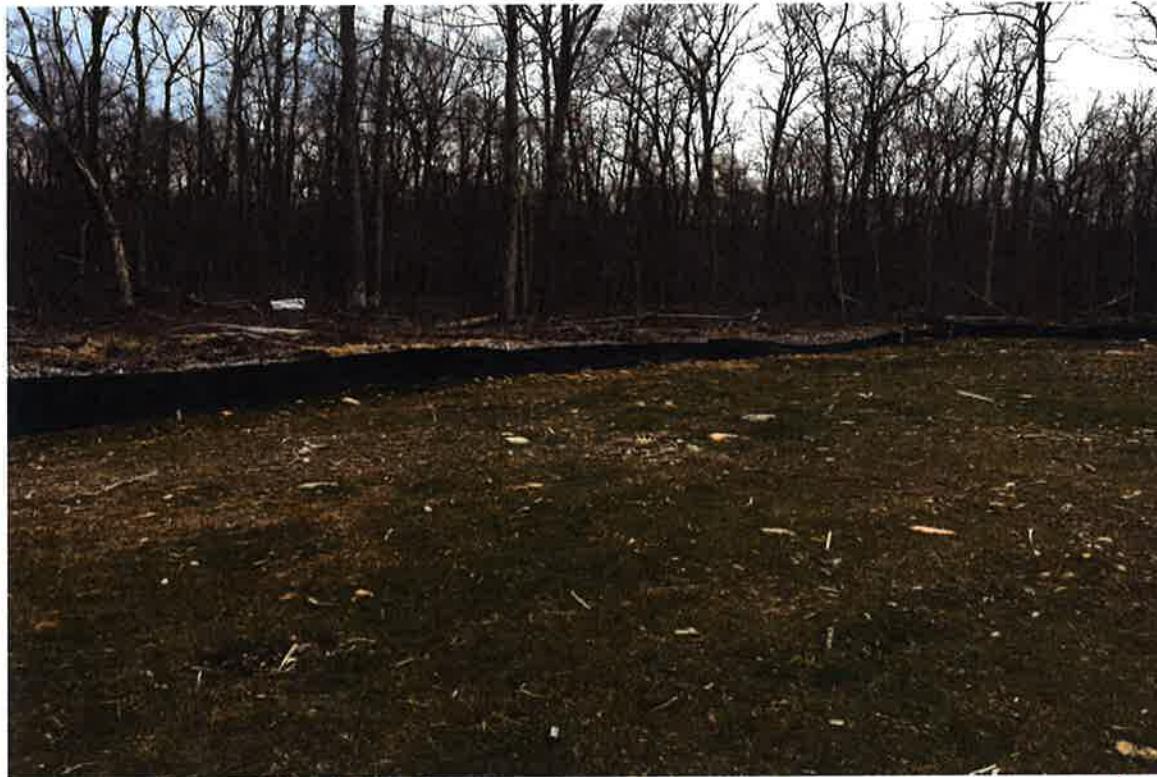
Photo 3: View of eastern edge of project area.

All gaps in the silt fence along the eastern end of the site should be closed up to prevent herpetofauna migration into the work zones.	
Project Modification Requested:	
Extra work space requested	<input type="checkbox"/>
Change to work area	<input type="checkbox"/>
Change to stormwater feature	<input type="checkbox"/>
Description of Modification: N/A

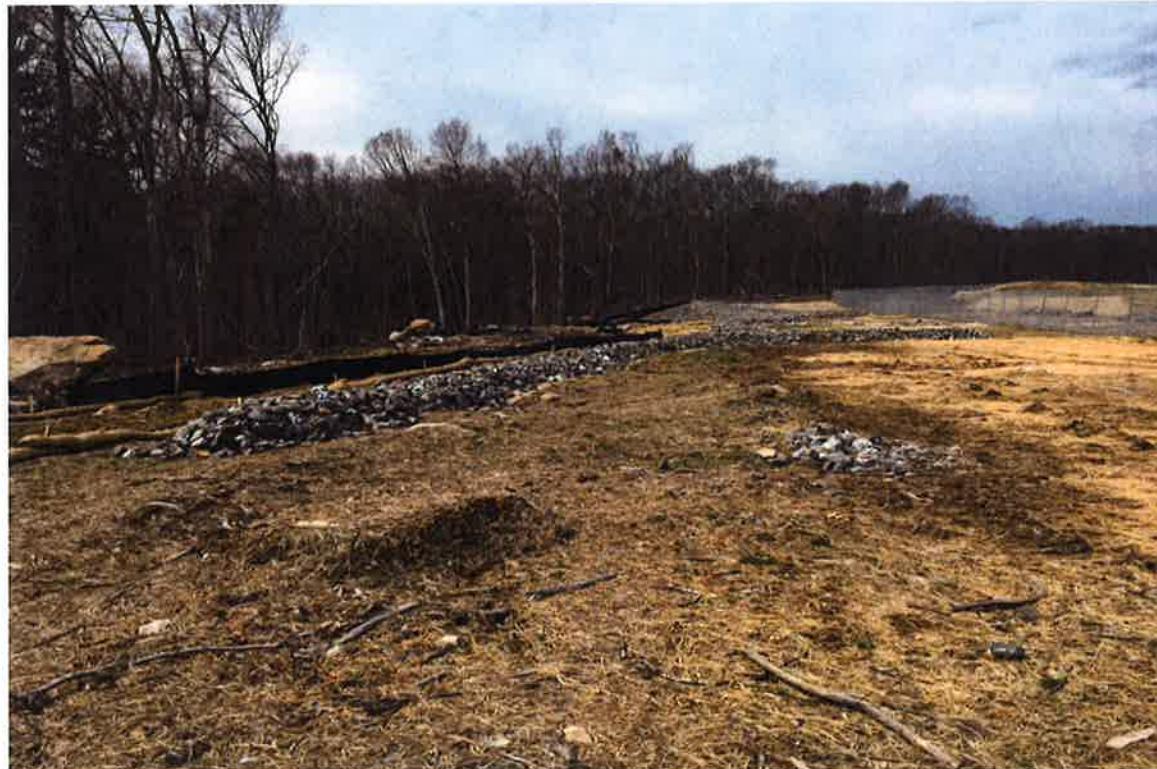
Photo 4: View of northwest project corner.

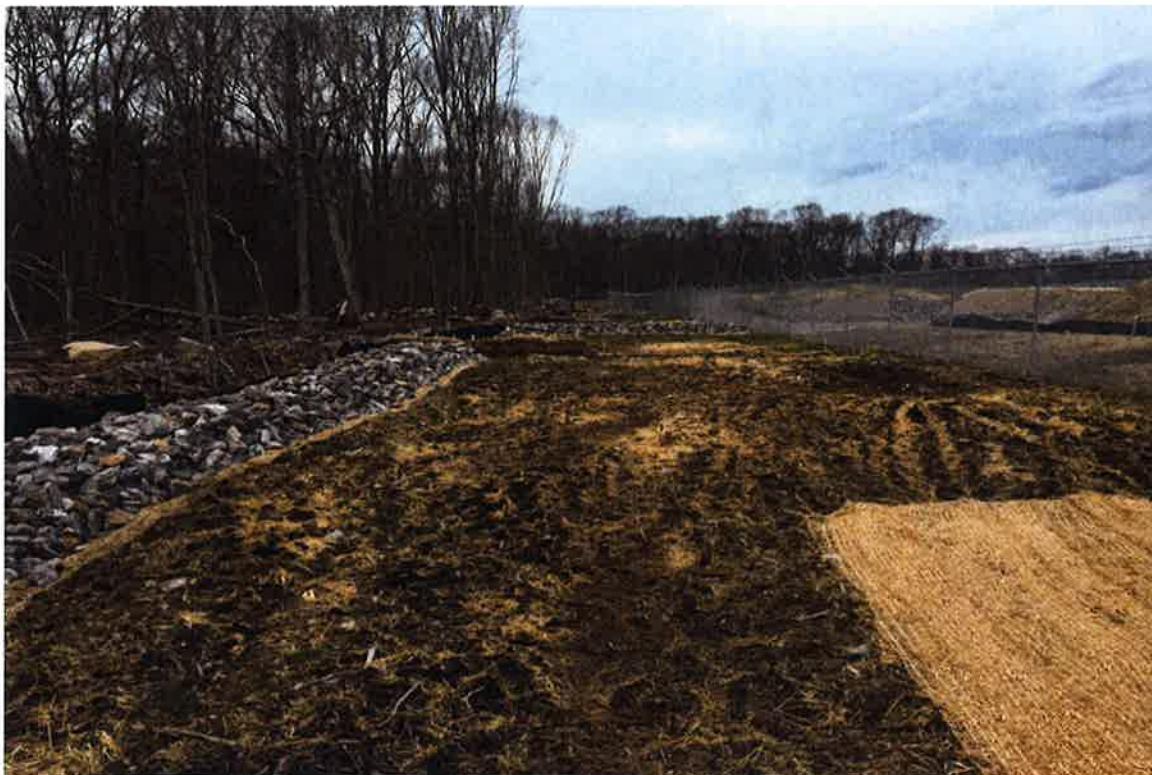
Photo 5: View of northwest project corner.

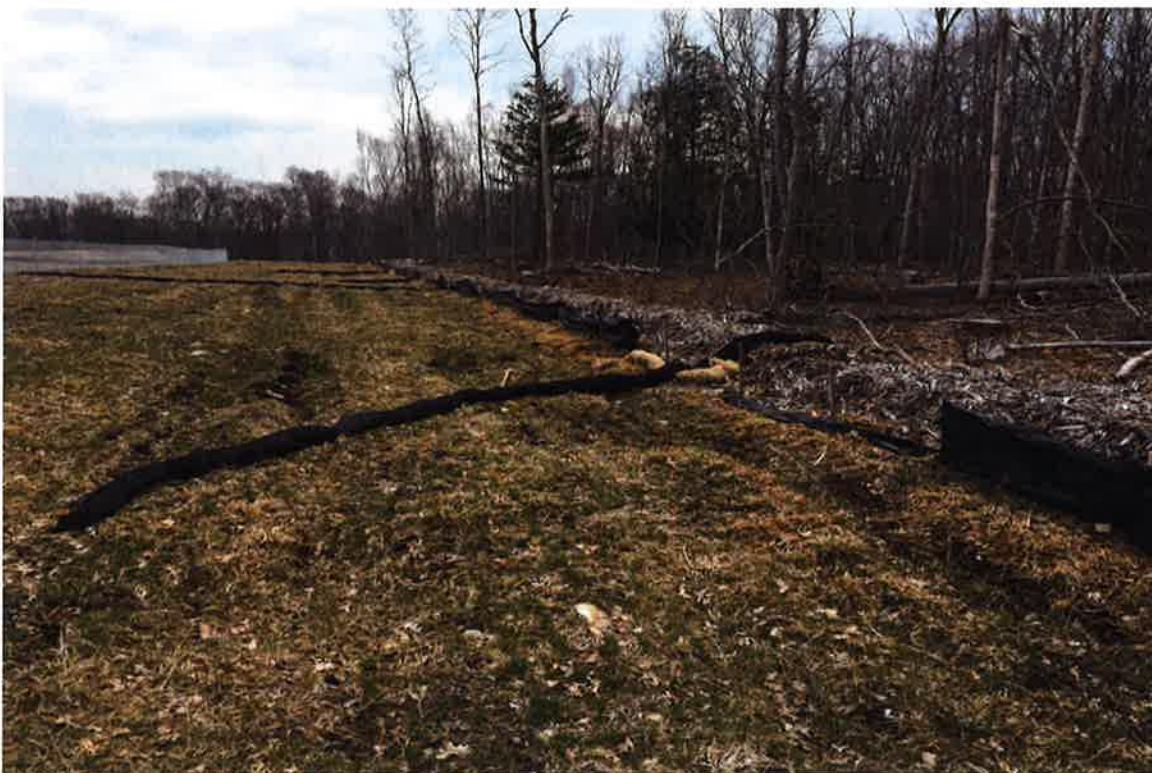
4/13/18 – Site is generally temporarily stable with no releases observed. All arrays etc. are fully constructed and no more heavy machinery traffic is expected on site until the site is transitioned to permanent stabilization. Openings/gaps in the silt fence have been created on the western and eastern ends of site. The eastern end of the site, being close to vernal pool resources, should have all gaps closed to recreate the isolation barrier for the remainder of the breeding season. All gaps should be closed when heavy machinery is active again.

Photo 6: View of typical silt fence opening.

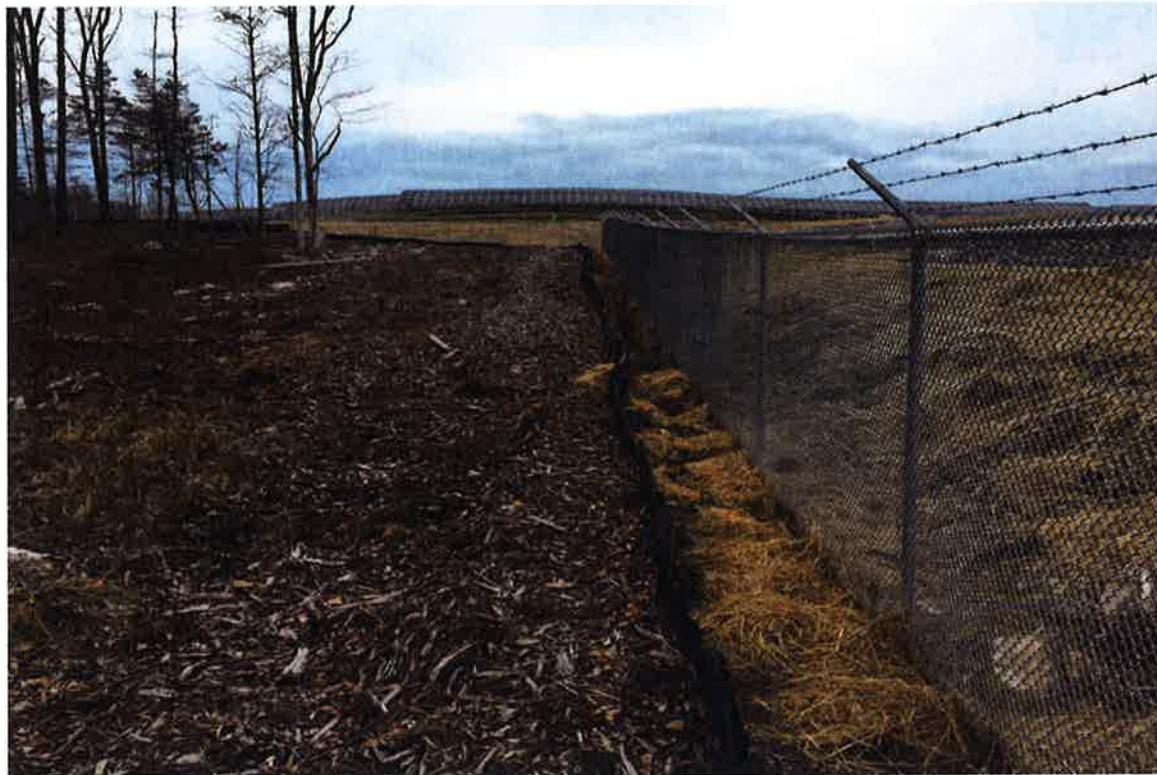
Photo 7: View of typical silt fence perimeter.
