Re: **Petition No. 1178 – Fusion Solar Center, LLC – Environmental Monitoring Reports and Daily Site Observation Form Report Nos. 4, 5 and 6**

ENVIRONMENTAL MONITORING
DAILY SITE OBSERVATION FORM

Project: DEPCOM Power, Fusion Solar Center
Address: Potash Hill Road, Sprague, Connecticut

APT Project #: CT511100

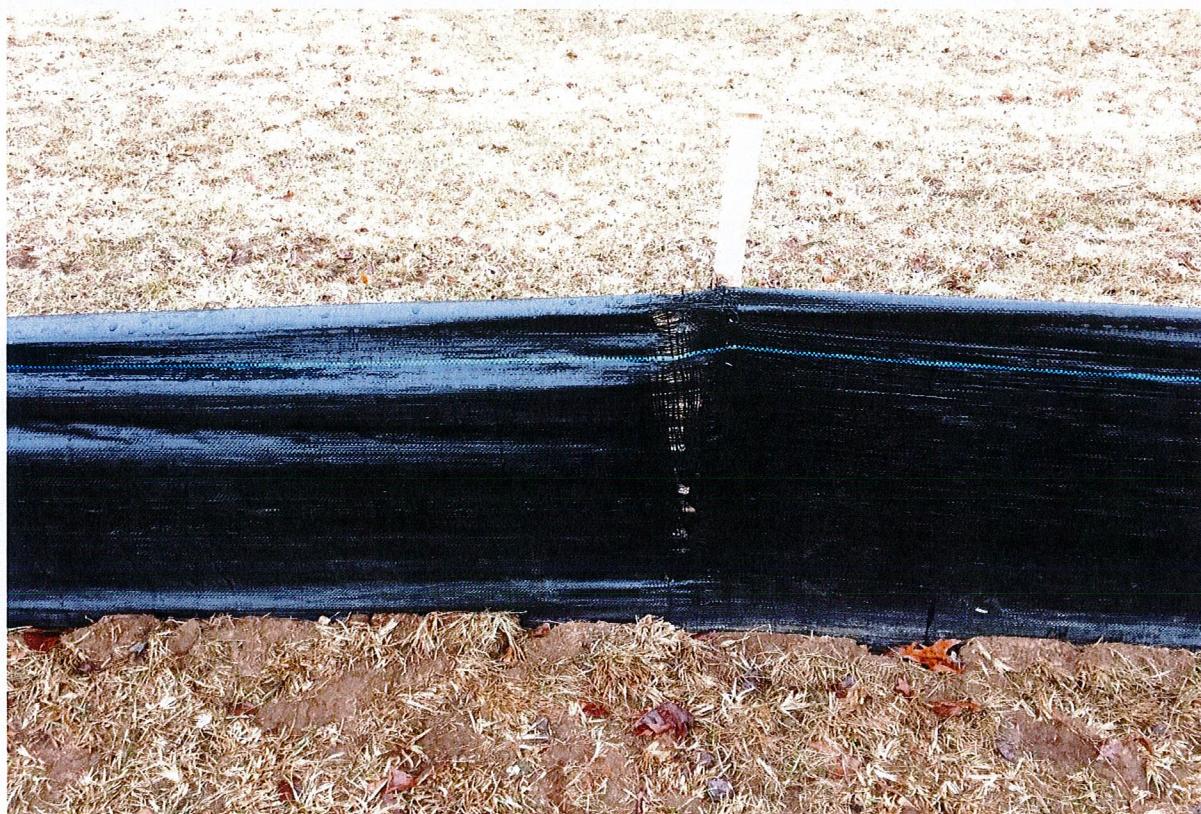
Photo 4: View of evidence of silt fencing tearing off staking (CA#4).

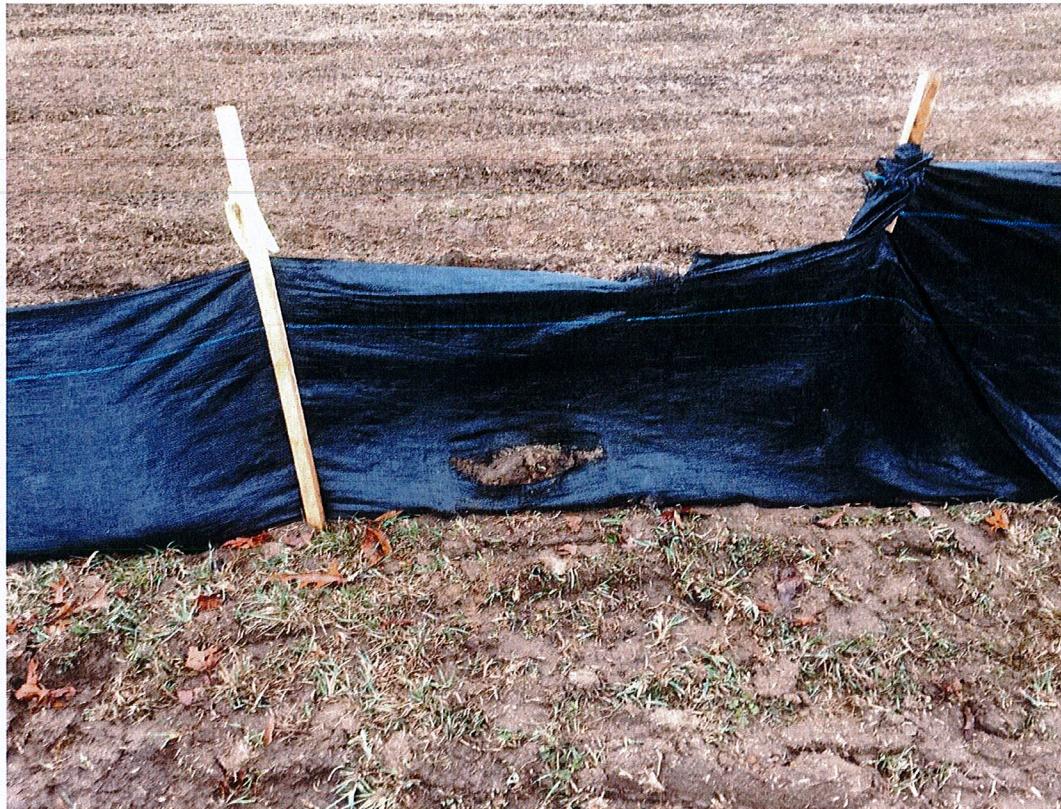
Photo 5: View of CA#4, gap in silt fencing.

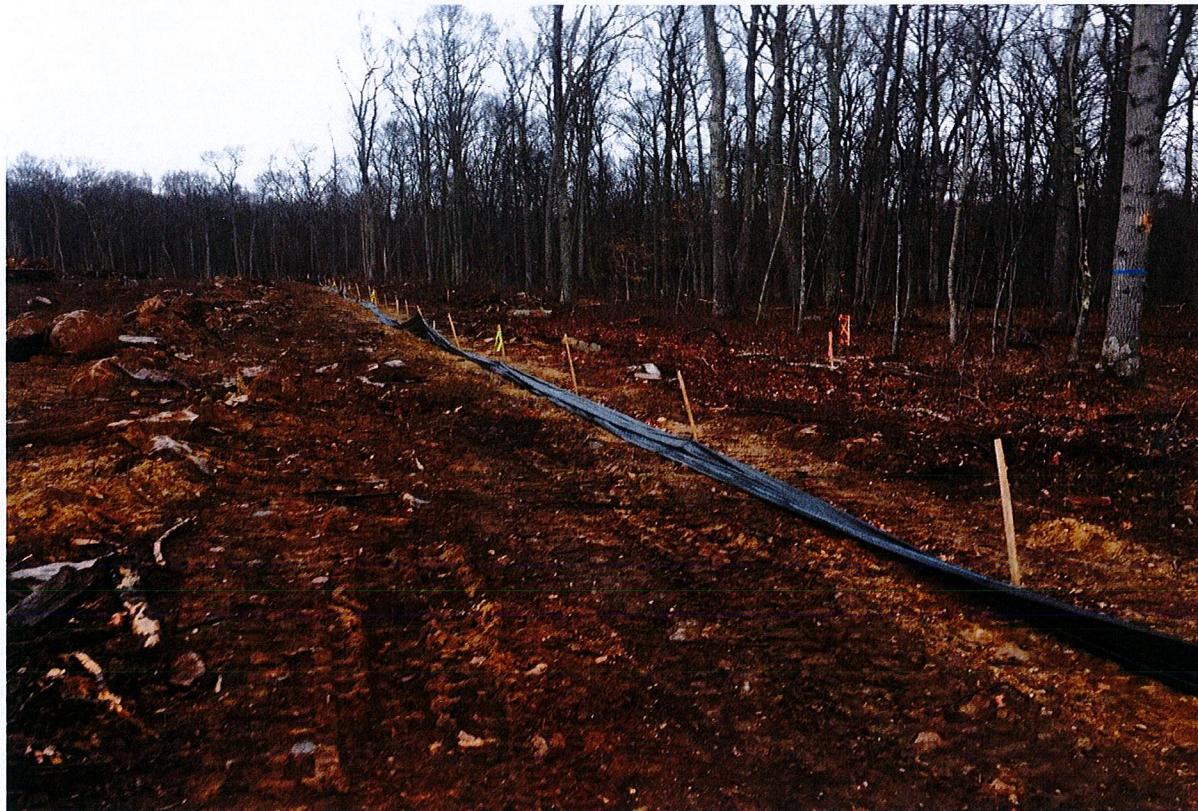
Photo 6: View of previously identified silt fence repair (CA#4) in northeast corner of project.

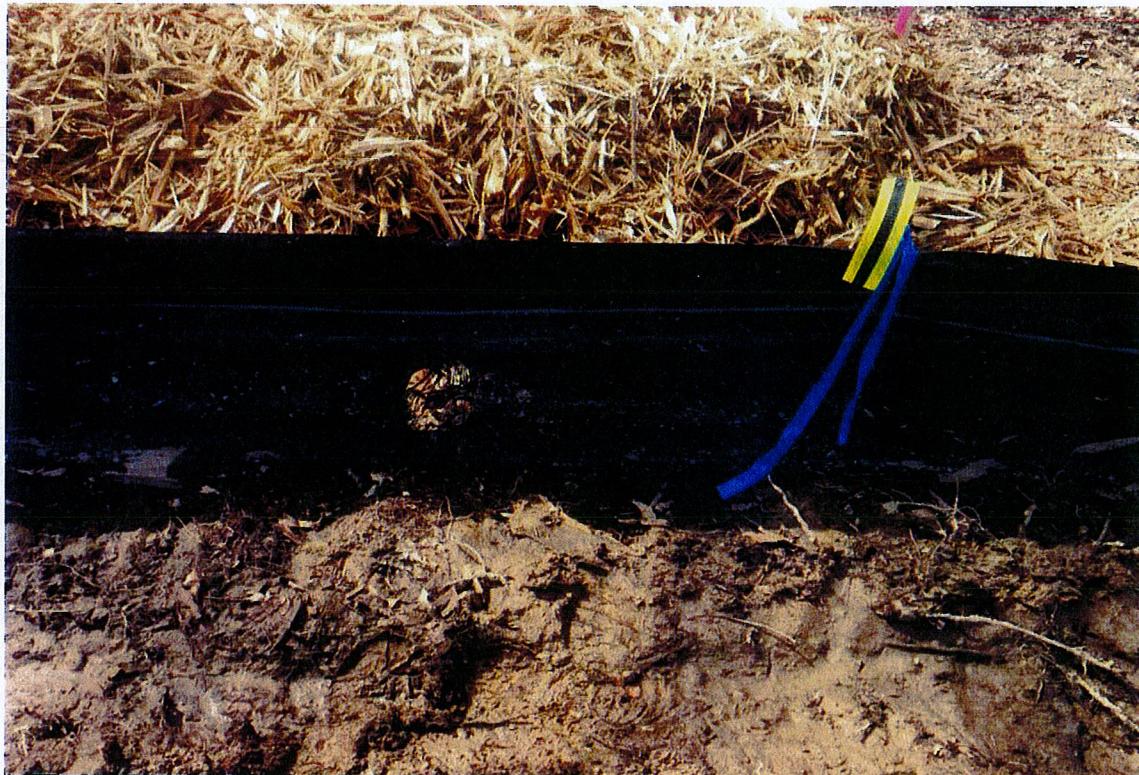
Corrective Action #6 – one area of insufficient silt fence height due to sagging.	3/7/17
Corrective Action #7 – numerous areas of silt fence have separated from staking or ripped resulting in sagging and disconnected silt fencing needing repair. (4/3 previous areas fixed CA #4 – new areas have been identified as of this inspection date).	
Corrective Action #8 – Two areas identified where gaps in silt fence formed underneath due to focused erosion from stormwater flows.

Photo 3: View of CA #7 gap in silt fence requiring repair.

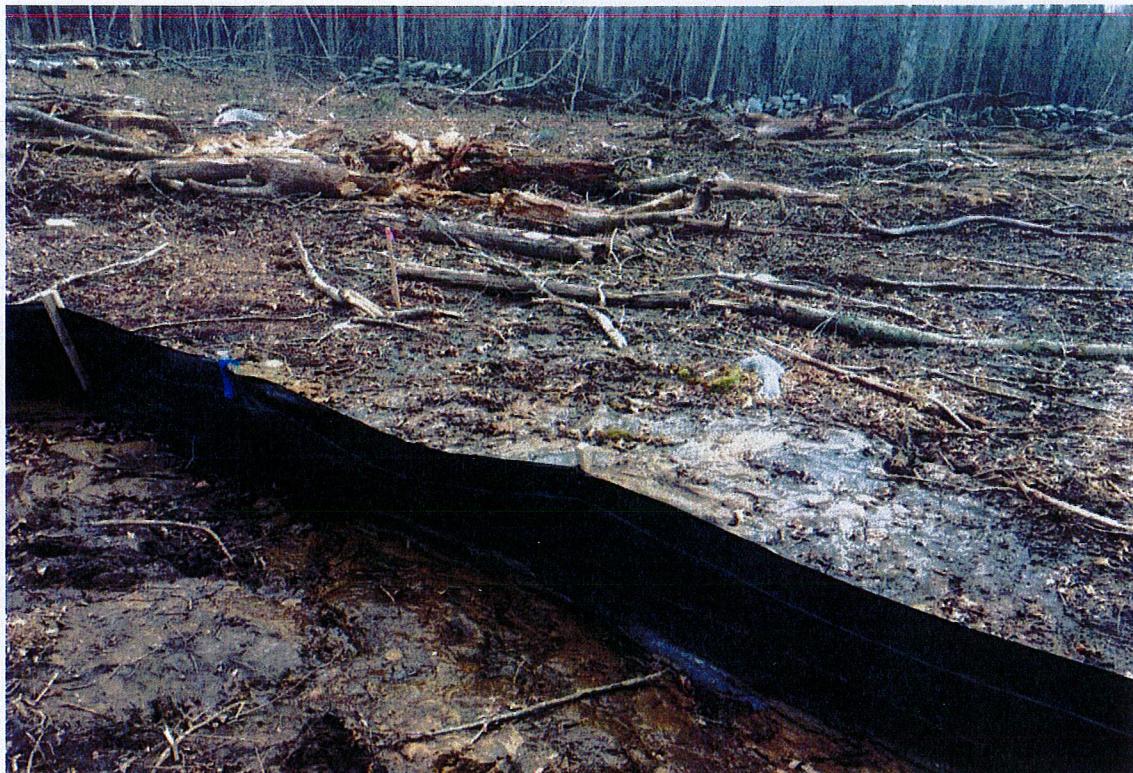
4/3/17 – Neighbor (to the south) observed and reported silt laden stormwater leaving site and flowing through their property. No clear cause identified onsite during inspection due to dry site conditions. Two possible locations identified where sediment accumulation has occurred in front of perimeter controls and reviewed with DEPCOM. With the rain forecasted 4/4/17, the site will be reviewed and additional control installation will be evaluated and implemented, as necessary.

Photo 5: View of CA #8 sediment release within uplands on site.

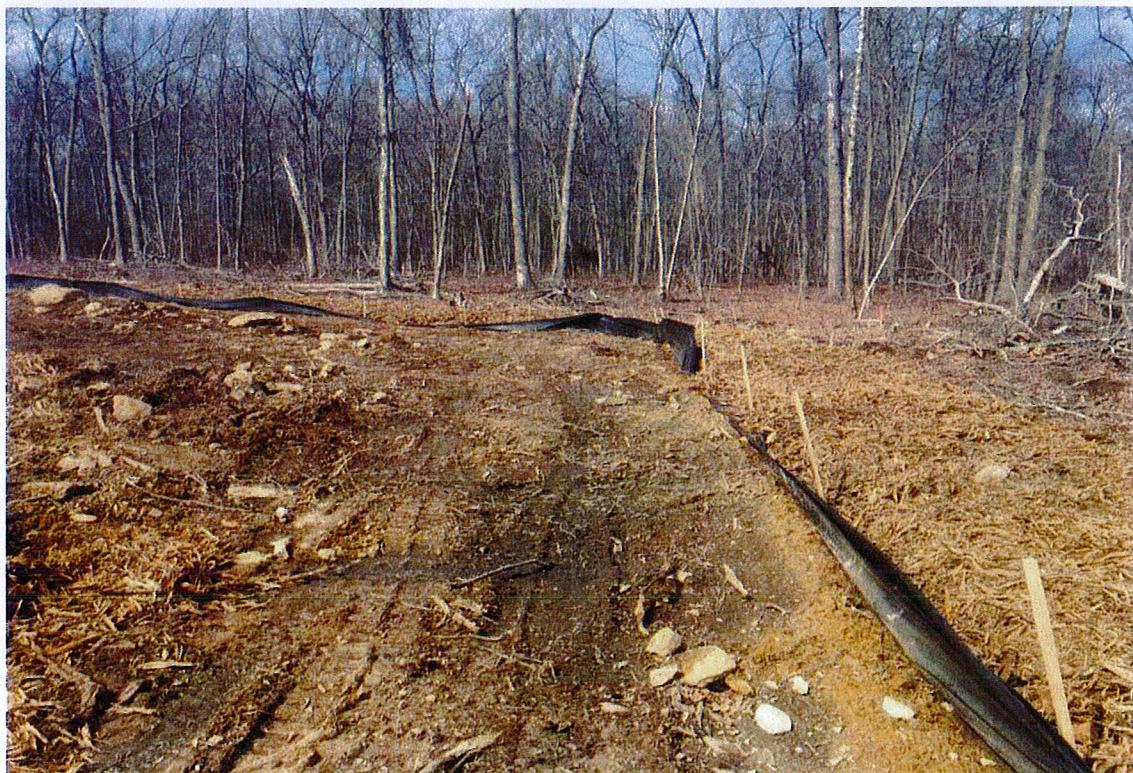
Photo 6: View of CA #7, silt fenced knocked over.

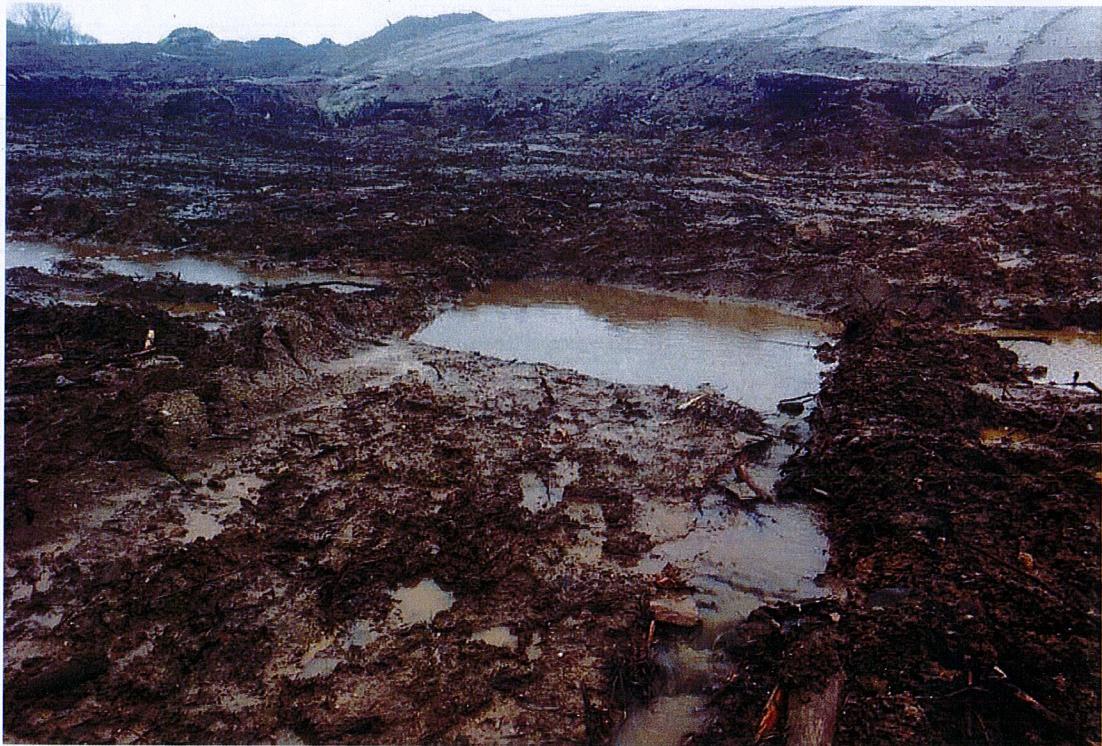
4/4/17 – breach in diversion swale repaired, silt fence knocked over by overflow in south end of project repaired and stormwater released during 3/31 to 4/1 rain storm and again on 4/4 resulted in silt laden water released off site at two locations (one of which is a wetland/IWC and other is a southern neighbor's property). No significant release of sediment occurred in either location. Corrective actions were immediately taken on 4/3 and 4/4 to reinforce perimeter controls, drainage patterns, and basins to remedy situation. Additional temporary stormwater controls will be installed on 4/5 as identified on attached sketch map. All basins should be reevaluated to ensure they are functioning as designed, proper drainage is being received, and if they are sufficient to handle the stormwater being received. Meeting with CSC staff occurred on 4/4/17 to review recent stormwater release and remedial actions taken and to be taken by DEPCOM; Town Wetlands Agent also present at meeting.

Photo 3: View of breach in diversion channel to sediment basin SB-3 looking north.

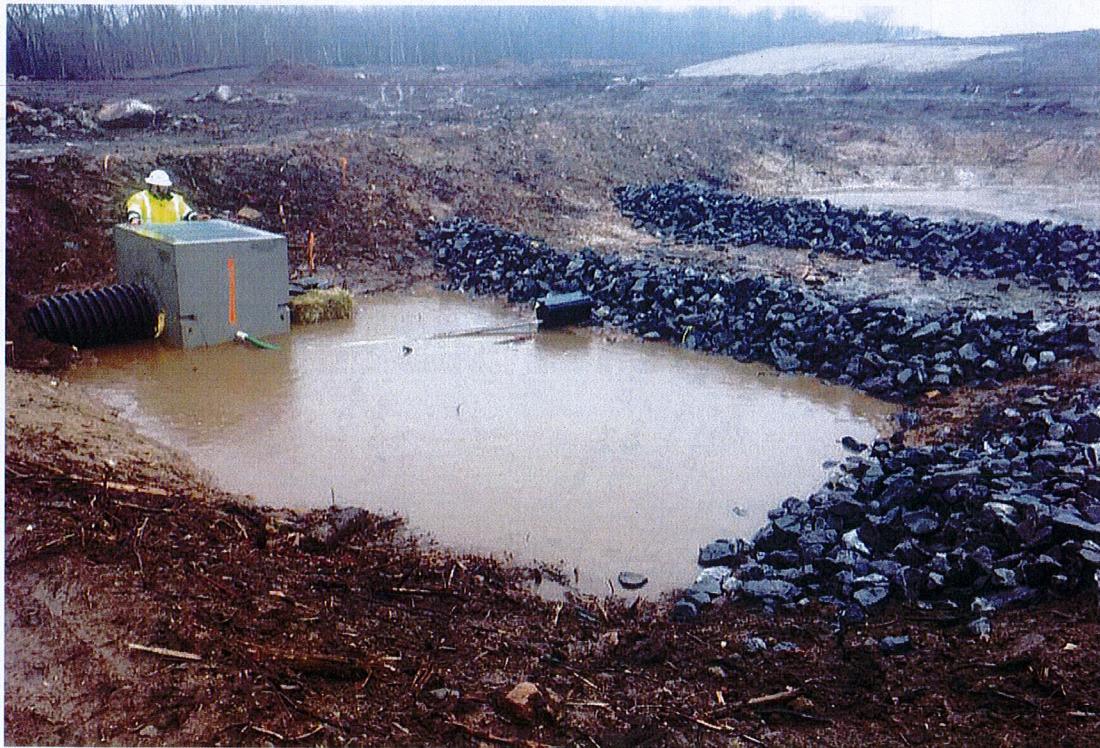
Photo 5: View of temporary sediment basin SB-3.

4/10 – (info provided by DEPCOM via phone conversation) low flow outlets on the two basins were plugged on 4/6-4/7 (precipitation event) to improve sediment removal capabilities of the basins.

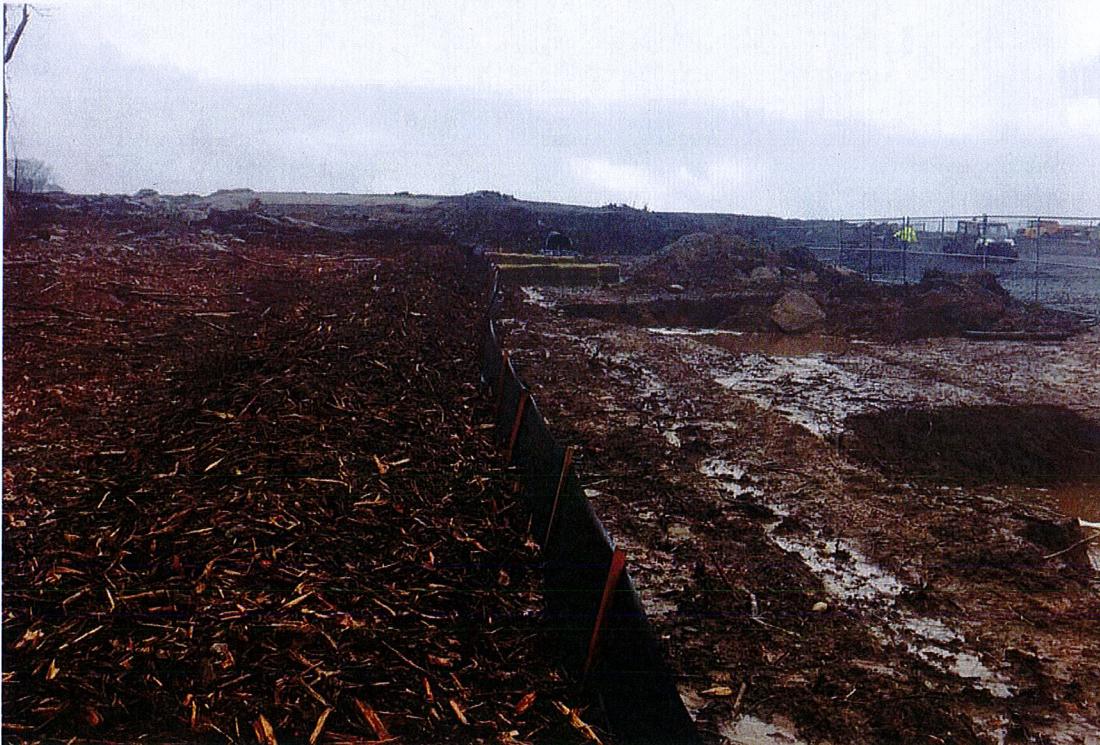
Photo 6: View of perimeter controls and primary flow path out-letting from temporary sediment basin SB-3 looking north.
