LM6000PC
BORESCOPE INSPECTION (HSE) REPORT
for
191-327

Customer	LS Power
Site	Wallingford
Address	115 John Street Wallingford, CT 06492
Phone	
Contact	David Evinrude
Unit No.	191-327
Engine Model No.	LM6000PC
Engine Serial No.	191-327
Fired Hours	13,478
Fired Starts	629
Inspection Date	April 9, 2018
Field Services Rep	Chris Harris
Job Number	1015-5113

Unit 7 LP Vibration Investigation

Engine Serial Number: 191-346
Engine Model: 7LM6000PC – NGW
Project Number: 1015-5113-346W
Date Started: 03/16/2018
Date Completed: 4/05/2018

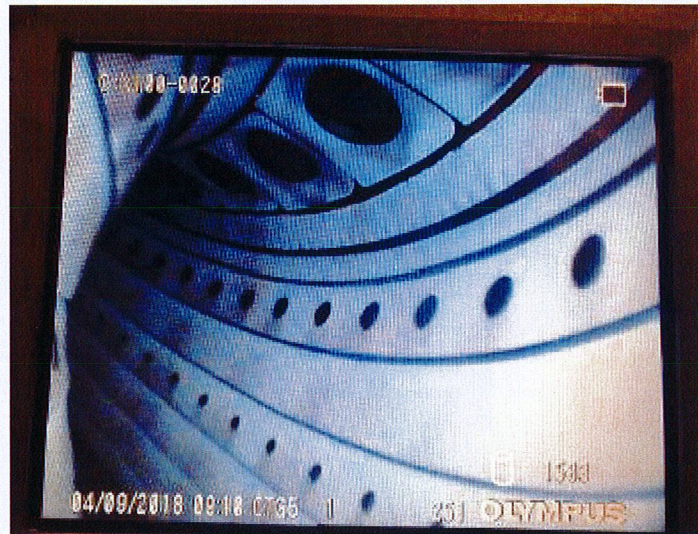
Port S6-1 - Inner & Outer Liners, Dome assembly, Fuel Nozzles and HPT1 Nozzles

This is an over view of the combustor. No discrepancies noted.

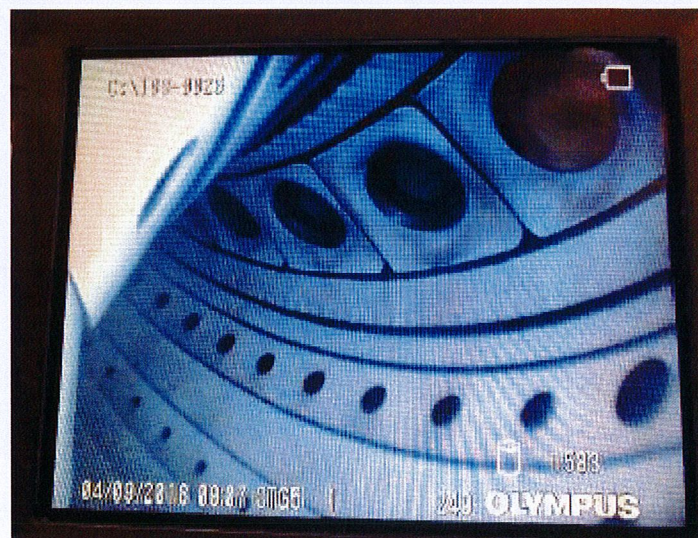
This is an over view of the combustor. No discrepancies noted.

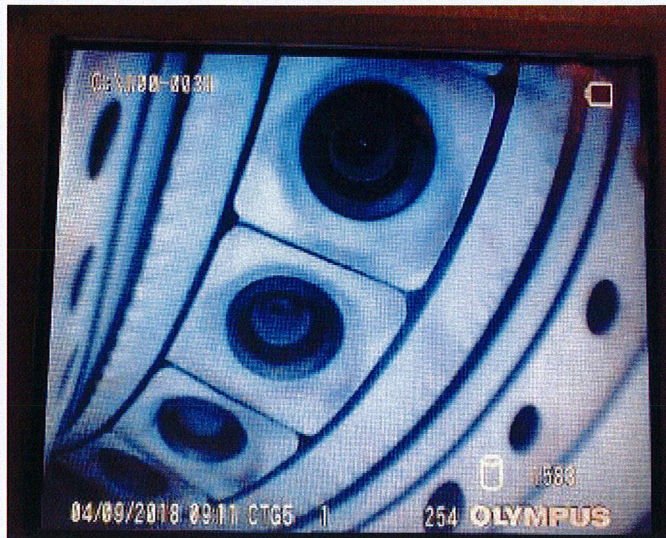
Port S6-2 - Inner & Outer Liners, Dome assembly, Fuel Nozzles and HPT1 Nozzles

This is a typical view of a "trumpet" No discrepancies noted.

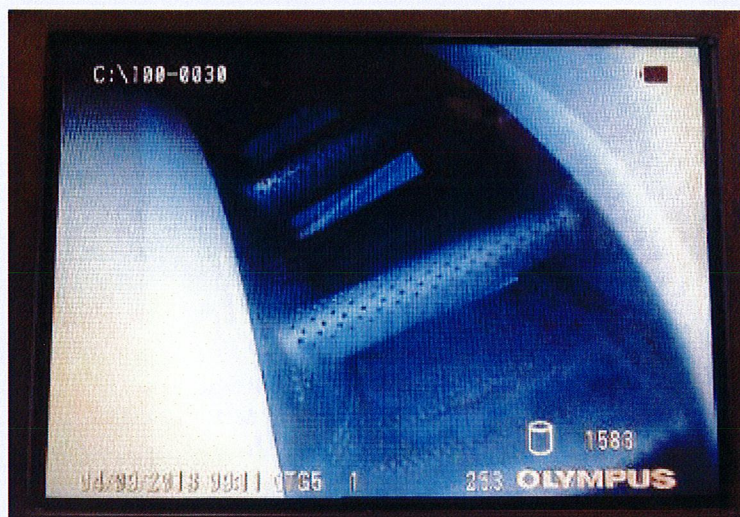
Port S6-3 - Inner & Outer Liners, Dome assembly, Fuel Nozzles and HPT1 Nozzles

This is a view of a stage 1 HPT nozzle . No discrepancies Noted.

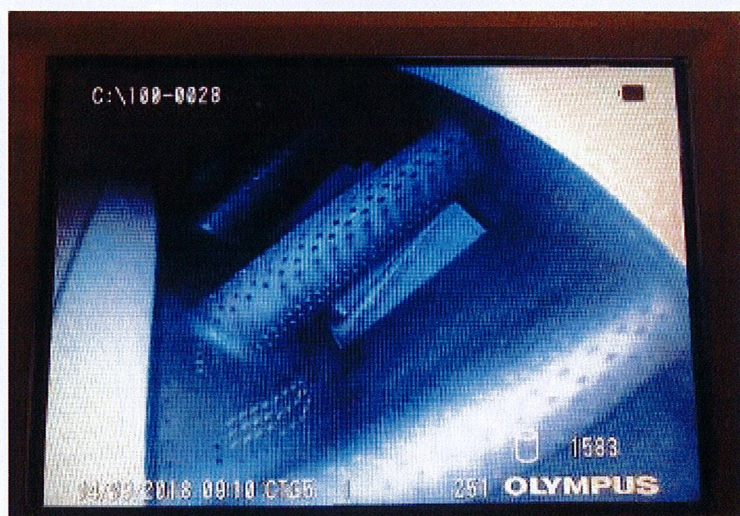
This is a view of a stage 1 HPT nozzle . No discrepancies Noted.

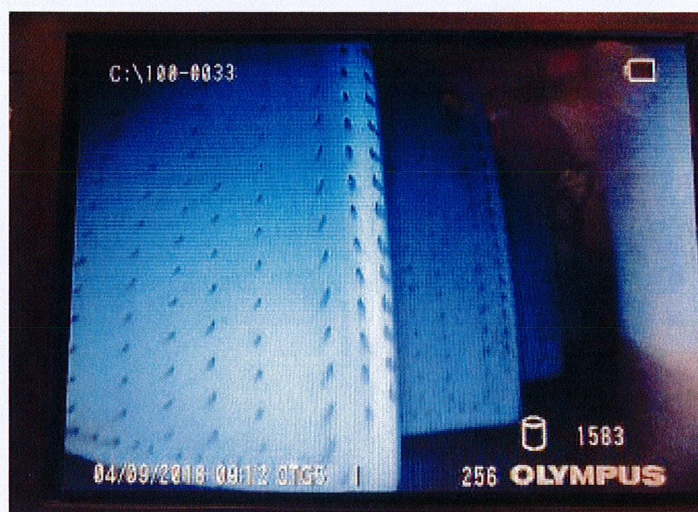
Port S7-1 - Stage 1 Blade Leading Edges, Tips, Platforms and Seal Bodies

This is a view of a stage 1 HPT blade. No Discrepancies Noted.

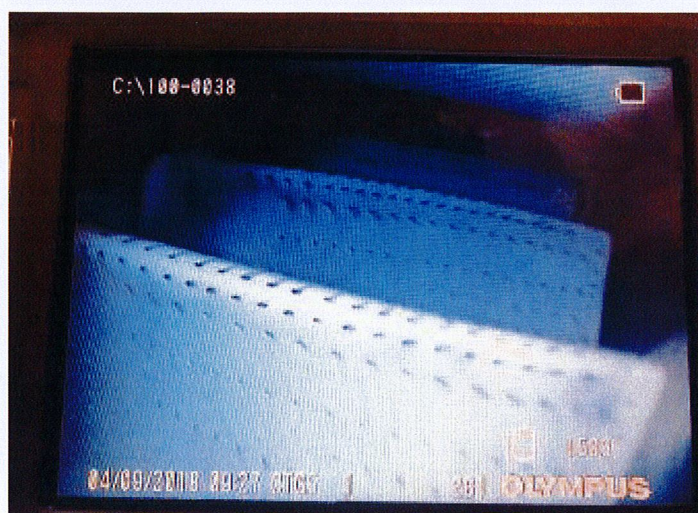
This is a view of a stage 1 HPT blade. No Discrepancies Noted.

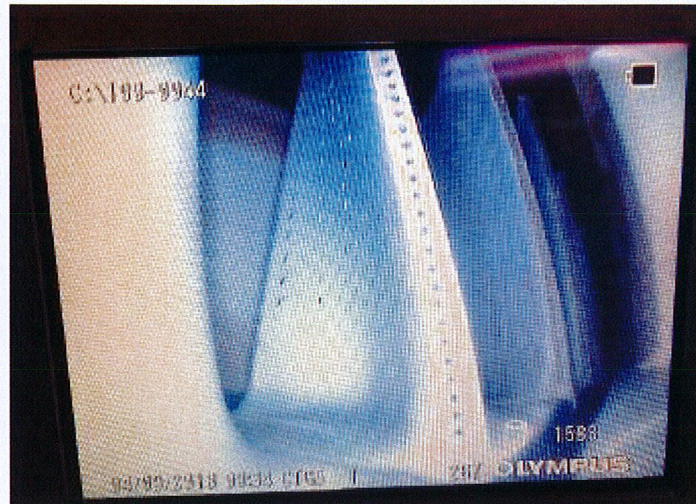
Port S7-2 - Stage 1 Blade Trailing Edges / Stage 2 Blade Leading Edges, Tips and Platforms

This is a view of a stage 1 HPT blade trailing edge. No Discrepancies Noted.

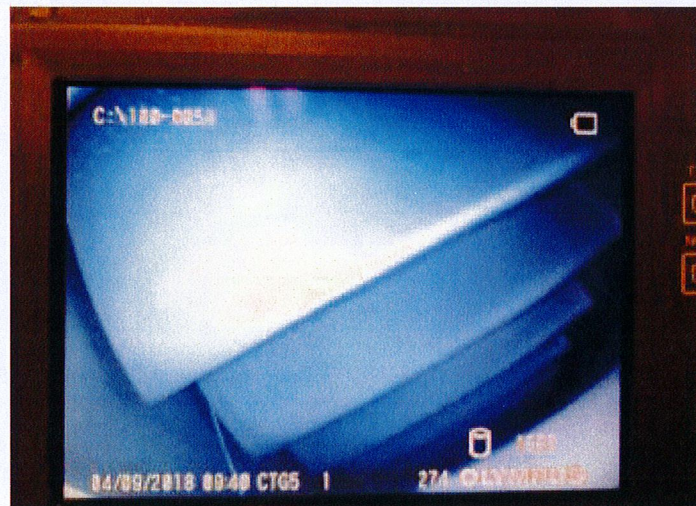
This is a view of a stage 2 HPT blade. No Discrepancies Noted.

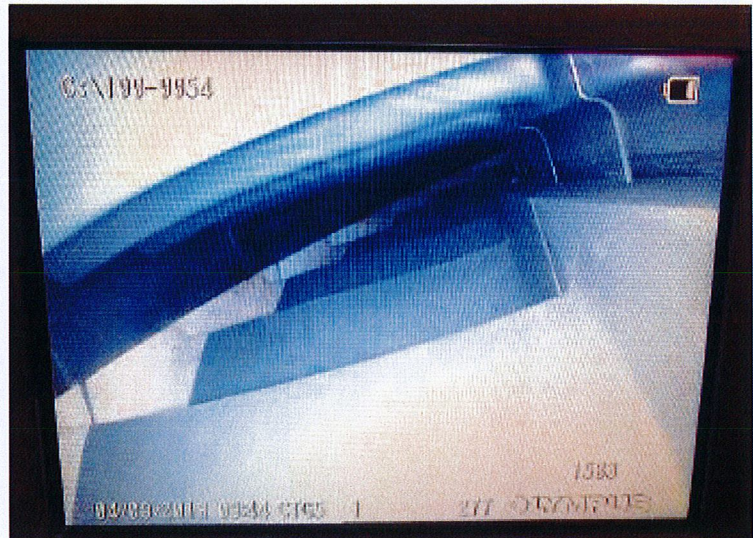
Port S7-2 - Stage 2 HPT nozzle

This is a view of a stage 2 HPT nozzles trailing edge and leading edge of stage 2 blades. No Discrepancies Noted.

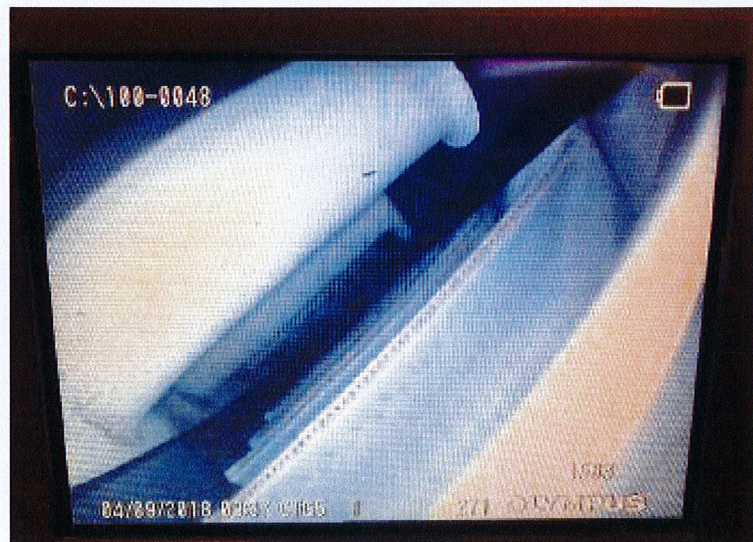
This is a view of a stage 2 HPT nozzles leading edge and trailing of stage 1 blades. No Discrepancies Noted.

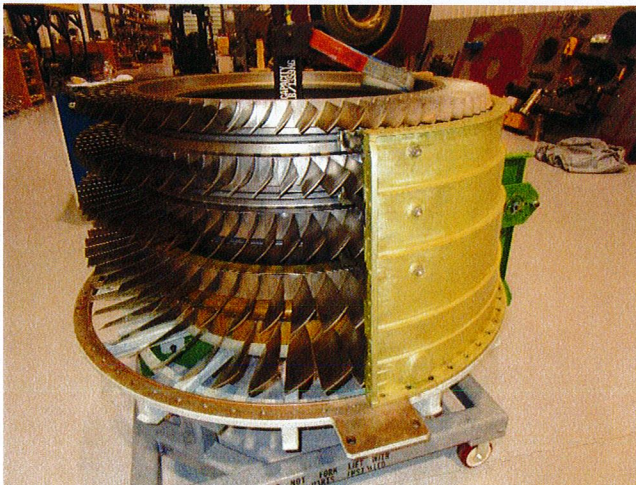
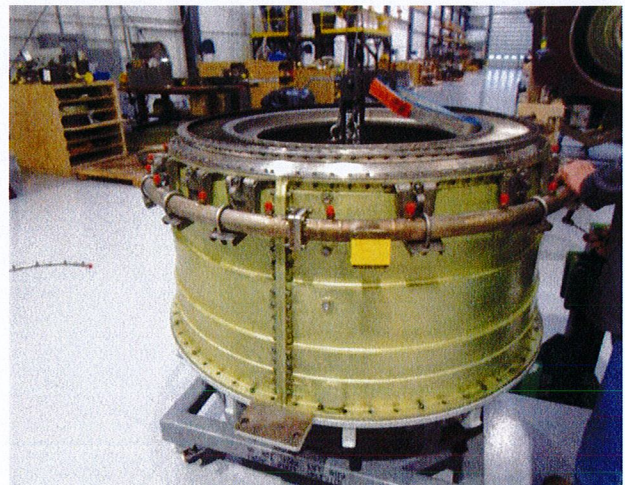
Photos:

- No discrepancies noted

- The LPC Stator Cases were found to be in Serviceable condition.
- LPC Stator Case shrouds were found to be in Serviceable condition.
- LPC Stator Cases re-installed on the LPC Rotor.

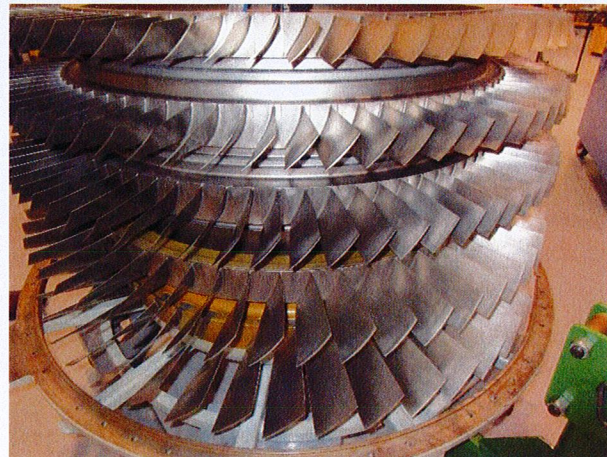
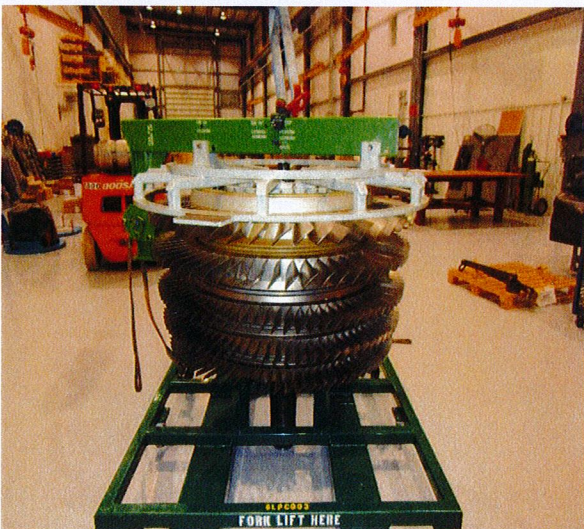
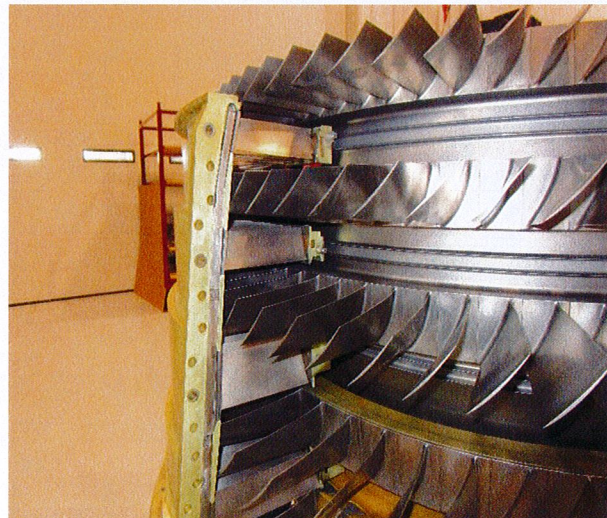
LPCR Pictures:

- LPC Rotor was found to be slightly outside desired balance specifications.

- LPC Rotor rebalanced to tighter specifications. Results shown below.

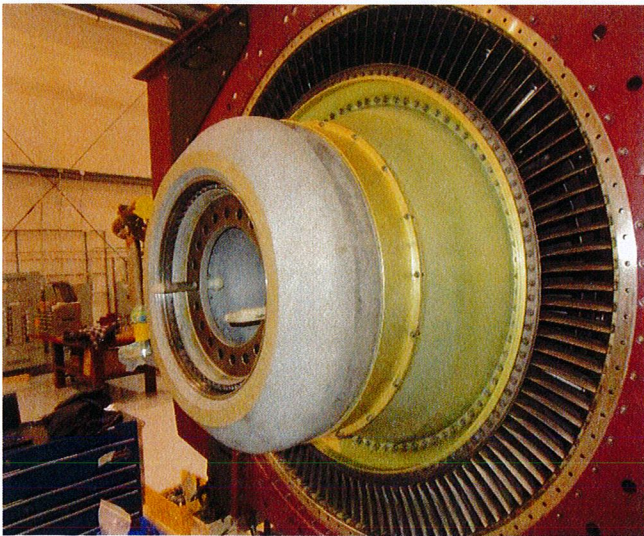
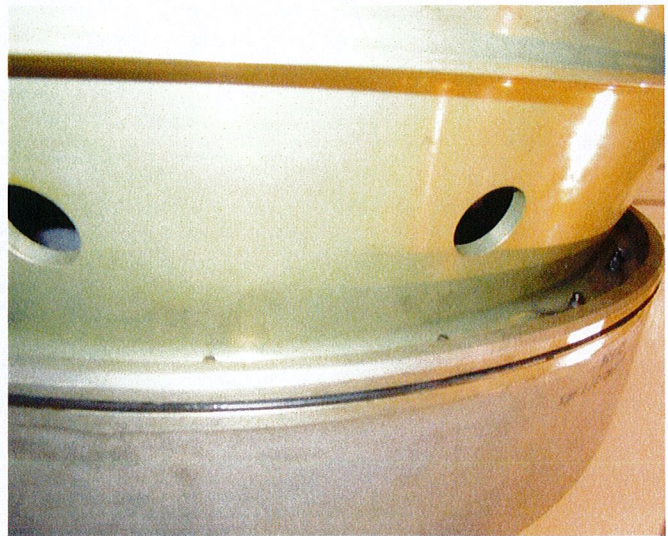
CFF Photos:

- During the inspection it was noted that SB 181 had not been implemented
- CFF in serviceable condition

- SB 181 was implemented to bring the unit into compliance

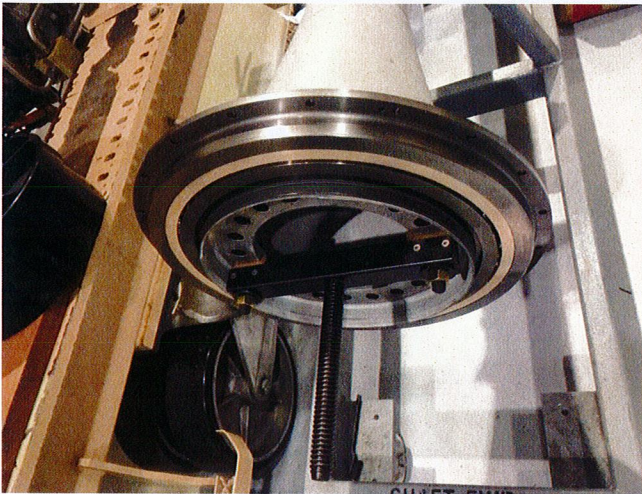
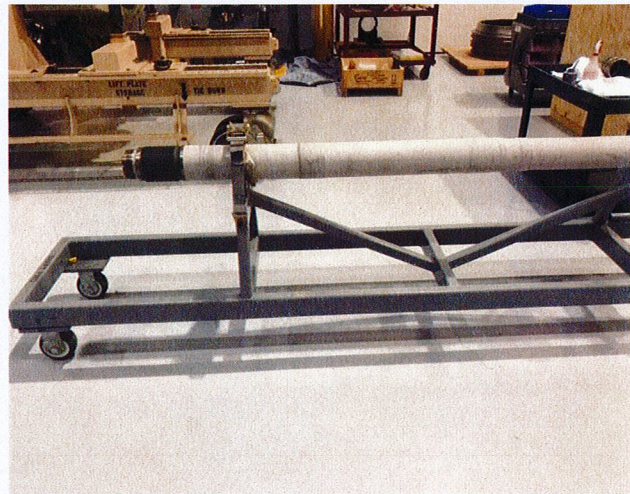
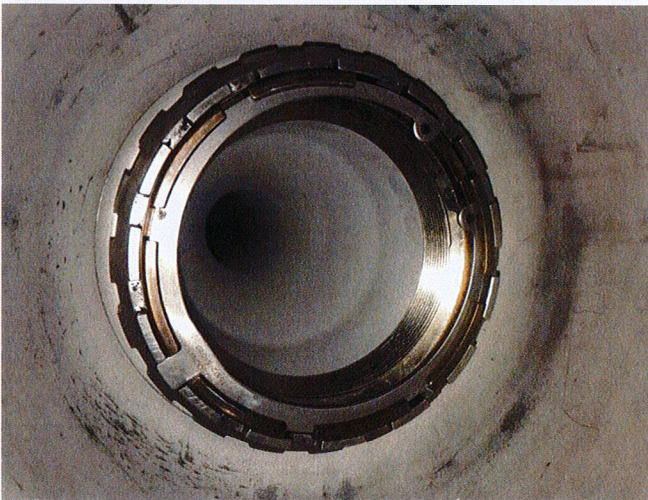
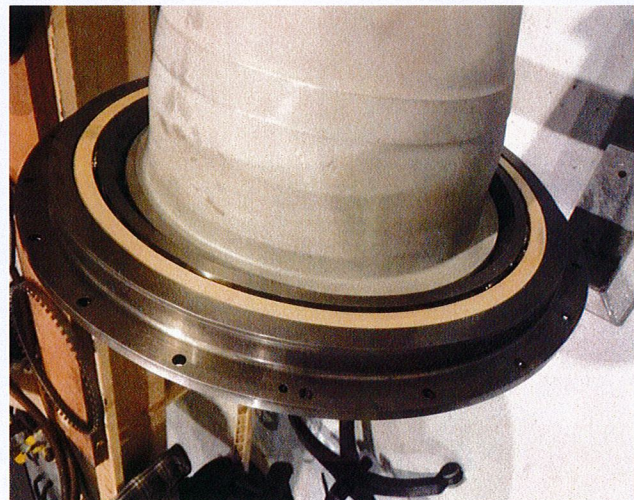
LP shaft Assembly Pictures:

- Performed stack check of the 1B Bearing and found the measurement to be out 0.014" out of specification
- 1B Bearing routed to outside vendor for inspection. Results of inspection indicated galling/scratches on the bearing races, small dents and flat spots on the bearings balls/bearing surface.
- Inspection of the forward shaft bearing journal was found to be in serviceable condition.
- Forward shaft to mid shaft runouts were found to be within specifications. Measurement is as follows:
 - **Runout:** 0.0025

- Routed 1B Bearing to OSV for evaluation
- Referenced original build records and "As Built" stack up was 0.164"
- Reassembly stack check reading of 0.166' was similar to the As Built stack reading, however the disassembly stack check reading was 0.178. This 0.0140" discrepancy was noted and therefore an RCA was performed.
- RCA on the stack check process revealed a miss calibrated micrometer
- Recalculated the stack check measurements using properly calibrated micrometer
- As Found and As Built measurements within specification
- 1B Bearing replaced with OH'd bearing

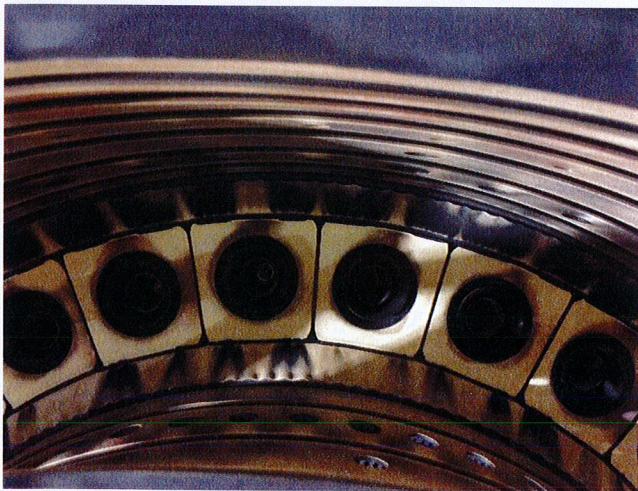
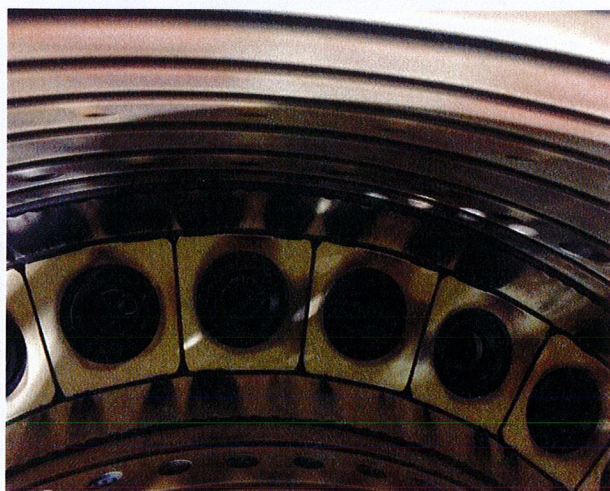
Combustor Pictures:

- Combustor was in serviceable condition and no deficiencies noted.

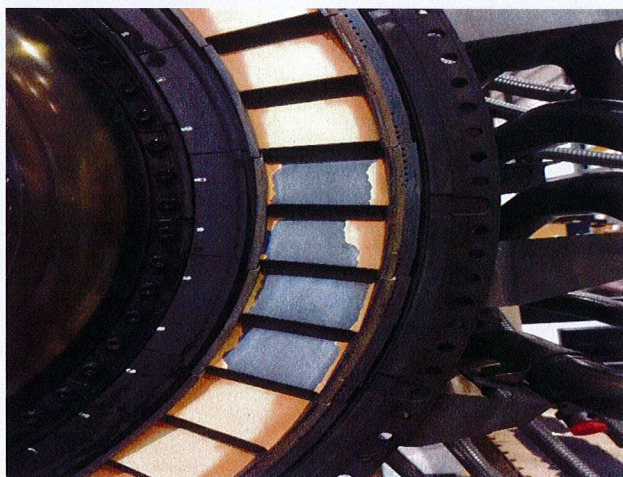
Removed

Prior to ESN: 191-346 being removed from the package for shipment back to the Pro Energy Aero Depot, a borescope inspection was performed on the engine. During the borescope of the S1NA spalling of TBC was discovered on the convex side of several nozzle segments. The S1NA was disassembled to piece parts and inspected.

- TBC spalling on several nozzle segments

- Nozzles segments removed and routed to OSV for inspection/performance a RCA to determine the cause of the TBC spalling on the convex surface of the nozzle segments.
- Replaced all nozzle segments with OH'd nozzle segments from PES inventory
- Assembled S1NA

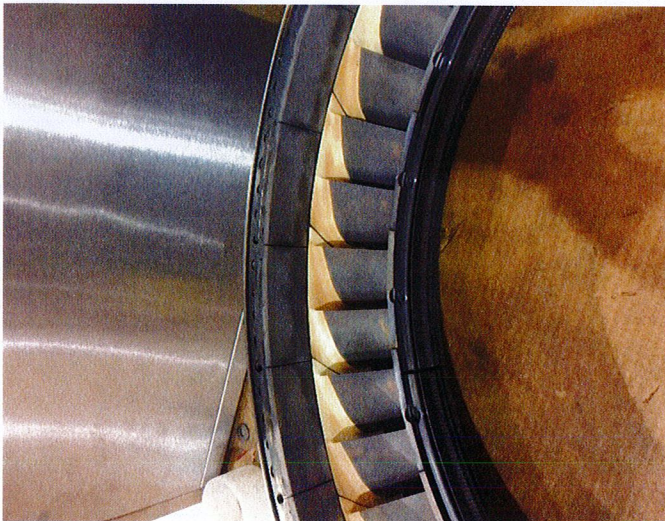
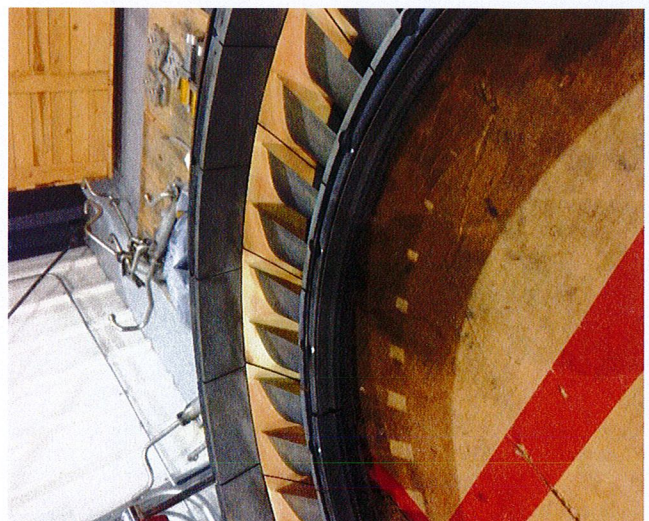
S2NA Pictures:

- S2NA found in serviceable condition

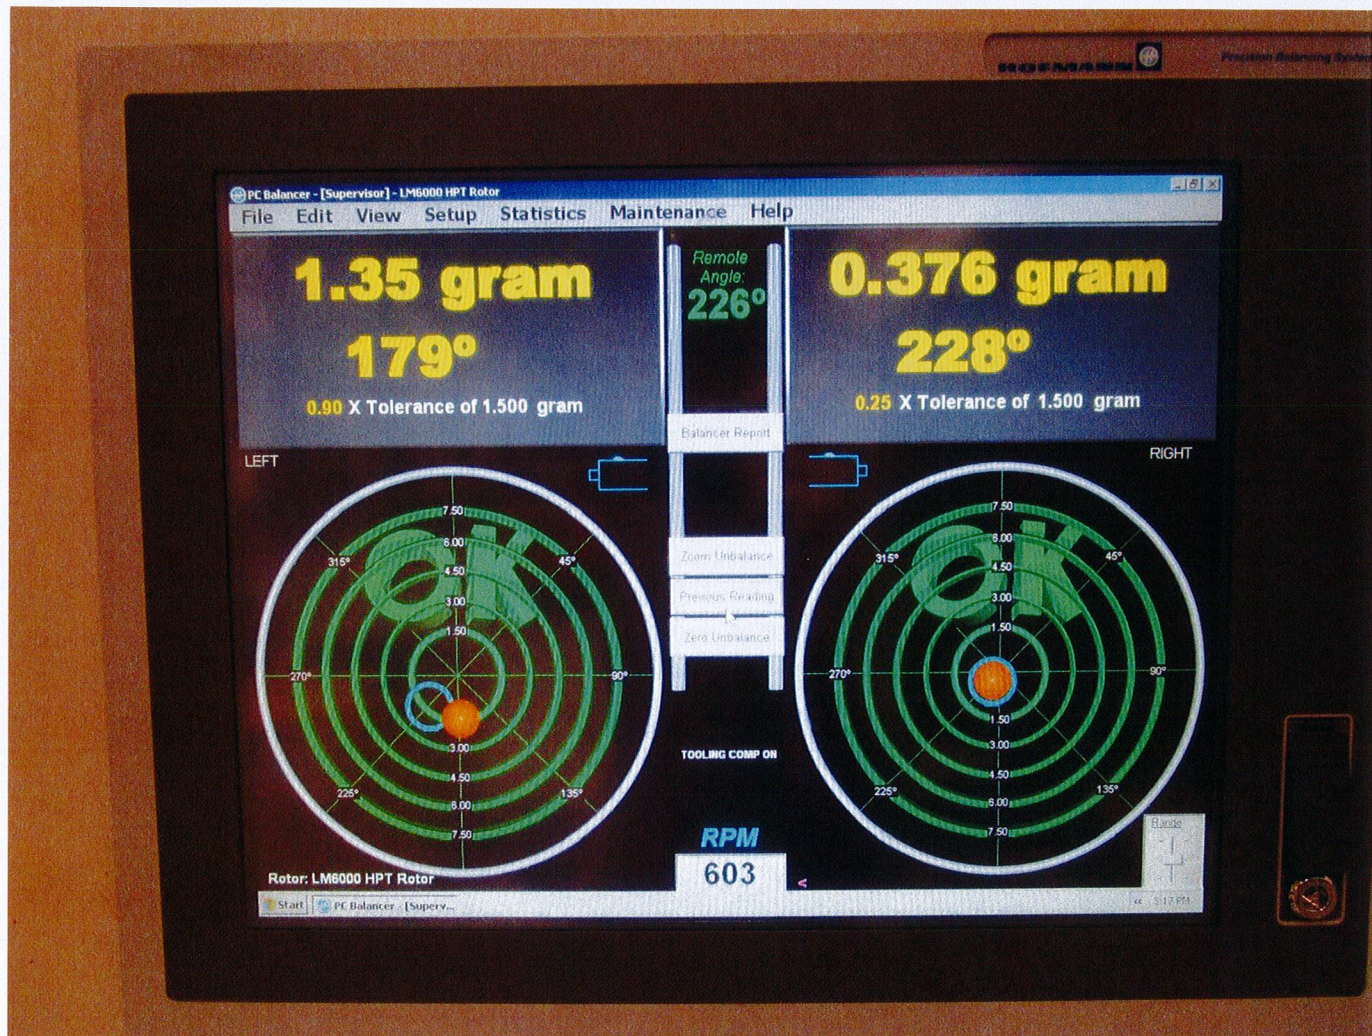
HPTR Pictures:

Prior to ESN: 191-346 being removed from the package for shipment back to the Pro Energy Aero Depot, a borescope inspection was performed on the engine. During the borescope of the HPT Rotor, TBC chipping was noted on the leading edges of the 1st Stage HPT Blades. The HPT Rotor was removed, disassembled to piece parts, and visually inspected.

- All 1st Stage HPT Blades exhibited TBC chipping
- 1st Stage HPT Disk exhibited signs of minor coating spalling on the pilot surface

- Removed 1st Stage HPT Blades and routed to OSV for inspection and repair
- Changed out 1st Stage HPT Disk with OH'd disk from PES inventory
- Installed complete set of OH'd 1st Stage HPT Blades
- Performed tip grind on 1st Stage HPT Blades to match 1st Stage Shrouds
- Balanced HPT Rotor

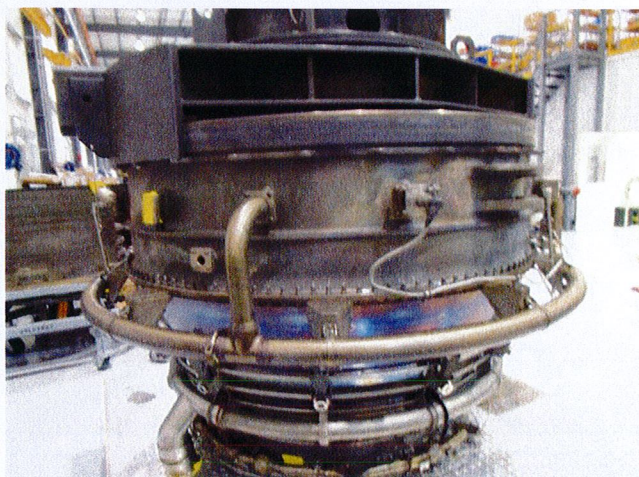
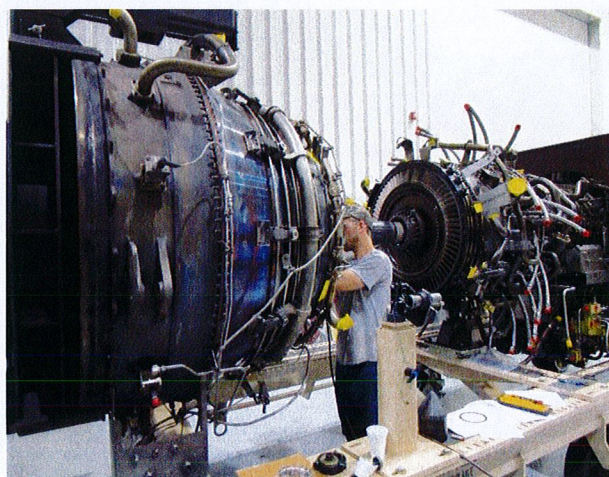
LPT Photos:

- LPT in Serviceable Condition

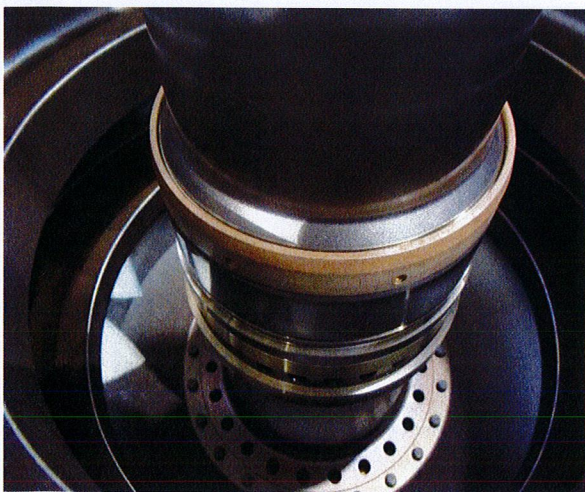
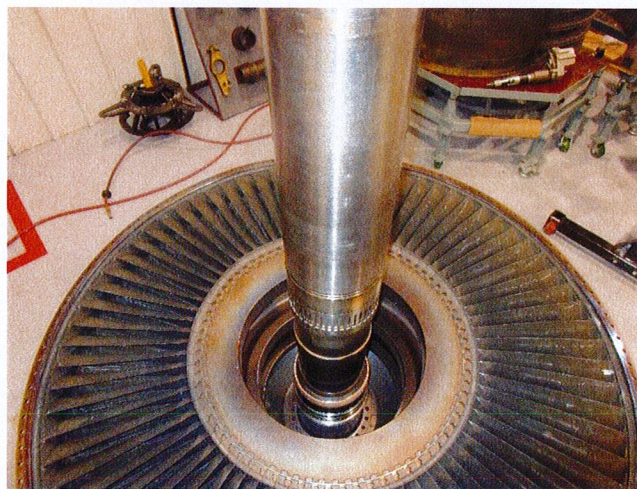
TRF Photos:

- 6R/7R Bearing found to be in serviceable condition. No deficiencies noted
- Balance piston seals in serviceable condition. No deficiencies noted
