**Written and Photographic Documentation
of the
Hopmeadow Street Tobacco Sheds
1503 Hopmeadow Street
Simsbury, Connecticut**

**GLN Construction Management, Inc.
March 2011**

**Bruce Clouette, Ph.D.
Archaeological and Historical Services, Inc.
Storrs, Connecticut**

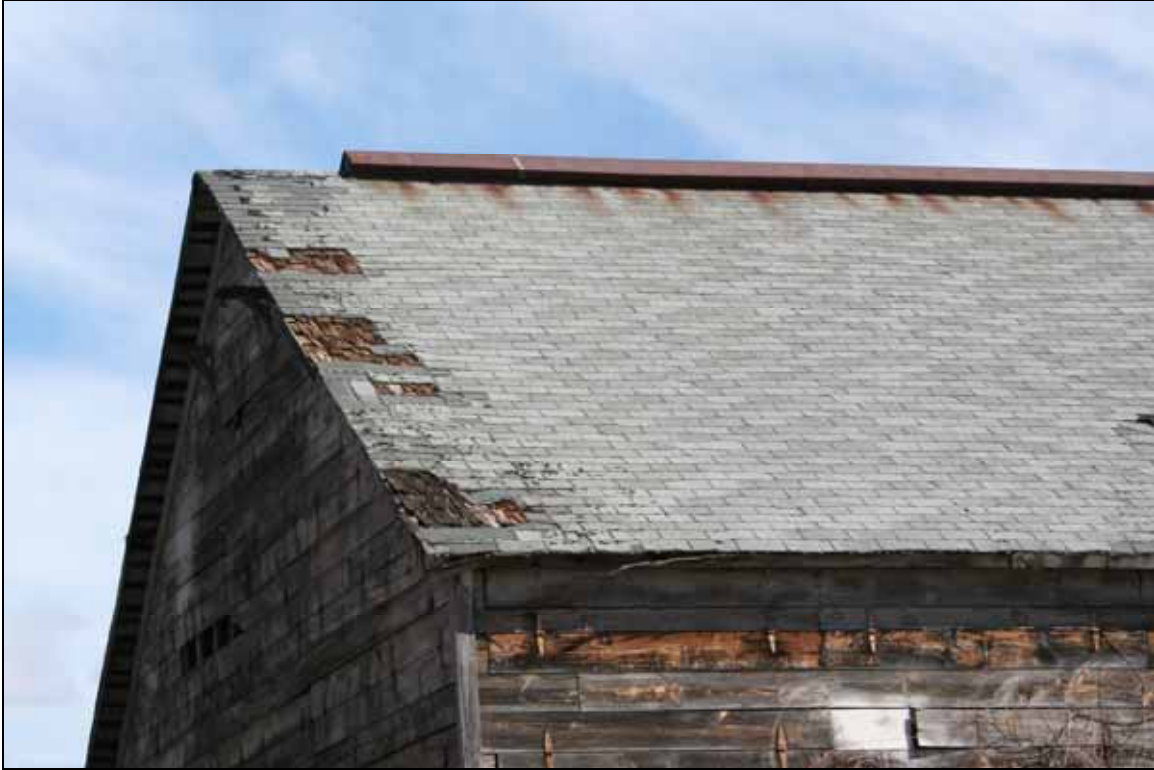
Roofs are now covered with asphalt shingles; where there has been damage, the original wood-shingle roof is visible underneath. A peaked sheet-metal ventilator runs continuously along almost the entire length of the ridge. Rafter ends are exposed at the

Photograph 32: Detail of sheet-metal ridge ventilator and roof damage, showing wood shingles under current asphalt-shingle roof (No. 92, west elevation, camera facing east).

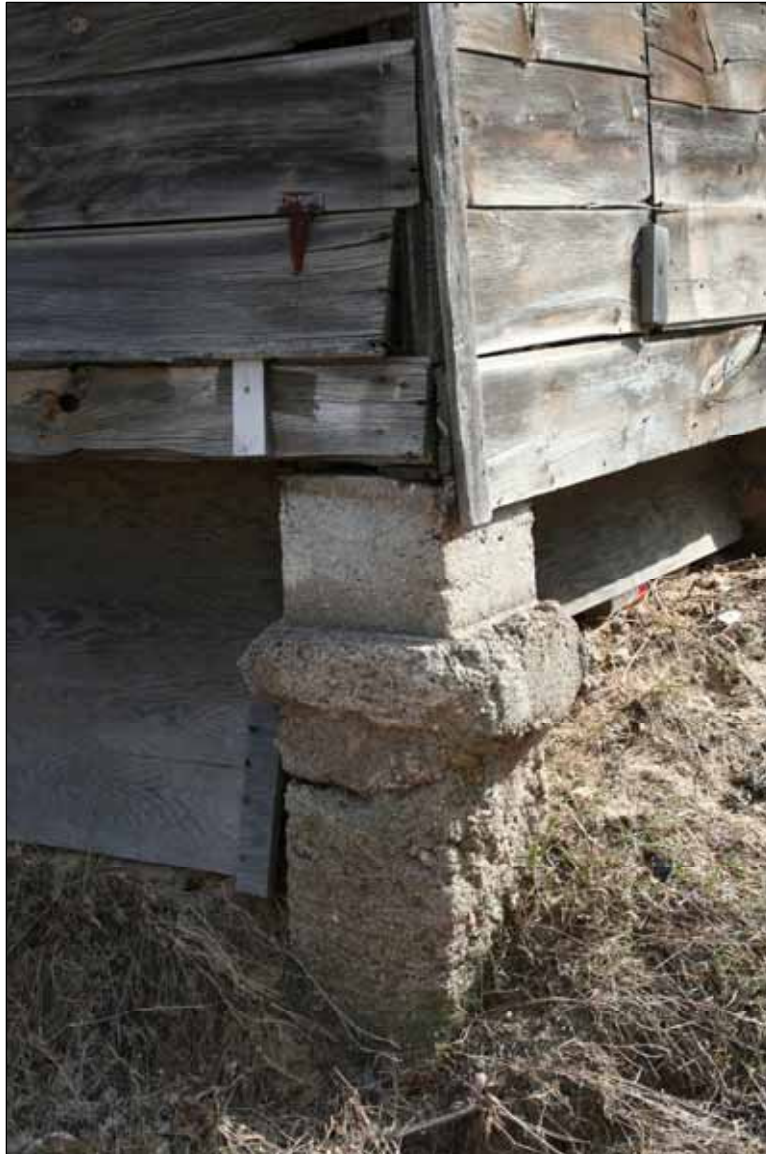
Photograph 34: Detail of eroded concrete foundation pier, showing lower portion, formerly embedded in the ground, exposed (No. 91, southwest corner, east elevation, camera facing northeast).

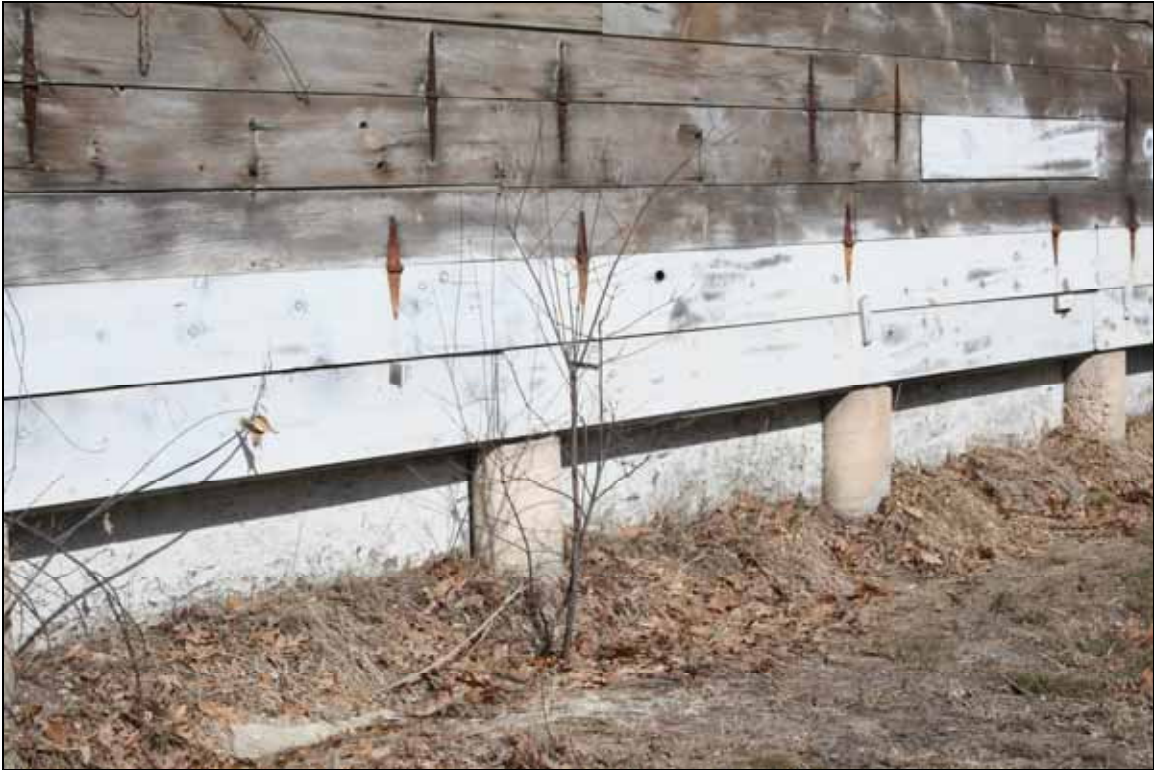
The sheds' sills rest upon poured-concrete piers, 12" by 12" by 10" high. Typically, construction of tobacco sheds of this period began with the preparation of a compacted-earth platform, into which footings for the foundation piers were excavated and then filled with concrete. Because of erosion, most of the pier footings are now exposed to a greater or lesser extent. A number of piers at the north end of No. 90 have been replaced by 12" round piers poured using cardboard-tube forms.

Photograph 35: **Detail of replaced foundation piers, north end of No. 90, east elevation, camera facing northwest.**

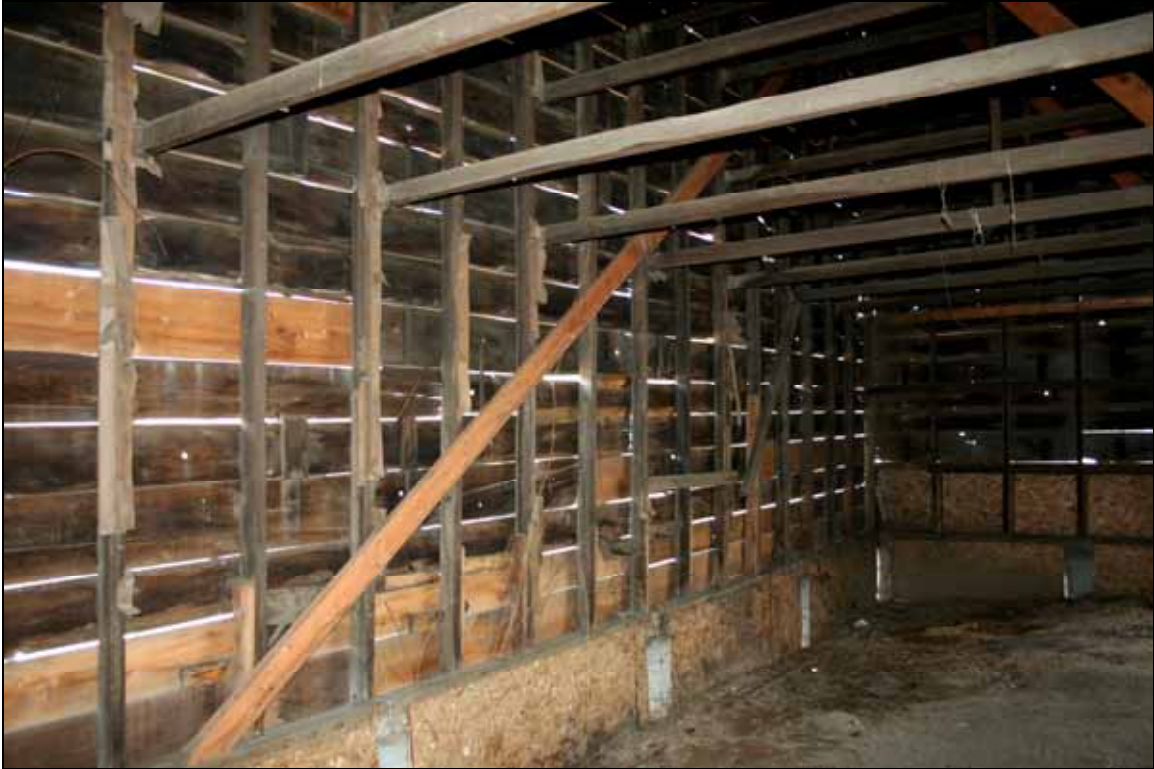
Differences in surface color and dimension indicate that many cross-members, particularly on the lower levels, have been replaced over time with more modern lumber. In addition, Shed No. 90 has modern 2 x 6 wind braces added at the corners to supplement the original wind bracing, and both No. 90 and No. 93 have additional modern 2 x 6 diagonal bracing running from the posts to the side walls. No mechanical or utility fixtures are in place, other than gas pipes along the sills for the heating system. The gas entered the sheds from the midpoint of the west elevation.

Photograph 41: **Detail of added side-wall wind brace, No. 90, northwest corner, camera facing northwest).**

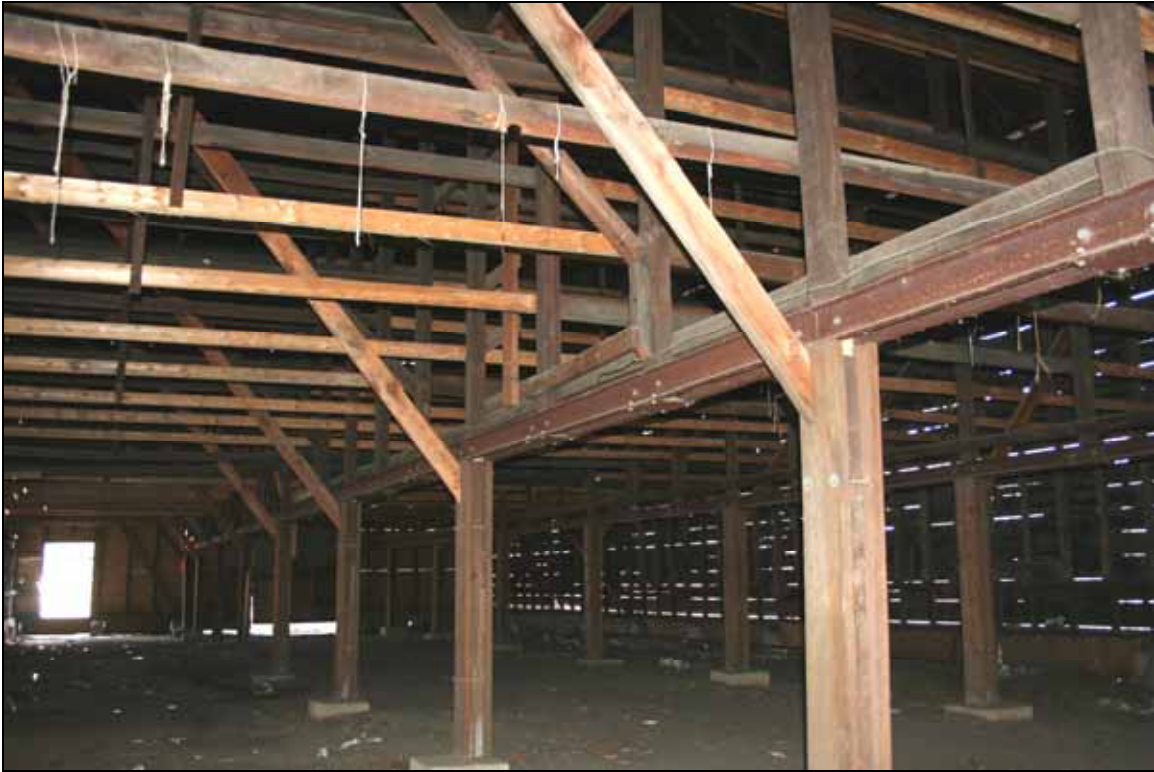
Photograph 42: Detail of added diagonals running from side walls to posts, No. 93, south end, west aisle, camera facing northeast. No. 90 also has this modification.
