Morgan Brook Watershed Based Plan

Barkhamsted, New Hartford and Winchester, CT
August, 2012

Prepared by the
Northwest Conservation District
www.conservect.org/northwest

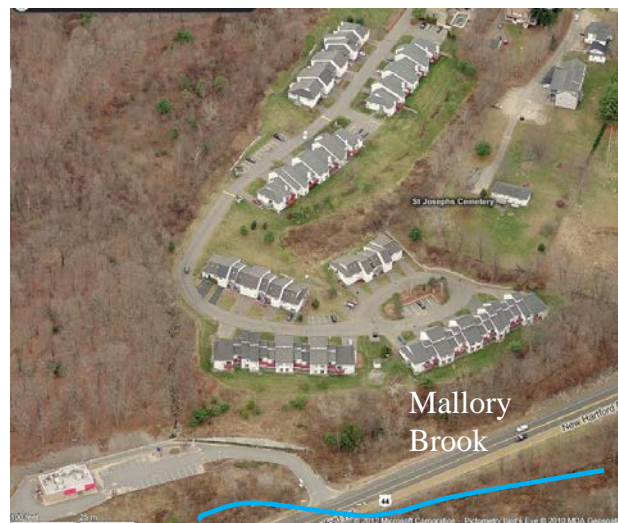
Fig- 3 Green Ridge Condominium and Former KFC Restaurant

Green Ridge Condominiums and the former KFC Restaurant (Winchester) - In this location, approximately 2 acres of impervious surface drains directly to Mallory Brook via a rip-rap channel with no visible control technology at the outlet (Figure 3).

Given the space constraints, there are a limited choice of stormwater management retrofits that would be effective in this developed area. Stormwater management strategies could be dispersed throughout the development to cumulatively renovate stormwater so that end of pipe discharges would have reduced pollutant loads.

Stormwater management practices appropriate for use throughout the condominium development and KFC include underground sand filters, infiltration trenches and bioretention areas. These measures are commonly used when space is limited.

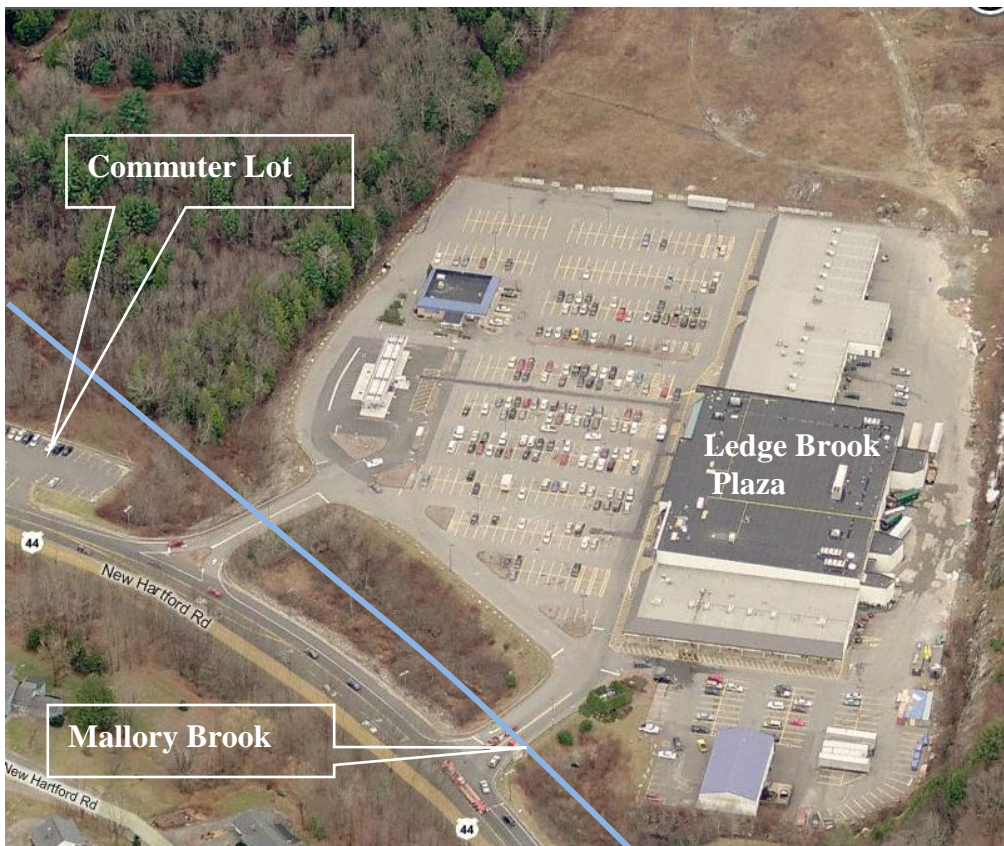
Figure 4 – Ledge Brook Plaza and State Commuter Parking Lot

Ledgebrook Plaza (Winchester) - Ledgebrook Plaza contains approximately 11.4 acres of contiguous impervious surfaces that drain directly to Mallory Brook (Figure 4). Currently there is no stormwater quality or quantity management of runoff from this area. The health of Mallory Brook – and subsequently Morgan Brook - would benefit greatly if runoff from this commercial development were routed through a properly sized gravel wetland or extended detention wetland.

State Commuter Parking Lot (Barkhamsted) - The State Commuter Parking Lot adjacent to Ledgebrook Plaza is almost 1 acre of pavement with no stormwater management measures (Figure 4). A simple bioretention measure or infiltration trench structure would help protect the water quality in Mallory Brook.

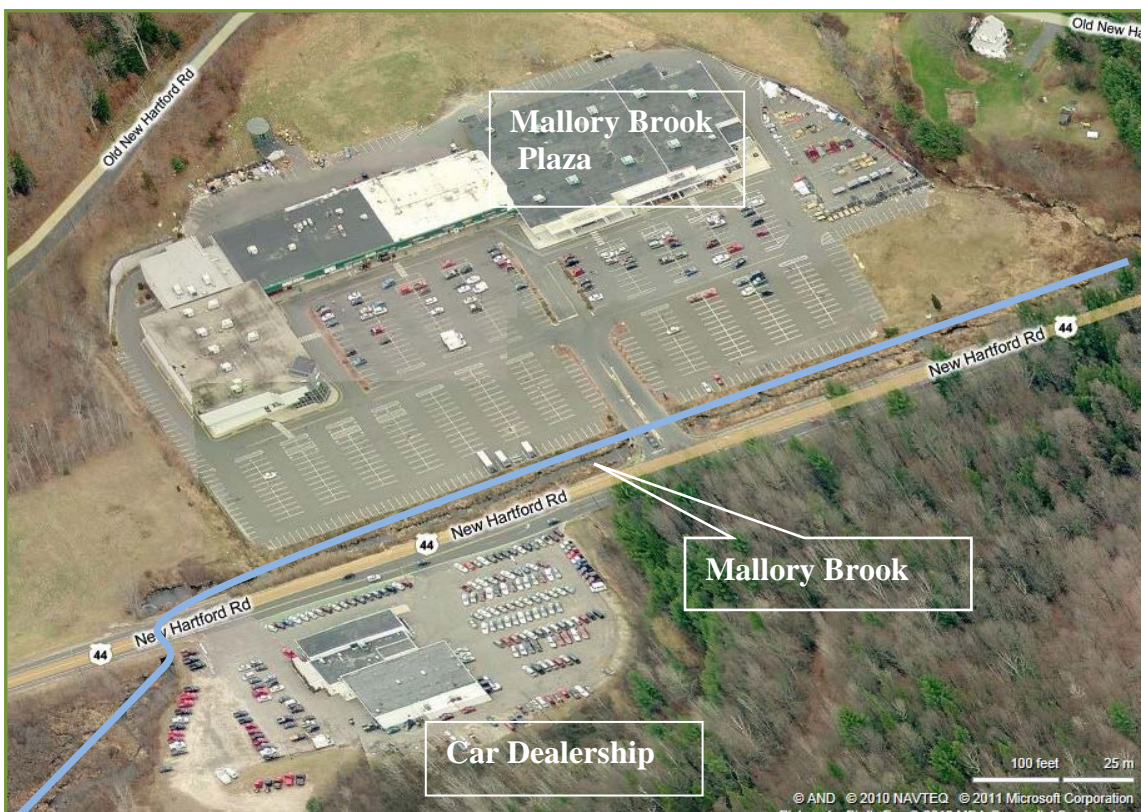
Figure 5 Commercial Development and Car Dealership

Mallory Brook Plaza (Barkhamsted) - Mallory Brook Plaza on Route 44 contains approximately 11.6 acres of contiguous impervious surfaces that drain directly to Mallory Brook (Figure 5). Currently there is no stormwater quality or quantity management in this area. It is recommended that runoff from this commercial development be routed through a properly sized gravel wetland or extended detention wetland. However, it may be necessary to use the combination of a smaller sized gravel wetland and extended detention wetland in a treatment train, given the extremely flat nature of the site.

In addition, the stream has been ditched between the Mallory Brook Plaza parking area and Route 44. Water quality would be improved if this portion of Mallory Brook could be returned to a more naturalized channel with meanders, pools and riffles. The ability for a stream to buffer against pollutant loading is greatly reduced when a stream is not allowed a more natural morphology. In other words, streams with a series of natural meanders pools and riffles, creating a diverse habitat for plants and animals, is better equipped to handle and renovate pollutant loads. Restoring stream morphology is an important retrofit consideration for this area.

Car Dealership (Barkhamsted) - A car dealership on the south side of Route 44 roughly opposite the Mallory Brook Plaza has 4 acres of contiguous impervious surfaces that drain directly to Mallory Brook (Figure 5). Stormwater quality management structure(s) are needed to treat stormwater runoff from the parking area and roof. Treatment systems could include a bio retention area, sand filter and perimeter bioswale. To minimize pollutants loads from generalized sheetflow, a filter strip should be combined with reestablishment of a riparian buffer.

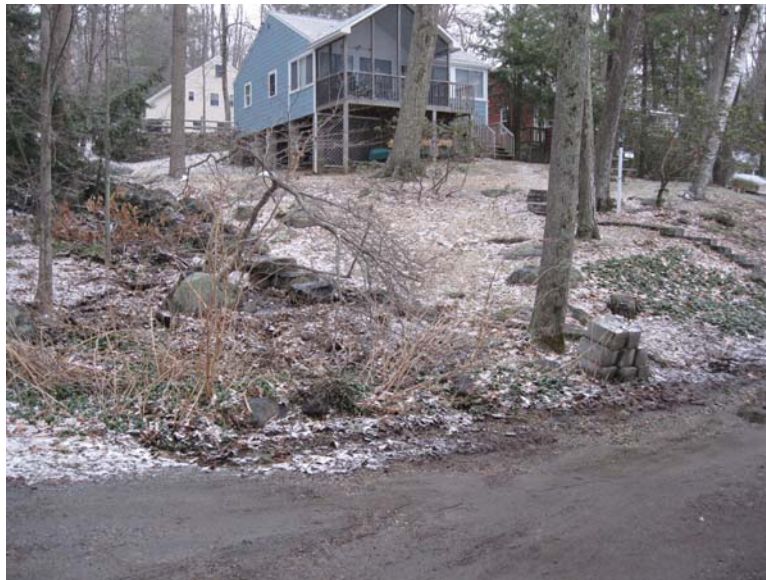
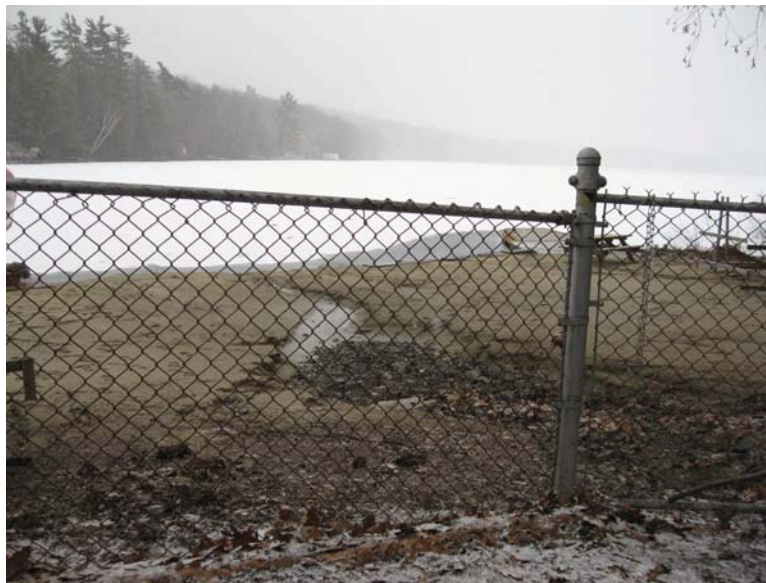
LAKE IMPACT ASSESSMENT: Moderate (2)

Inadequate sized CB on west side of road typically plugged or covered with leaves, overflow puddles in road and then erodes LAPOA beach.

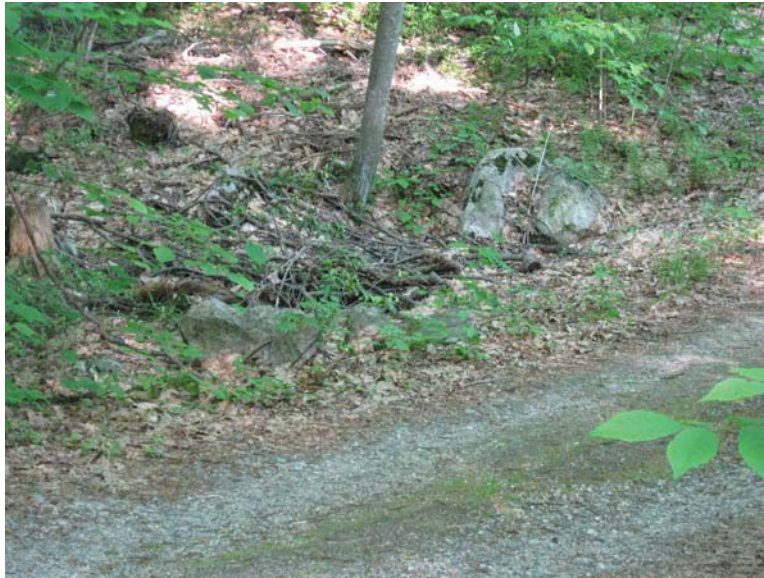
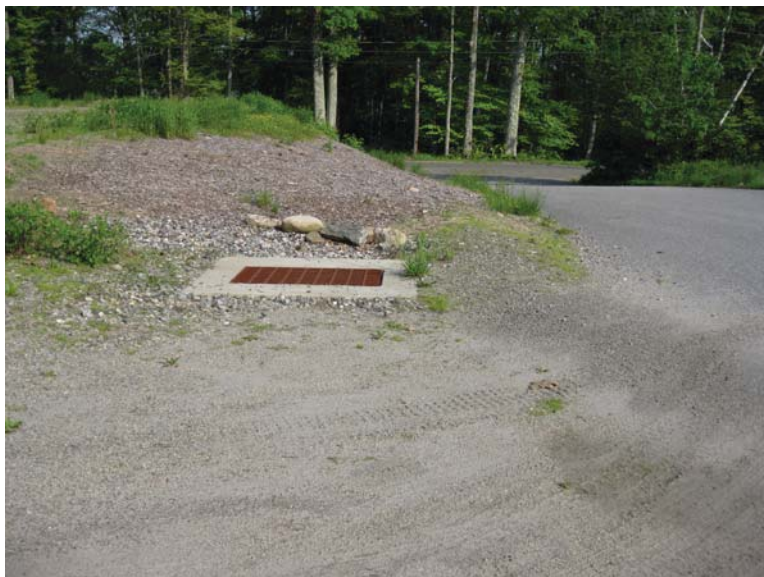
- A. Drainage from East side of road, crosses under several private drives and is used for deposition of landscape debris.
- B. Drainage from playing fields/parking area on west side of road is collected in CB's and piped to rock lined outlet area with level spreader.

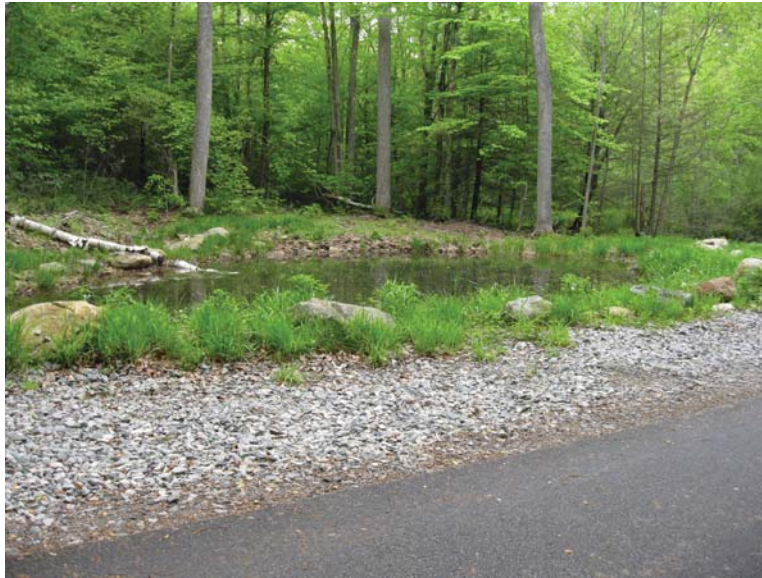
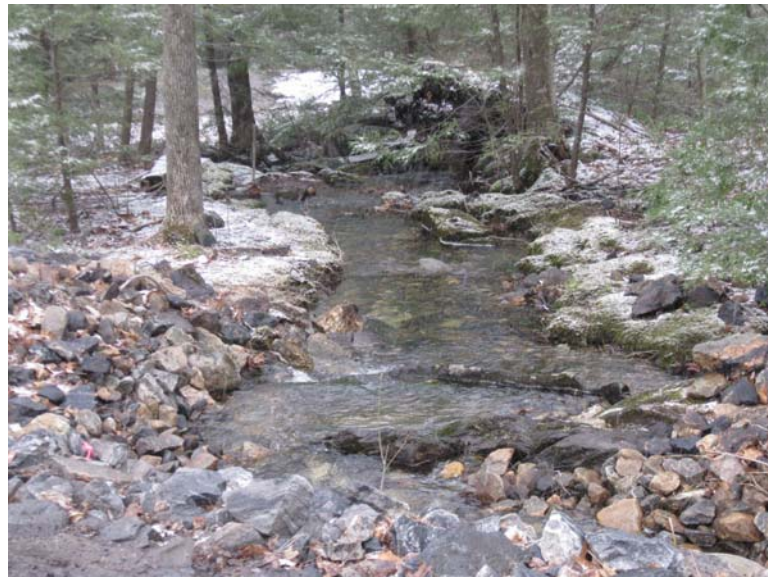
INFLOW 4

DRAINAGE AREA: 151.5 Ac.
LAKE IMPACT ASSESSMENT: High (1)

The road was recently regraded and repaved to reduce roadside erosion and a settling pond for road runoff was created. A rock dam created to maintain a water levels in a large undeveloped wetland acts as a metering device to attenuate outflows and reduce erosion of banks below (east) of the road. Road regrading and paving appears to have significantly reduced erosion and sediment loads from road shoulders.

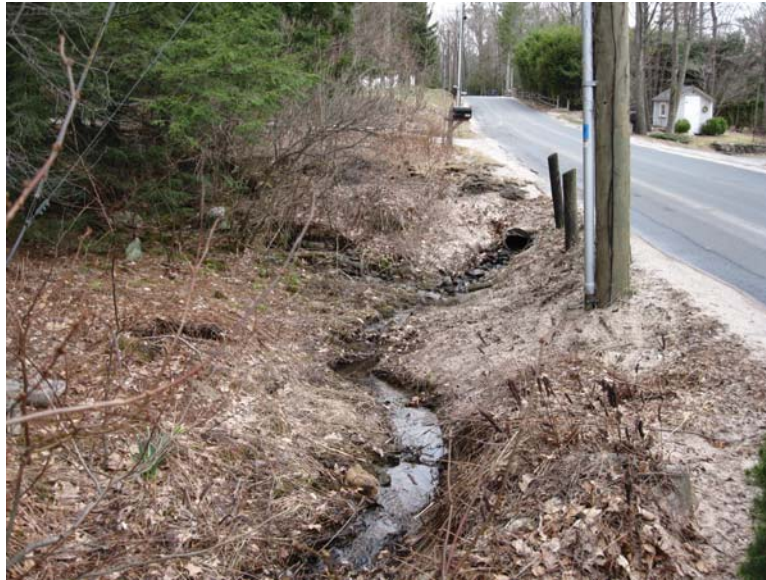
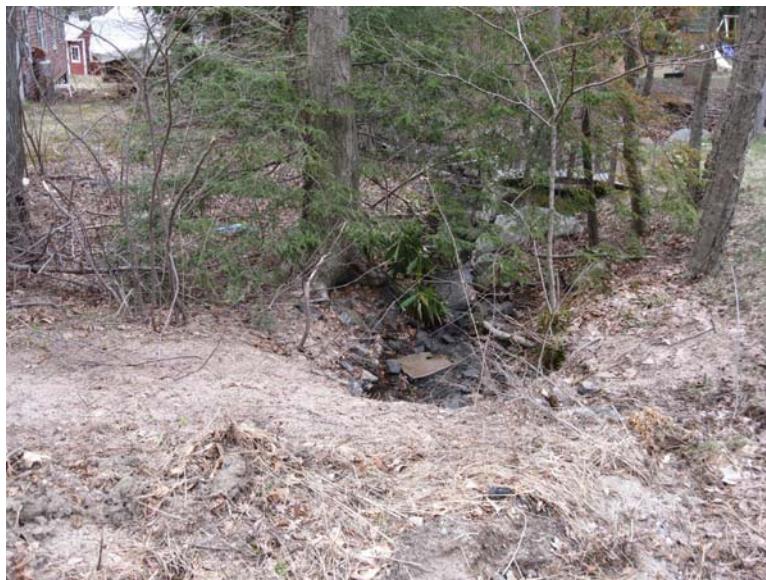
LAKE IMPACT ASSESSMENT: High (1)

Roadside drainage through a Catch Basin (4) system into a wetland area on south side of West Hill Rd and then culverted under the road to an open drainage to pond. End of brook is full of sediment and during high flows material is eroded into pond

Install deep sump (2-ft min) CB's. Regrade and vegetate roadside area to reduce exposed soil. Create roadside sediment basin for yearly cleaning. If unable to create sediment basin (property rights or wetland issues) then install a large particle separator (equivalent of a septic tank) alongside or under road. Amour or maintain vegetated roadside discharge points. Remove accumulated sediment adjacent to pond to prevent ponding of storm flows and erosion into lake.

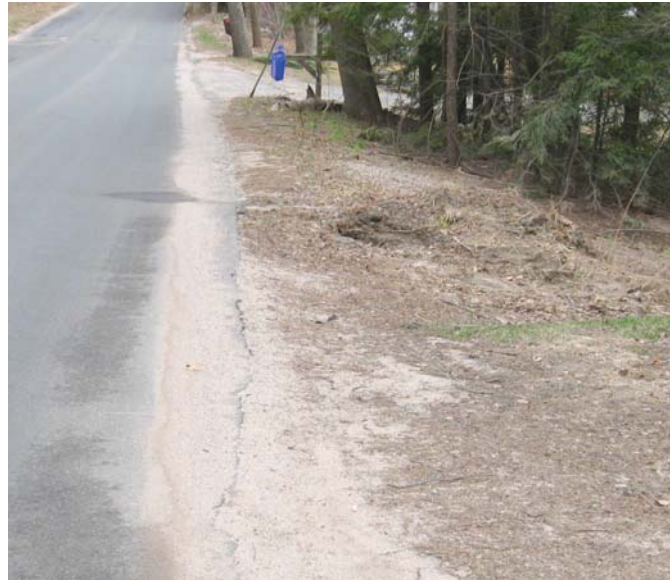
Amour roadside discharge point

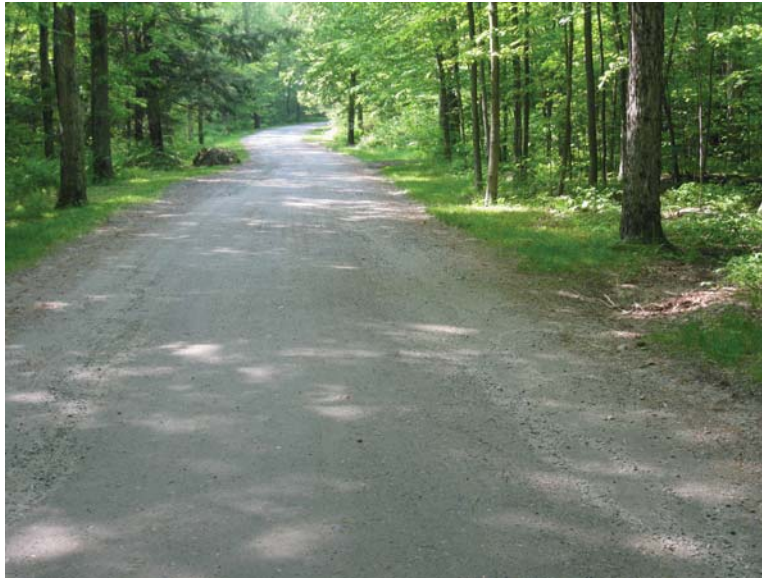
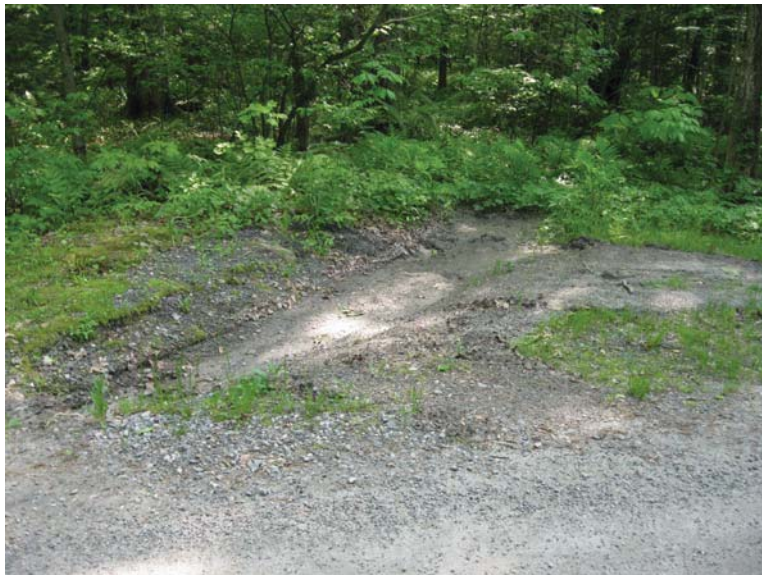
Drainage from the Brodie Park area, and an access road to the Town Beach and then through wetlands to the lake. The road has multiple discharge points which fill up with eroded road surface material. Outfall has deposits of sand covered with weedy/rush growth. Deposition can be eroded into pond during high flow events. The Beach area has a fine, silty sand which is easily eroded and drainage from parking area is directed over beach area.

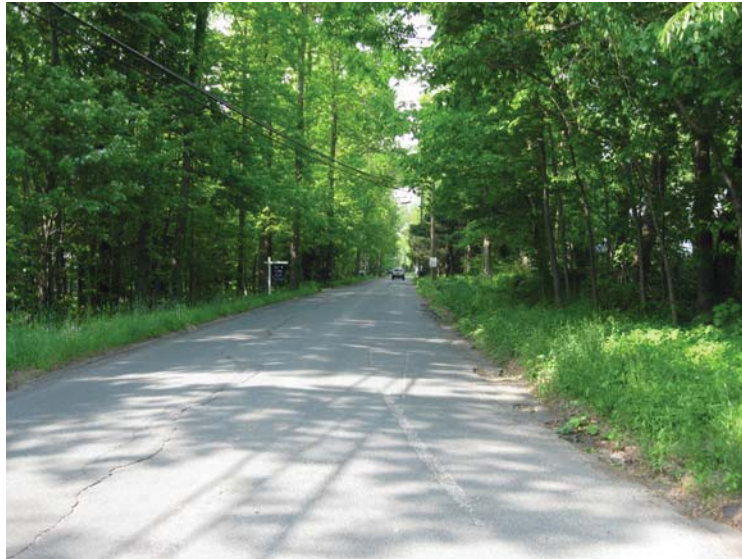
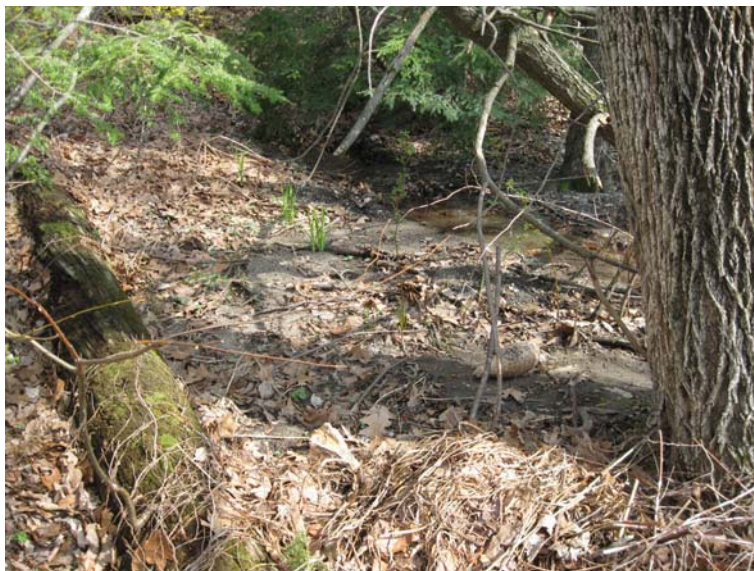
Multiple diagonal swales from upland area and roadside runoff enter a wetland area with no distinct outfall to lake. Some of the swales have areas of exposed or disturbed soil due to recent driveway construction. There are currently 9 catch basins along Niles Road. Drainage paths adjacent to Niles road are filled with road sand.

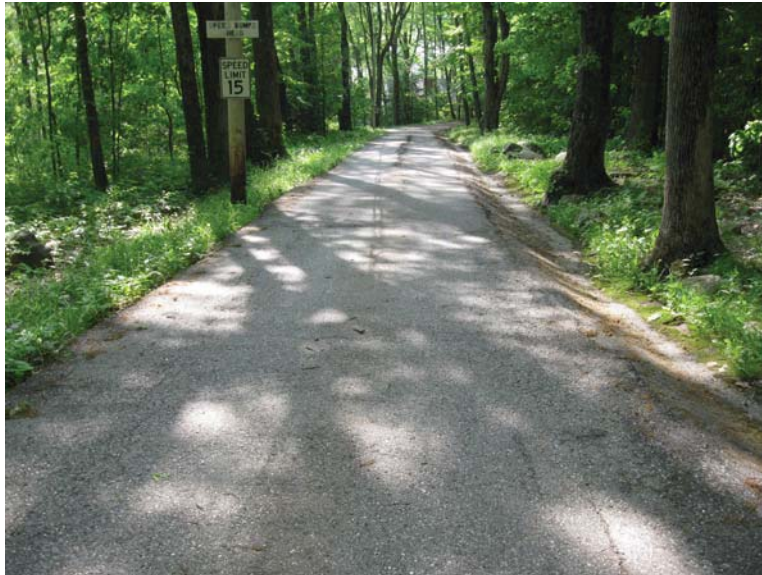
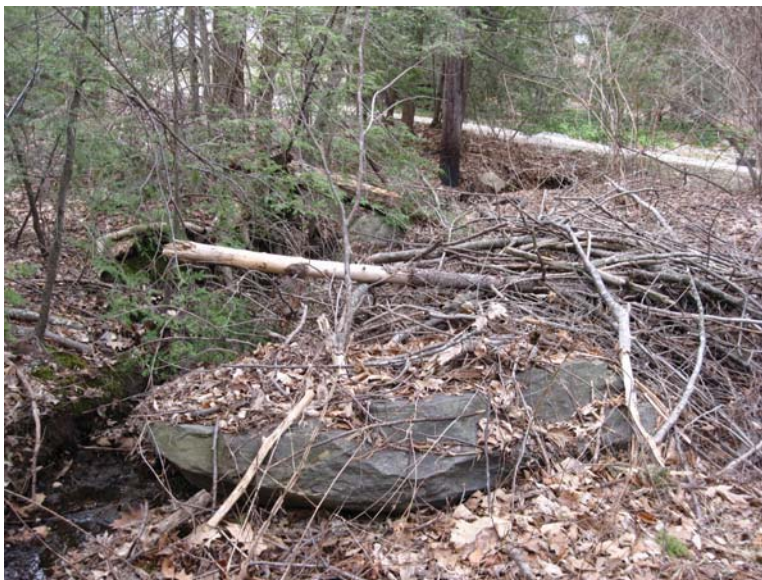
Paved access way with paved roadside swale and a very steep eroding channel at north end of development.

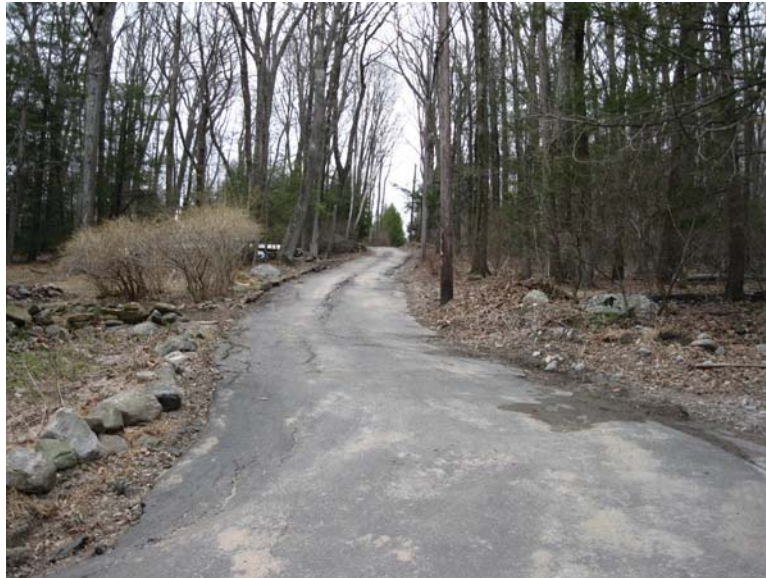
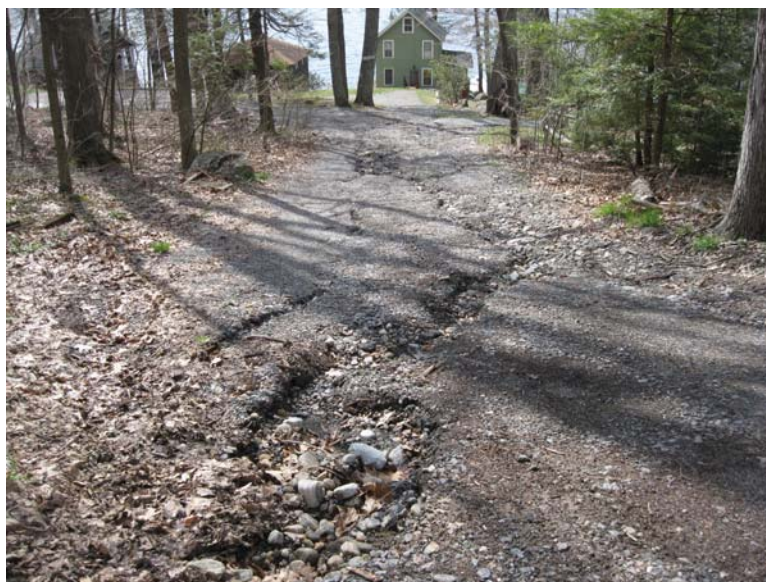
A paved road with roadside erosion and poorly maintained drainage paths. The lower portion of the access way is steep gravel with no drainage control.

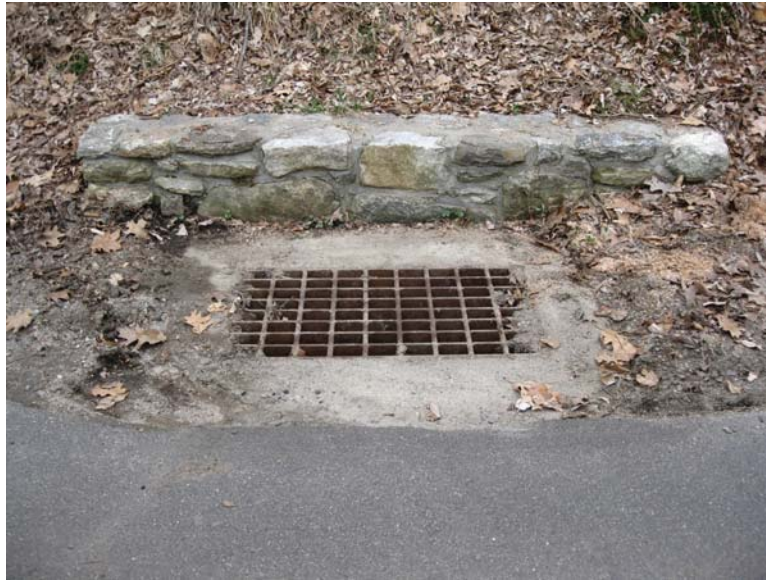
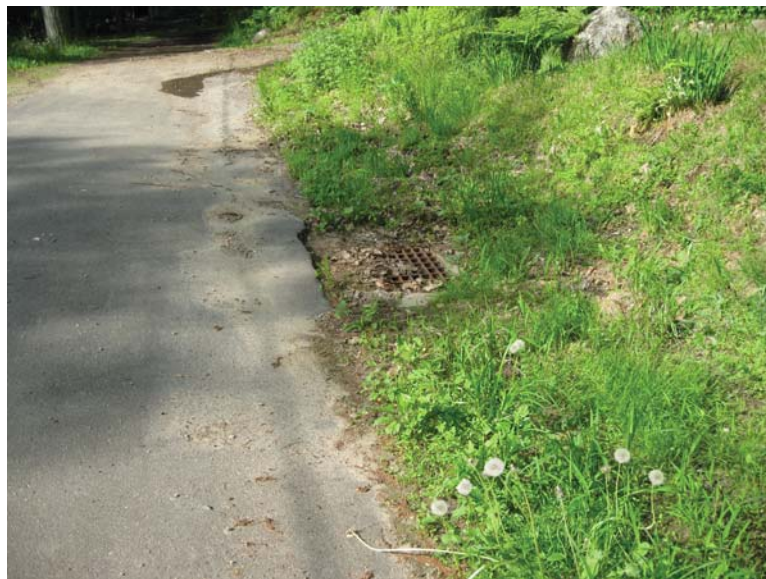
Residential area with light to moderated development, previously installed sediment catch basin that has not been maintained. Roadway appears to stay wet from hillside seepage.

Clean and maintain existing sediment catch basins or install deep sump basins
Regrade road to drain to roadside swale and existing CB.

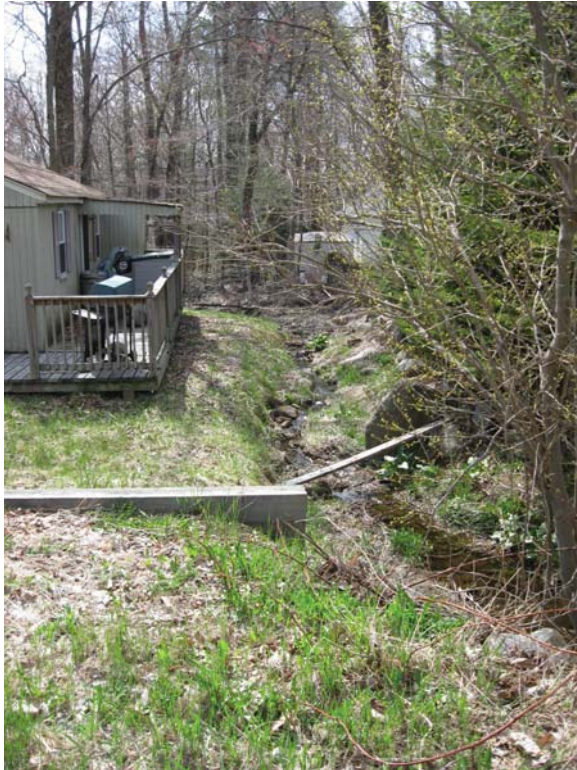
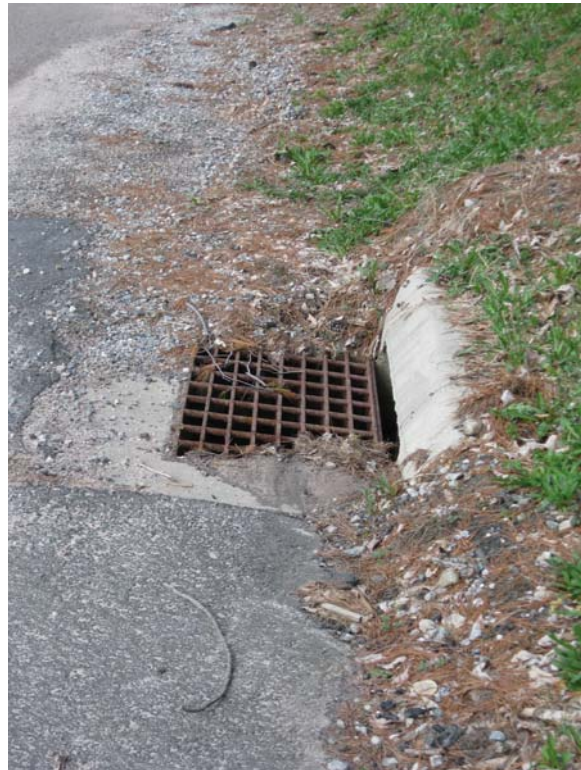
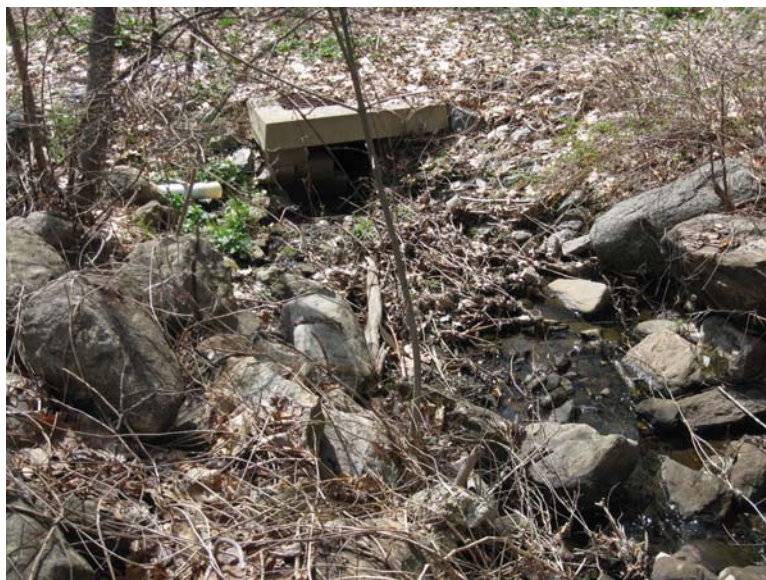
INFLOW 14

LAKE IMPACT ASSESSMENT: High (1)

Drainage is from a relatively densely developed residential area through a system of culverts and open channels. Most of the roads are gravel with poor shoulder drainage, allowing storm flows to erode roadway. Lower portion of the channel is blocked by debris, and has actively eroding areas.

Install deep sump catch basins or large particle separators Create roadside grassed channels or armor shoulders with 2-in stone. Remove debris and stabilize exposed channel banks

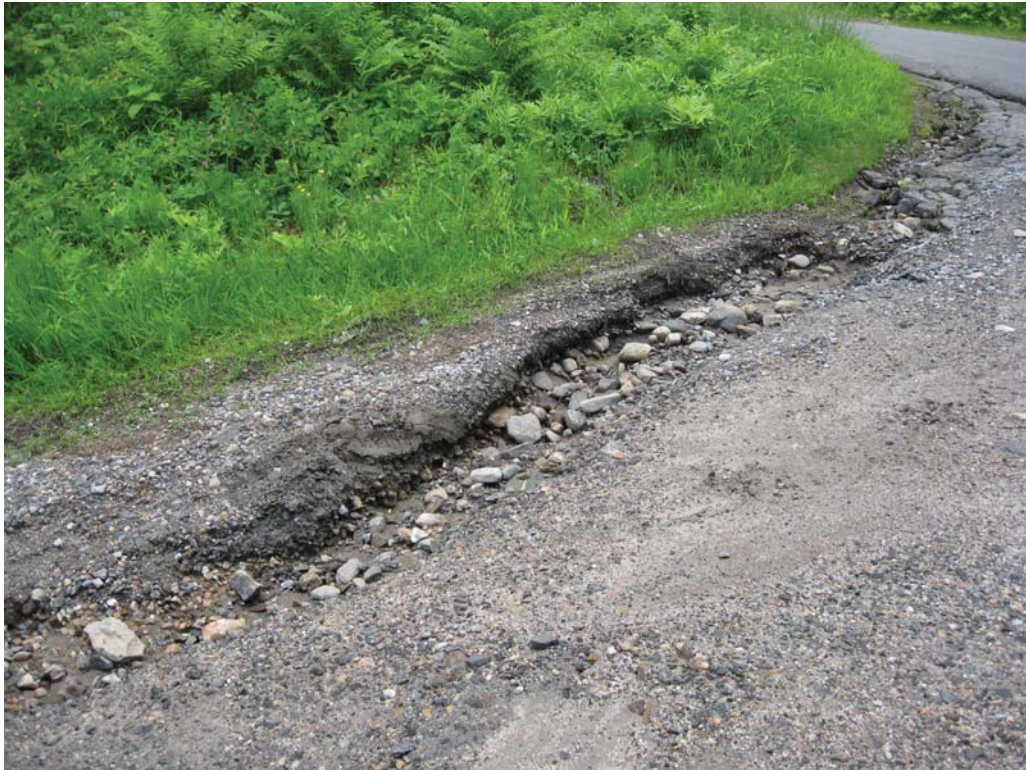
Eroded Shoulders - Install shoulder armor or create grassed swales.

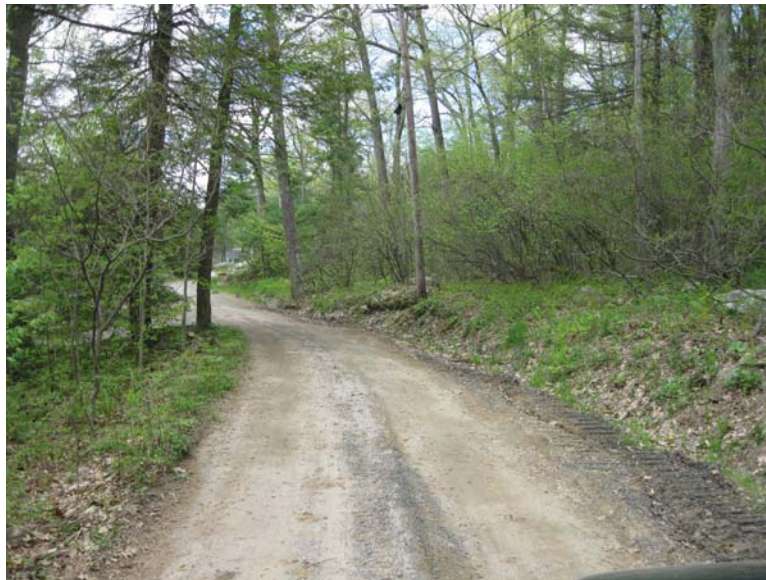
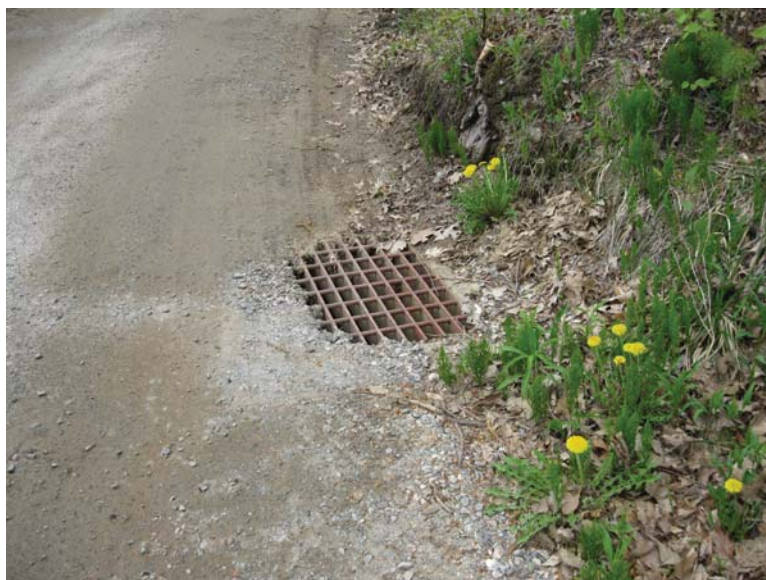
Gravel access way with eroding roadside swale, culverted under access way and discharges to an open ditch alongside cottage. Large impervious paved area from former parking area.

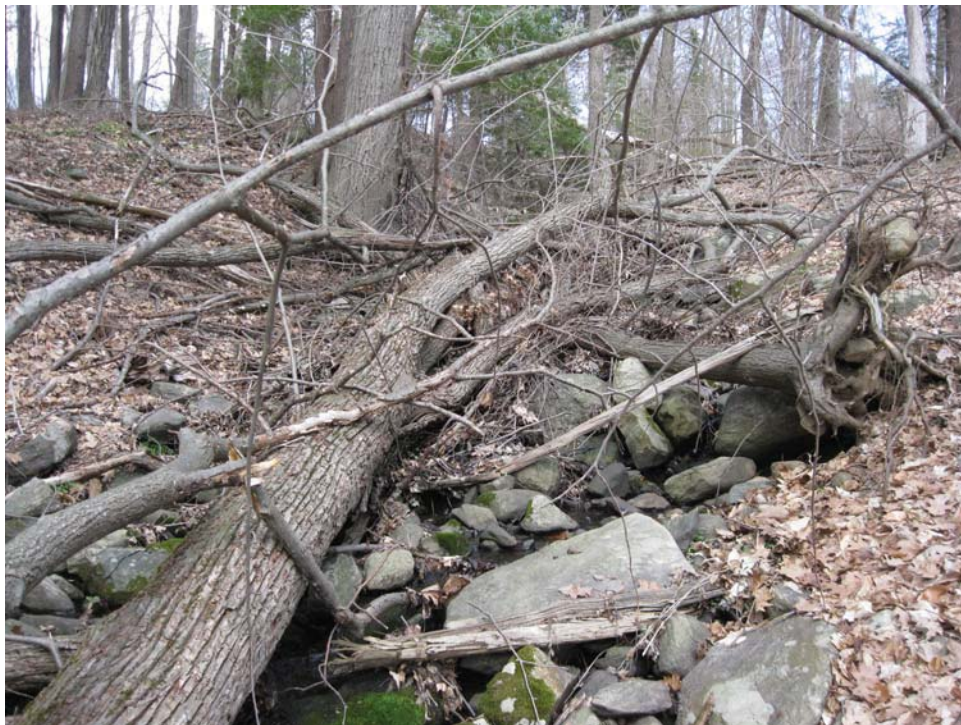
Allowing drainage channel to remain blocked by debris, creates dams and forces storm flows to create new paths, eroding material in the process

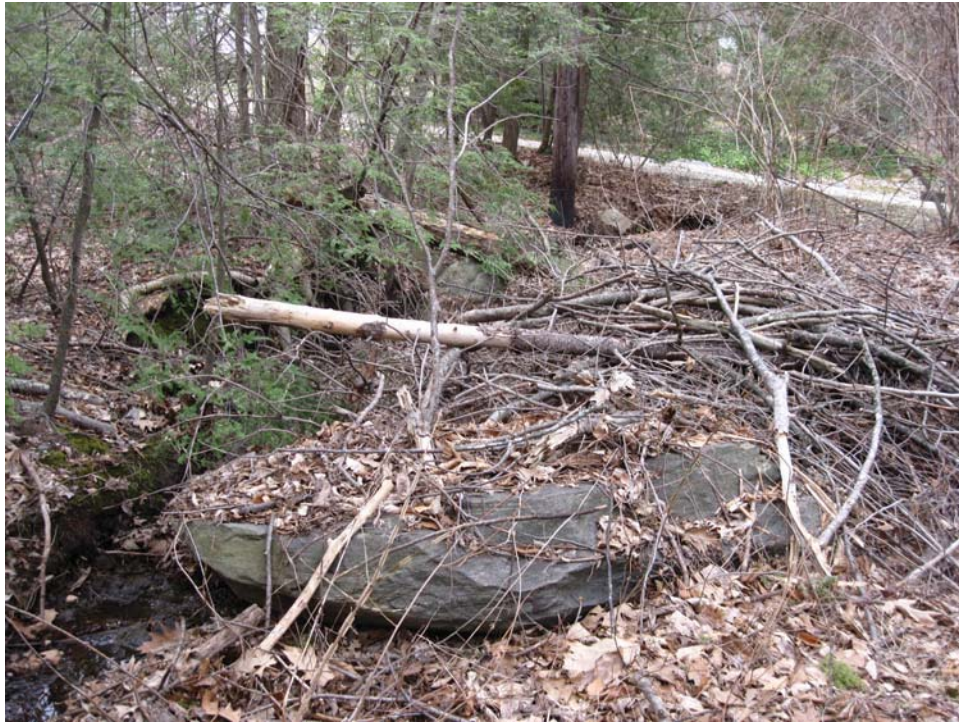
Disposal of landscaping wastes in drainage paths

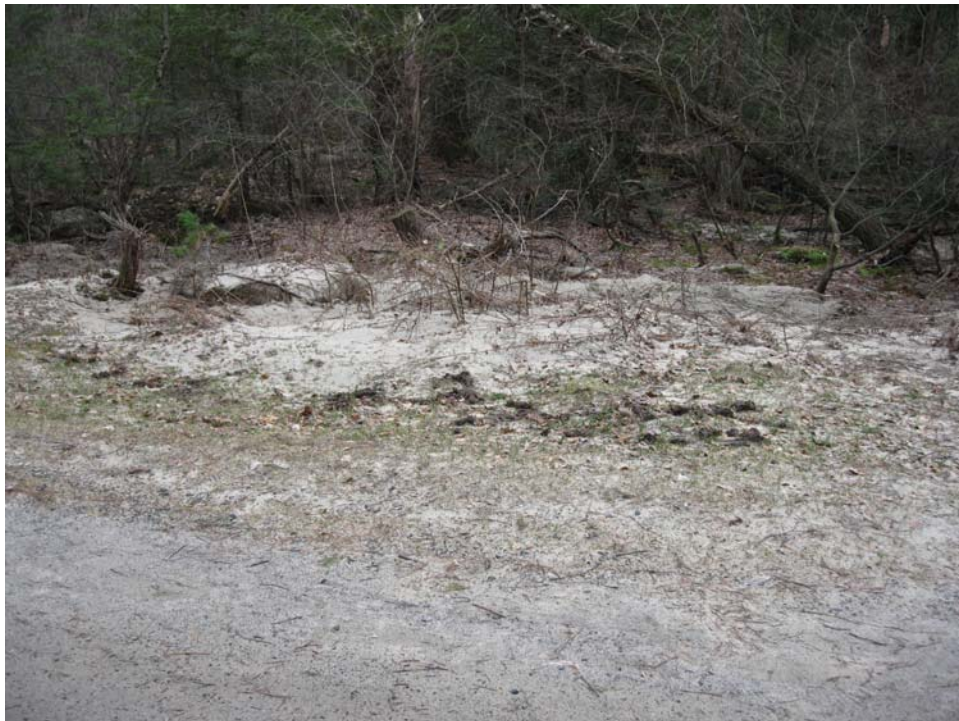
Wrong gradation of beach sand, allows erosion by both wind & water

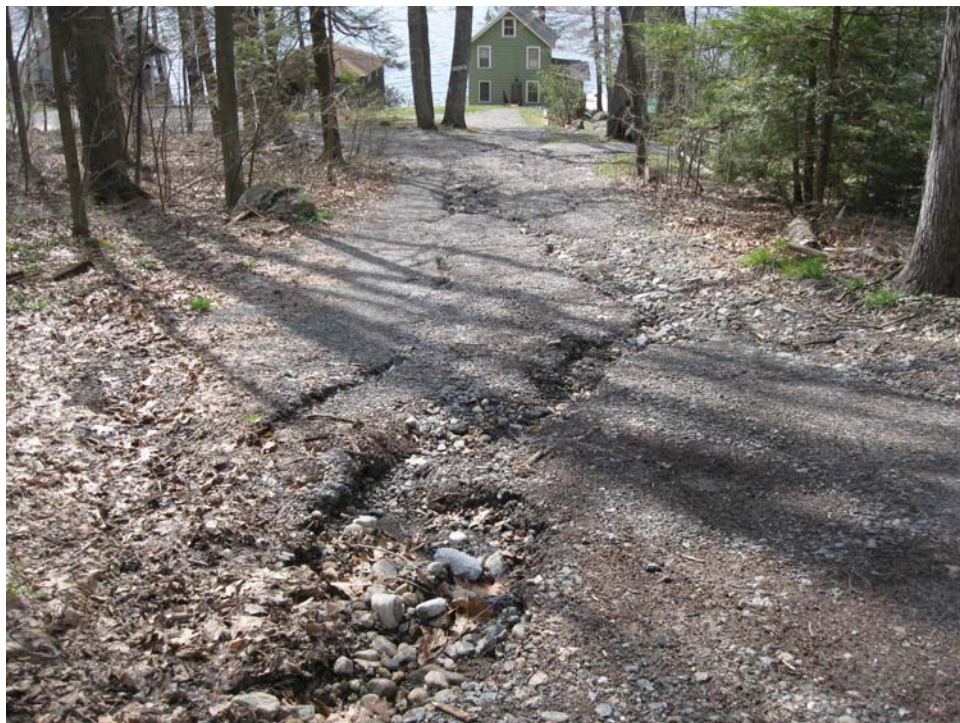
Improper grading and maintenance of drives and roads
