Tankerhoosen River Watershed Management Plan

**Friends of the Hockanum River
Linear Park of Vernon, Inc.**

March 2009

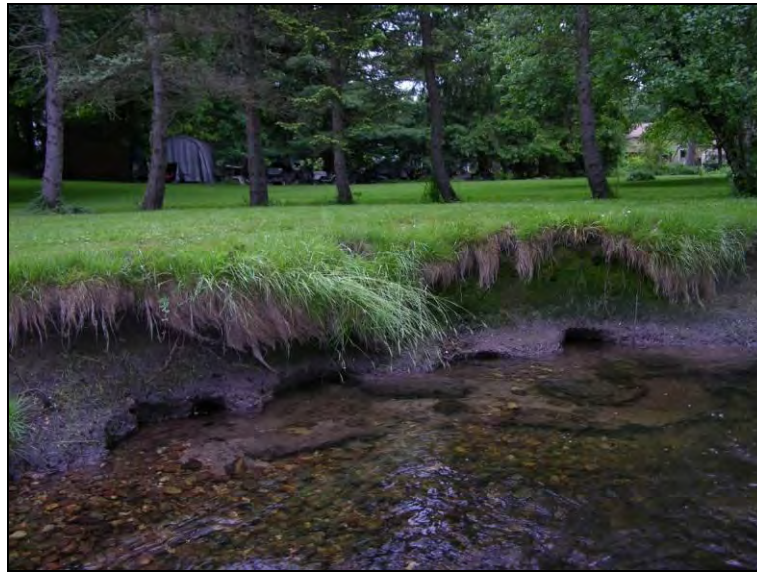
vegetation and habitat and moderate floodplain encroachment. The dominant in-stream substrate is gravel and cobble, and 50 percent of the stream surface is shaded.

Stream segment MRT-01 has areas with little or no vegetative buffer.

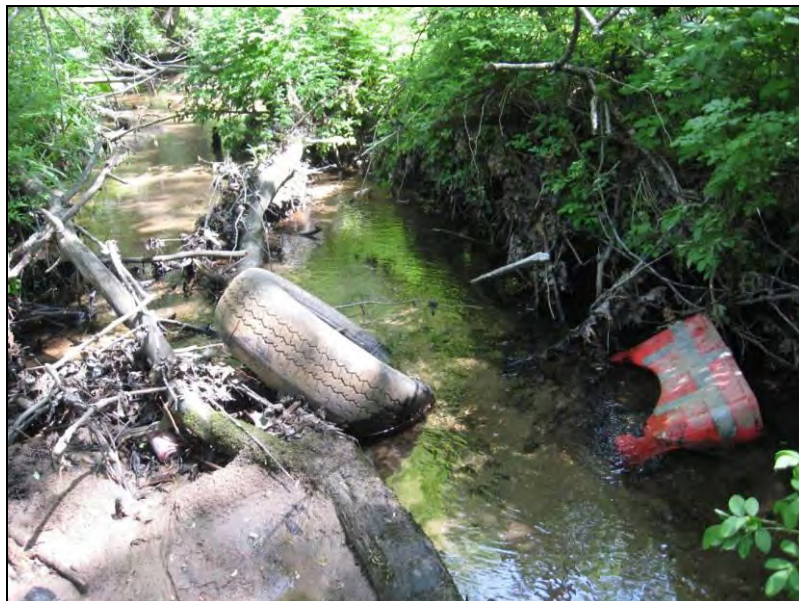
- RCH - The stream is mostly shaded with some evidence of sediment deposition. In-stream habitat was marginal, with other in-stream metrics ranging from suboptimal to optimal. The reach includes a high-quality buffer and good floodplain connection, with associated metrics ranging from suboptimal to optimal.
- TR - A small quantity of automotive debris was observed and should be removed. Access is difficult, although cleanup would be straightforward.

Trash and debris in stream segment GB-02

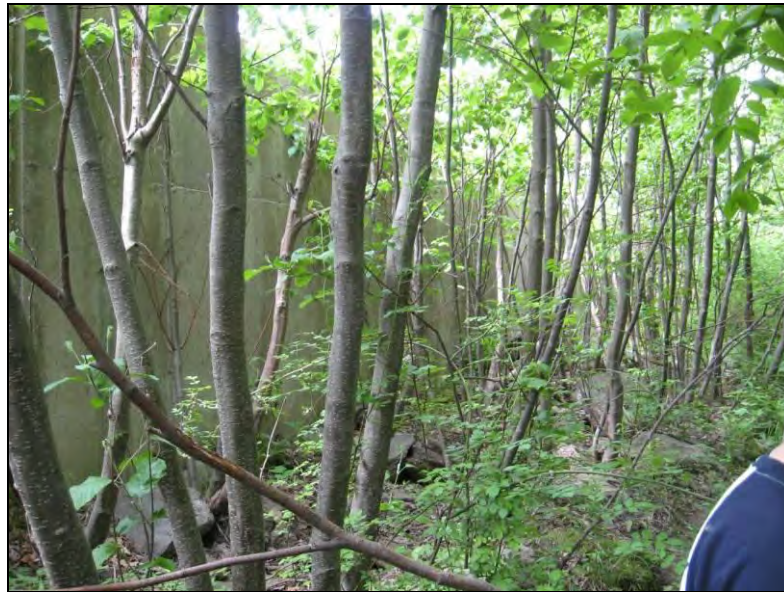
- IB – The majority of the stream reach has limited and highly impacted stream buffers. At the downstream end of the reach, a retaining wall is located along the top of the right bank, and industrial parking lots are located close to the left bank. Due to the limited area on both sides of the stream, there is low potential for stream restoration along this reach.

Concrete retaining wall adjacent to Gerber Drive along segment GB-03B

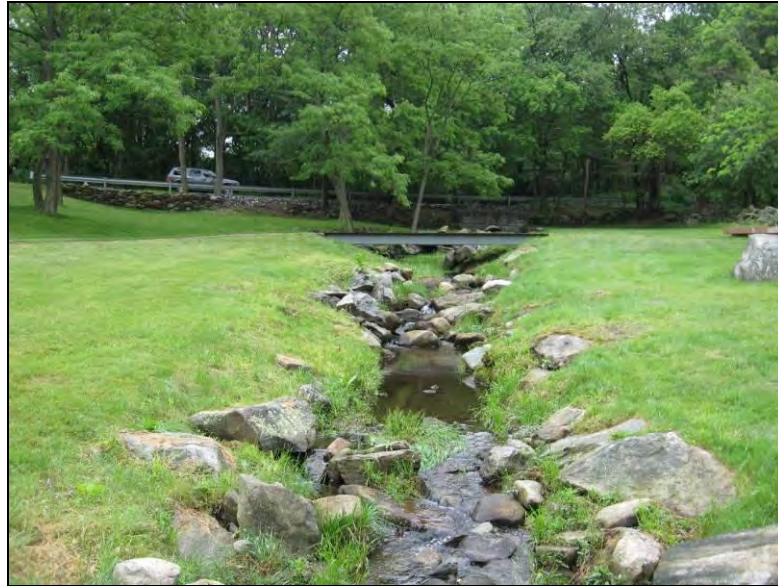
Stream segment GB-05B showing limited vegetative buffer and a small footbridge crossing the stream.

- IB – Little or no vegetative buffer exists along the stream through the commercial/office building site. Mowed lawn borders much of the stream on both sides, and several footbridges have been constructed over the stream. This stream segment is a potential candidate for stream buffer restoration.

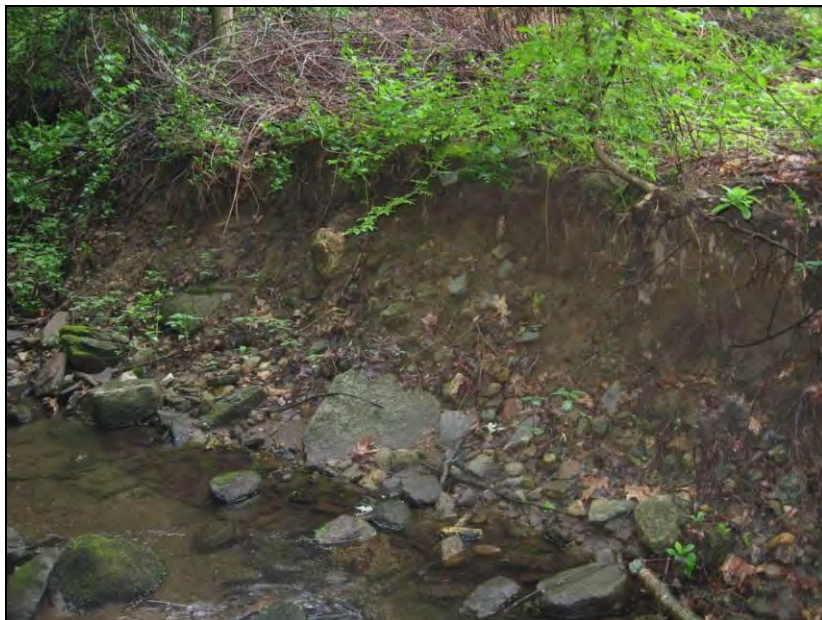
- ER - Numerous areas of significant erosion were identified along this stream segment. Three areas of bank scour on the outside banks of bends were observed. One area included a low-head concrete dam where the stream eroded the abutment, creating a bypass channel around the structure. The last area included active downcutting ending at a nick point behind several residences at the terminus of the reach. These areas are potential candidates for stream bank stabilization.

Stream segment GB-06 showing area of stream bank erosion.

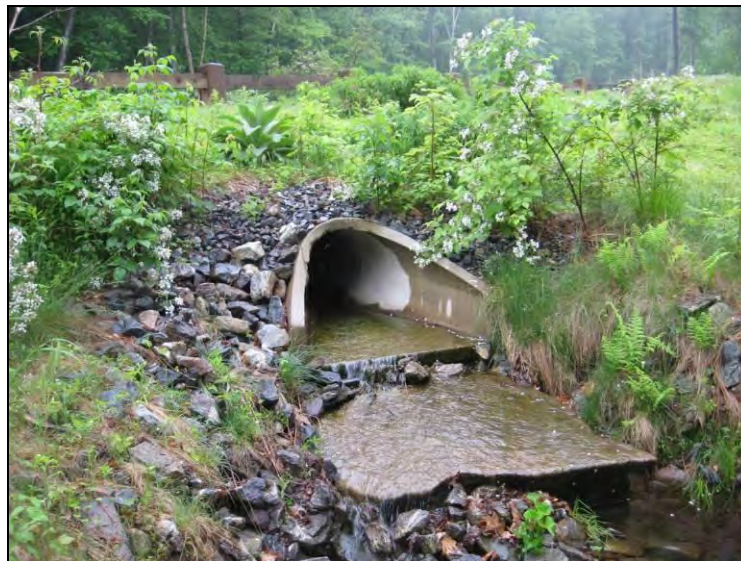
- SC - A new stream crossing was observed under the subdivision road, consisting of a 24-inch concrete pipe. A boulder was present below the flared-end outlet. The culvert outlet is perched several inches above the stream bed, and the depth of flow in the pipe was approximately 1-inch. Due to the headwater location of the culvert, upstream fish passage is unlikely to be an issue in this portion of the watershed.

New stream crossing on segment GB-10.

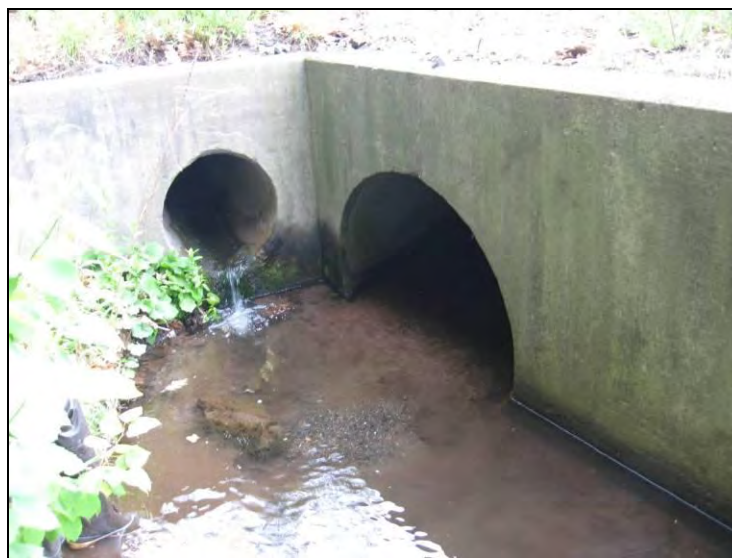
Stream crossing (SC-01) below I-84 and outfall (OT-03) along reach GBST-02.

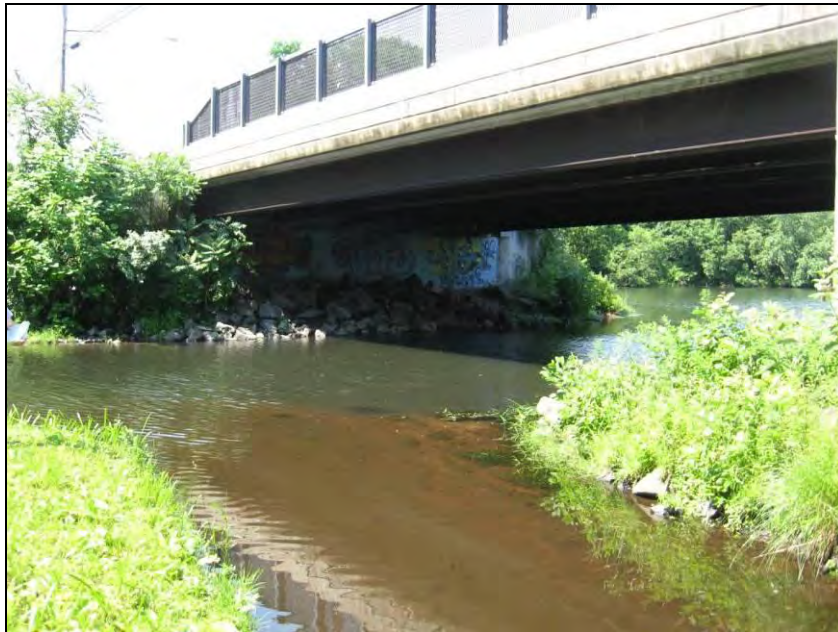
The left and right streambanks along the lower portion of Tucker Brook (foreground) at the confluence with the Tankerhoosen River (background) are potential candidates for reforestation.

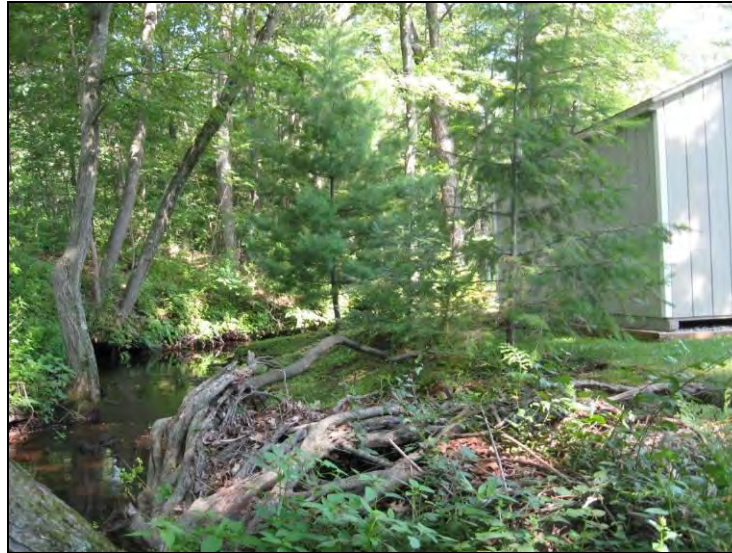
This section of river is abutted by residential properties along the right bank and has an impacted buffer on this side of the stream from lawn vegetation and items such as this shed.
