South Norwalk Electric and Water

Re: Non-Compliance Letter / Docket 431

TREE REMOVAL & SOIL REMEDIATION D & M Plan – Phase I

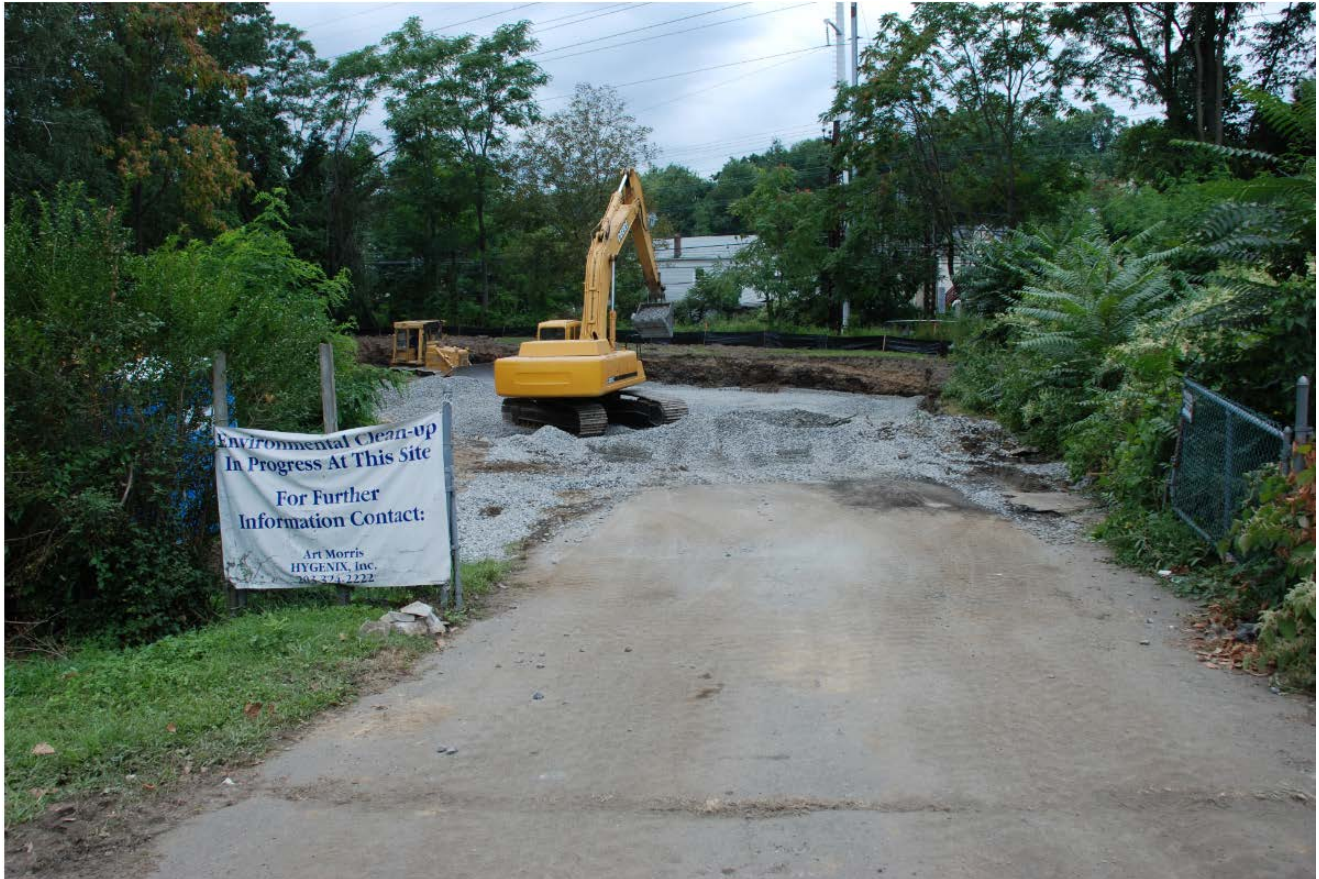
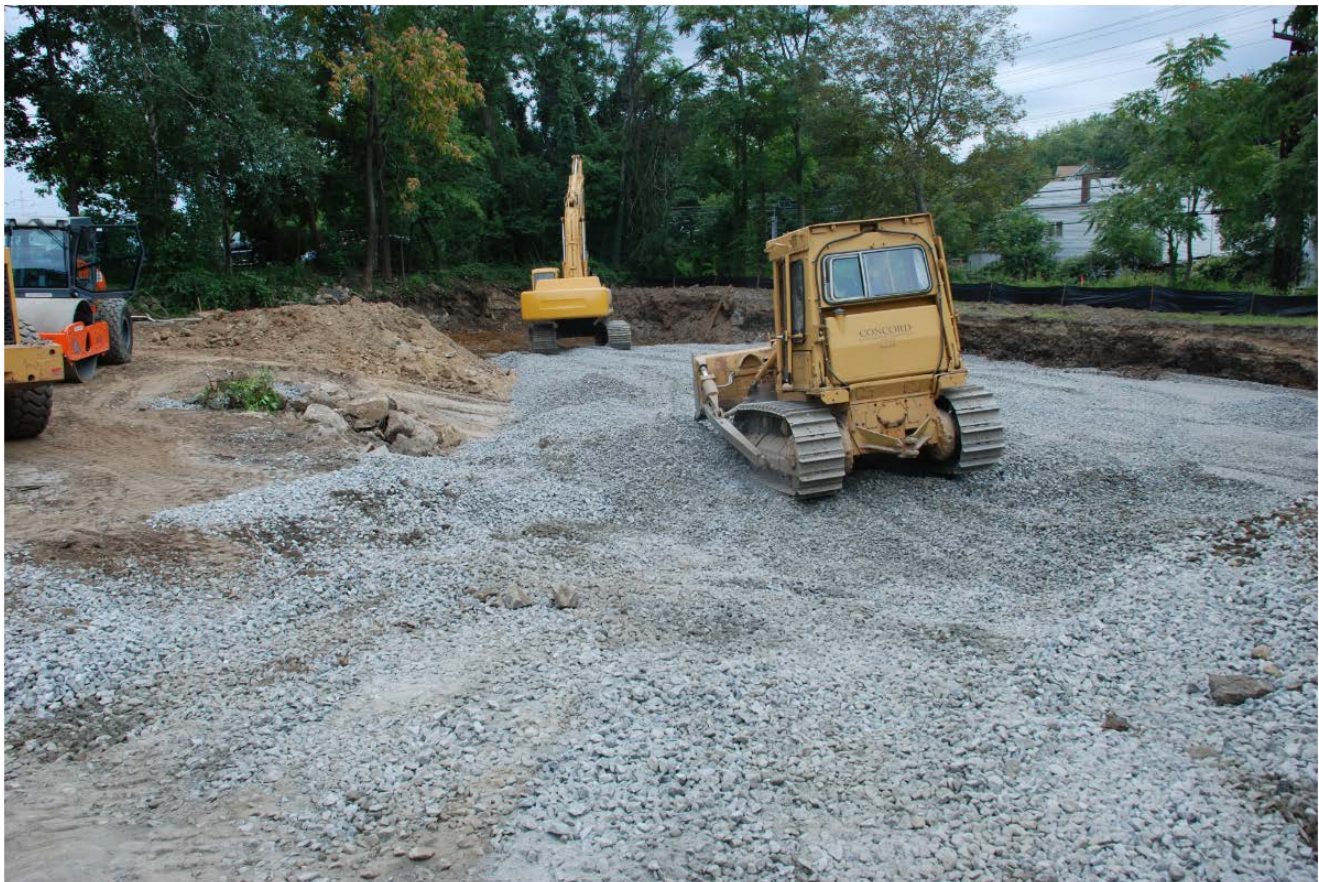
EXHIBIT A

No specific information exists as to the exact status of the tree removal & the soil remediation at the beginning of each month during this phase of the construction. The construction was done in two phases, the tree removal and then the soil remediation and rough grading of the site with the replacement fill. This part of the project only took 2 months to complete and the pictures in Exhibit A shows the construction in progress.

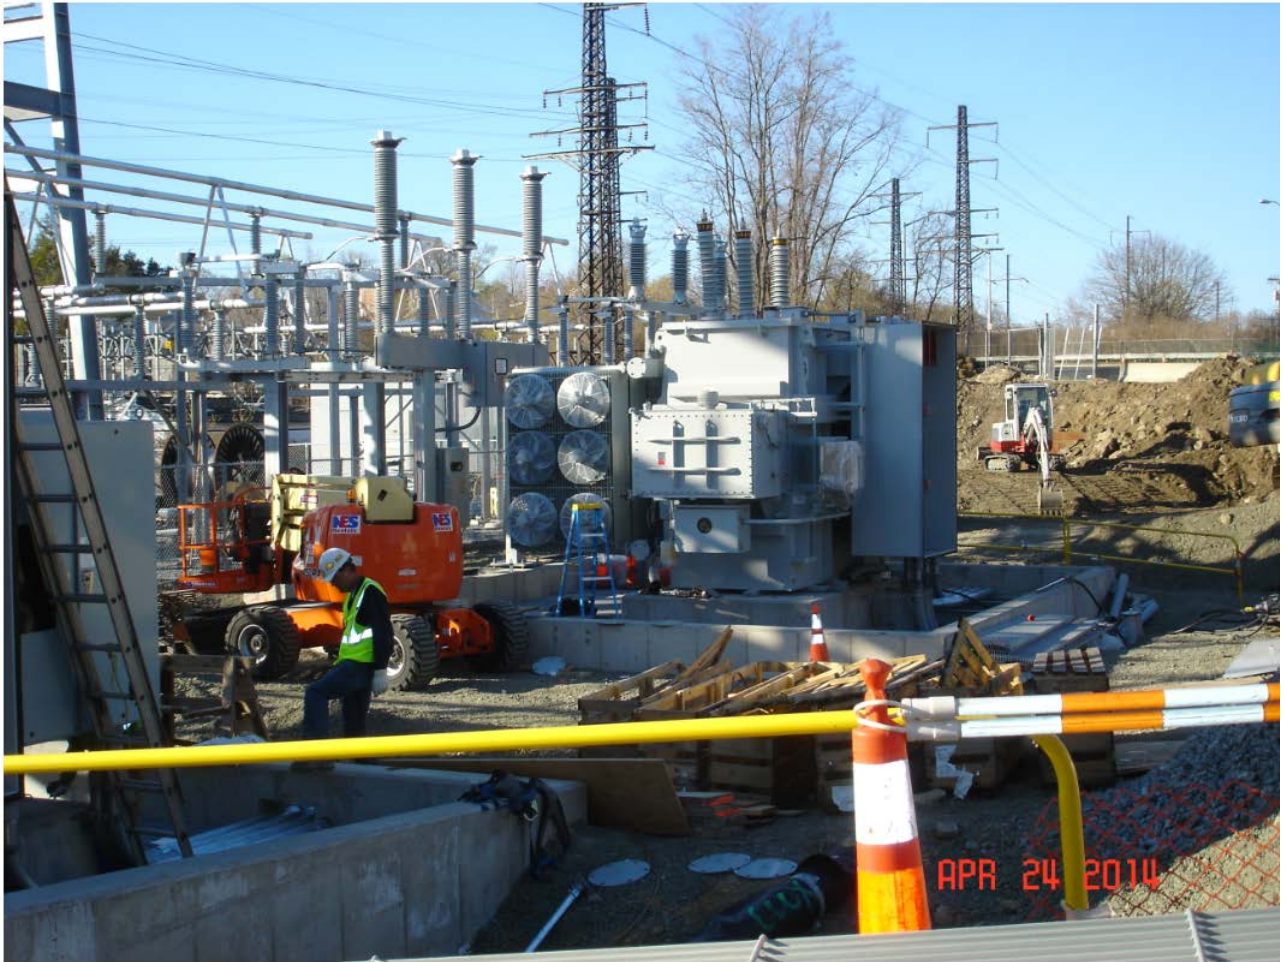
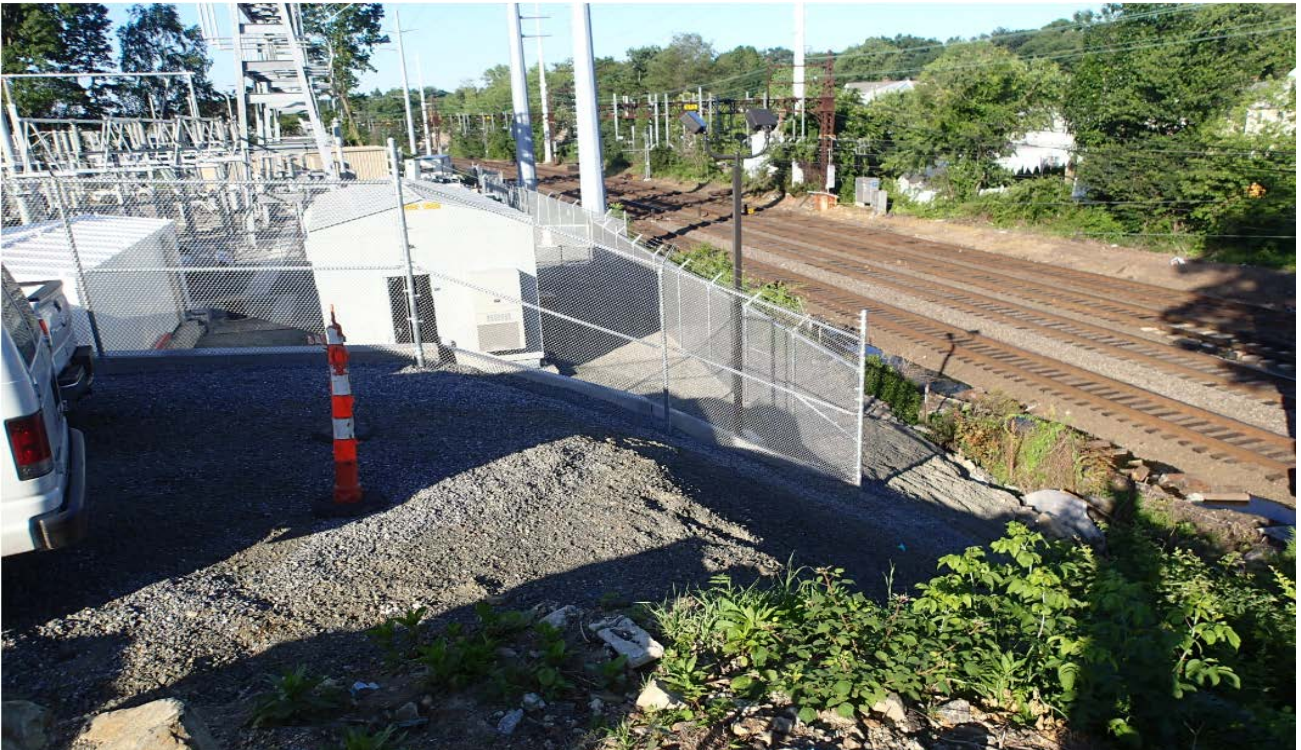
EXHIBIT E

Exhibit E shows the progress of the construction where the 2 transformer foundation have been completed (except for the crushed stone installation) and the transformers having been placed on them. The 2nd photo shows the placement of the control house and the switchgear building placed on their foundations. These photo shows the completion of the construction phase at approximately the 2/3 point.

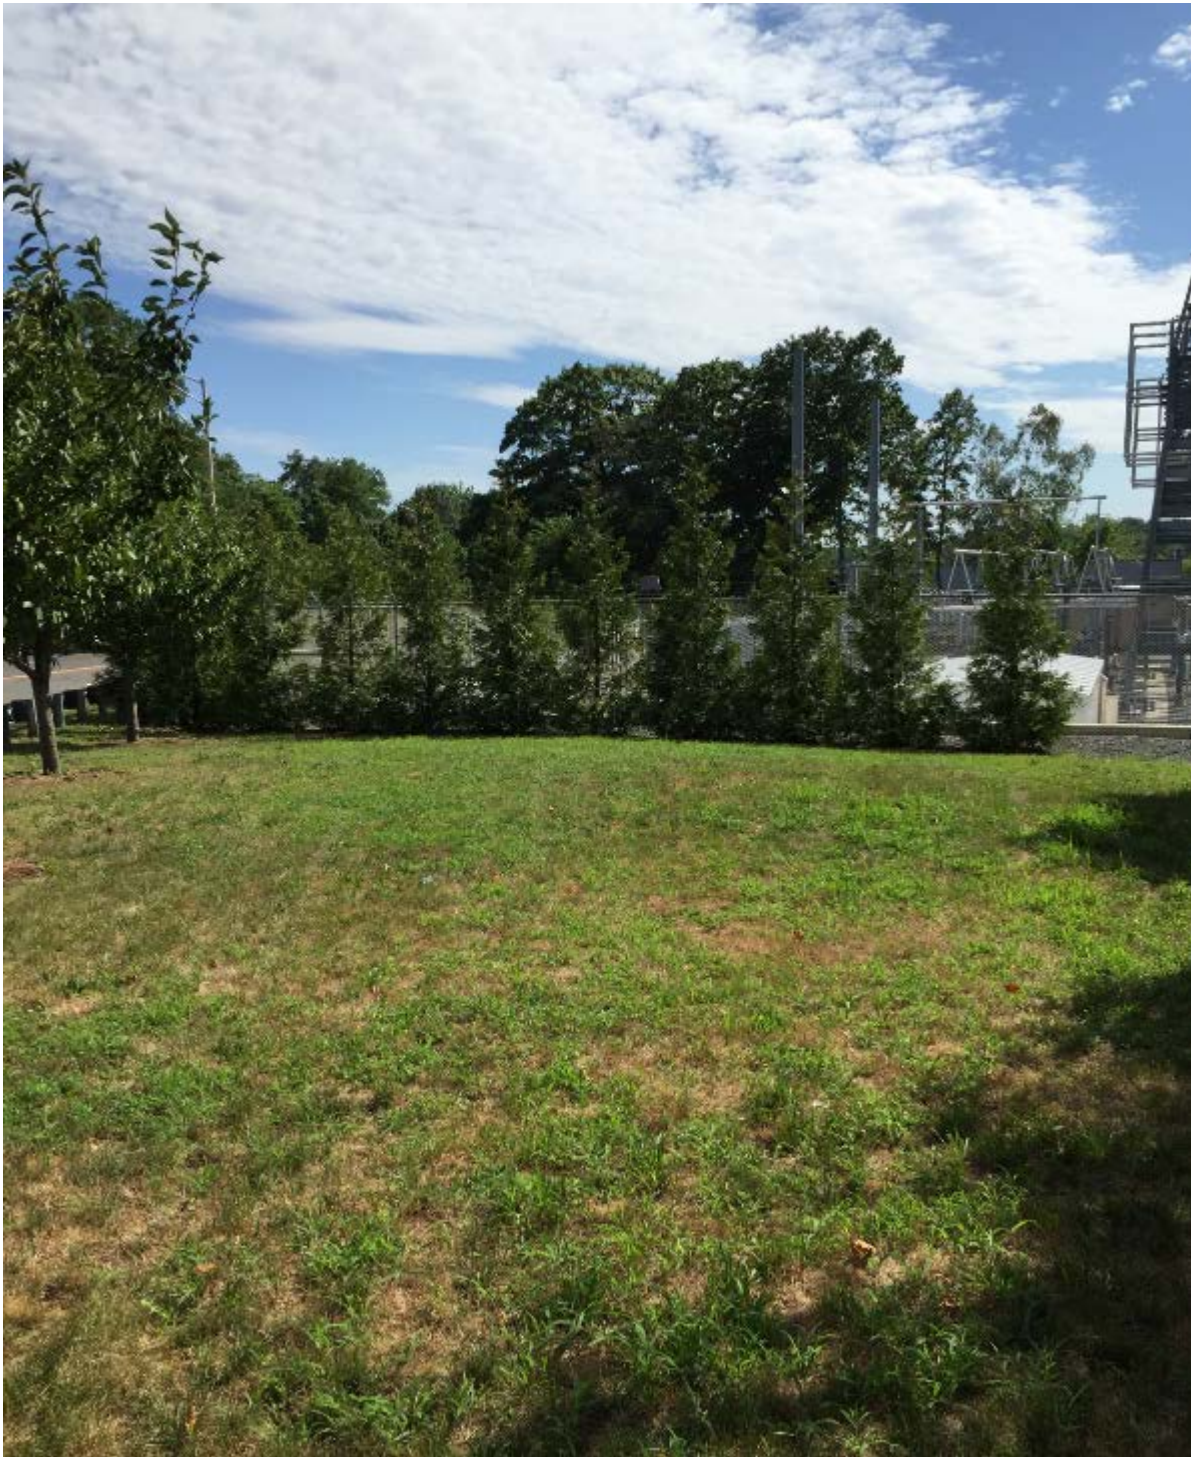
EXHIBIT G

On the north side, the row of arborvitae along the fence line are planted close enough and tall enough to obstruct the view into the substation and provide the necessary visual barrier. In addition, there are no businesses or houses bordering the north side of the property and the curve in the roadway of Martin Luther King, Jr. Drive, makes this portion of the property the least visible. See EXHIBIT G.

CURRENT VIEW OF THE NORTH FENCE LINE

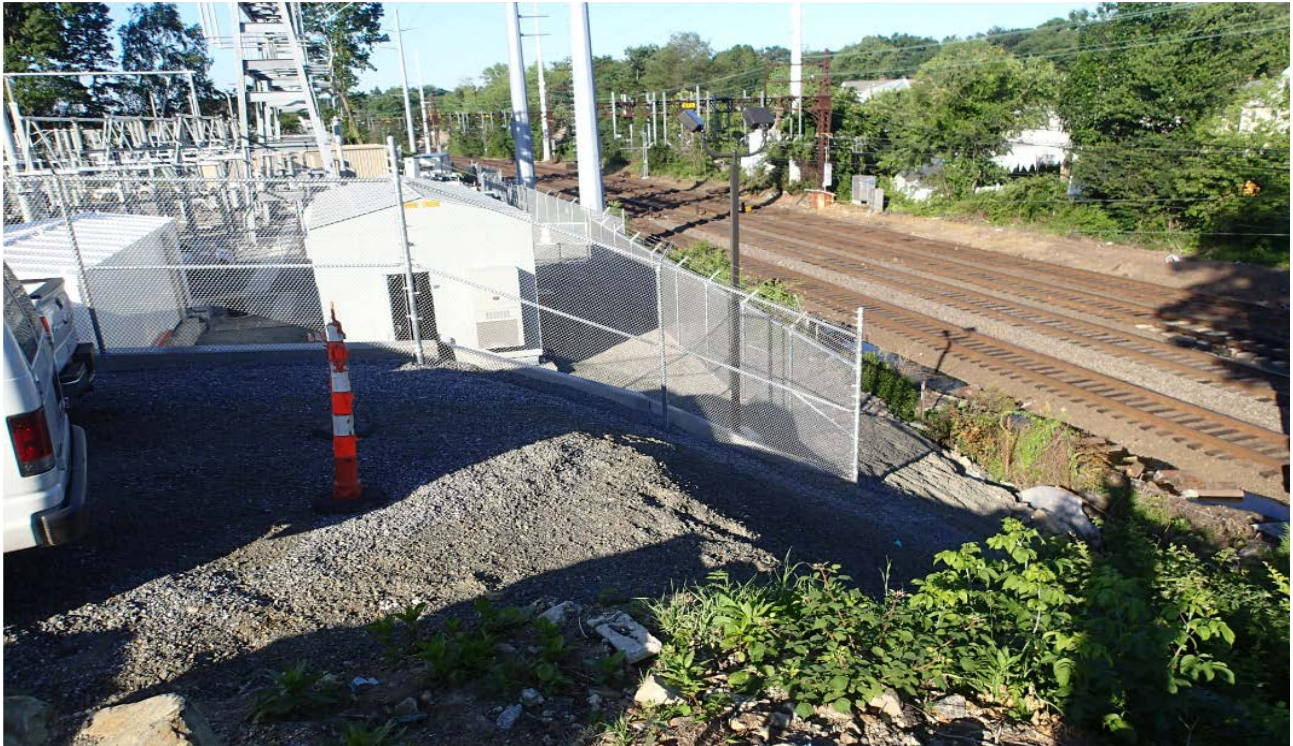
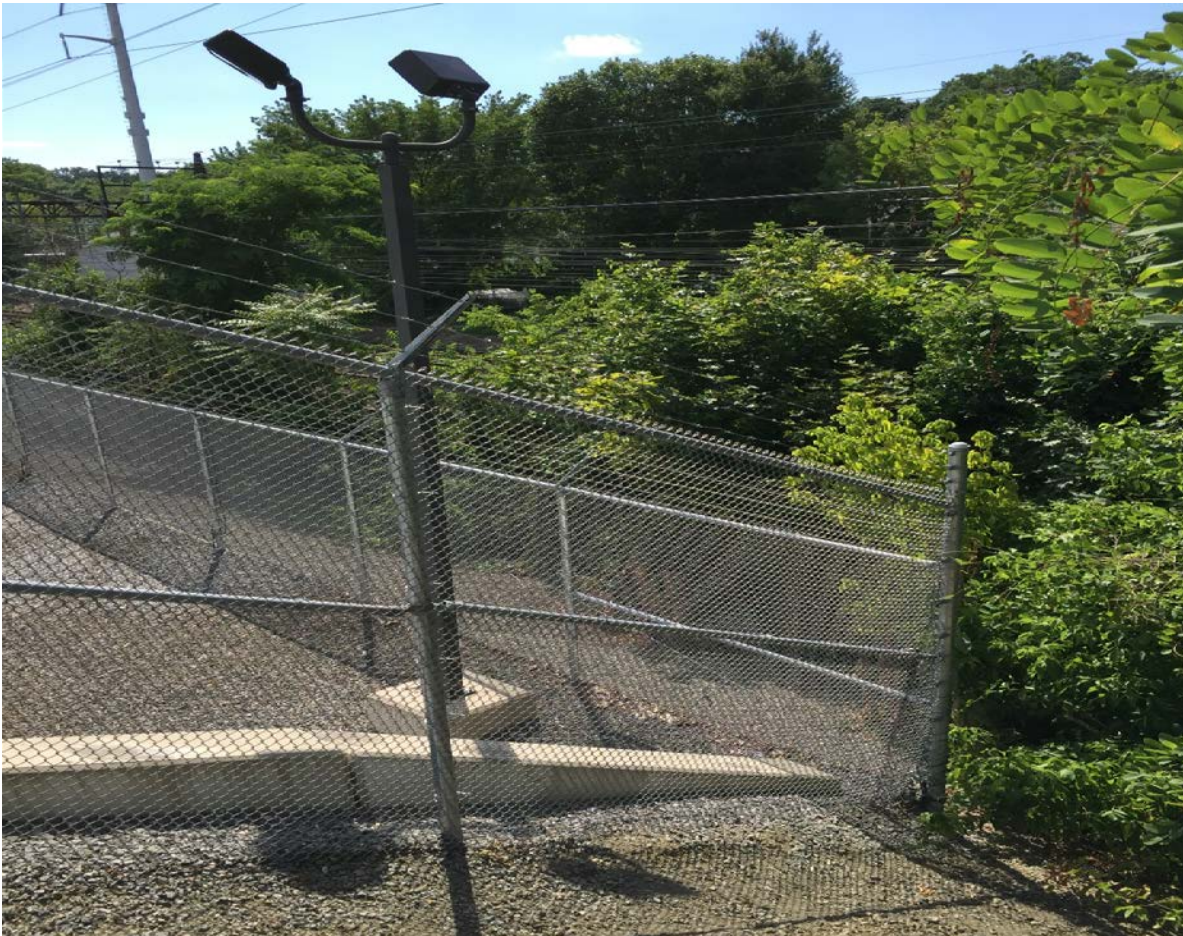
EXHIBIT H

On the west side, adjoining the railroad tracks, the natural plant growth has since recovered from the site construction to provide screening to at least the height of the fence for the portion of the fence line controlled by SNEW. The only open spot is on the west side is along the Eversource controlled portion where their transmission facilities are located. The height of these facilities are significantly higher than the fence line, so the installation of slats in this area would not effectively provide any screening. However, effective screening is provided by the tall tree line along the west side of the railroad tracks. The businesses and houses on Bouton St. are thus provided with a visual barrier. See EXHIBITS H & I.

VIEW OF THE NORTHWEST CORNER DURING CONSTRUCTION & EXISTING CONDITIONS

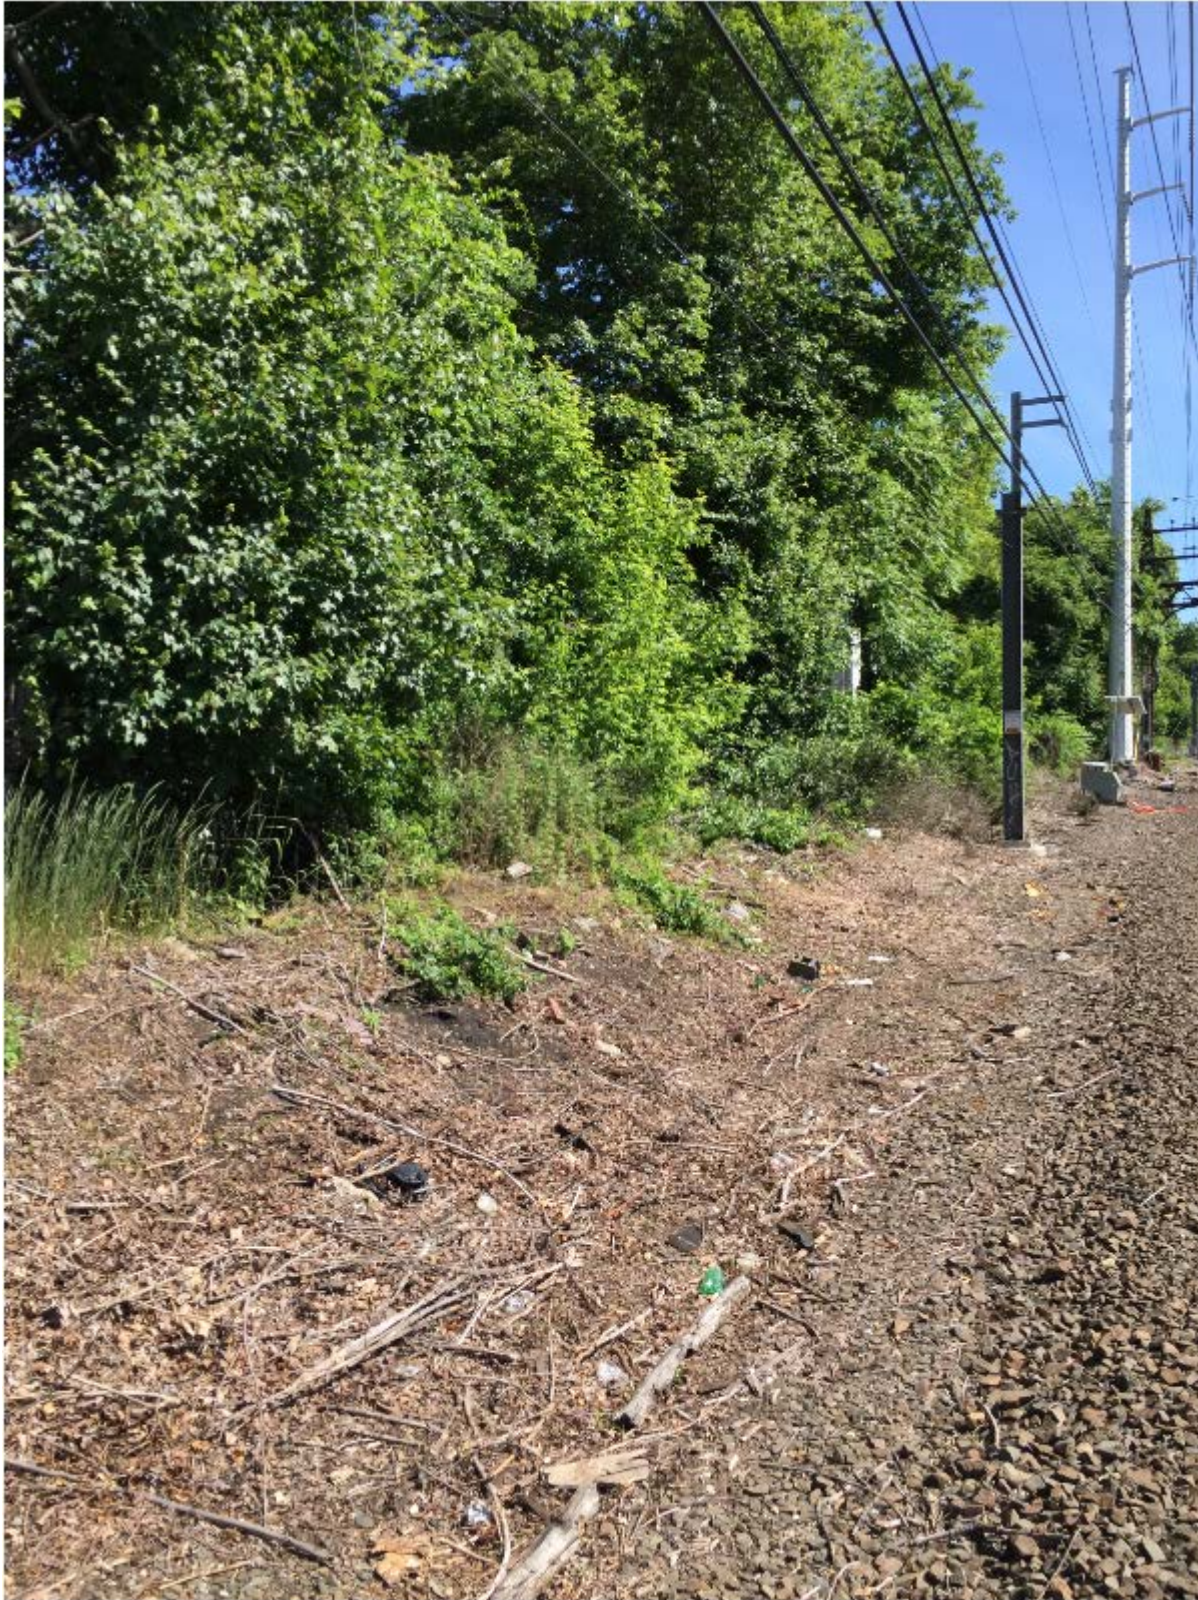
EXHIBIT I

CURRENT VIEW OF WEST SIDE OF RAILROAD TRACKS

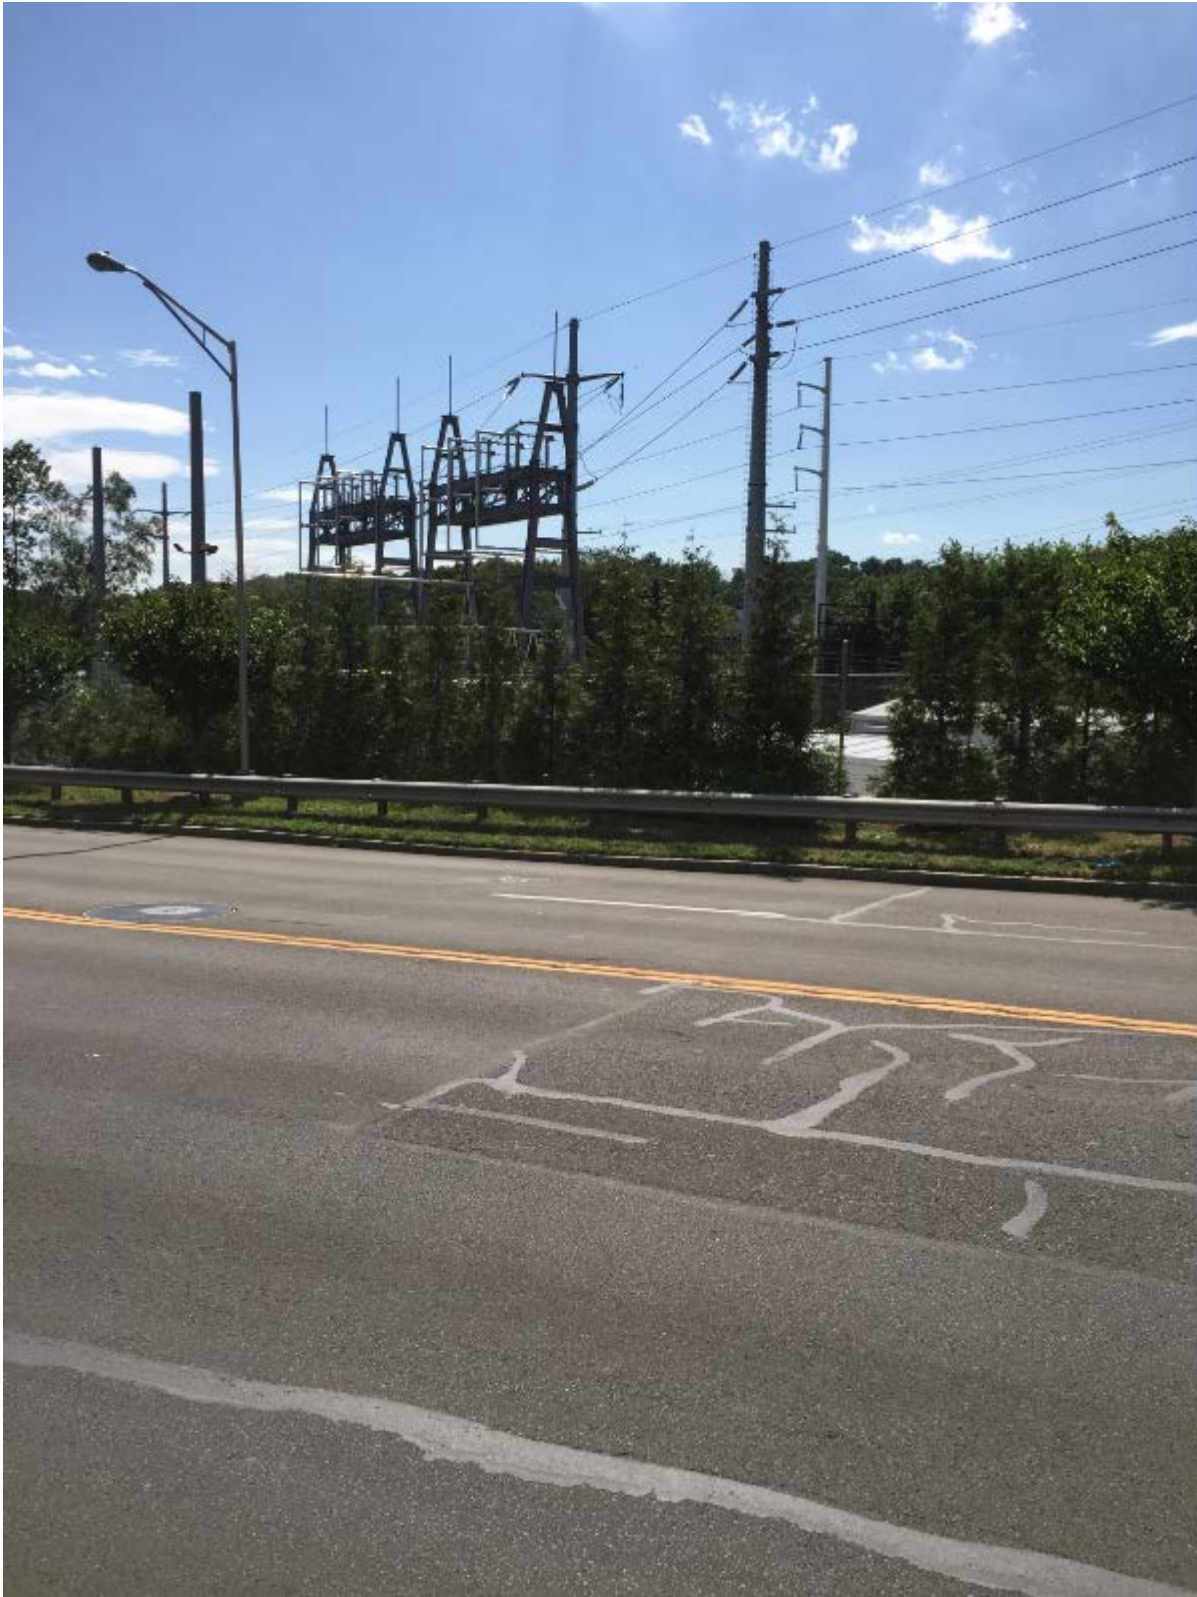
EXHIBIT J

On the east side, this is the side of the substation that is most visible to the general public. However, there are no businesses or houses bordering the east side of the property so the only view of the substation is from the moving traffic on Martin Luther King, Jr. Drive. The planting of arborvitae and cherry trees effectively provides significant visual screening particularly for the static portions of the fence. This is the side of the substation that provides the access, so the plantings do not cover the gates. Again, this is not a significant issue as the view into the substation is only momentary and based on the speed of the passing traffic. Finally, there is a tall tree line on the east side of the roadway which provides screening of any view of the entire substation to the houses on Laura St (the next adjoining street). See EXHIBITS J, K, & L.

CURRENT VIEW OF EAST SIDE OF SUBSTATION

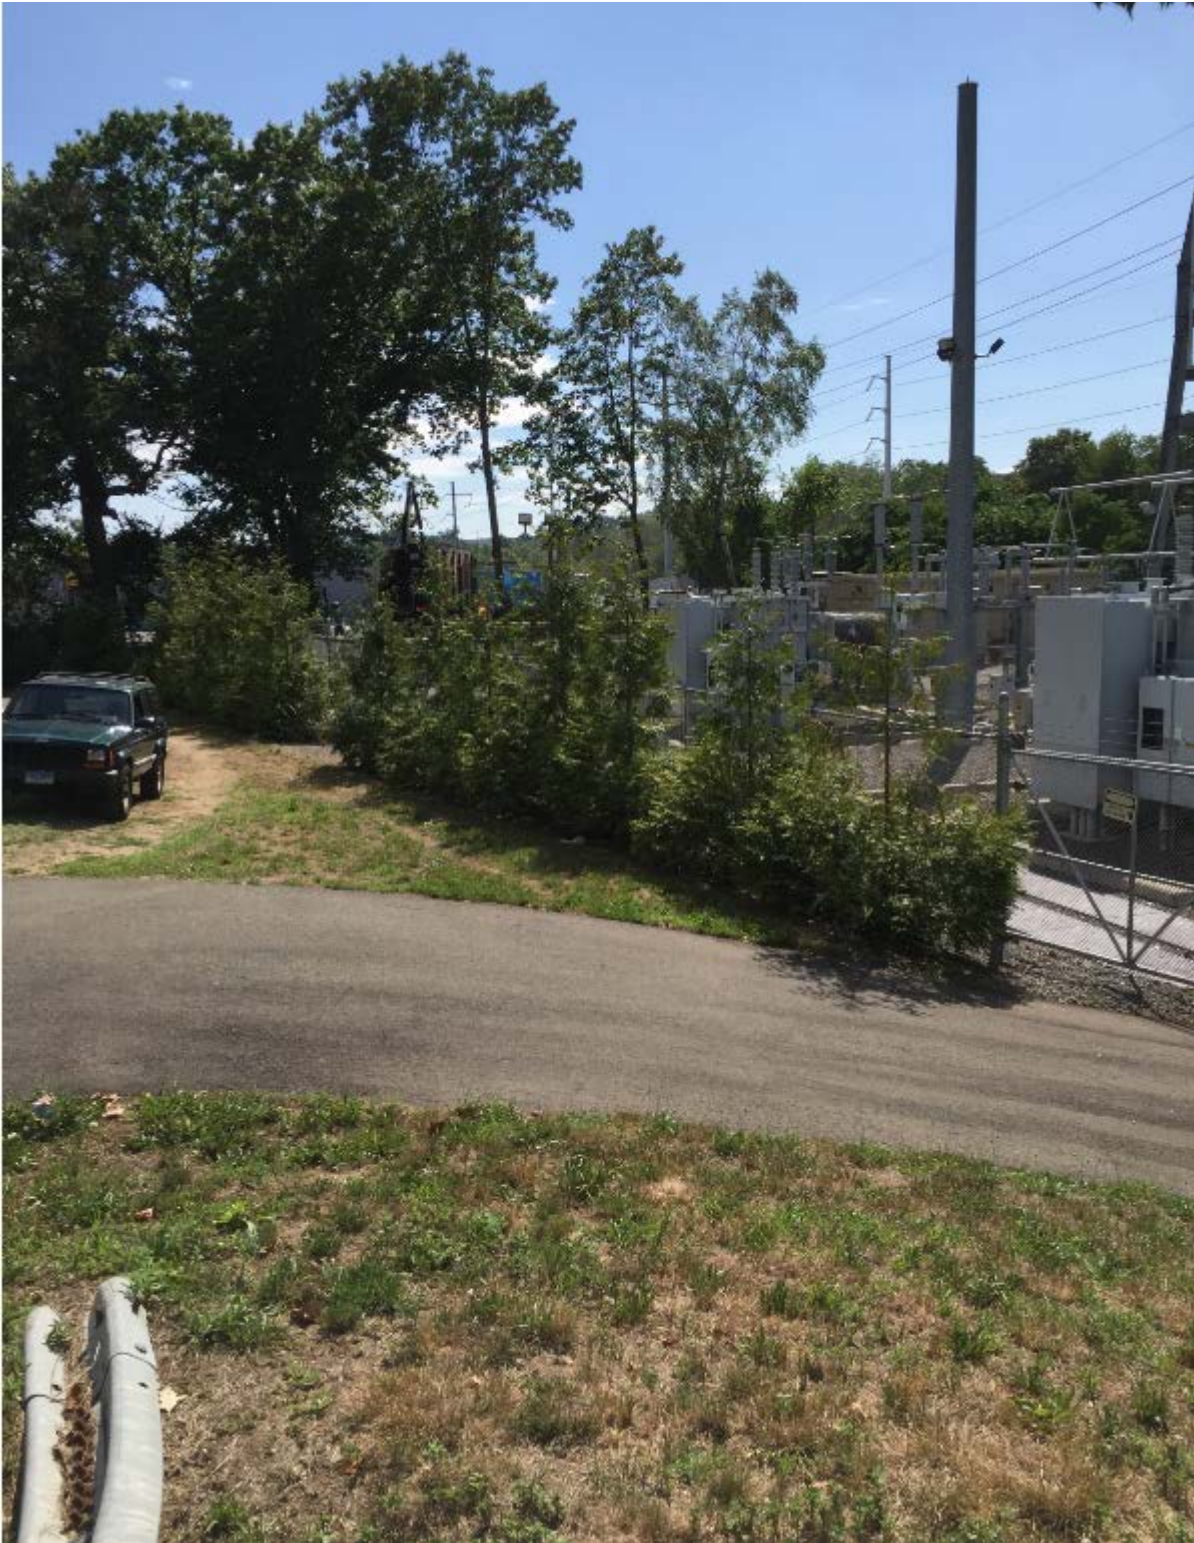
EXHIBIT K

CURRENT PARTIAL VIEW OF EAST SIDE OF SUBSTATION

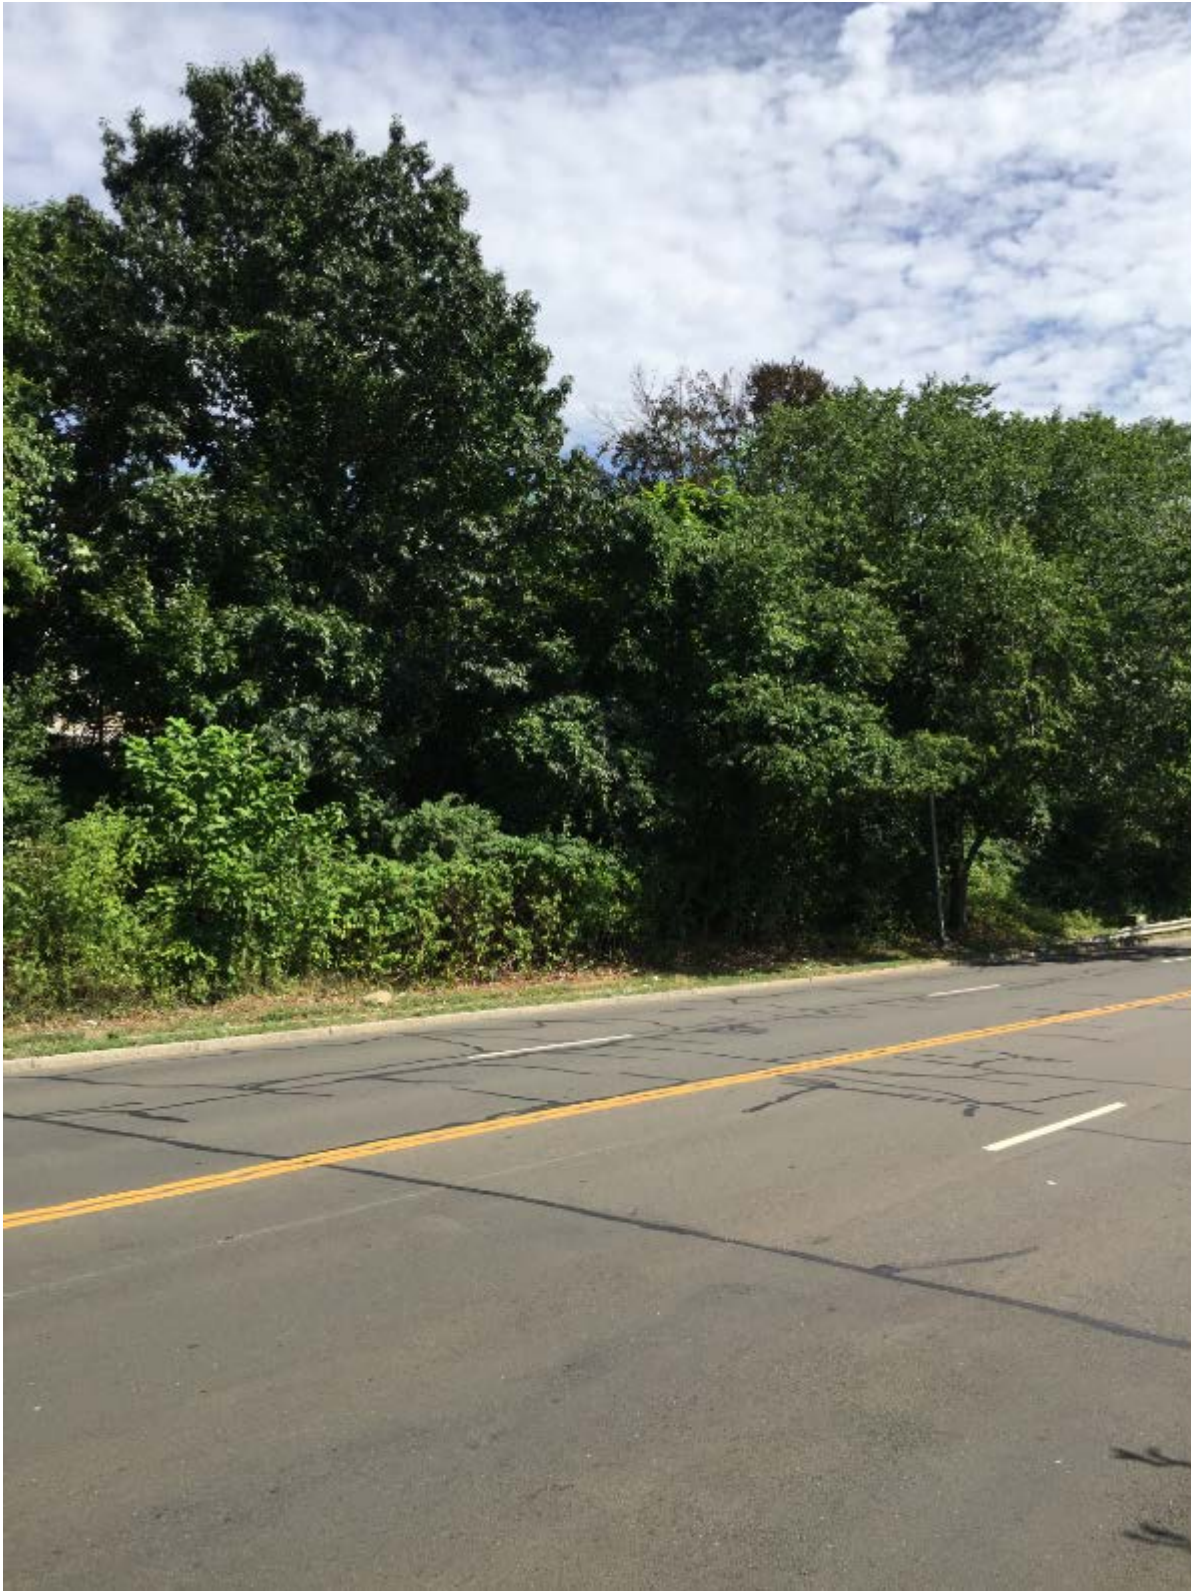
EXHIBIT L

CURRENT VIEW OF EAST SIDE OF MLK Jr. DRIVE
