2016 Bird and Bat Fatality Monitoring Results

Colebrook South Wind Energy Facility

Flagg Hill Road, Colebrook

January 21, 2017

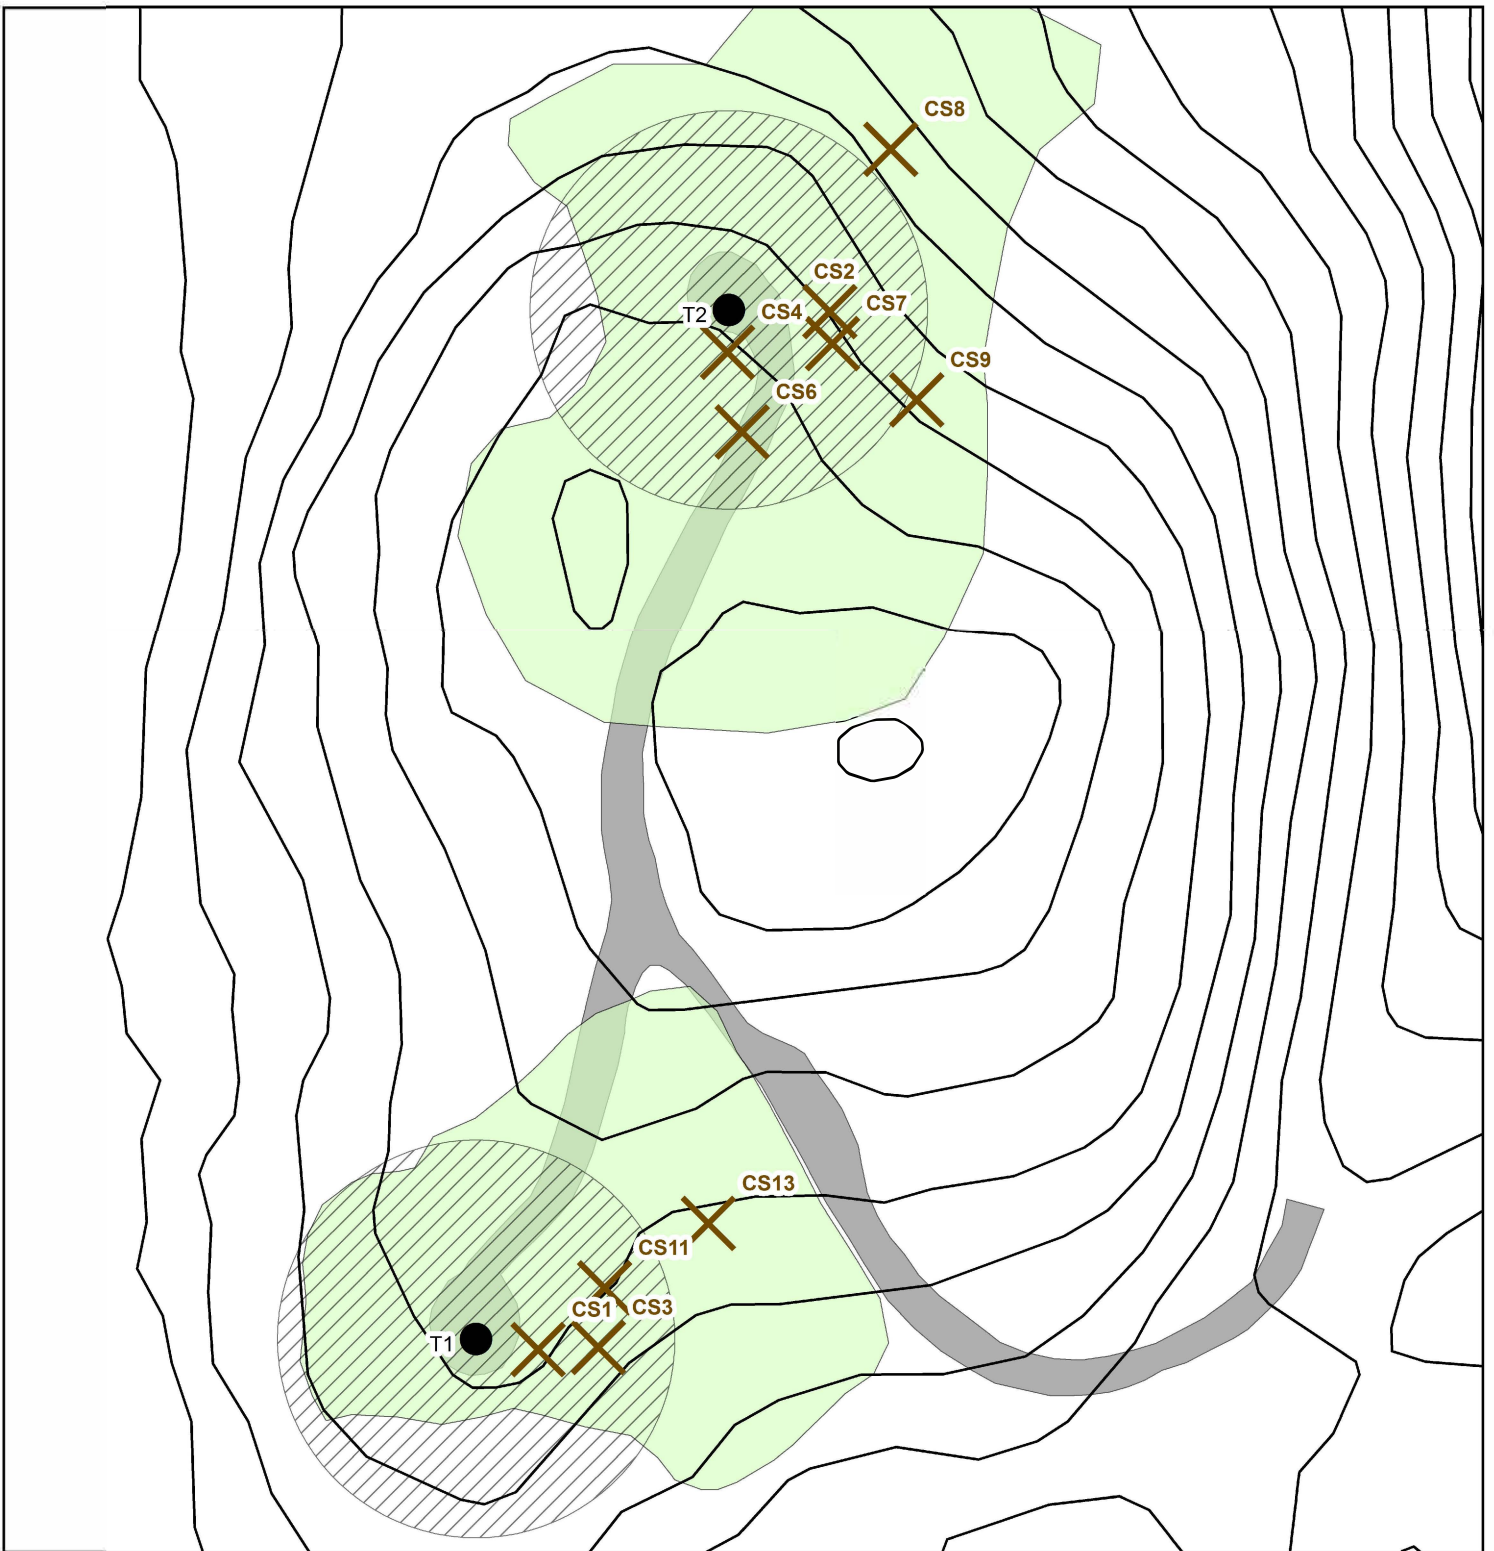
**FIGURE 2:
Bat Mortalities**

Three bat species were observed; big brown bat (6 mortalities), hoary bat (1 mortality) and silver haired bat (3 mortalities). Bat carcasses were bagged, labeled and placed in a freezer on the property.

Most mortalities occurred at Turbine #2, with a total of 13 (10 bats and seven birds). All bird mortalities were found at Turbine #2. A total of four bat mortalities occurred at Turbine #1 and no bird mortality. Most mortalities (70%) occurred near the turbines and within the 338-foot diameter travel path of the rotor blades.

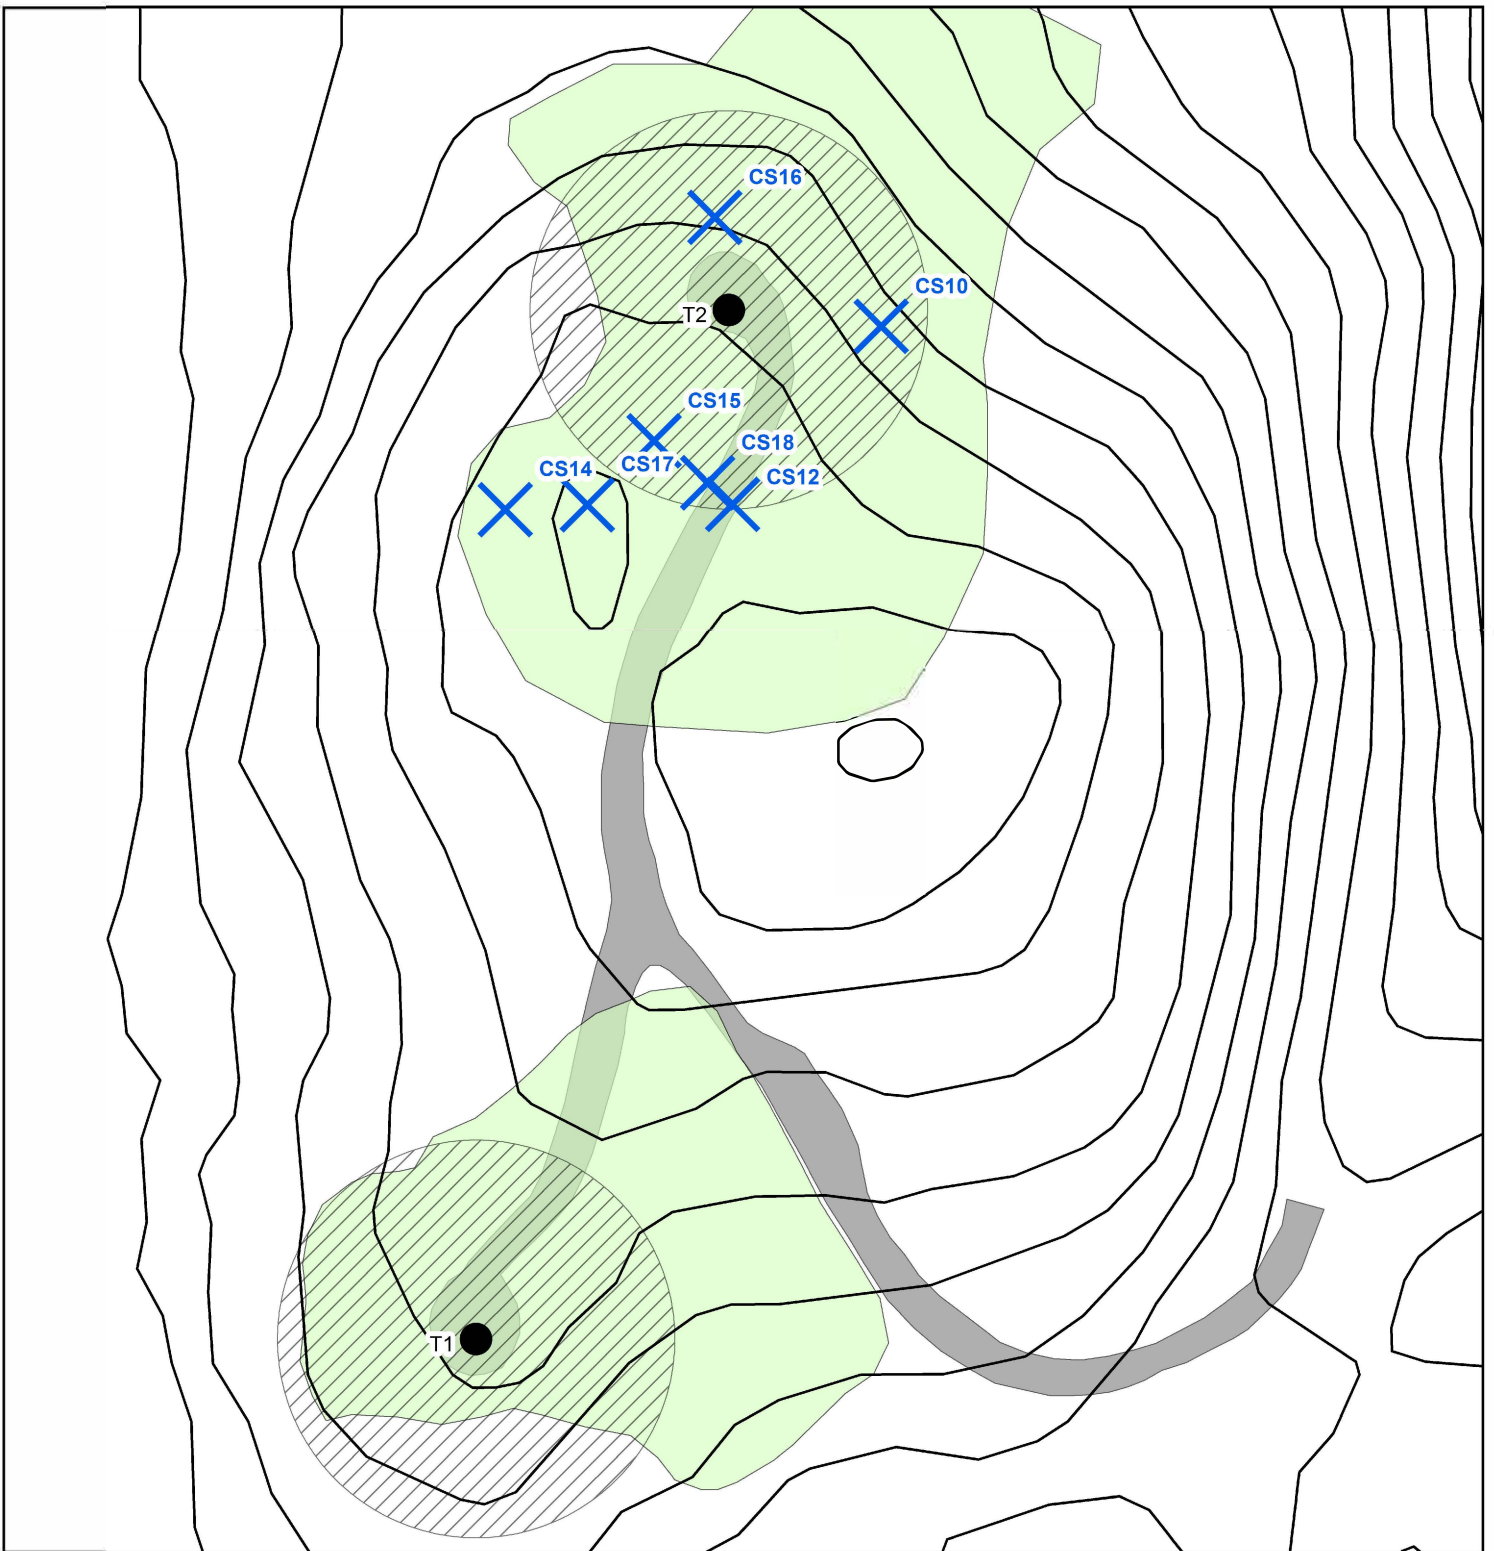
**FIGURE 3:
Bird Mortalities**

Five bird species were observed; eastern bluebird (1 mortality), yellow-bellied sapsucker (1 mortality), magnolia warbler (1 mortality), red-eyed vireo (2 mortalities) and yellow-throated vireo (3 mortalities). The bird carcasses were left in place in the field. The eastern bluebird (CS5) found on 7/18/16 died as a result of being trapped in the mesh erosion control blanket. Therefore, it is not included on Figures 2-4. With the exception of CS5, all mortalities were assumed to be attributable to turbine collision.

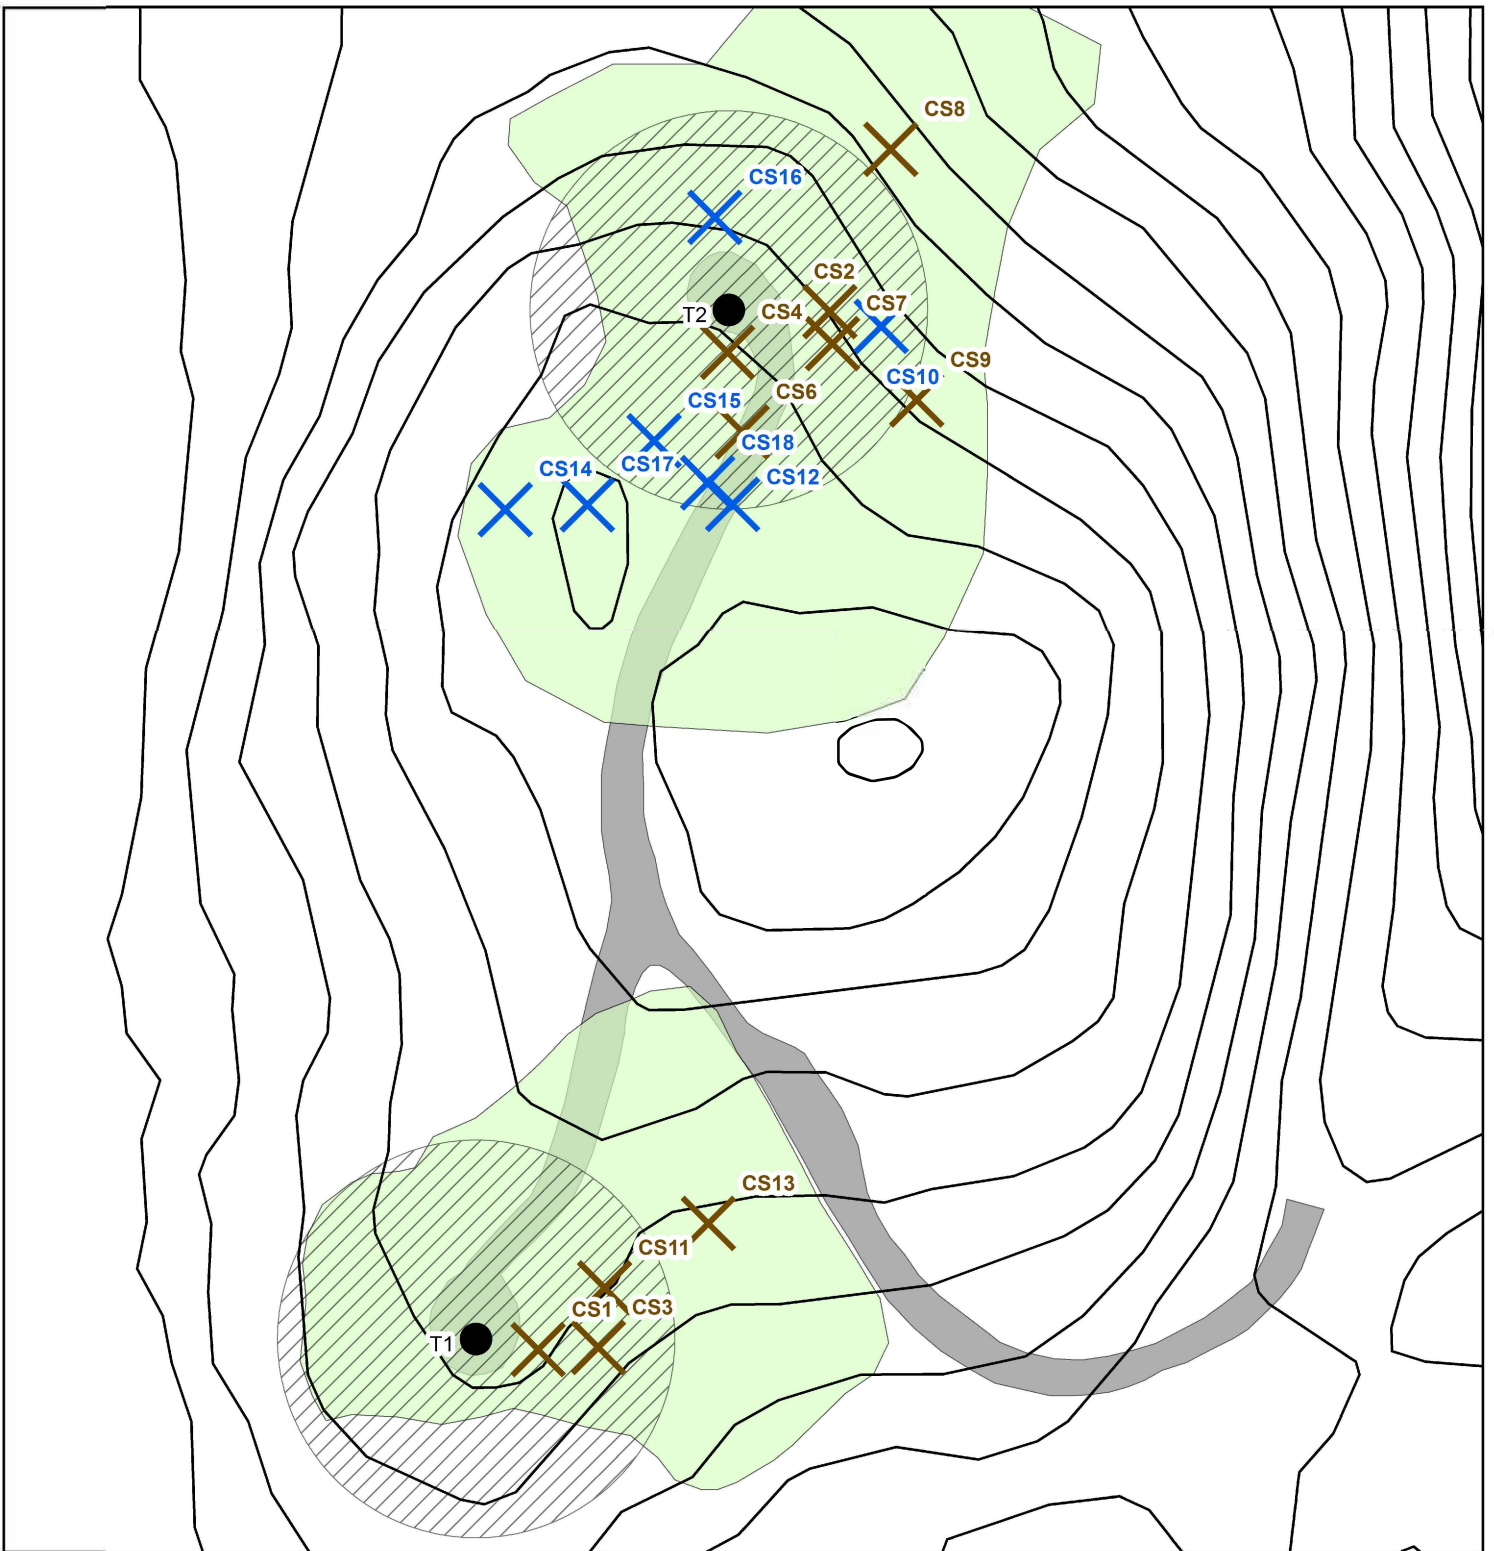
FIGURE 4:
Mortalities (All species)

A total of 18 mortalities were observed including 10 bats and 8 birds. Mortalities are summarized in Tables 1 and 2 and illustrated on *Figure 2 – Bat Mortalities*, *Figure 3 – Bird Mortalities* and *Figure 4 – Mortalities (All Species)*.

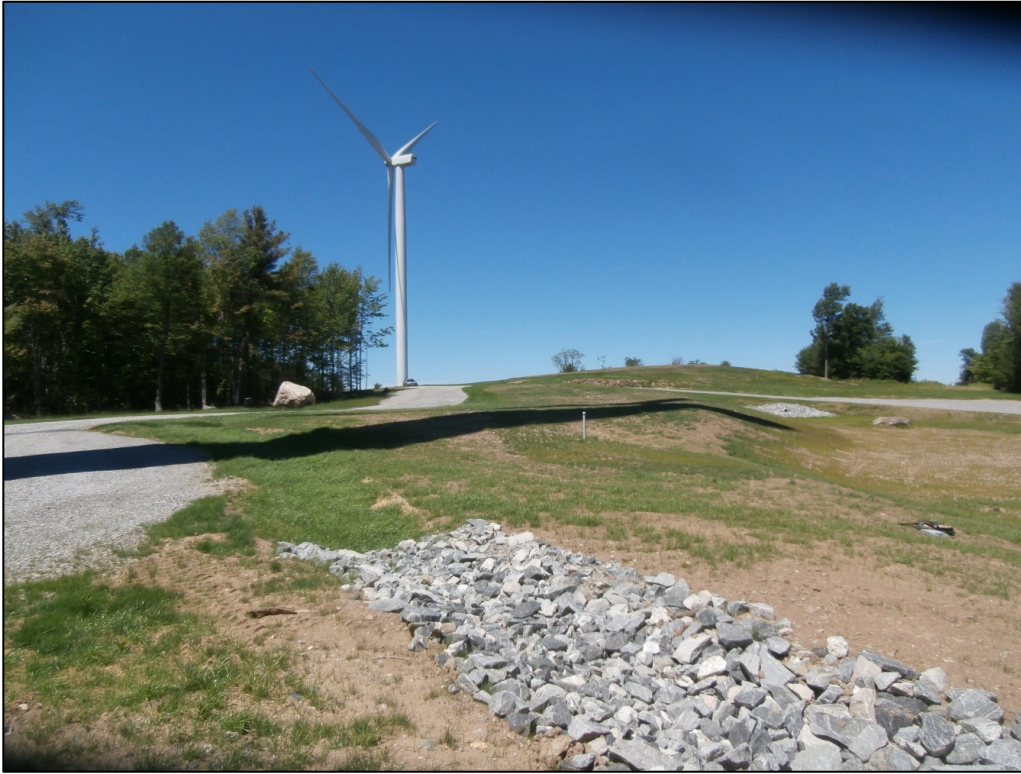
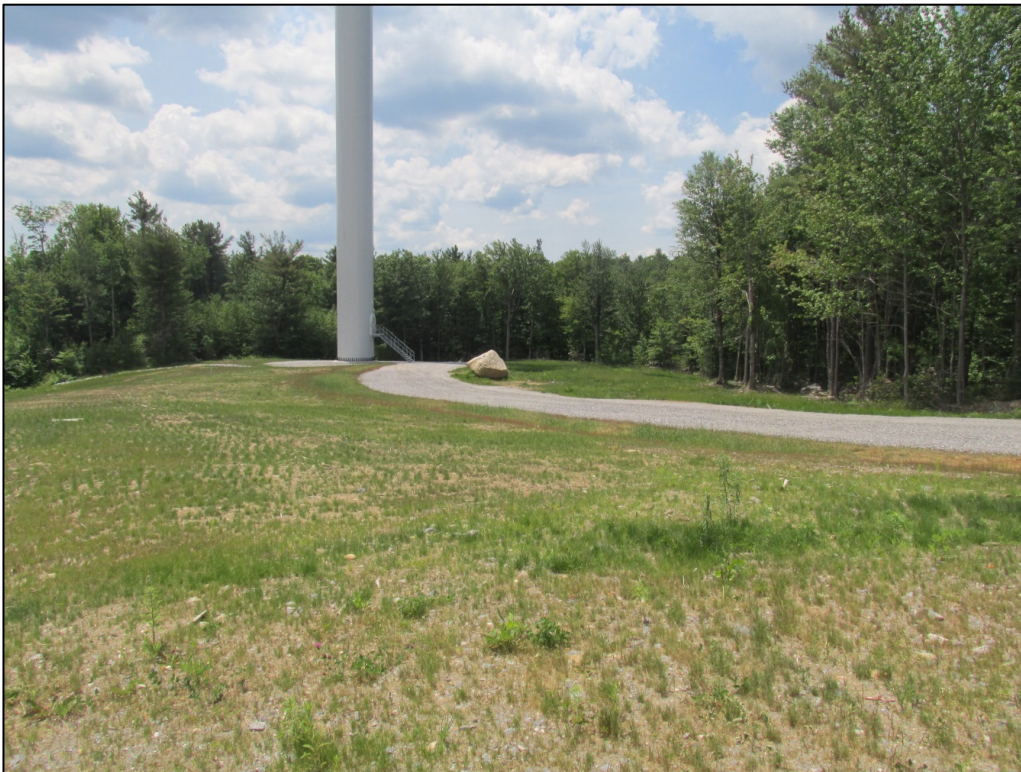
June Site Conditions: Some grass growth following hydroseeding in May. Some shrub growth. Two bat carcasses were located this month.

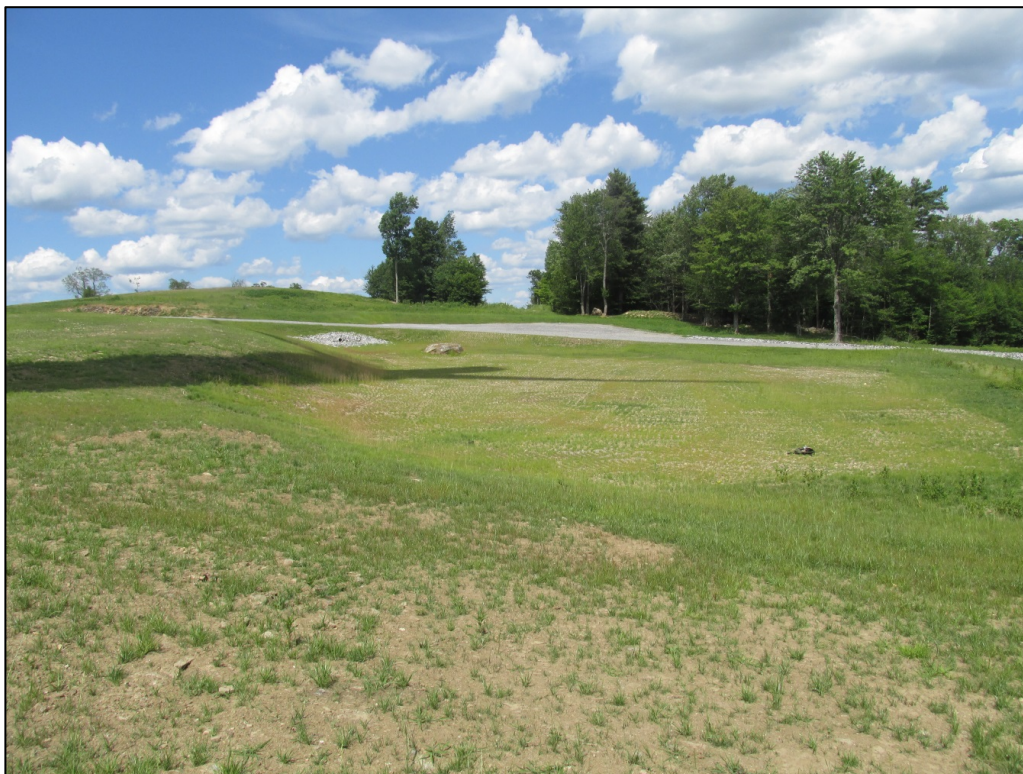
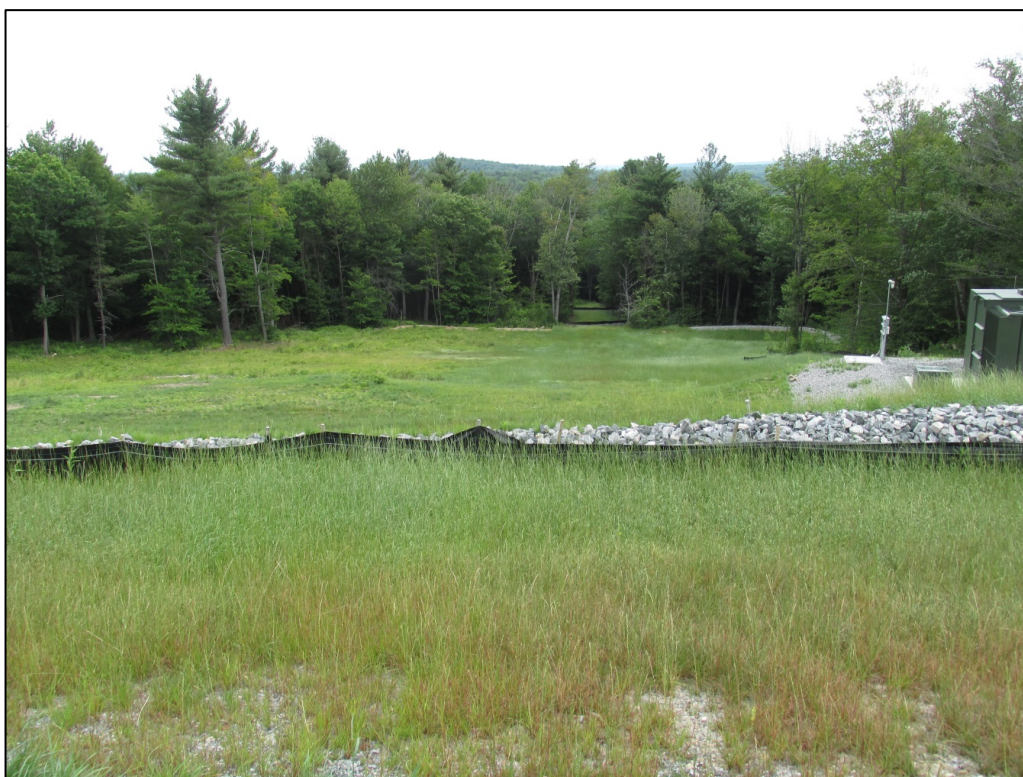
July Site Conditions: Grass now growing on most of site, with grasses up to 24 inches in some areas. Shrub growth now stabilized. Six bat carcasses and one bird carcass were located this month.

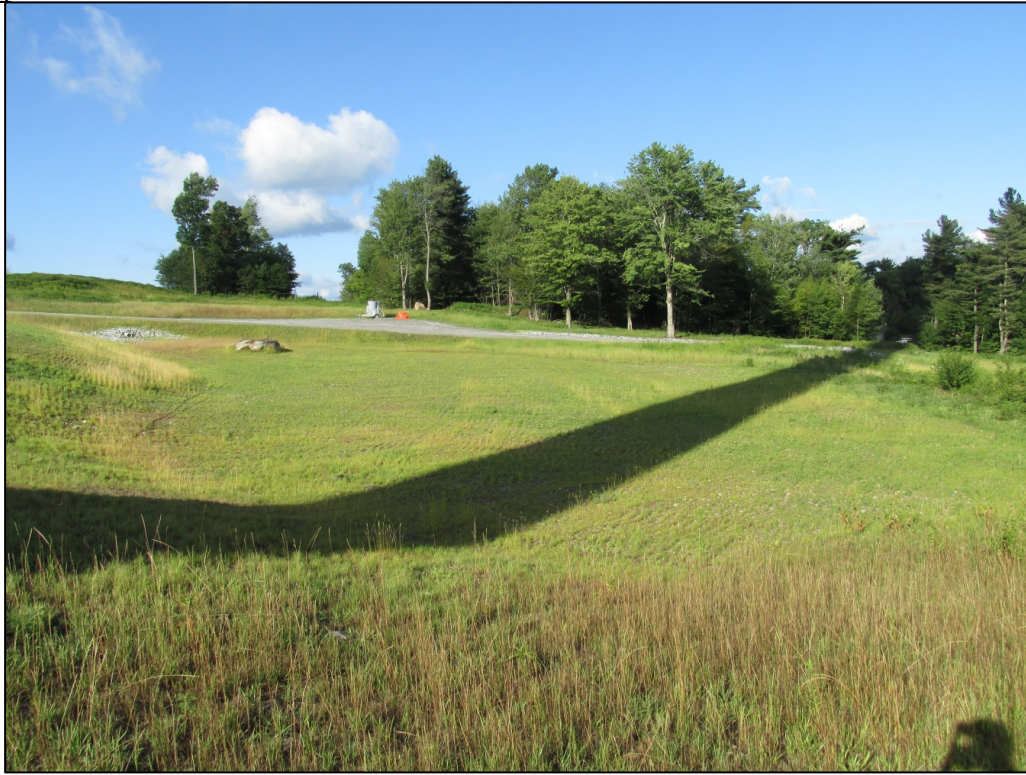
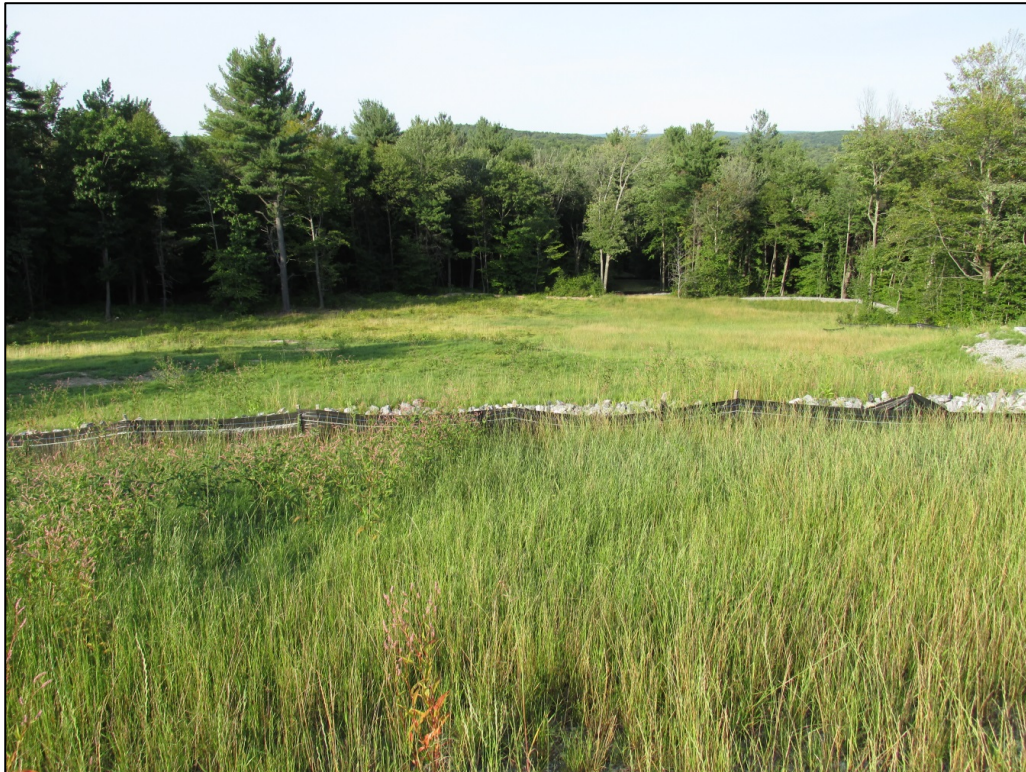
August Site Conditions: Grasses have now stabilized in height. Lack of precipitation this month resulted in browning grasses and shrubs. One bat and one bird carcass were located this month.

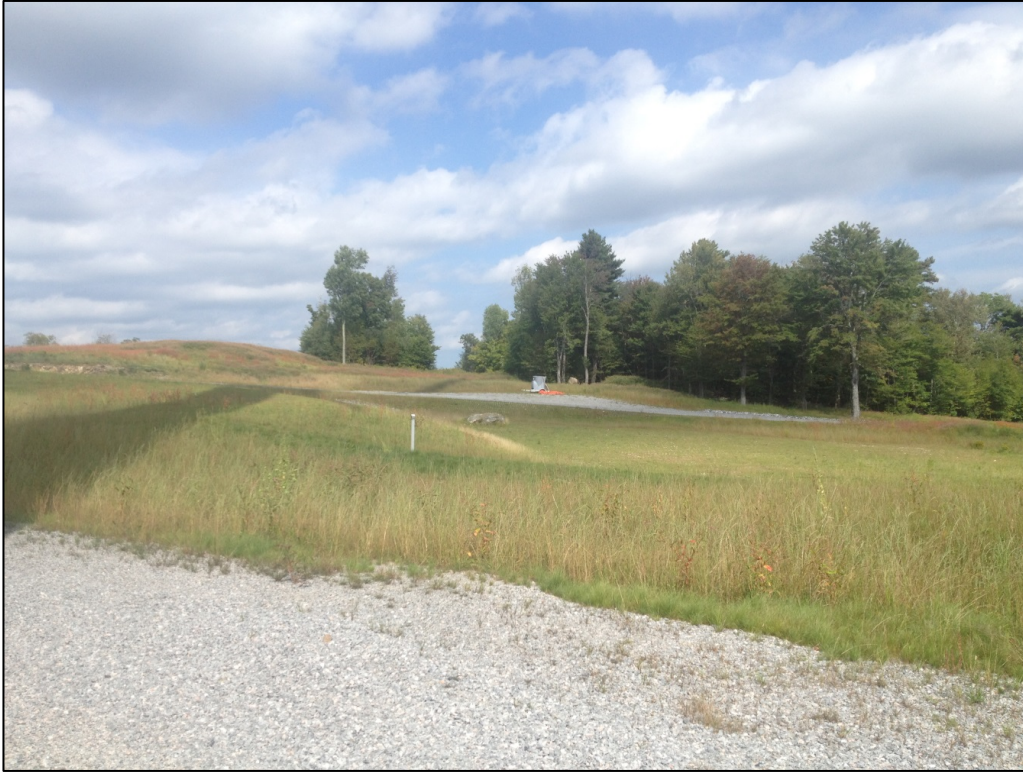
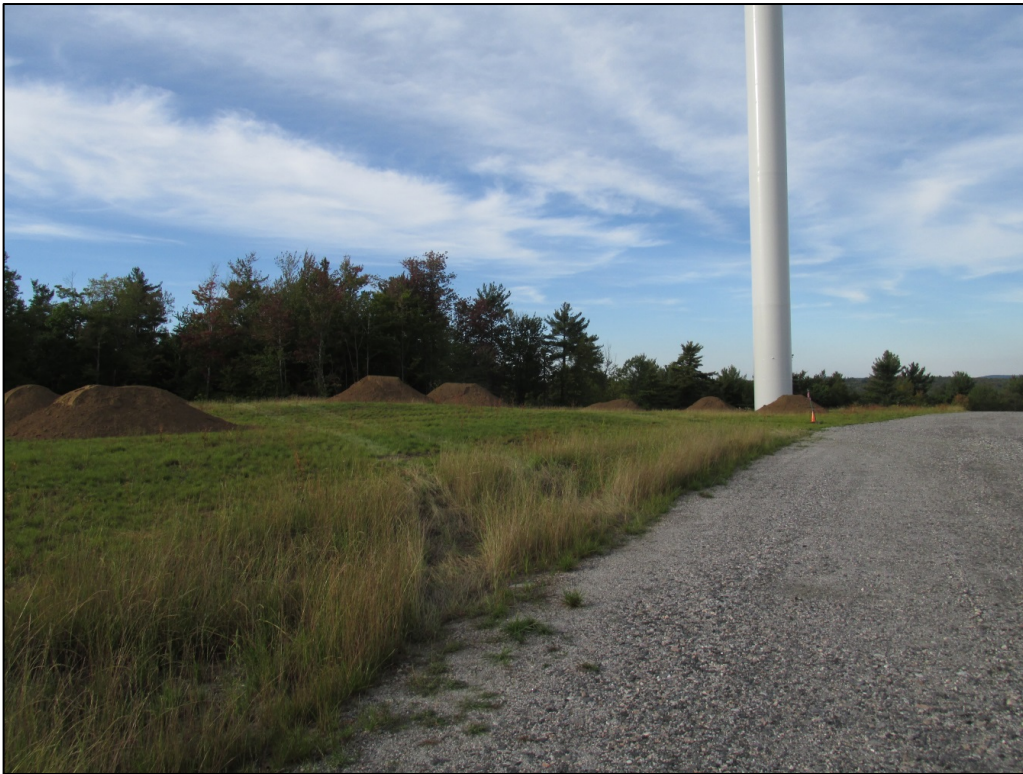
September Site Conditions: Some grasses were mowed mid-month near access roads. Grading and hydroseeding occurred on much of the property at the end of the month. One bat and one bird carcass were located this month.

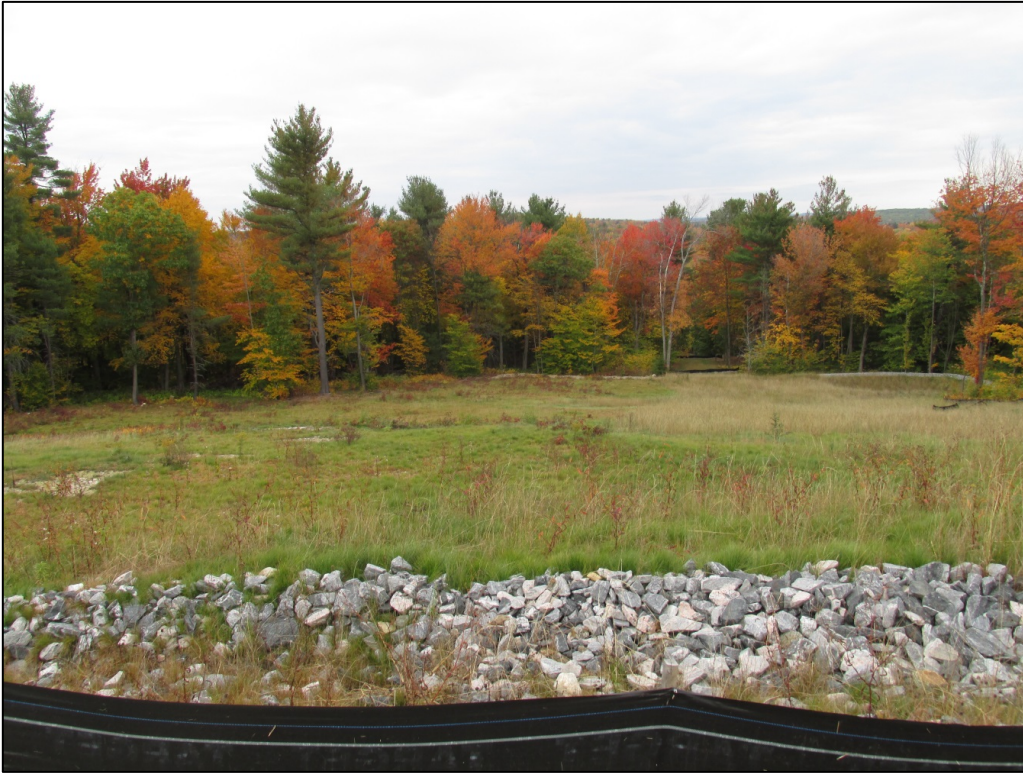
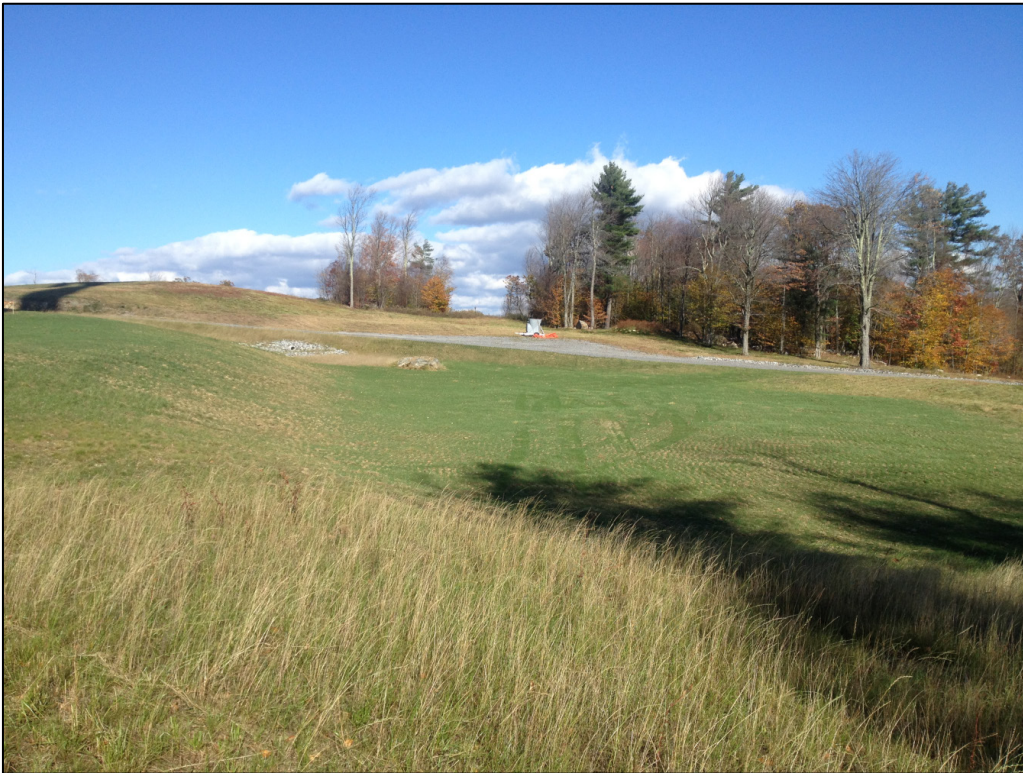
October Site Conditions: Some grass growth was seen from late September hydroseeding. Additional mowing of shrubs and grasses occurred near service roads. Five bird carcasses were located this month.
