RE: **PETITION NO. 1567** - The Connecticut Light and Power Company d/b/a Eversource Energy petition for a declaratory ruling, pursuant to Connecticut General Statutes §4-176 and §16-50k, for the proposed 1637/1720 Lines Rebuild Project consisting of the replacement and reconductoring of electric transmission line structures along its existing 4.0 mile electric transmission line right-of-way shared by its existing 115-kilovolt (kV) Nos. 1637 and 1720 Lines between Grist Mill Road in Norwalk, Norwalk Junction in Wilton, and Weston Substation in Weston, Connecticut traversing the municipalities of Norwalk, Wilton, and Weston, and related electric transmission line and substation improvements.

MOTION FOR PARTY STATUS, OR ALTERNATIVELY, VERIFIED PETITION TO INTERVENE BY MR. AND MRS. PETER RUBSAM

Rubsam Property Copts Brook Habitat Assessment Wilton, Connecticut

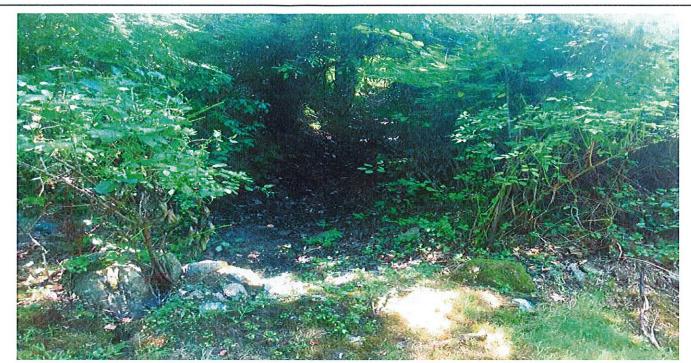
Photo 1: View of the tributary to Copts Brook on the Rubsam's property, located along the northern property boundary. Note: Dry conditions with no vegetation growing in streambed and thick canopy cover. (Facing South)

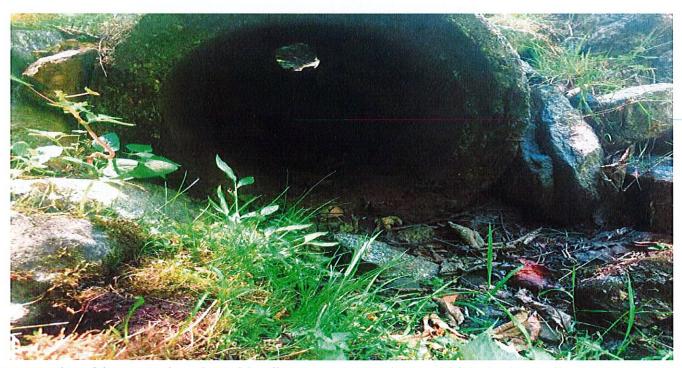
Photo 2: View of the cement pipe culvert of the tributary to Copts Brook clear of debris. (Facing south).

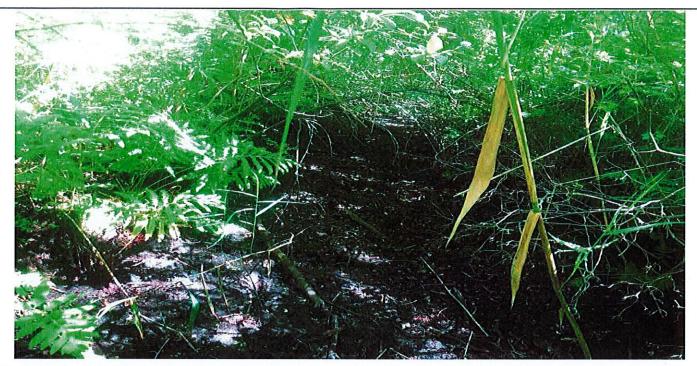
Photo 3: View of Copts Brook where the tributary enters the stream on the Rubsam's property. Note: Clear streambed and overhanging vegetation from the bank. (Facing west)

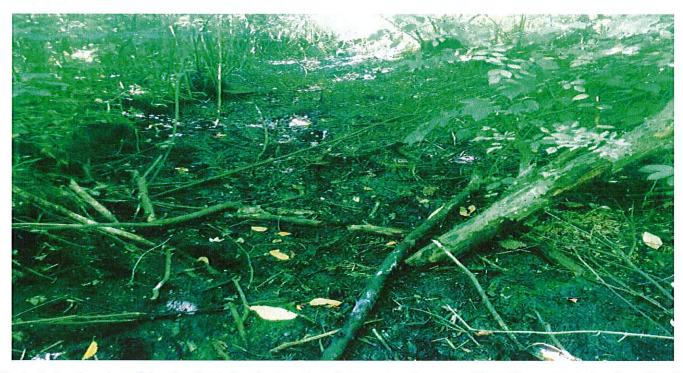
Photo 4: Another view of showing Copts Brook where the tributary enters the stream. Note: Clear streambed and overhanging vegetation from the bank. (Facing east)

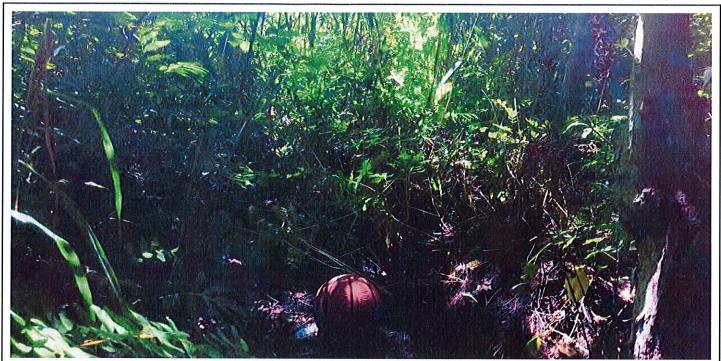
Photo 5: View of Copts Brook within the Rubsam's property and the ROW where vegetation starts to fill in and occupy the streambed. Note: stream remains dry with no pooling water. (Facing west)

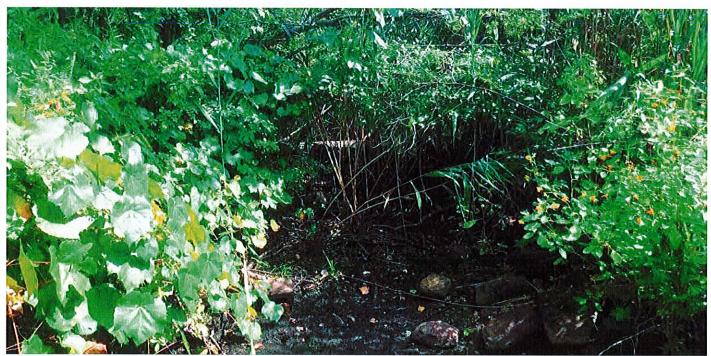
The Rubsam's expressed concern that the placement of timber matting during the 2021 project may have resulted in excessive vegetative growth, including an increase in the invasive common reed in Copts Brook within their property. However, the portion of Copts Brook on the Rubsam's property was observed to be mainly clear of vegetation and about 50 linear feet of the stream contained vegetation within the channel itself. This vegetation is mainly native with about 10% of common reed present and corresponded to where the stream daylights into the ROW and was closest to the culvert under Clover Drive. This small stretch of the stream also contained less canopy cover and likely has water that pools near the culvert as was evidenced by water marks and dark stained leaves. The presence of common reed (an invasive species) and thicker layer of vegetation in this area may be the result of having more daylight and mucky/wetter soils versus inundation during non-drought conditions. The fact that there is no common reed within other portions of the stream on the property may be due to the lack of sunlight. Therefore, the more open canopy and available sunlight likely allows for the thicker growth of vegetation near the culvert at Clover Drive.

Photo 6: Another view of the stream near the Clover Drive culvert within the ROW in southwestern corner of Rubsam property. Note: Common reed (Phragmites australis) and other native vegetation present within the streambed and along the stream bank.

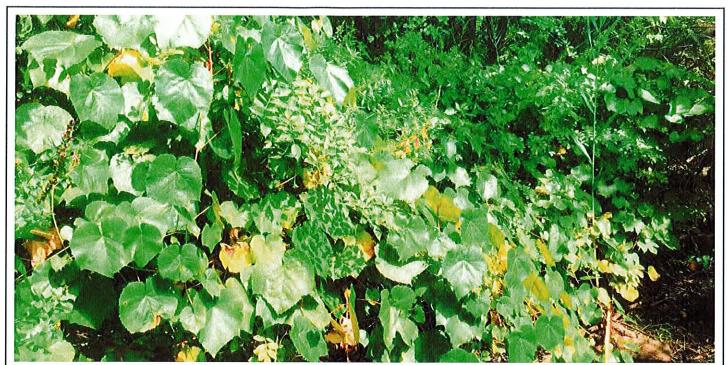
Photo 7: View of the northwestern bank of the stream near the Clover Drive culvert within the ROW. Note: Minimal invasive common reed is present.

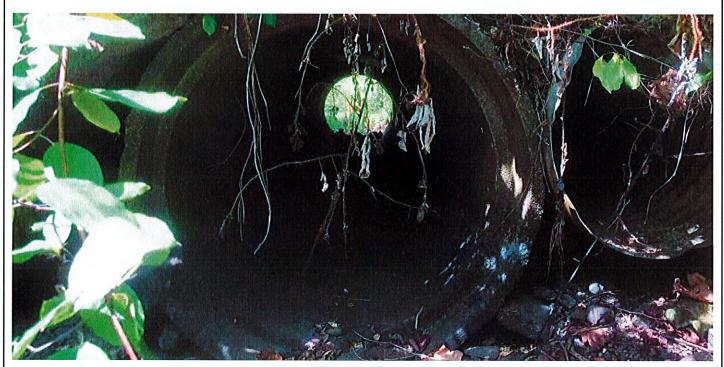
Additionally, during the investigation, the culverts located upstream and downstream of the Rubsam's property were inspected for potential obstructions. The culverts located on site (the southwest corner and northeast sections of the property) are concrete pipes. The culvert to the southwest conveys streamflow under Clover Drive and the culvert to the northeast conveys streamflow under the lawn at the property boundary. A third culvert is present to the east and runs under Westport Road. All three culverts were clear but very dry at the time of the investigation. No evidence of blockage was observed at the time of the investigation.

Photo 8: View of the culverts under Clover Drive showing unobstructed path for water to flow through.

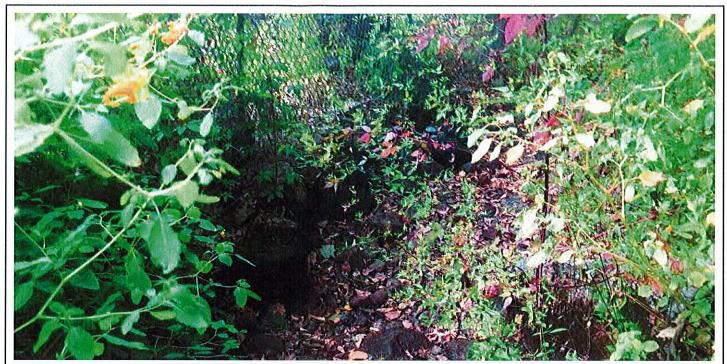
Photo 9: View of Copts Brook on the western side of Clover Drive showing a clear streambed and vegetated banks (Just outside of wetland area).

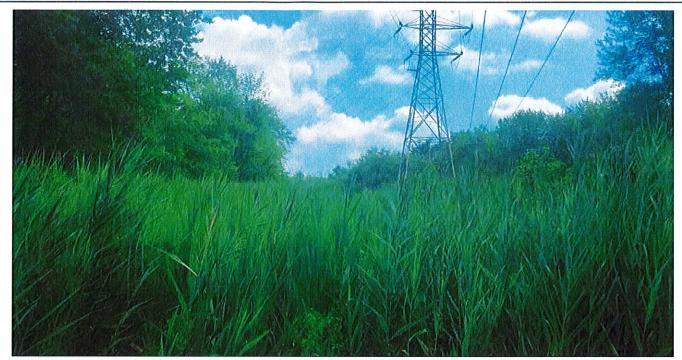
In addition, the adjacent ROW is dominated by common reed. This dominance of common reed is consistent with the pre-construction conditions of this wetland system (as demonstrated in the pre-construction (April 2020) and during construction photos [May 2021)]) that also show the thick cover of this plant species. Therefore, it is most likely that the constant seed source from the adjacent wetland (both upstream and downstream) as well as the drought conditions (preventing flow of water to wash out the establishment of common reed) likely have resulted in an increase in common reed as well as the rapid growth of native vegetation within and along the stream banks on the Rubsam's property. Standing pooled water near the culvert, sunlight, and mucky, rich organics within the stream bed allow for the perfect habitat for vegetative growth.

Photo 11: View of the ROW with common reed dominating the vegetation community. Note: Structure 943 is present in the background. (Facing east)

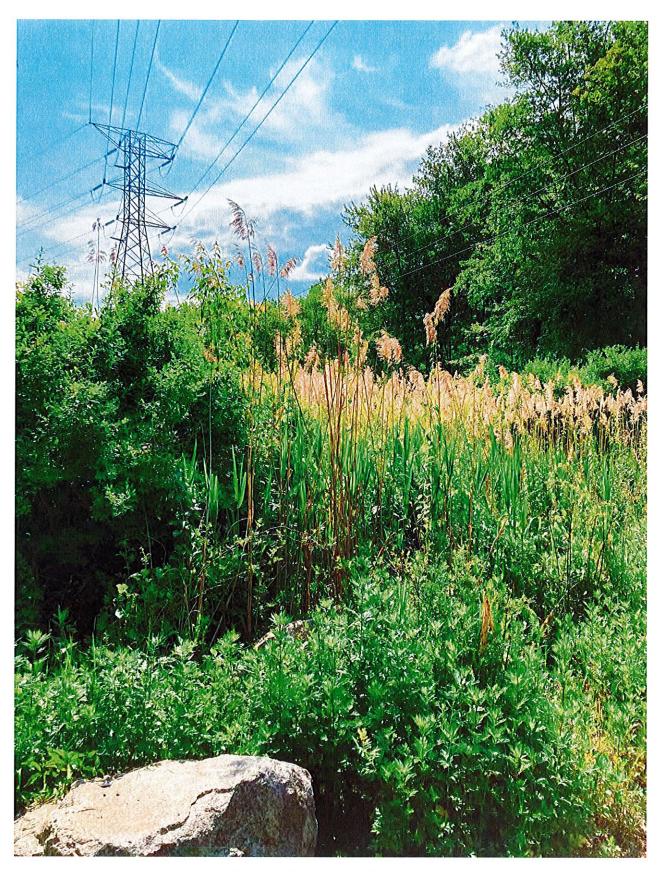
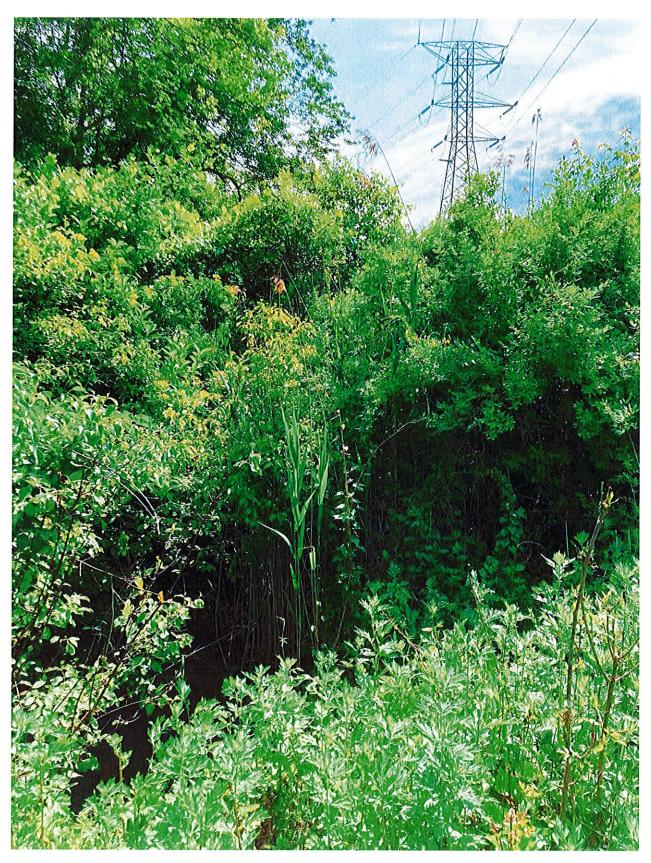
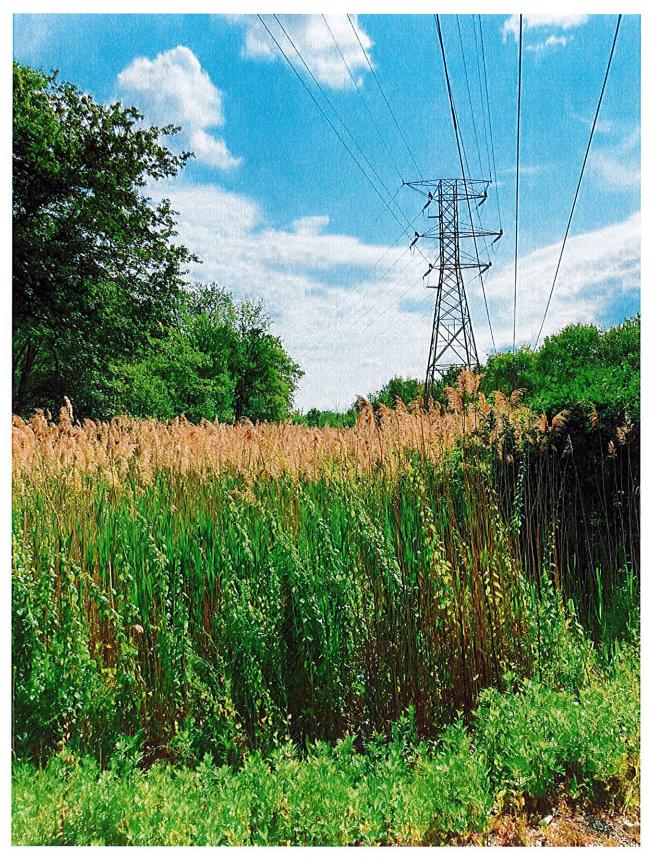
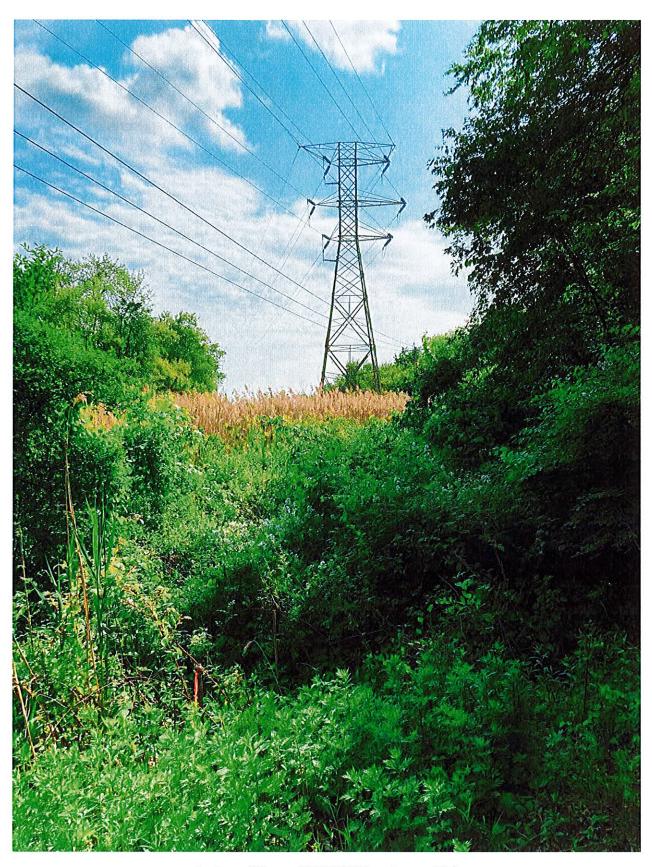
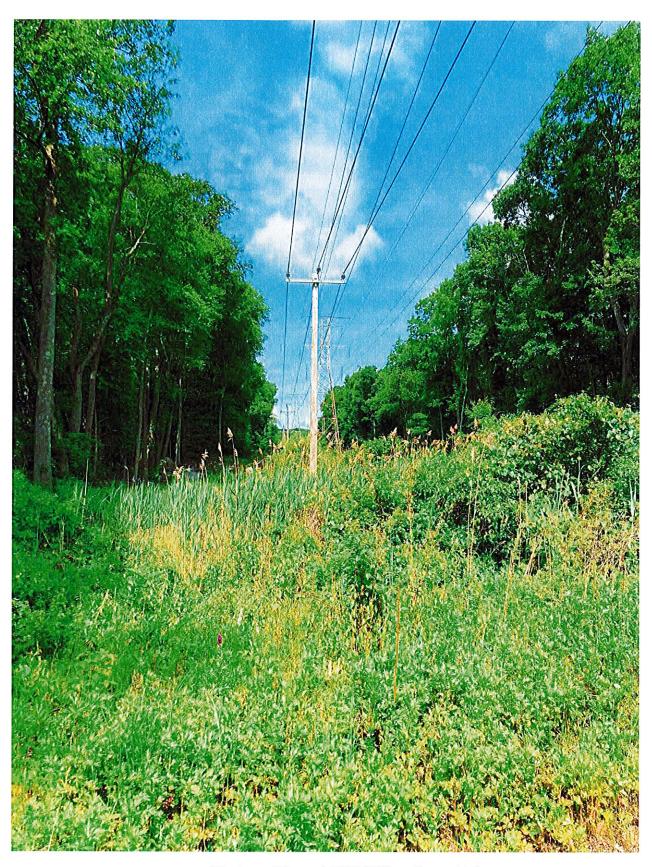
- 13. Photographs illustrating the Common Reed's dominance of the ROW adjacent to the Property have been attached as Exhibit C. The photographs were taken by Attorney Conant on June 9, 2023. The photographs illustrate Eversource's total failure to prevent the proliferation of invasive species in the ROW.

Southeastern View of ROW (Clover Drive side, above Culvert)

Eastward View of Copts Brook (prior to Culvert)
