## Docket No. 272 - Development and Management Plan Inspection

## **Beseck Switching Station**

Date:	May 4, 2006
Inspector:	Matthew Creighton
Location:	Beseck Switching Station

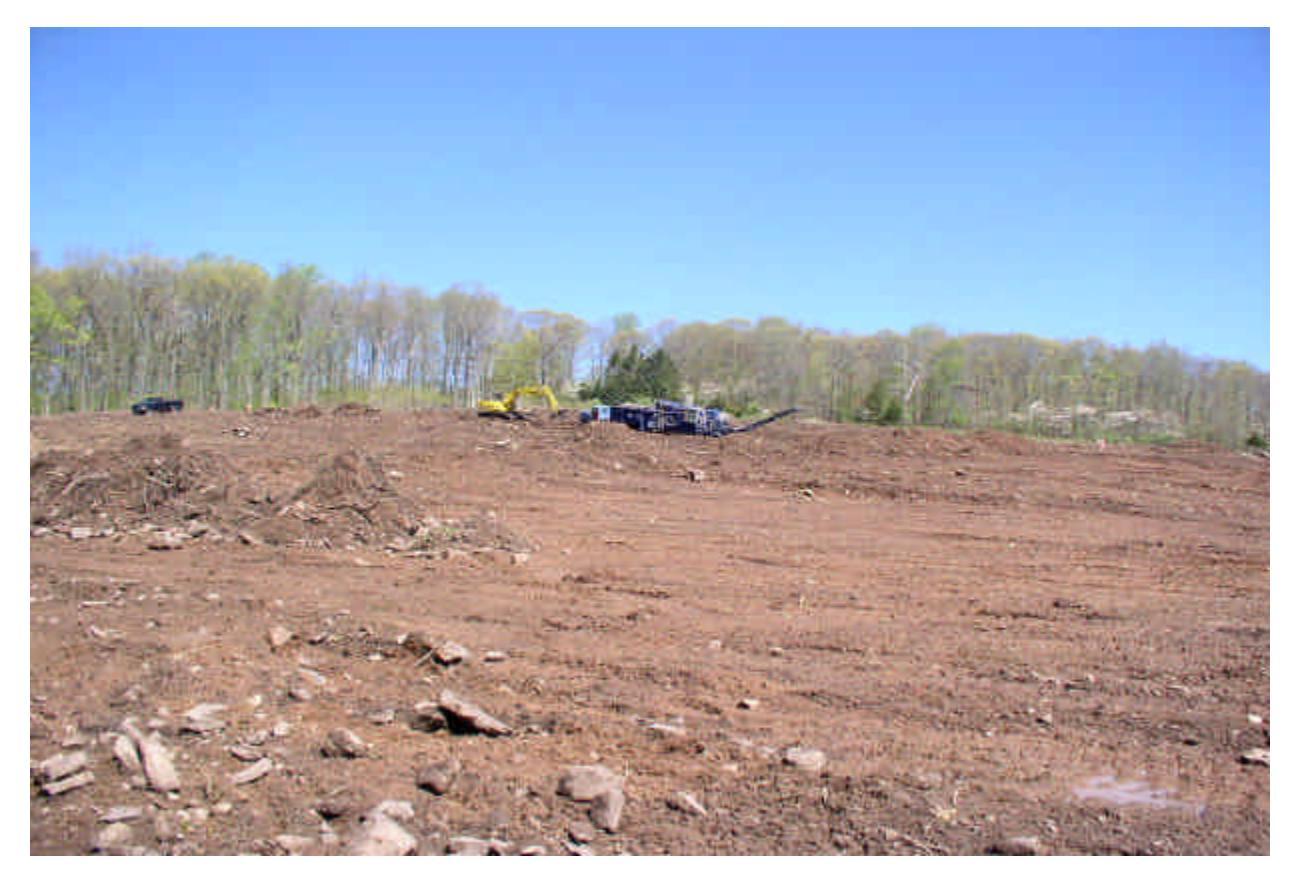
Entire site viewed from southeast corner toward northwest.

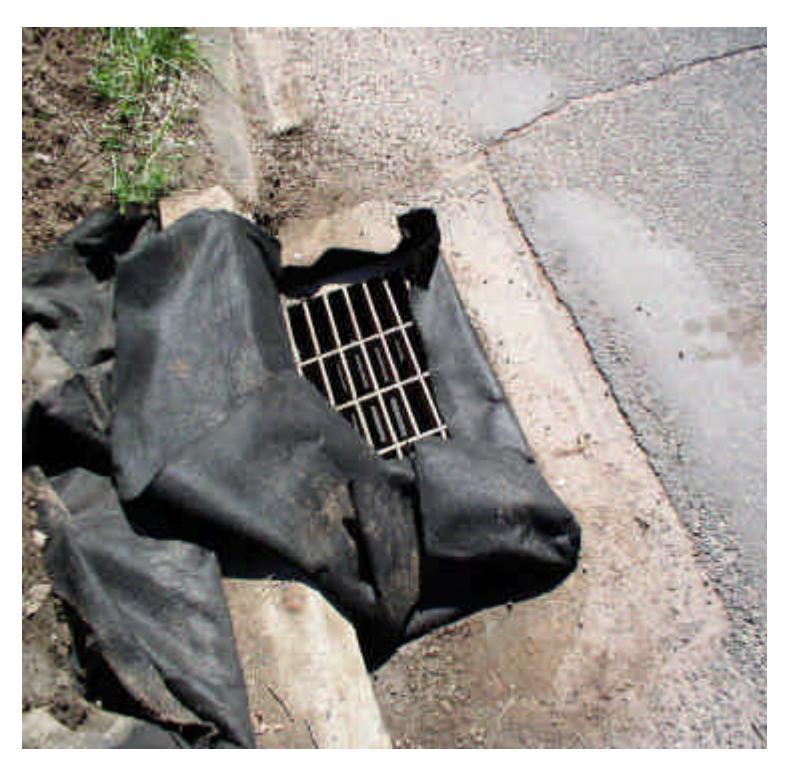
Catch basin on Carpenter Lane protected with silt sack.

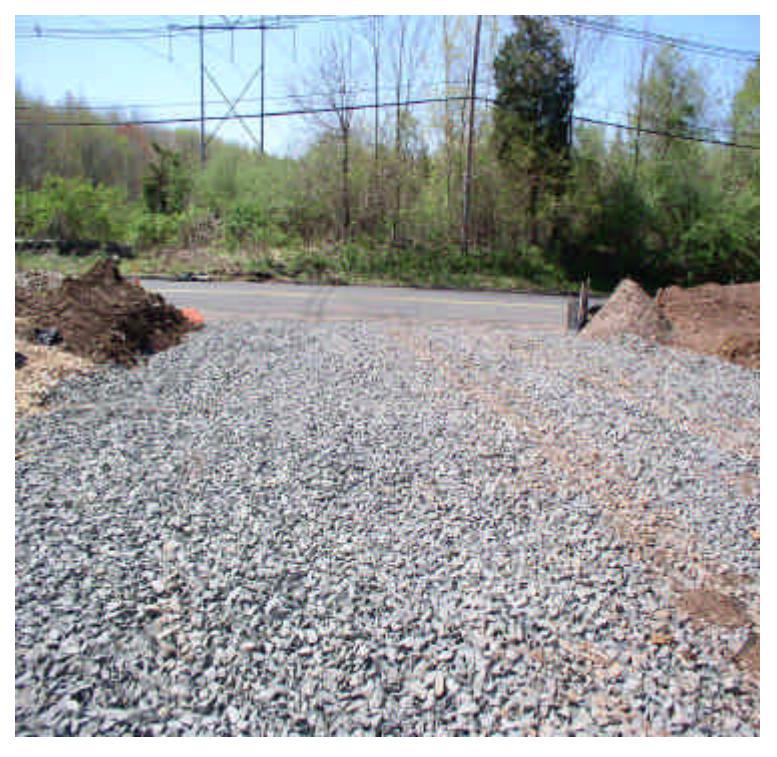
Crushed stone construction entrance at Carpenter Lane.

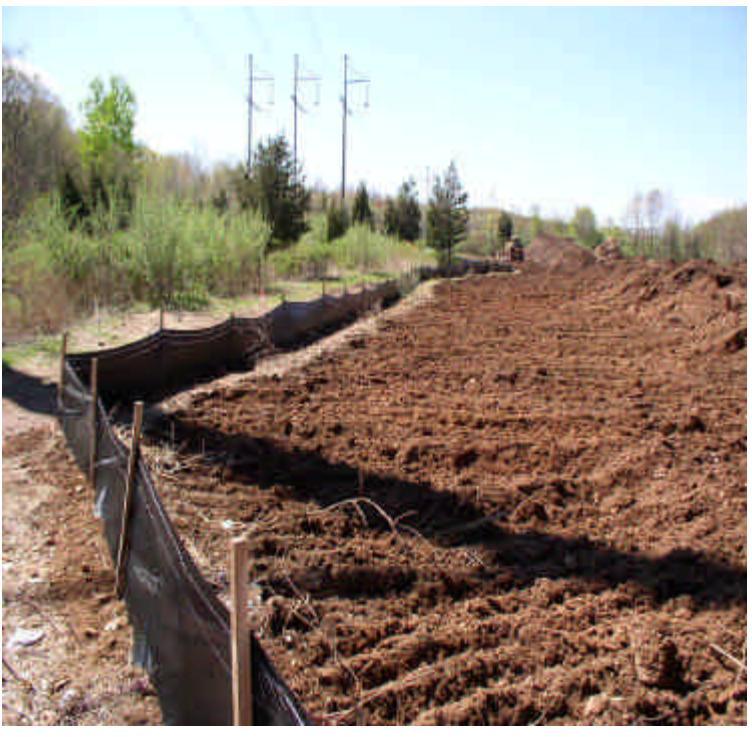
Silt fence installation is complete around the eastern and western work limit lines.

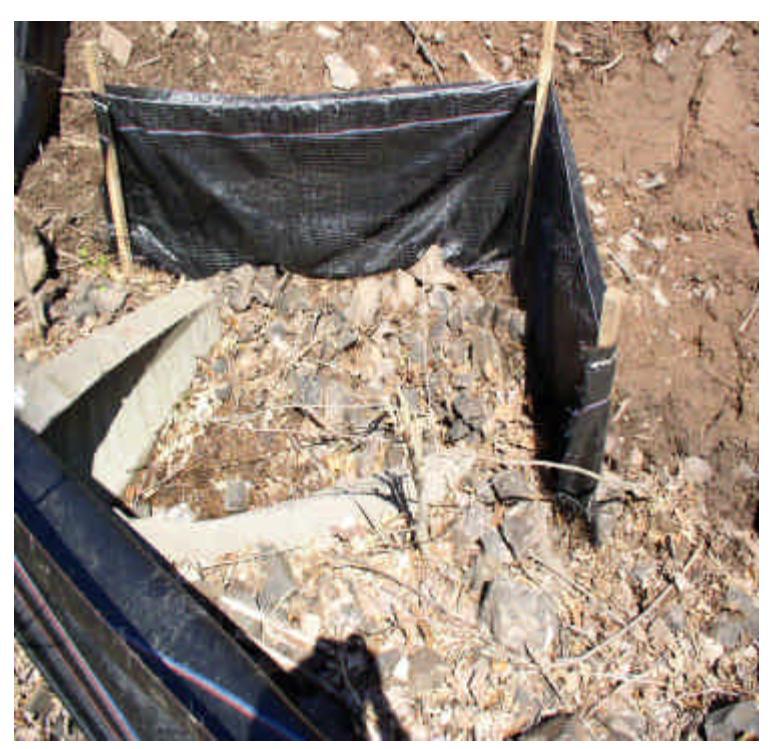
Storm drain inlet (leading to wetland across Carpenter Lane), with secondary silt fence and riprap in place.

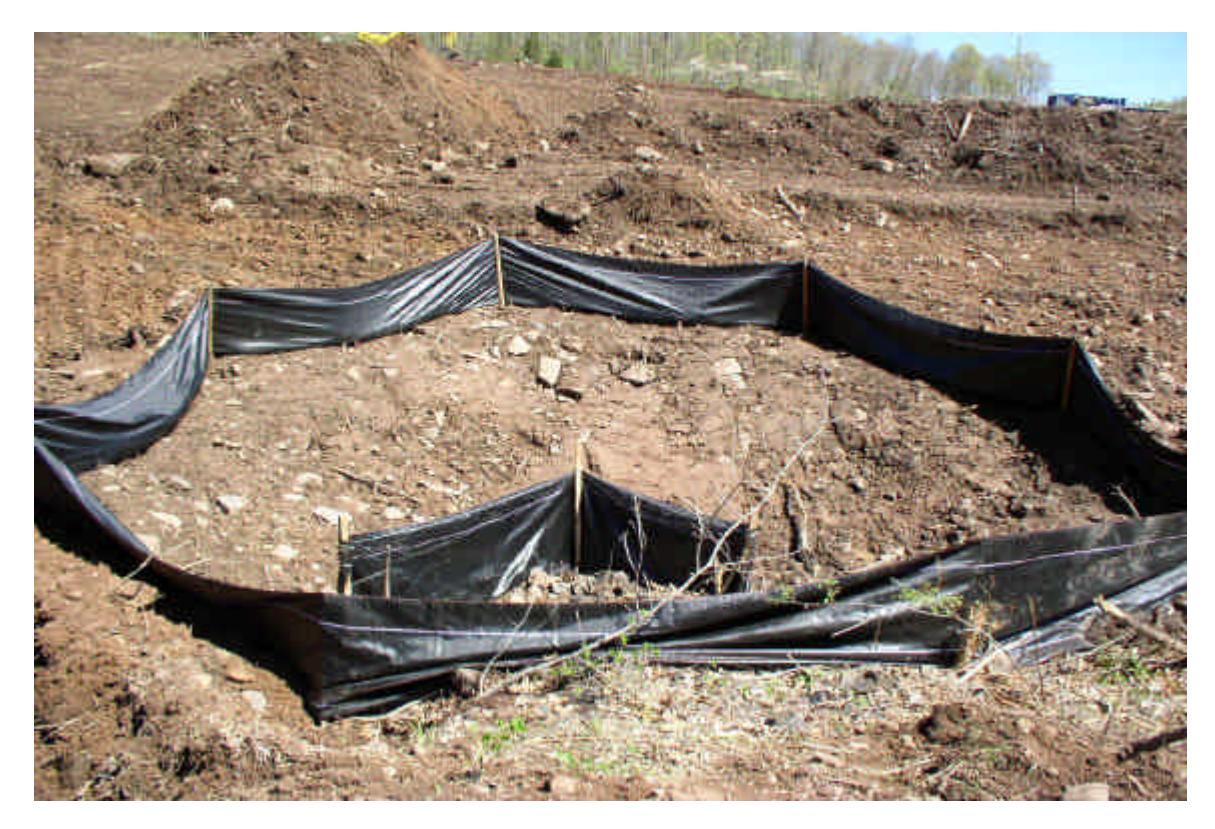
Additional silt fence was installed around the storm drain inlet. Consider providing stabilization measures within the enclosure to further reduce potential sedimentation.
