Merrick Brook Habitat Restoration Project

Location: Scotland, public property
Talbot Wildlife Management Area

Completed: September 1998

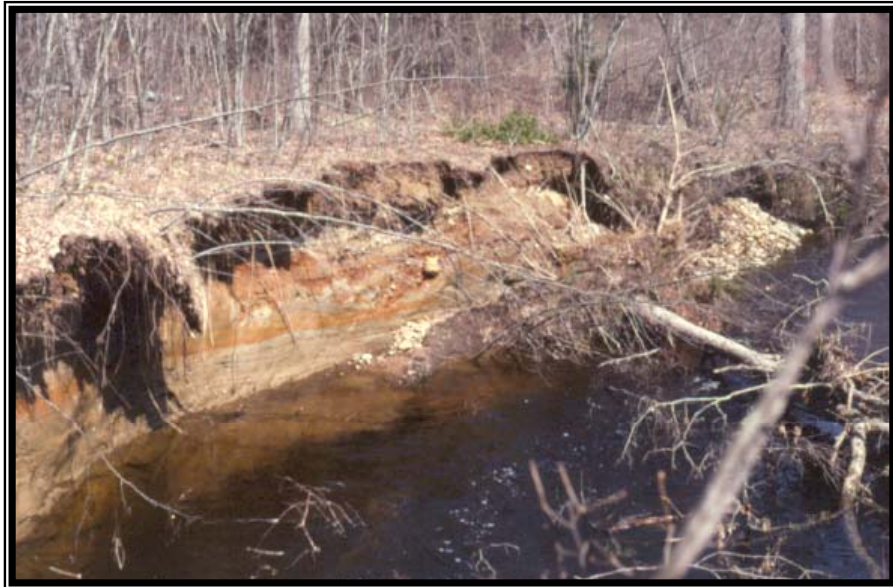
Approximately 350 linear feet of streambank along a channel meander of Merrick Brook was severely eroded causing a collapse of the streambank and degradation of instream and riparian resources. Irregular stream geometry was the suspected cause of channel instability (low radius of curvature) which resulted in an estimated loss of 400-600 tons of sediment from between 1982 and 1998. Primary objectives were to: (1) restore and stabilize streambanks and channel to correct local erosion problems, (2) decrease downstream sediment loading, and (3) restore instream fish and riparian habitats.

Meander bend bank erosion and instability in 1996 prior to restoration efforts.

Restoration design focused on increasing the radius of curvature and bankfull width ratio. These design parameters were consistent with stable meanders studied at unimpacted reference sites within Merrick Brook. To achieve the higher radius of curvature, 60 ft. of existing channel was realigned, 150 ft. of new channel was created through a forested floodplain, and a total of 140 ft. of channel was abandoned and converted to floodplain and vernal pool habitat. Bank and instream structures were installed which included vortex rock weirs, rock vanes, and root wads. These structures provided for grade control, energy dissipation and flow deflection in the restored channel as well as restored wild brown and native brook trout habitats through the creation of scour pools and a deep narrow thalweg adjacent to overhead and instream cover. Soil bioengineering techniques were used for bank protection and for the creation of a stable riparian area featuring indigenous plant materials.

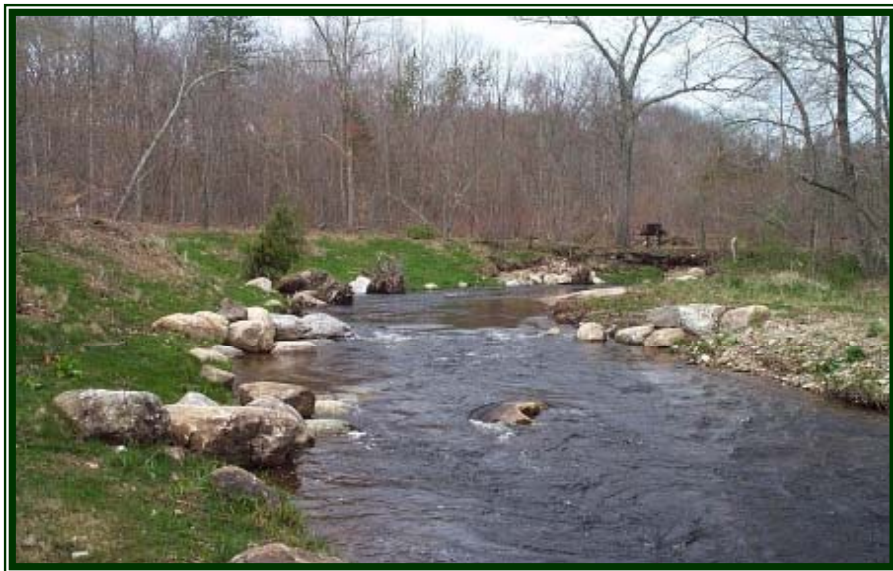
Meander bend and bank stabilization fall 1998, 2 months post restoration.

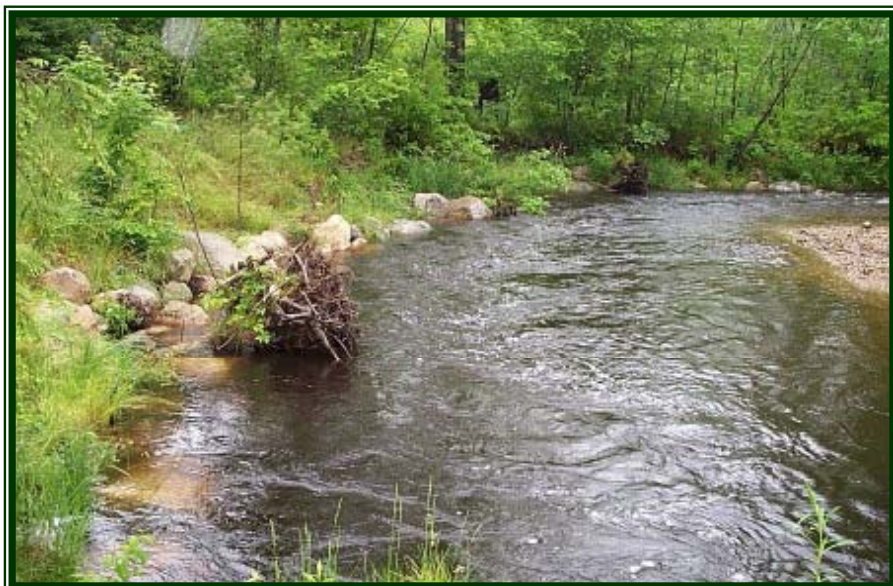
Meander bend and bank stabilization in 2002, 4 years post restoration.

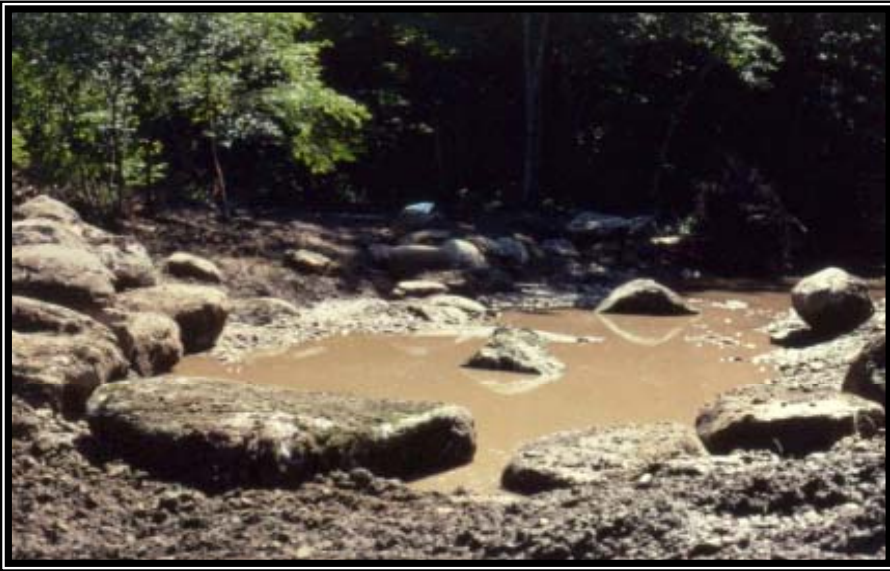
Construction of vortex rock weir designed to create pool mesohabitats and redirect water toward centerline of stream and away from streambanks.

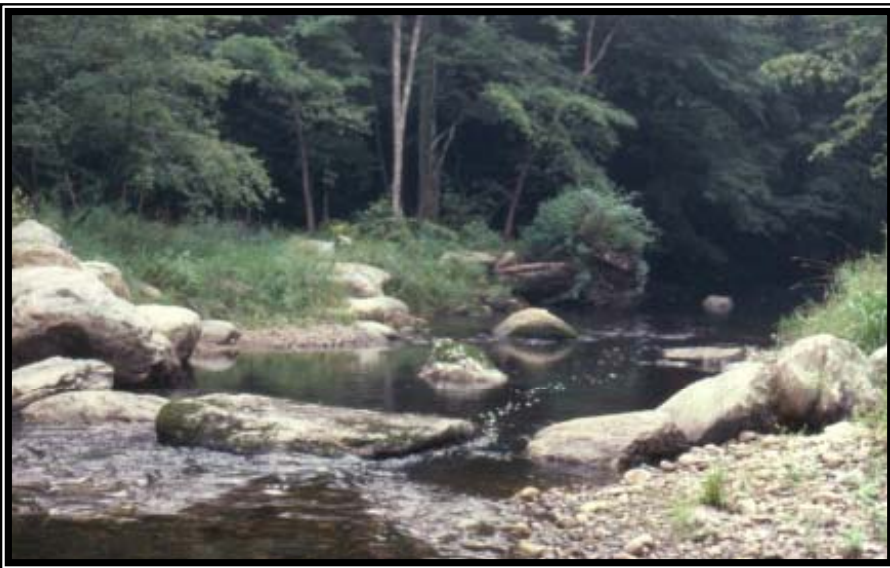
Vortex rock weir during low flow conditions providing critical deep pool habitat, 1 year post restoration.

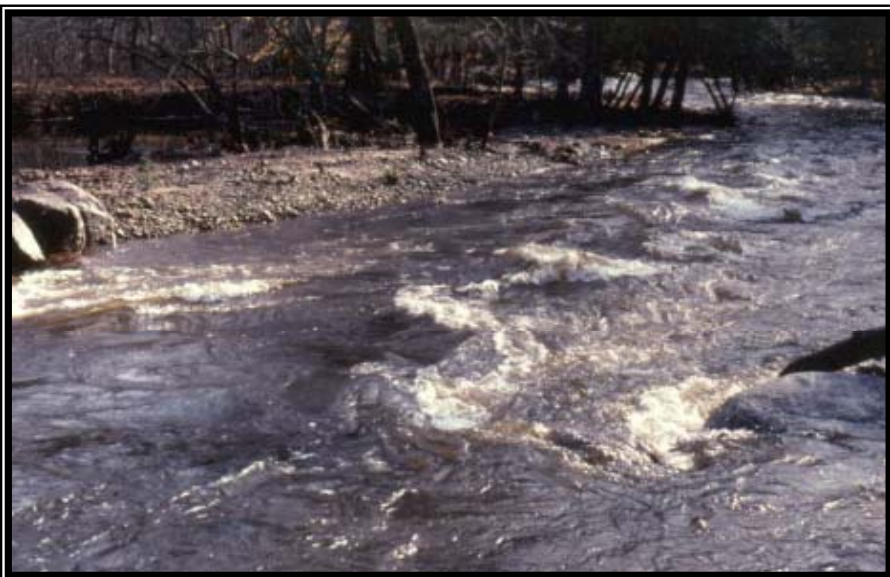
Vortex weir functioning to redirect high flows away from streambanks and towards centerline of stream.
