ENVIRONMENTAL REVIEW REPORT

**Community Development Block Grant – Disaster Recovery
Owner Occupied Rehabilitation and Rebuilding Program**

Applicant # 1398

**91 Longdean Road
Fairfield, Connecticut**

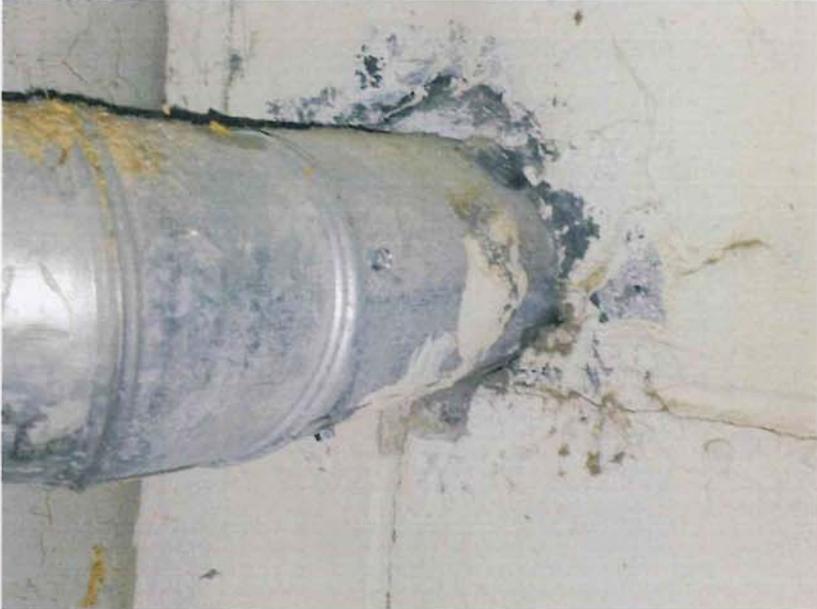
Photograph No.: 1	Date: 5/23/17
Description: Basement—Asbestos-containing Flue Packing

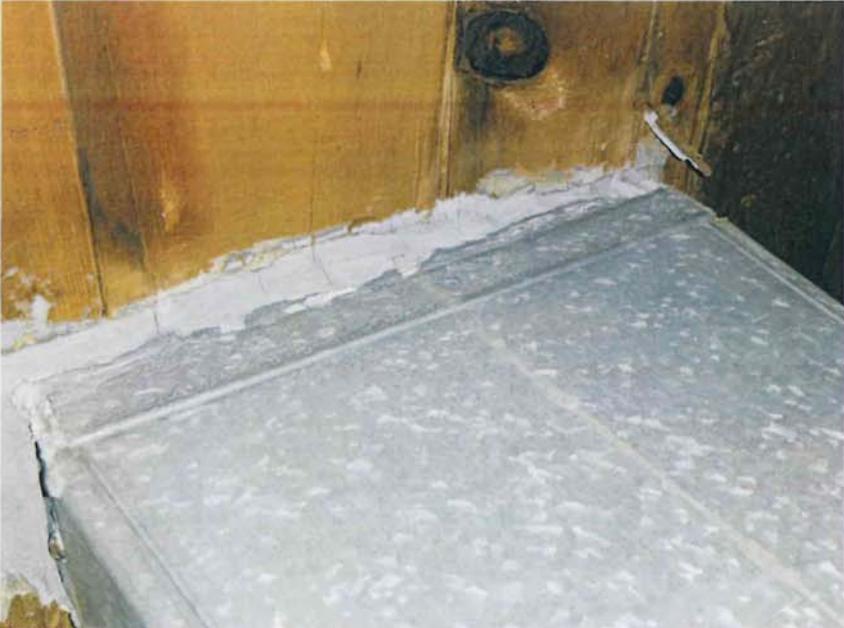
Photograph No.: 2	Date: 5/23/17
Description: Basement—Asbestos-containing Duct Penetration Sealant

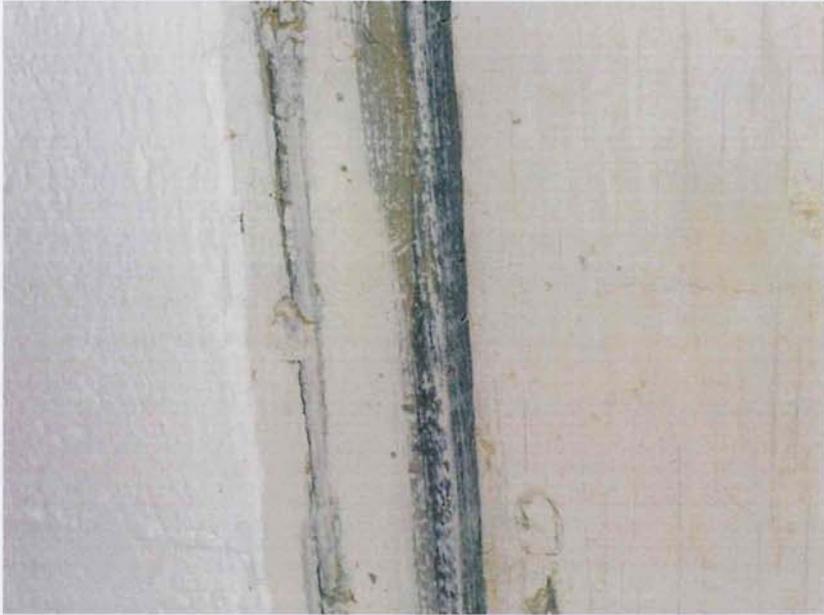
Photograph No.: 3	Date: 5/23/17
Description: Basement—Asbestos-containing Door Frame Caulking

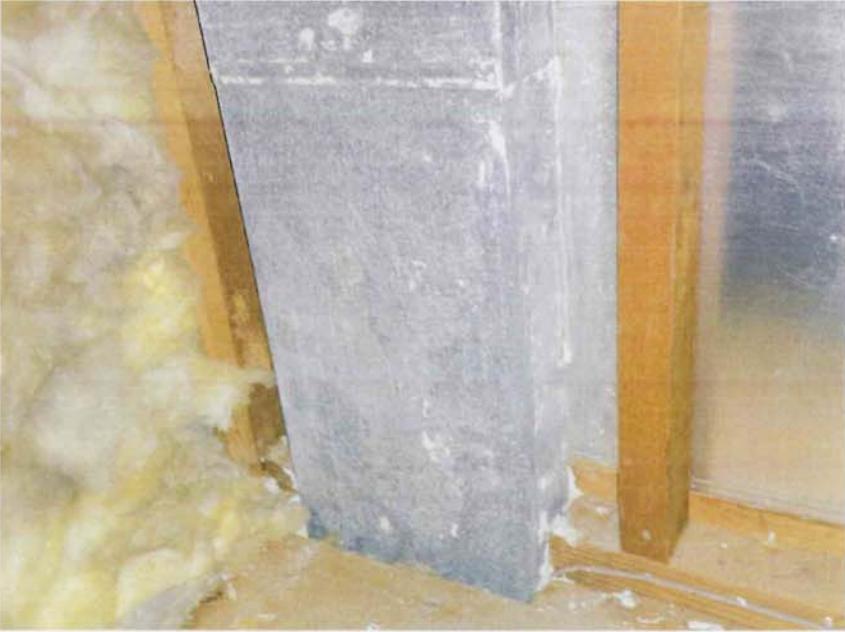
The asbestos-containing duct wrap observed within the second-floor crawlspace was significantly damaged. A CTDPH-Licensed-Asbestos Abatement Contractor should be retained to clean up/abate the ACM in accordance with CTDPH Standards for Asbestos Abatement (19a-332-1 through 19a-332-16) prior to renovation work in the area. This is recommended to be conducted regardless if renovation work in the area is anticipated to disturb the ACM.

Photograph No.: 4	Date: 5/23/17
Description: 2nd Floor—Crawlspace—Residual Asbestos-containing Duct Wrap
