ENVIRONMENTAL REVIEW REPORT

**Community Development Block Grant – Disaster Recovery
Owner Occupied Rehabilitation and Rebuilding Program**

Applicant # 1036

**21 Tremont Street
Milford, Connecticut**

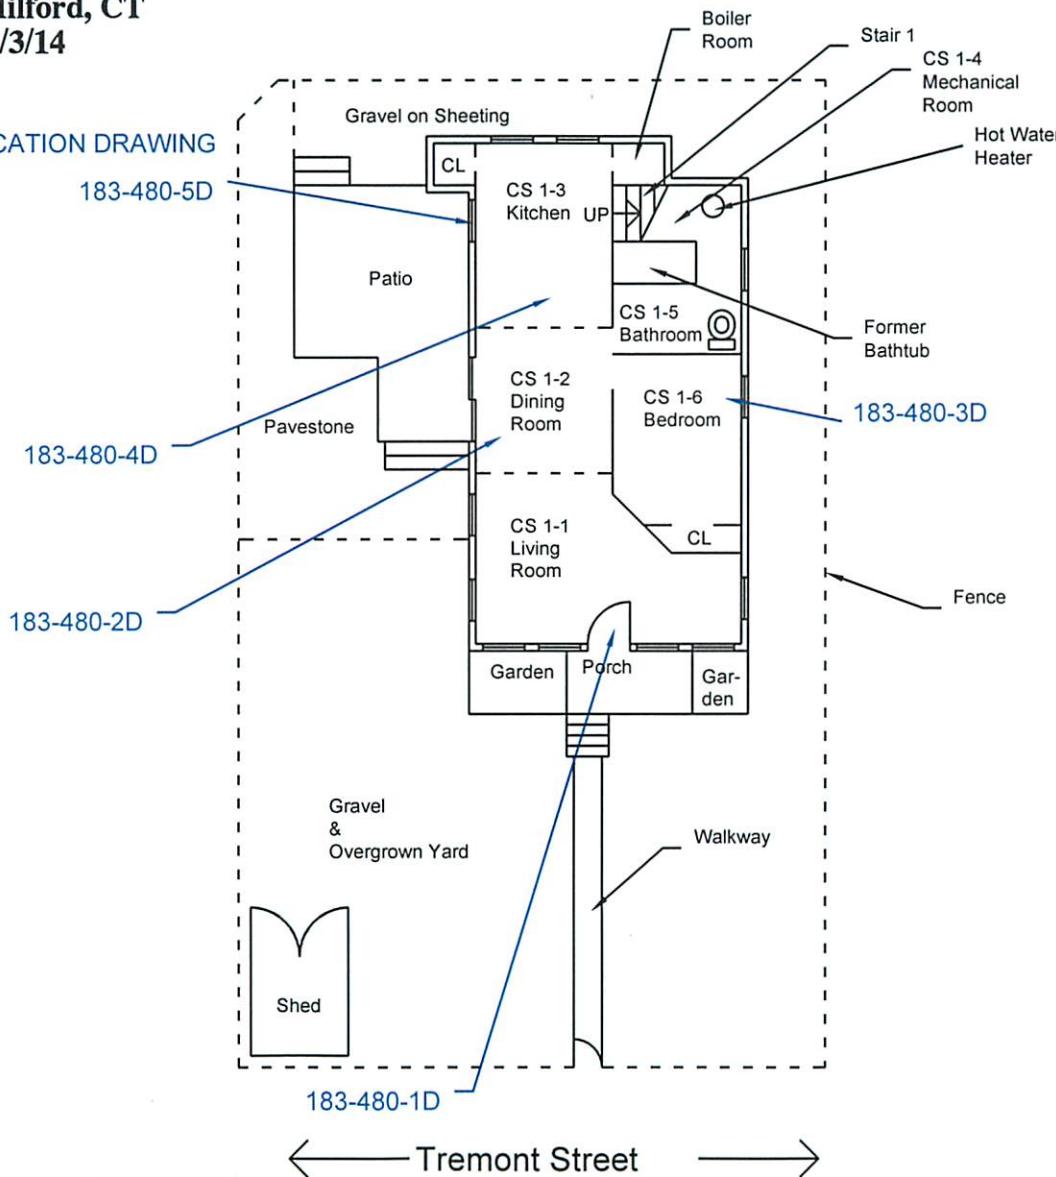
LEAD IN DUST SAMPLE LOCATION DRAWING

Five of the nine dust samples collected were within acceptable levels. A summary list is given below, see attached analysis reports and drawings for details. **Samples noted in bold on the following page exceeded HUD and CT-DPH standards and represent dust-lead hazards. These samples constitute dust-lead hazards in those rooms.**

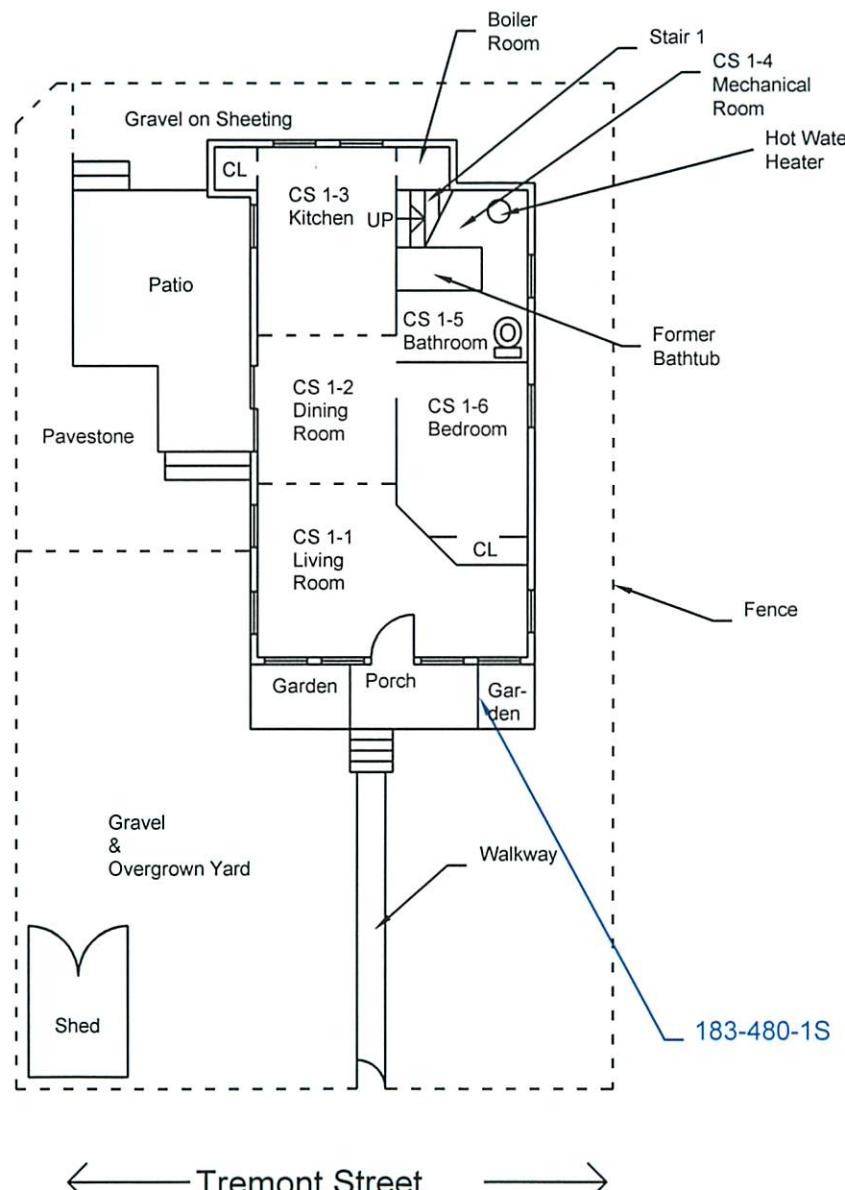
LEAD IN SOIL SAMPLE LOCATION DRAWING

SOIL SAMPLING AND LABORATORY INFORMATION: One (1) soil sample was collected at this residence in accordance with the requirements of ASTM Standard E-1727, Standard Practice for Field Collection of Soil Samples for Lead Determination by Atomic Spectrometry Techniques. The soil sample identified lead concentrations below the levels that EPA, HUD or CT-DPH identifies as hazardous. See the following table for a summary of the soil sampling results. Please refer to *Appendix C – Soil Sample Analytical Data* for the detailed analytical reports.
