ENVIRONMENTAL REVIEW REPORT

**Community Development Block Grant – Disaster Recovery
Owner Occupied Rehabilitation and Rebuilding Program**

**25 Jarvis Court
Fairfield, CT**

**Limited Hazardous Materials Building
Inspection Report**

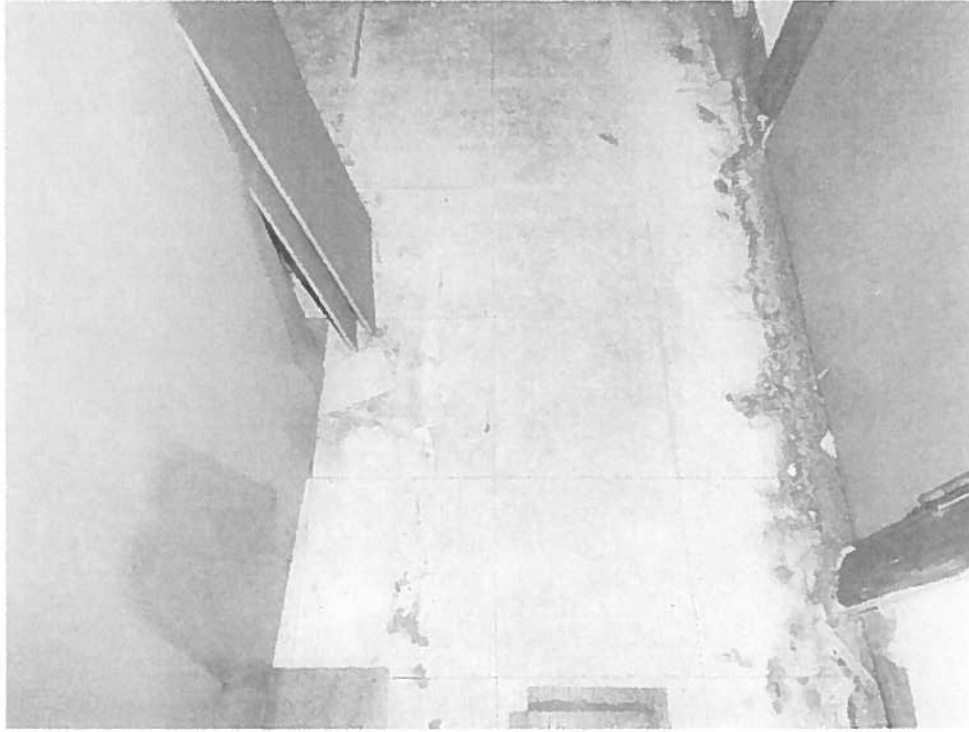
ACM 9"x9" Tan Floor Tile

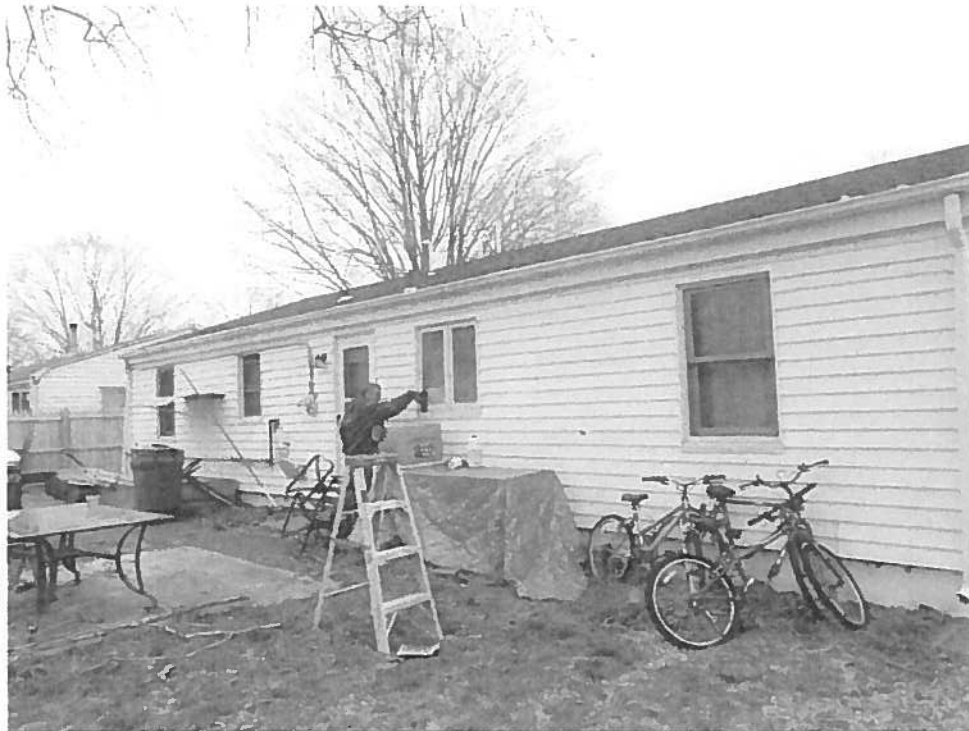
Side C Exterior (lead paint identified on upper face board)
