ENVIRONMENTAL REVIEW REPORT

**Community Development Block Grant – Disaster Recovery
Owner Occupied Rehabilitation and Rebuilding Program**

**9 Derby Avenue
Milford, Connecticut**

**ASBESTOS PRE-RENOVATION INSPECTION
MACIAG RESIDENCE – 9 DERBY AVENUE, MILFORD, CT
APPLICATION #1405
CS#190-150, 2/29/2016, PAGE 1 OF 4**

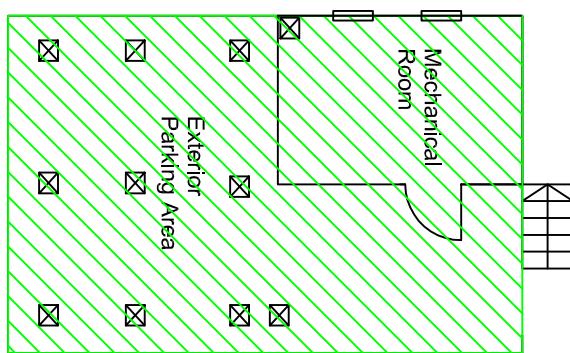
CS# 190-150
NOT TO SCALE
S-1

SCOPE OF INSPECTION
See Report for Detail
