**ENVIRONMENTAL REVIEW REPORT**

**Community Development Block Grant – Disaster Recovery  
Owner Occupied Rehabilitation and Rebuilding Program**

**94 Longdean Road  
Fairfield, Connecticut**

# **Limited Hazardous Materials Building Inspection Report**

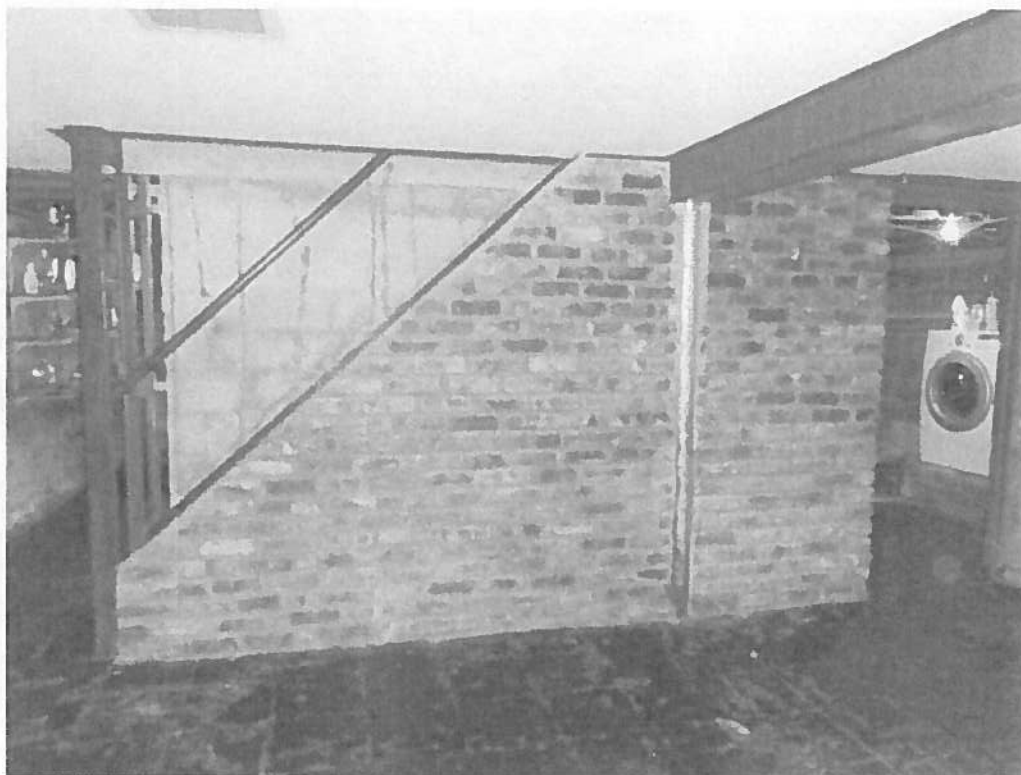
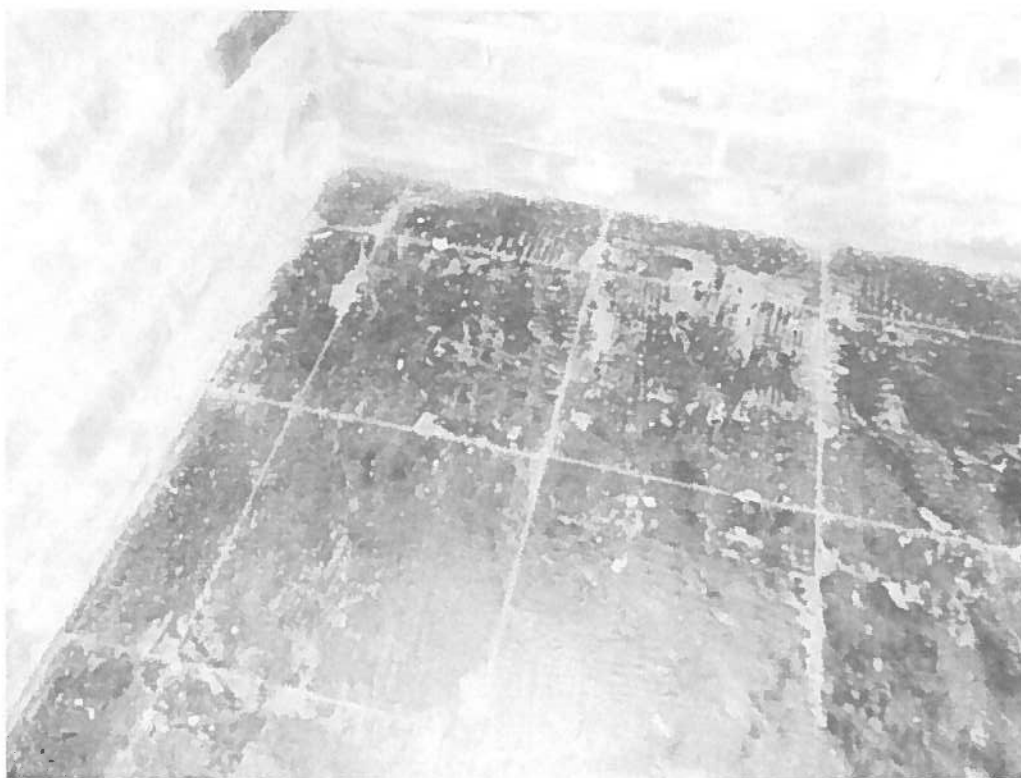
**Basement ACM Black Floor Mastic**

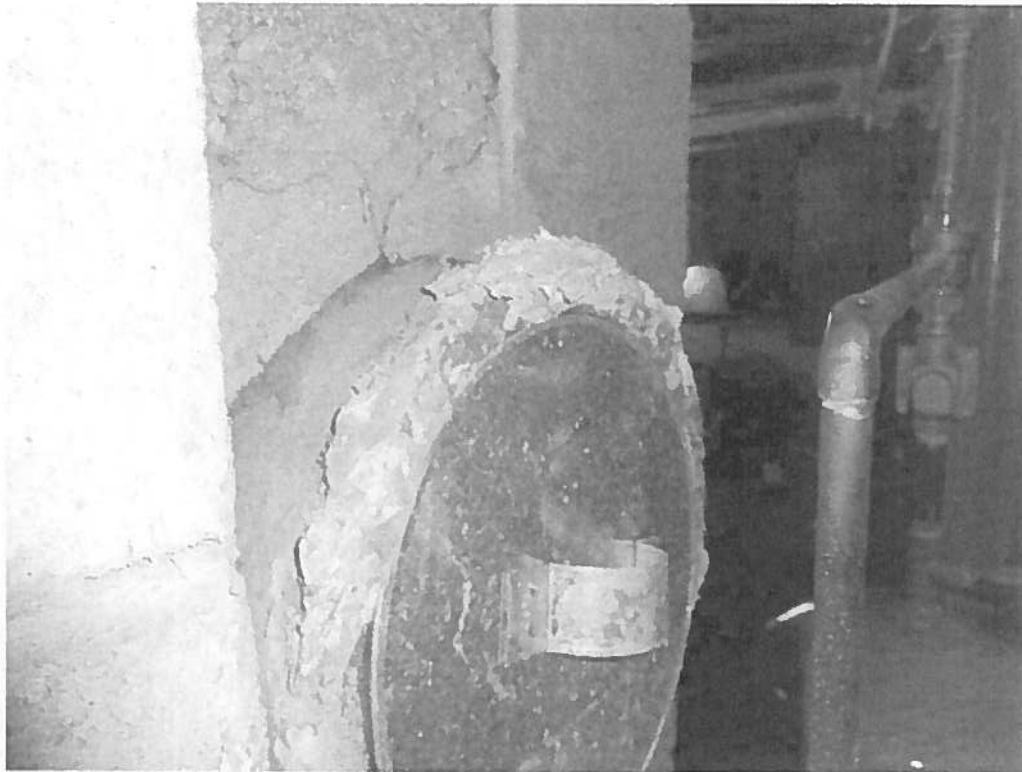
**ACM Chimney Flue Cement**

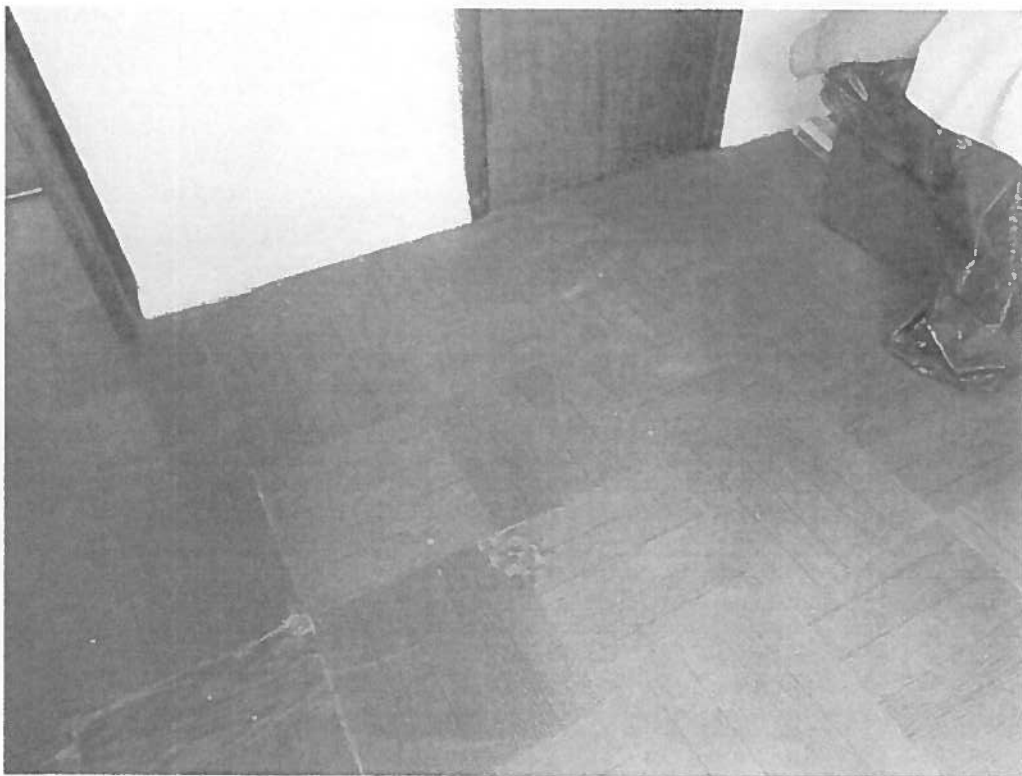
**2<sup>nd</sup> Floor ACM Brown Self-Stick Floor Tile**
