Wetlands and Watercourses – Wallingford Renewable Energy
Photos taken in October and November 2017, by REMA Ecological Services, LLC

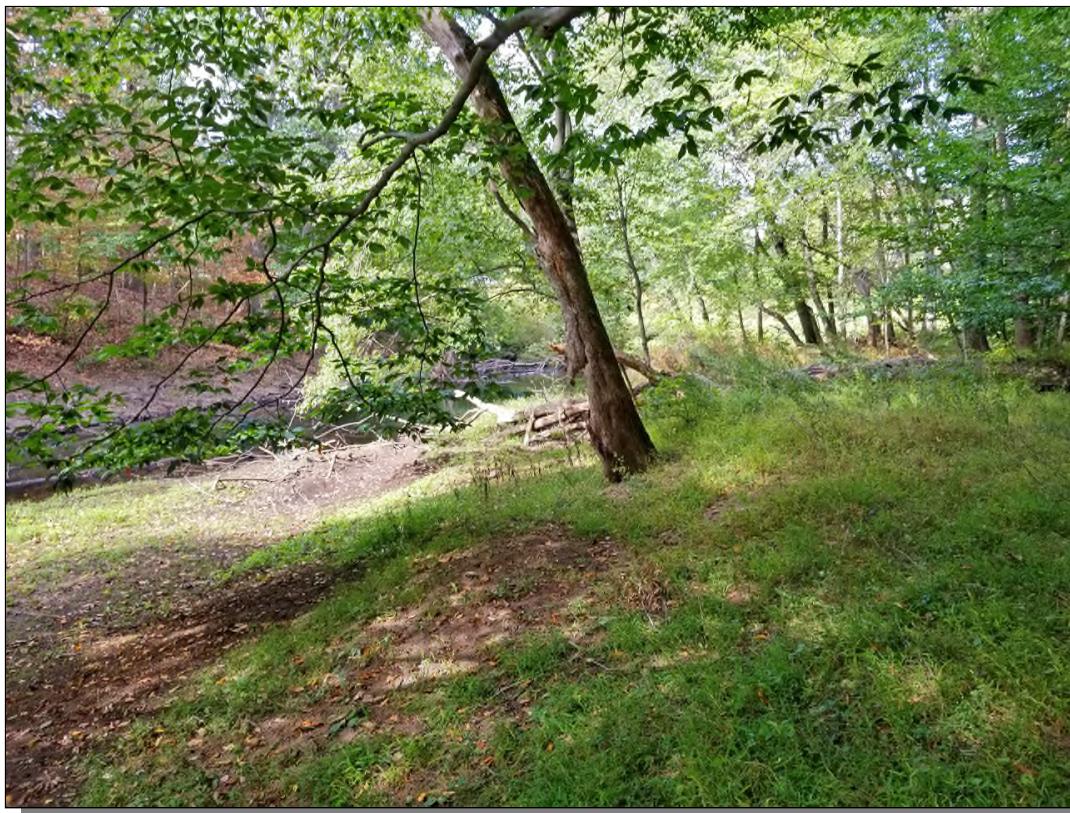
Photo 7A: Wetland A2; MIRA Property; note floodplain terraces dominated by annuals in the herb layer, poorly to very poorly drained; facing northwesterly

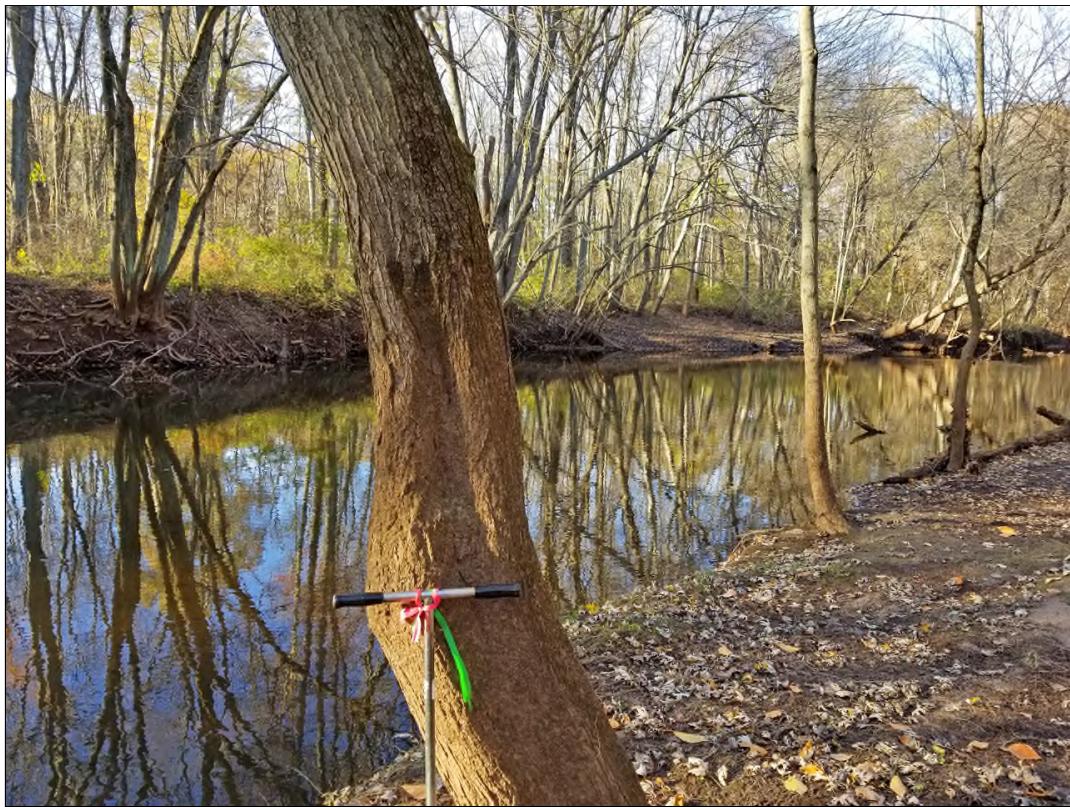
Photo 8A: Wetland A2 (MIRA Property); note silt staining several feet above soil auger, indicating flood level; facing northwesterly

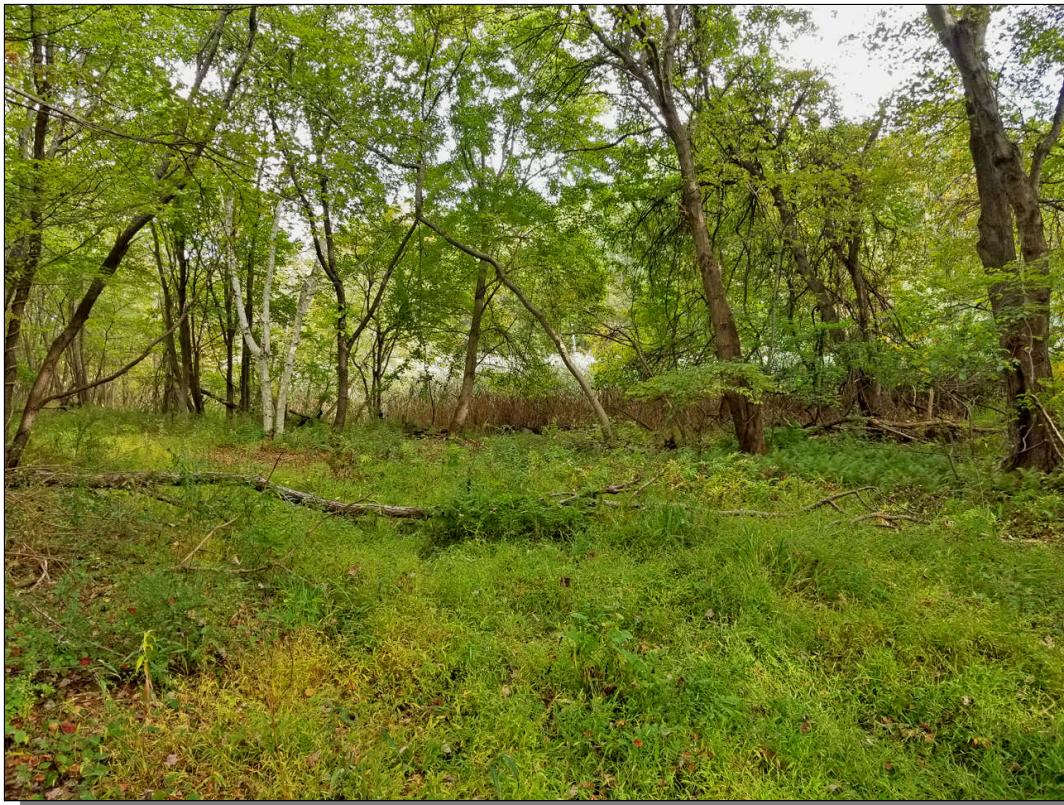
Photo 7B: Wetland B2; western section; note Phragmites in background; facing southeasterly

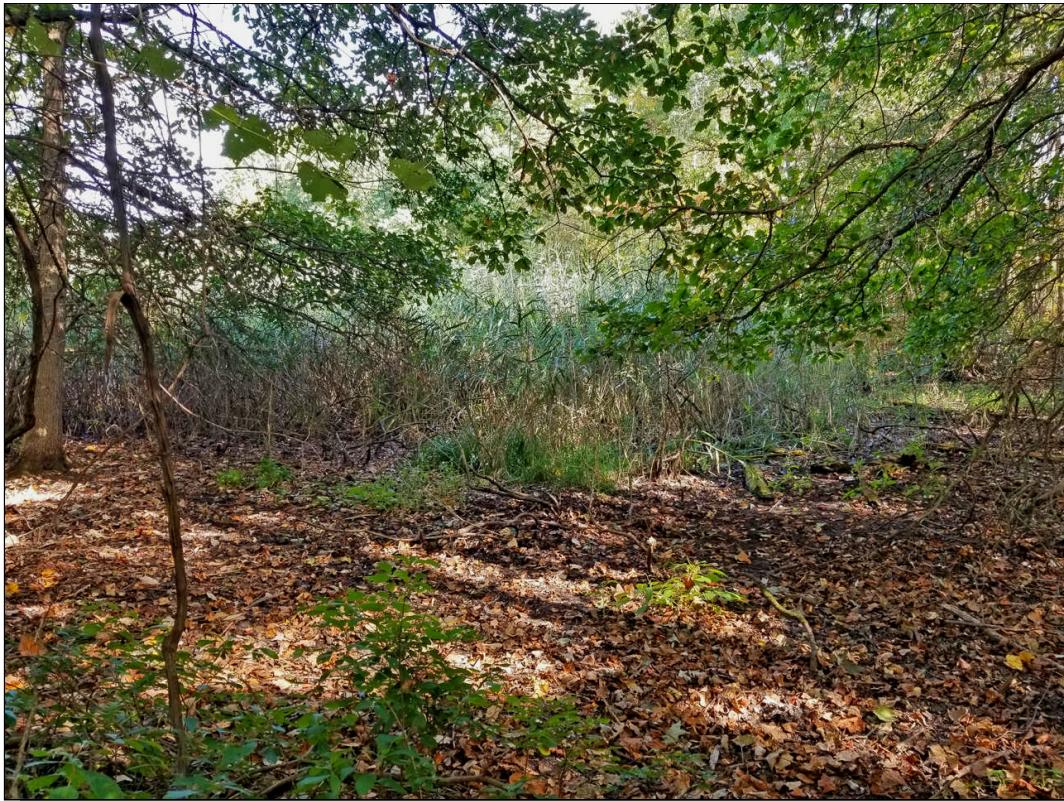
Photo 8B: Wetland B2, western extent; facing easterly

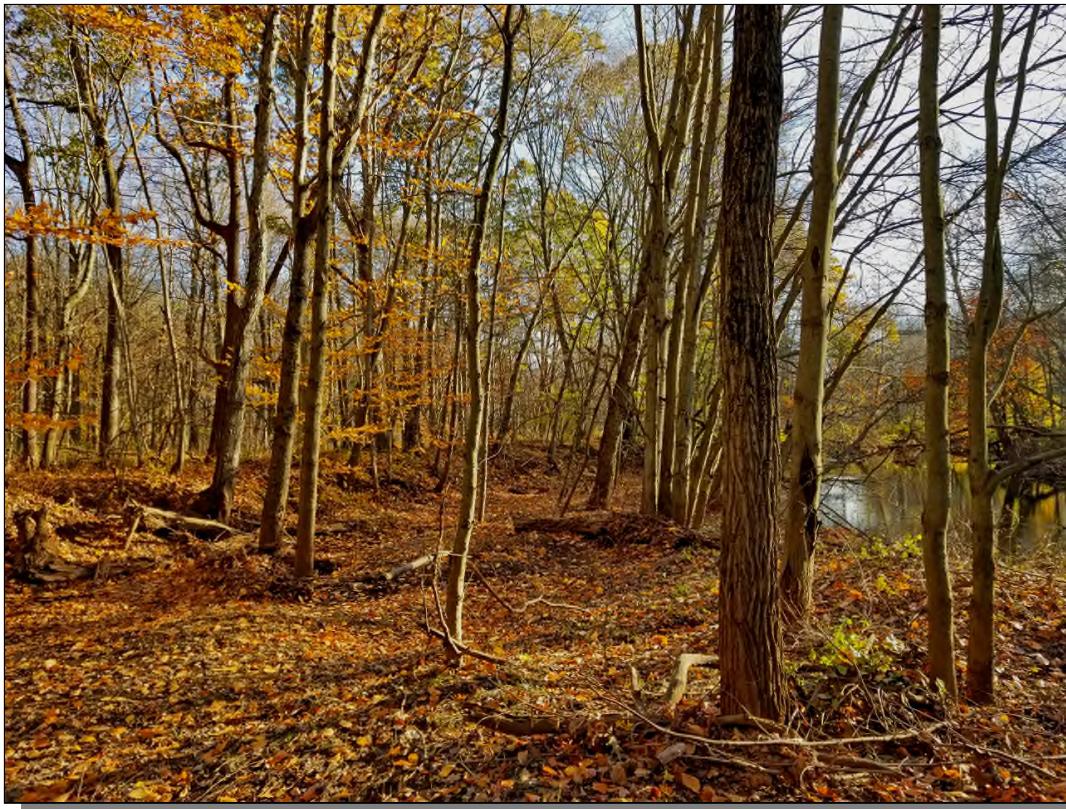
Photo 9A: Wetland A2 (MIRA Property); note higher moderately well drained floodplain terrace to the left; facing southerly

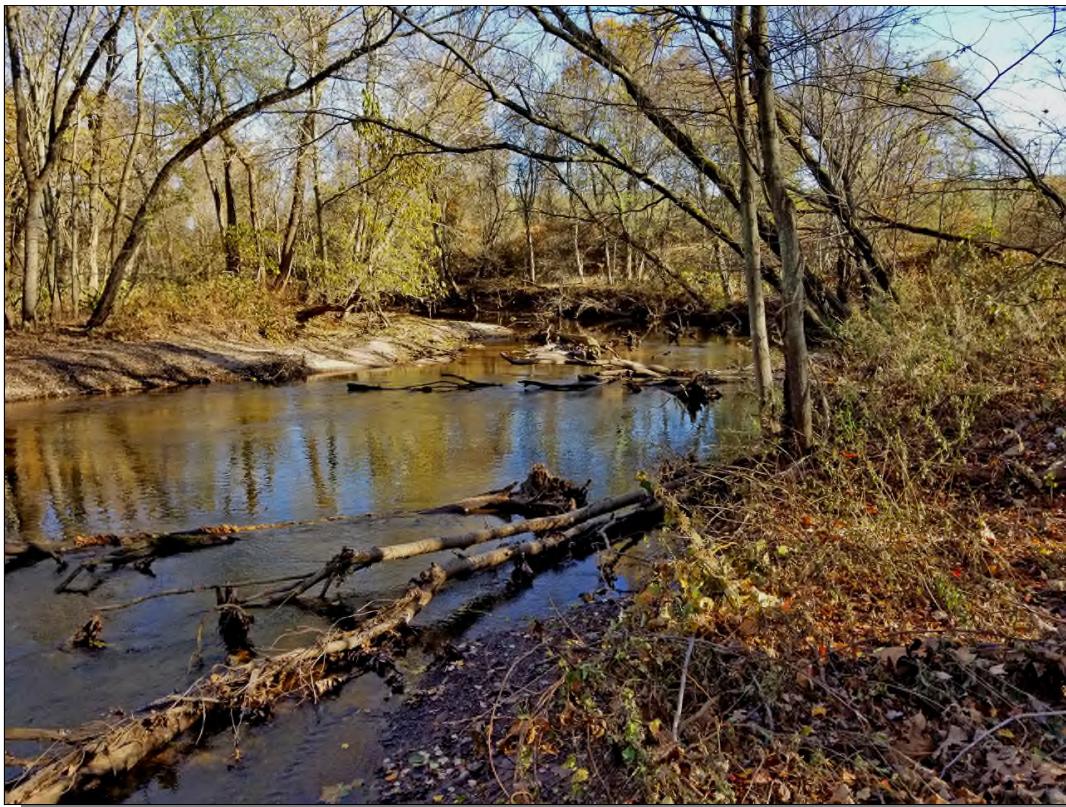
Photo 10A: Wetland A2; Town Property; note landfill in the background; facing easterly

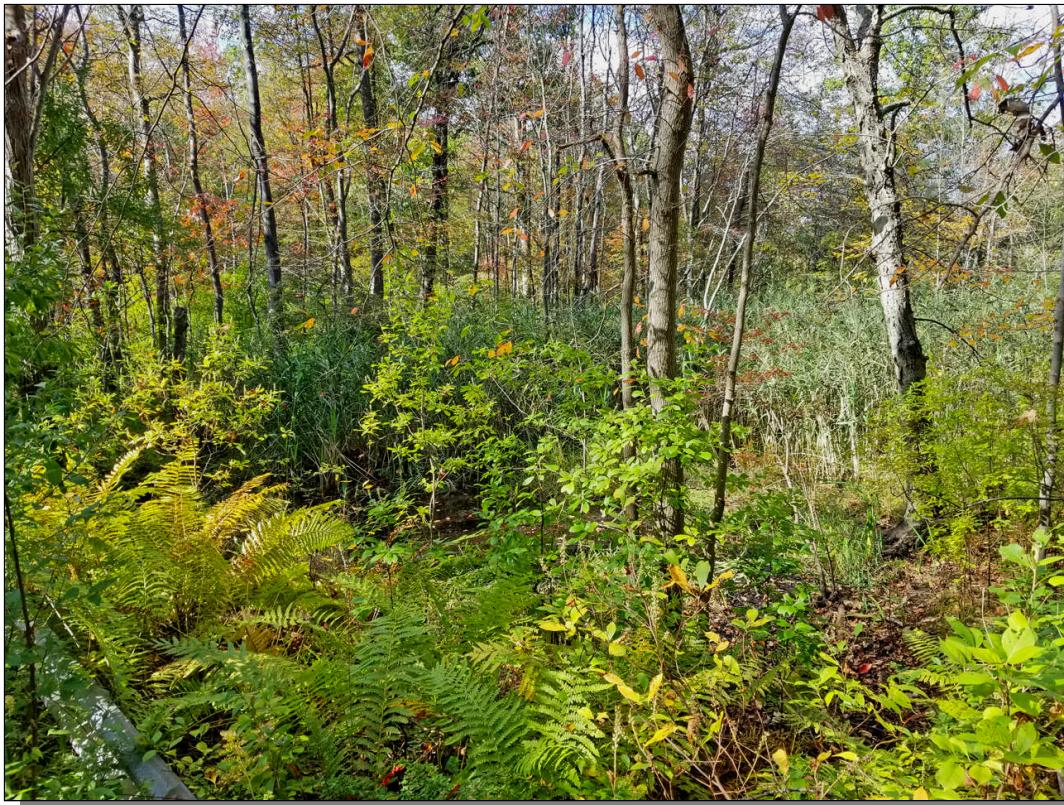
Photo 9B: Wetland B3; southeastern corner; note Phragmites in background; facing northwesterly

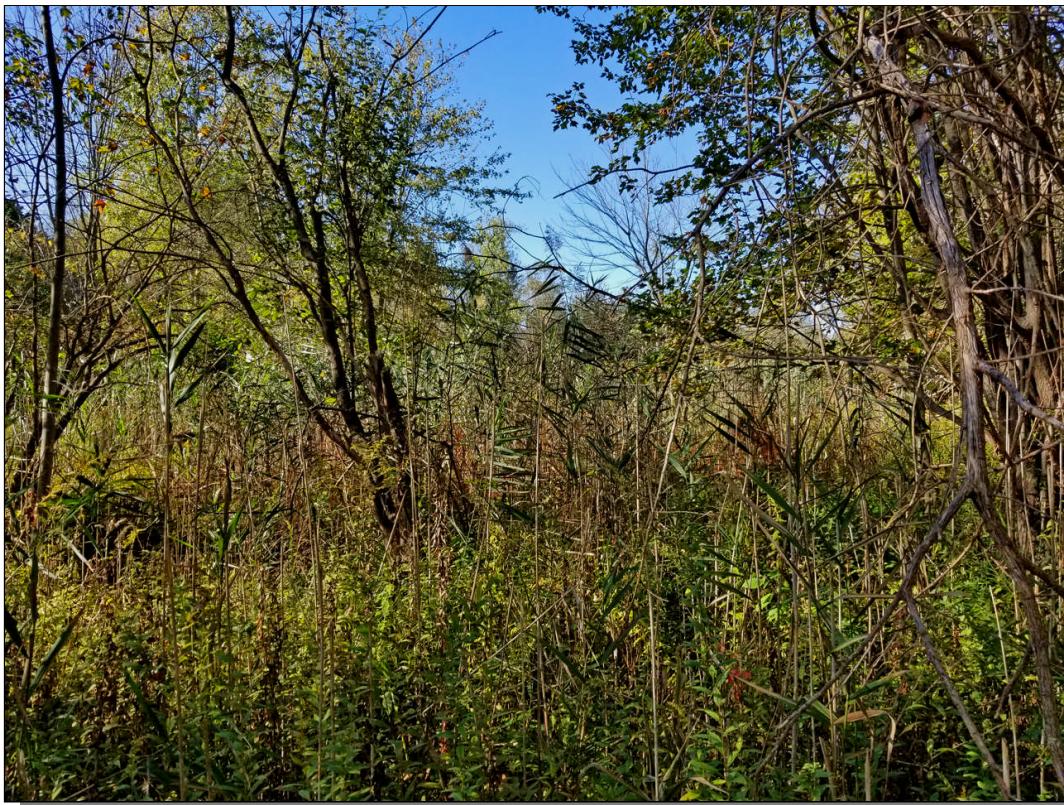
Photo 10B: Wetland B3, eastern edge; facing westerly

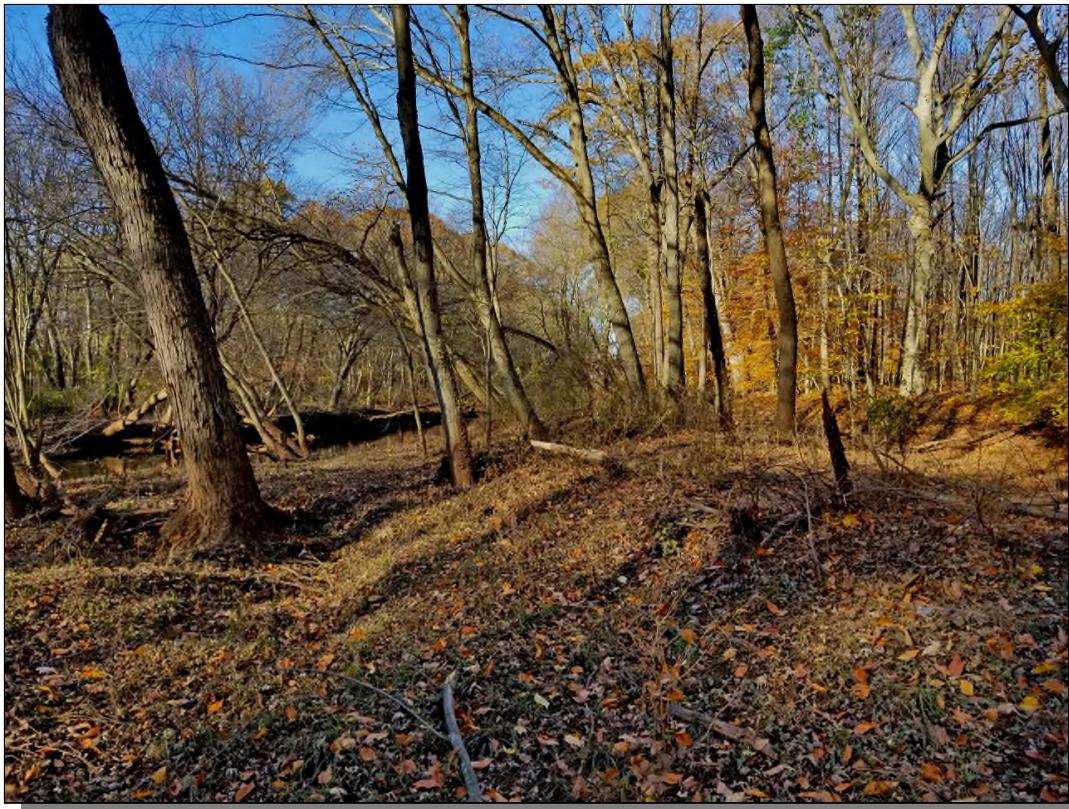
Photo 11A: Wetland A2; MIRA Property; facing northerly

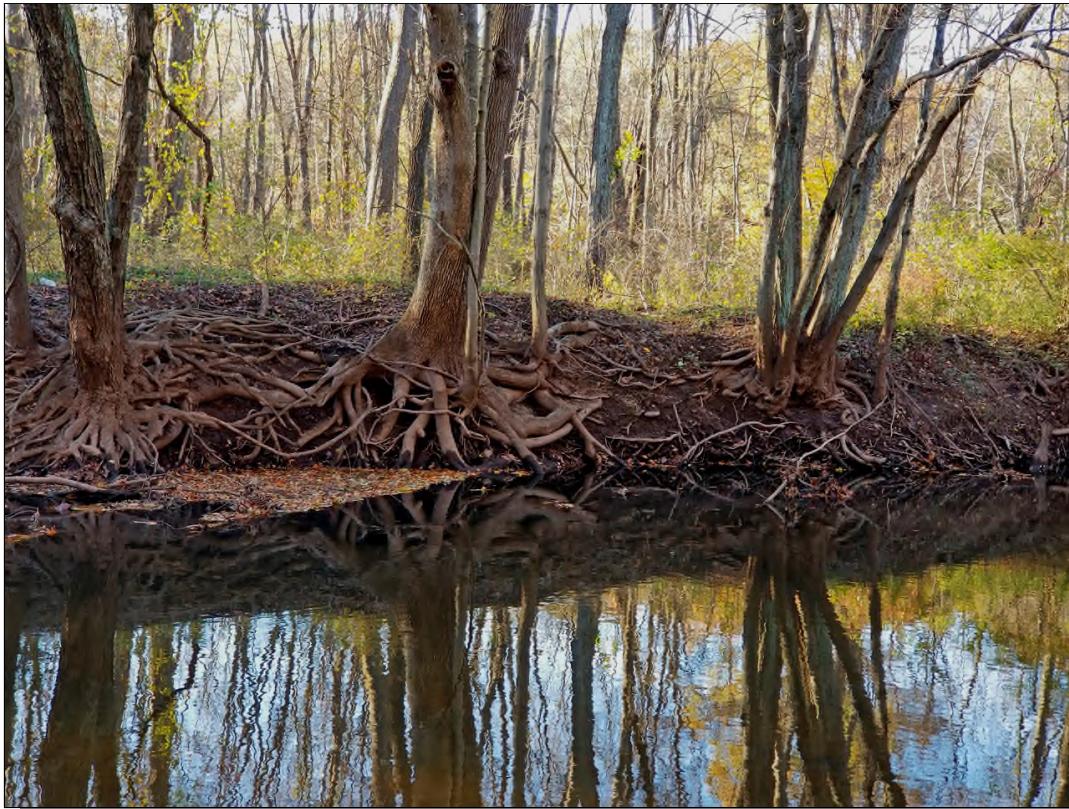
Photo 12A: Wetland A2; western bank of Q. River, across from MIRA Property; showing amplitude of flooding and erosive forces; facing westerly

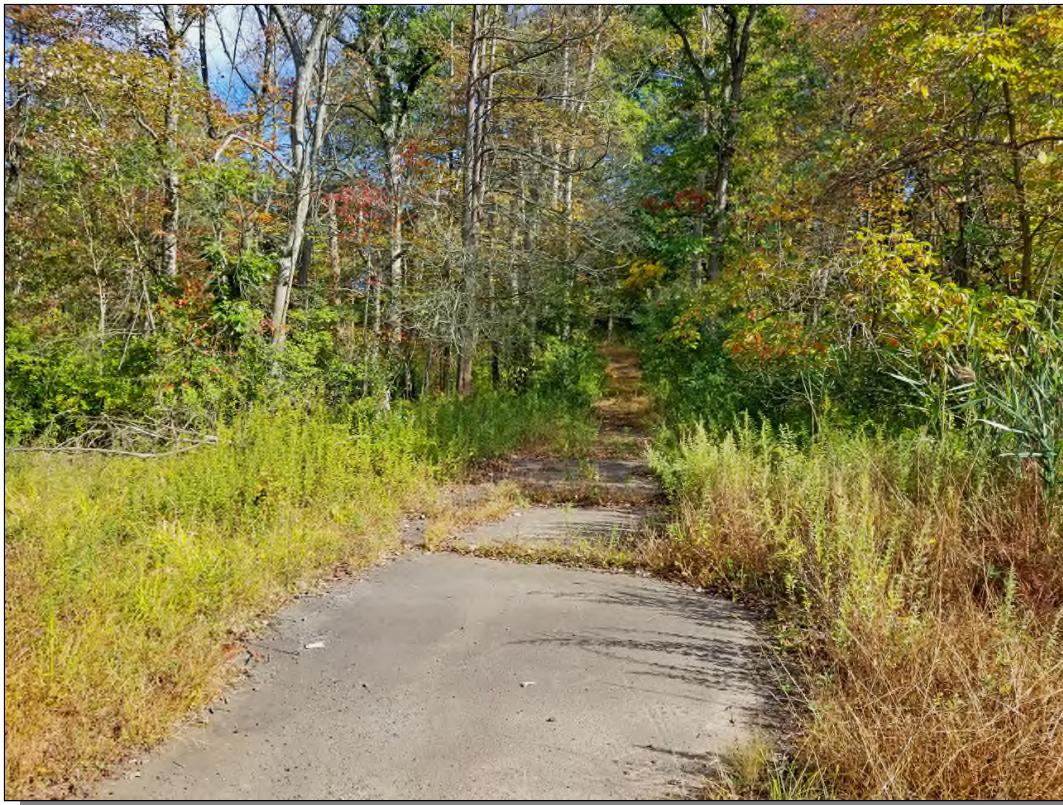
Photo 11B: Old abandoned access roadway between Wetlands B3 and B4; facing easterly

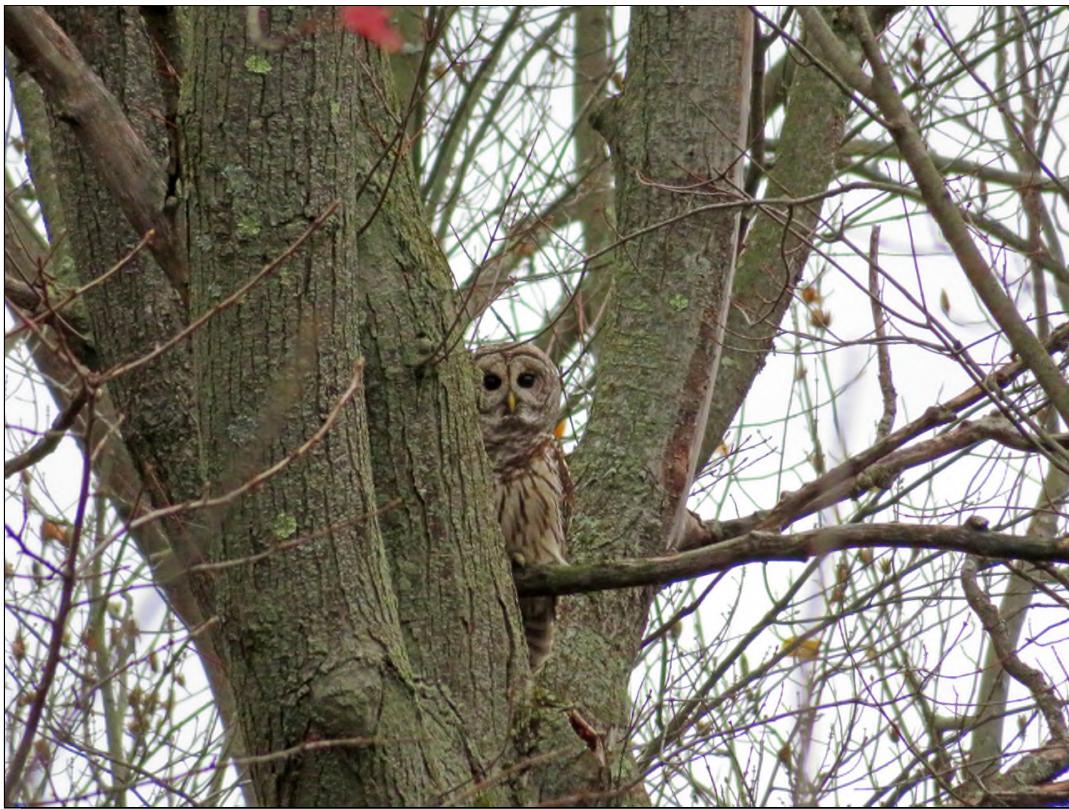
Photo 12B: Wetland B3, barred owl at the southwestern forested section

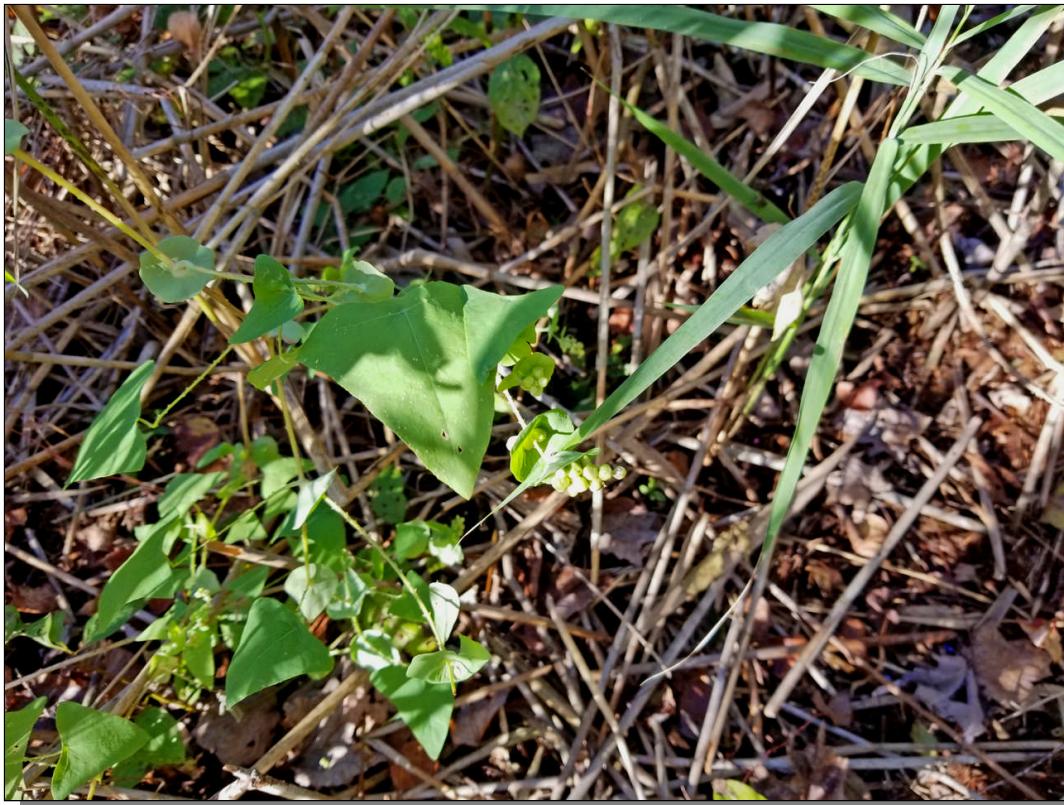
Photo 13B: Wetland B3, Mile-a-minute vine infestation in the wetland's eastern section

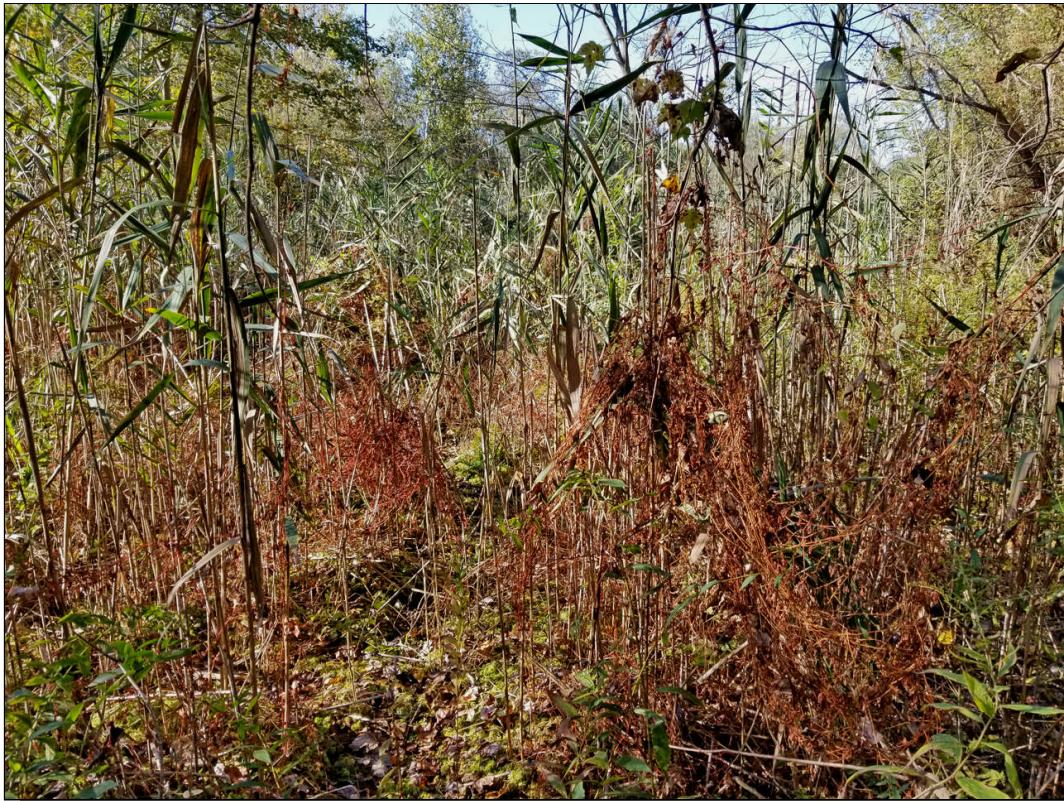
Photo 14B: Wetland B3, Phragmites and mile-a-minute vine; eastern section; facing northerly

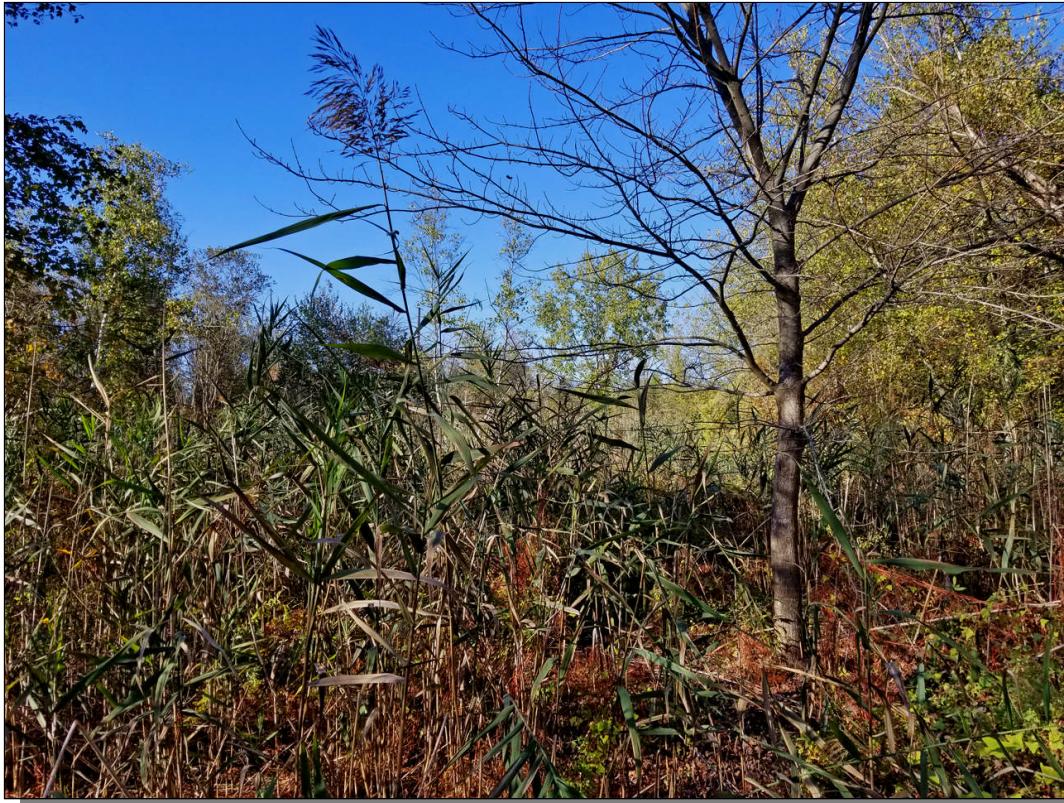
Photo 15B: Wetland B3; mosaic of *Phragmites* and young trees and shrubs; facing northwesterly

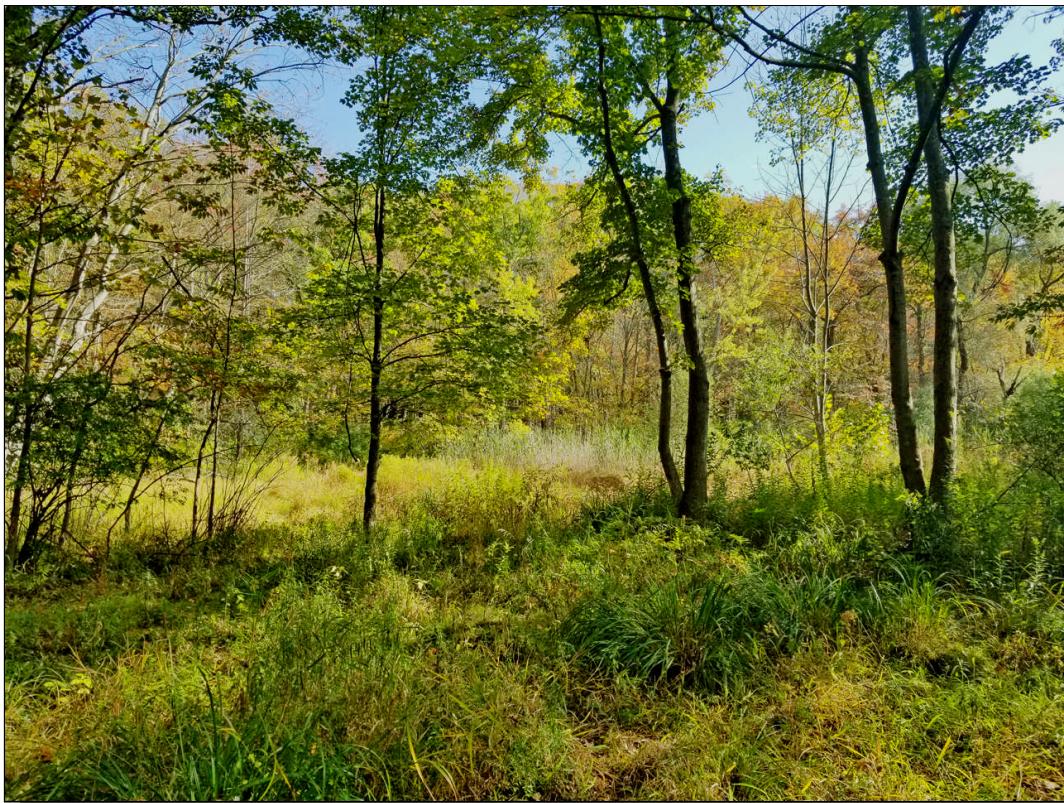
Photo 16B: Wetland B3, southern section; facing northeasterly

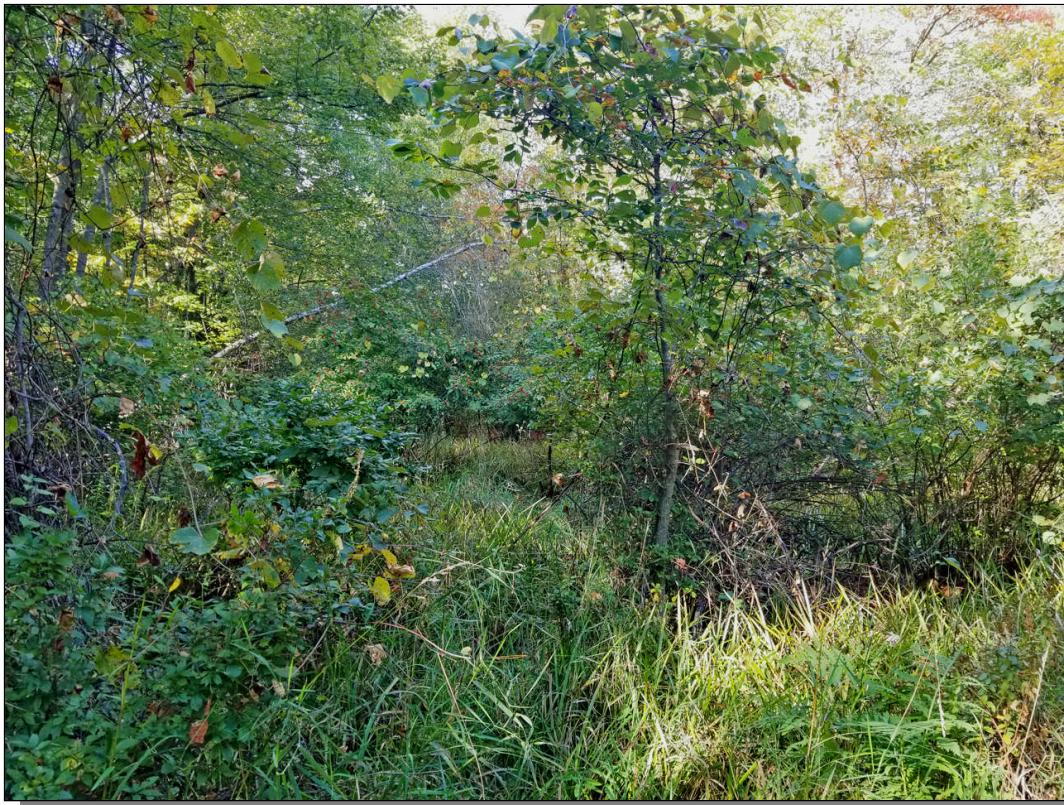
Photo 17B: Wetland B3, southwest corner; very poorly drained

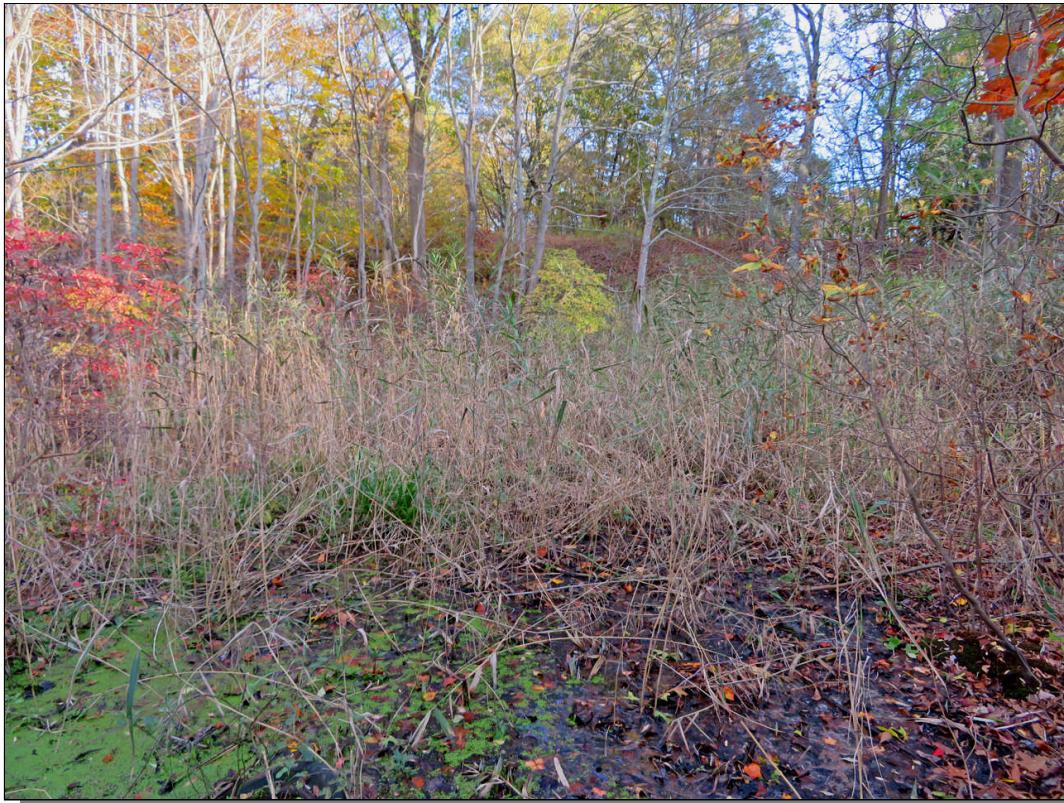
Photo 18B: Wetland B4; southeastern corner; note steep hillside in background; facing southeasterly

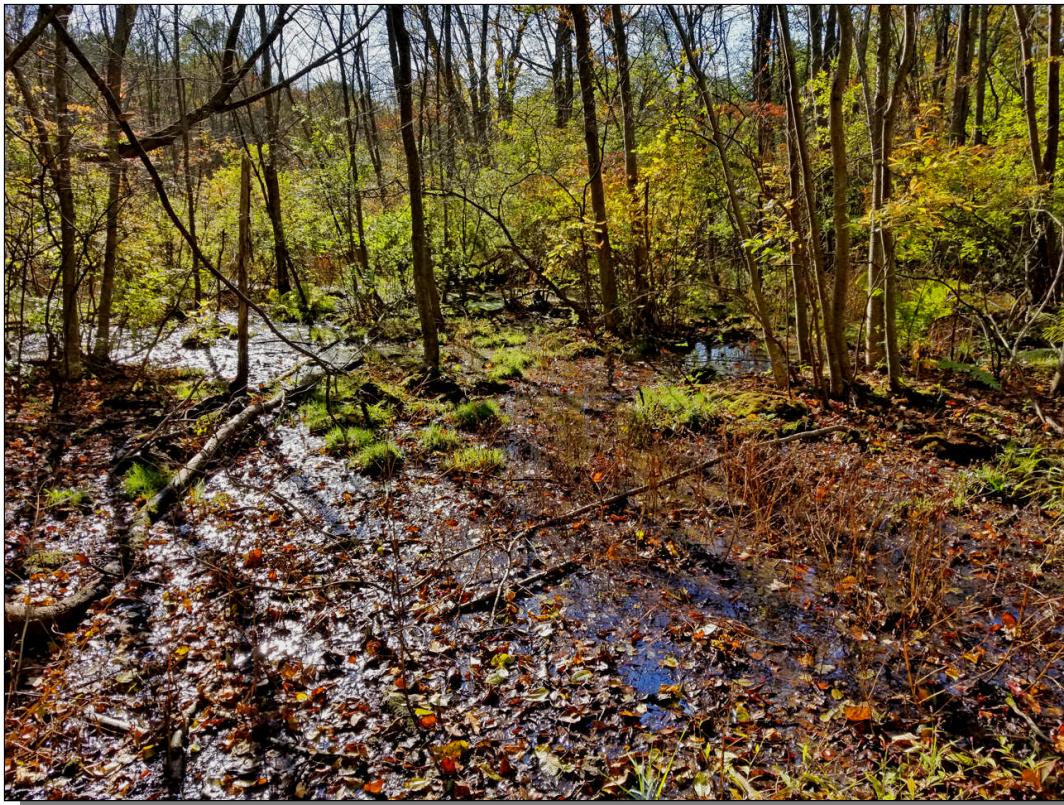
Photo 19B: Wetland B4; northeasterly forested section; hillside seepage; facing southwesterly

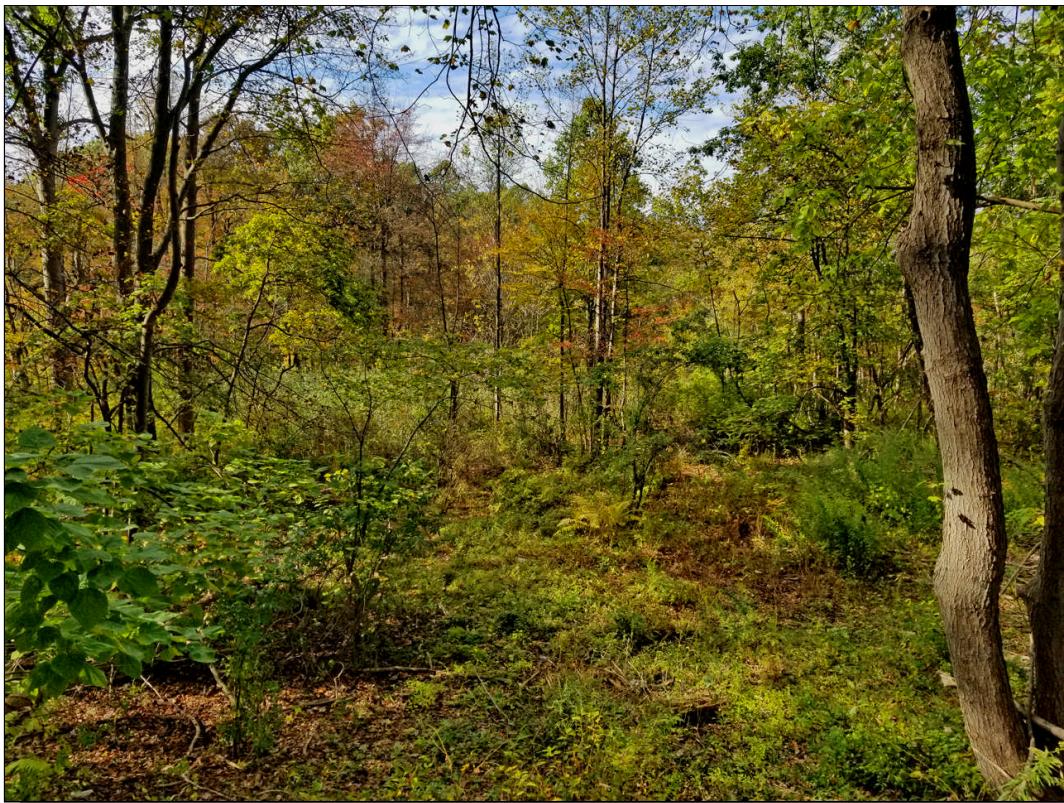
Photo 20B: Wetland B4; northern section; facing westerly

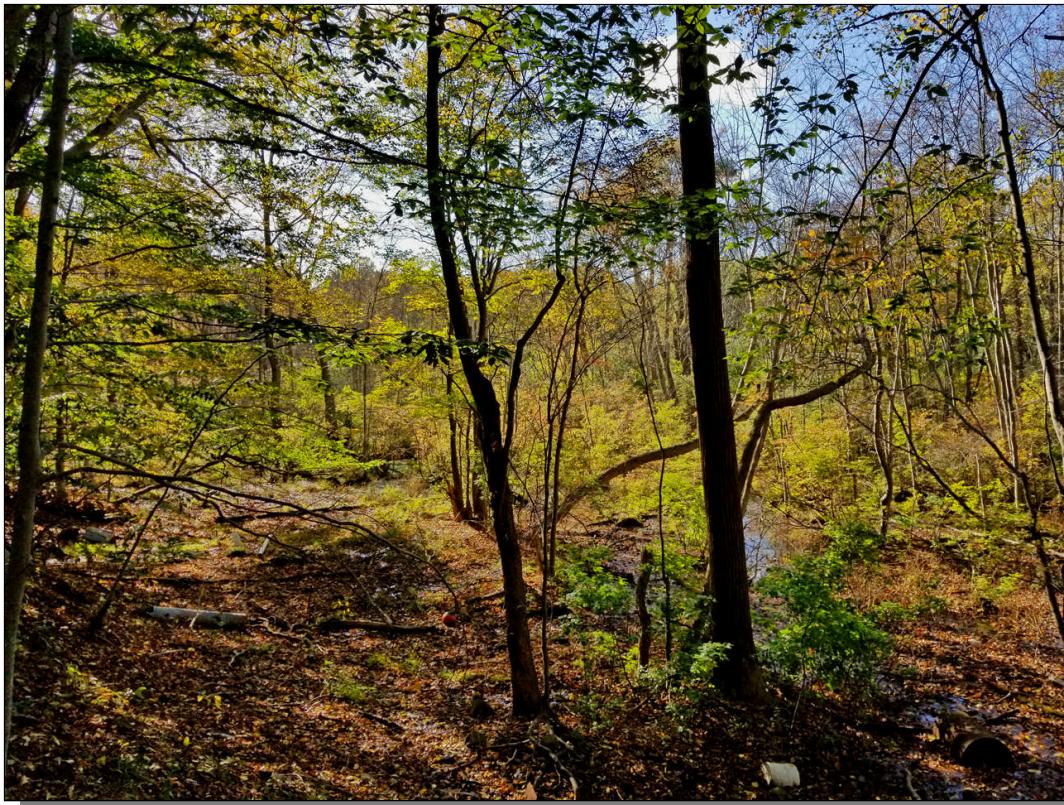
Photo 21B: Wetland B4; facing southwesterly

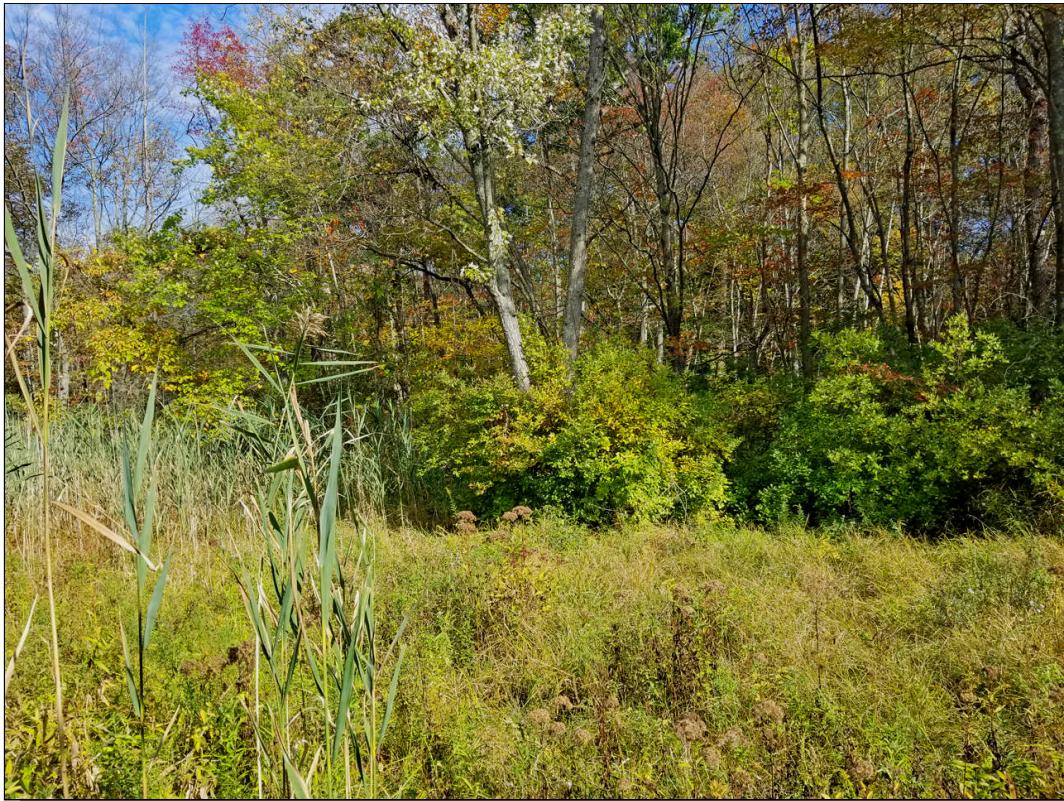
Photo 22B: Wetland B4; northwestern section; facing southeasterly

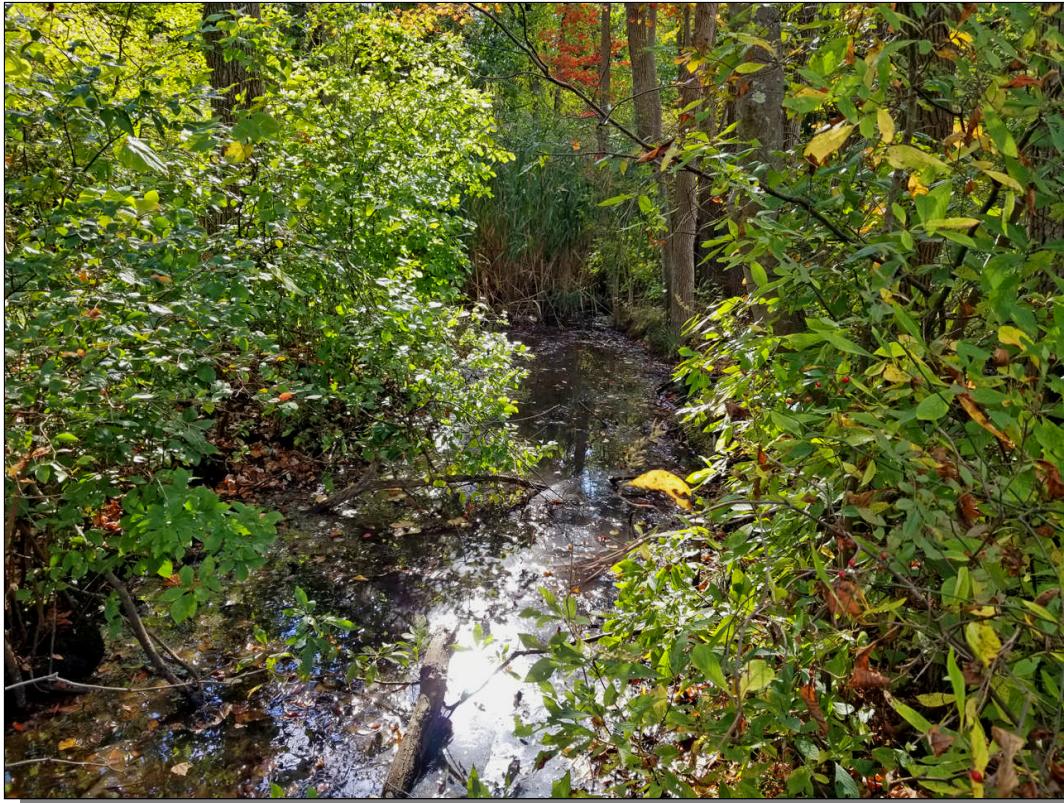
Photo 23B: Wetland B4; ditched watercourse draining swamp; facing southwesterly

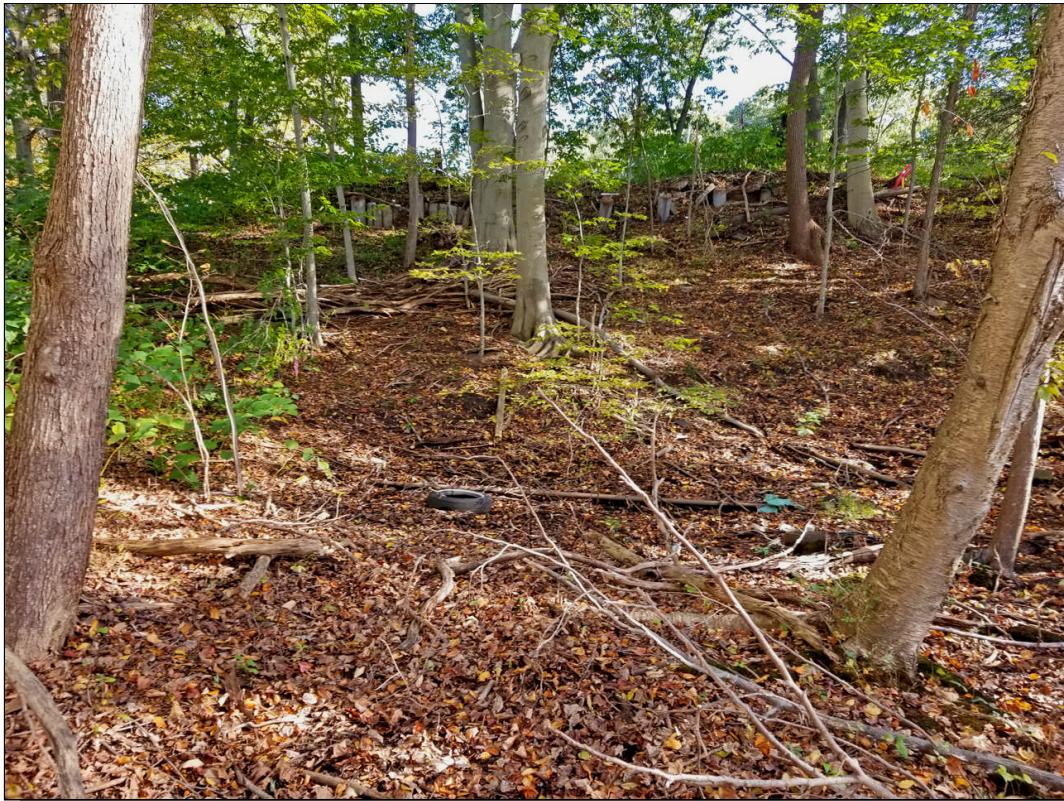
Photo 24B: Wetland B4, edge disturbance; eastern hillslope; facing easterly

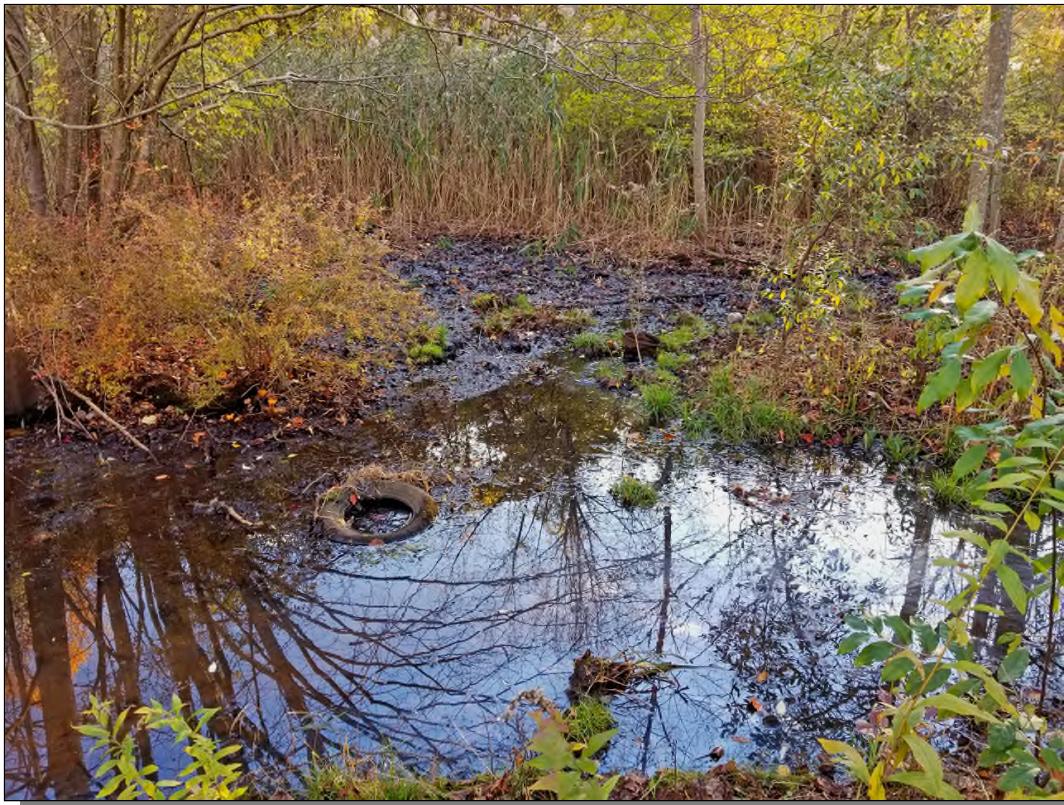
Photo 25B: Wetland B4; western extent; facing southerly

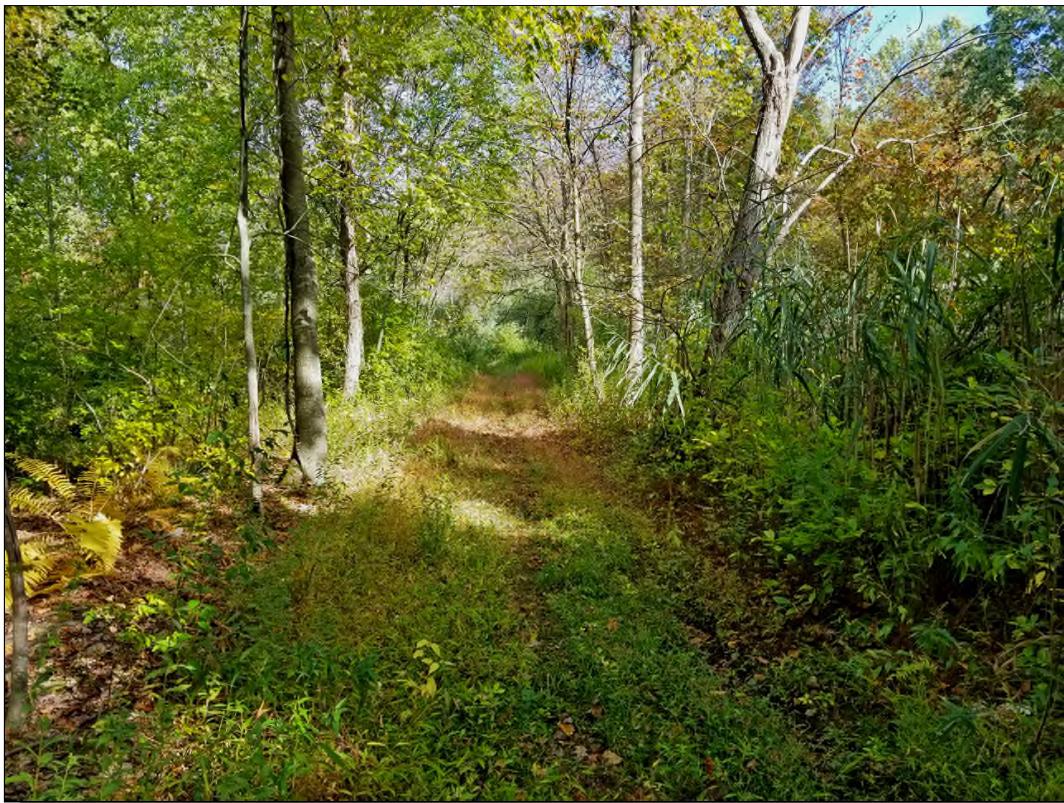
Photo 26B: Old abandoned access roadway separating Wetlands B5 and off-site wetlands to the south; also location of proposed wetland crossing; facing easterly
