Public Information Session Update on Firefighting Foam Releases at Bradley International Airport

Windsor Town Hall
October 30, 2019

Overview of Bradley Airport AFFF Releases

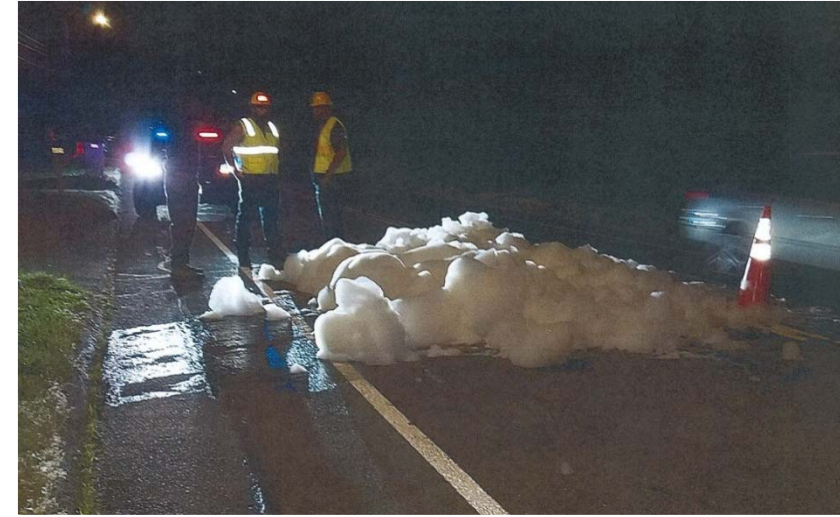
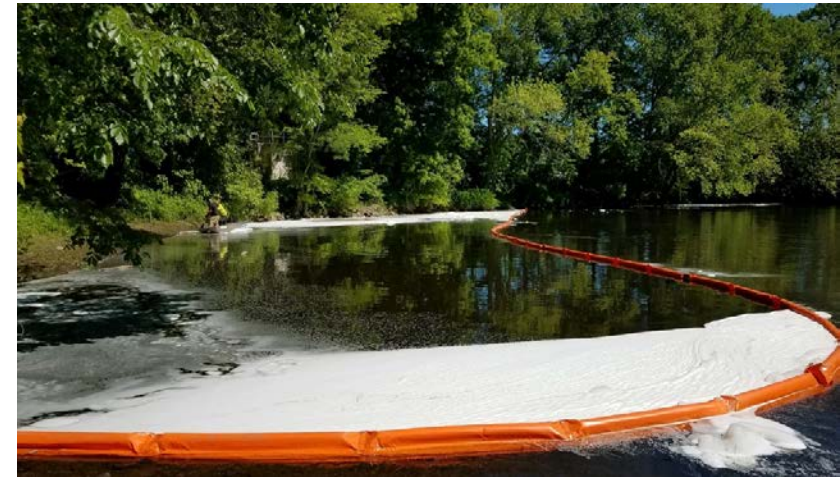
Signature Flight Hangar AFFF Discharge Event

- Approx. 7:30 pm, foam observed exiting sewer manhole on Rainbow Road
 - Emergency Contractor removed foam from vented manhole
- Foam entered MDC Plant ~ 12 am and the Farmington River in the early morning (5:30-7:30 am) of June 9
- Booms deployed at outfall to contain foam
 - ~5,000 gallons of contained foam pumped from the river
- Surface water samples collected
- DPH advises no contact with foam/do not eat fish

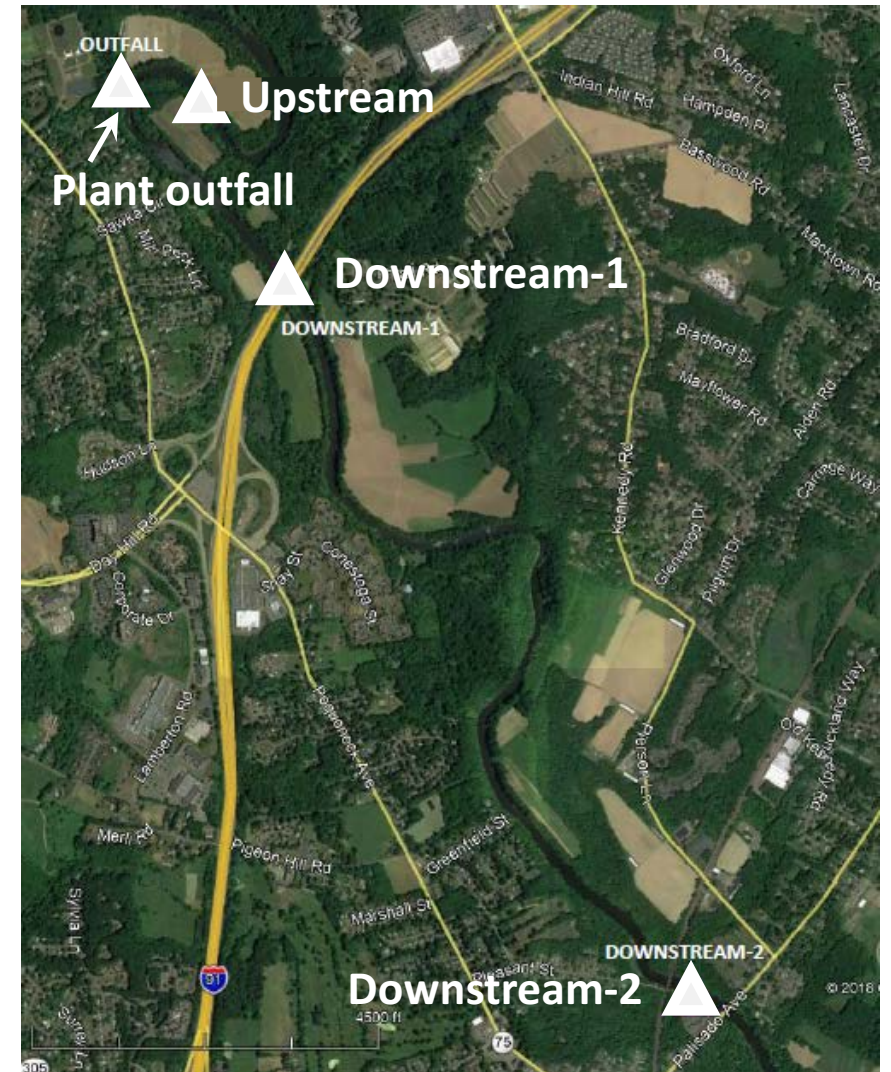
Surface Water Sampling

- 4 sampling events
 - June 9
 - June 11 (Outfall only)
 - June 21
 - July 10 (Upstream & Downstream-1 only)
- 4 locations
 - Upstream
 - Treatment plant outfall
 - Downstream-1 at I-91(0.6 mi.)
 - Downstream-2 at boat launch/Palisado Ave. (3 mi.)

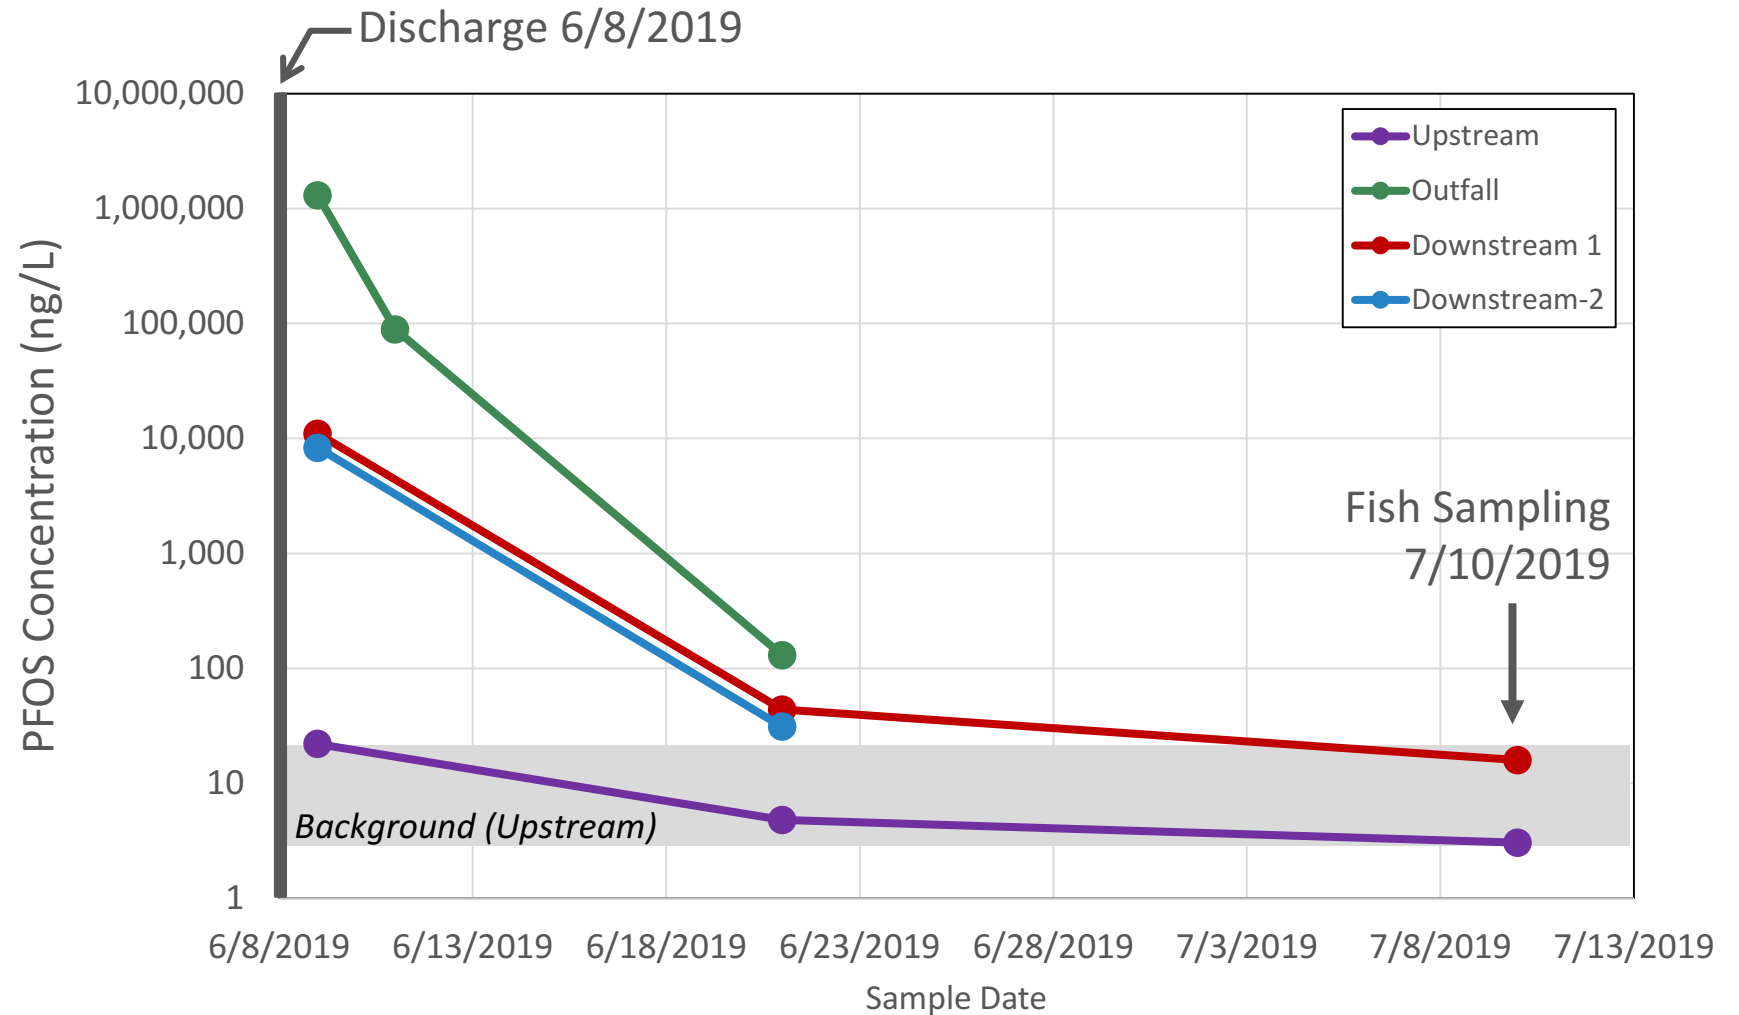
PFOS Concentrations in Surface Water

- **PFOS concentration at MDC Outfall decreased 4 orders of magnitude by June 21.**
- **Downstream concentrations were within upstream range by July 10.**

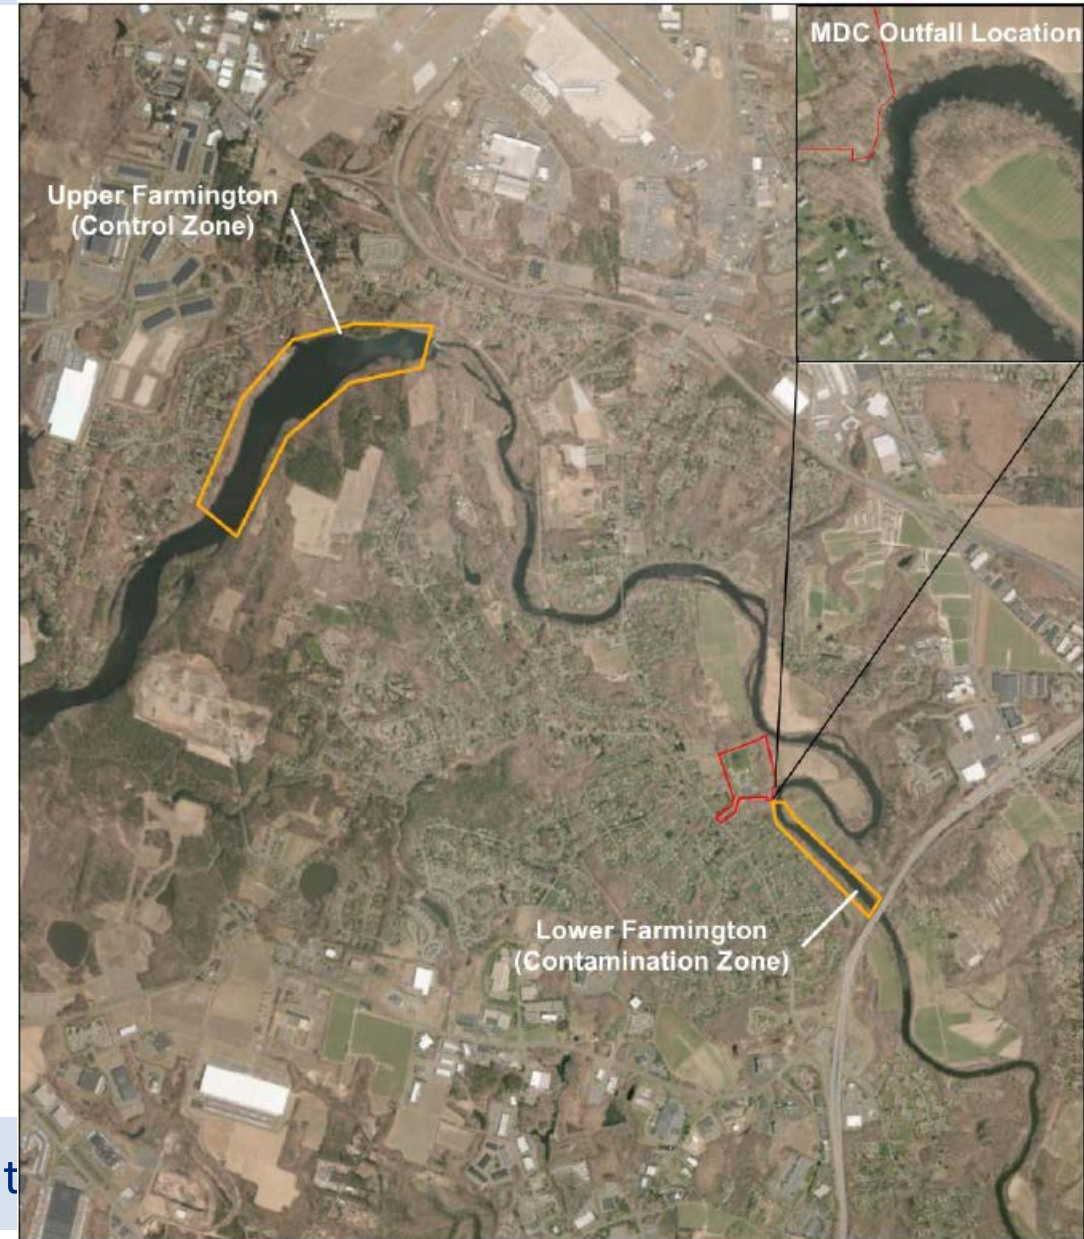
July 2019 Fish Sampling Results

- PFOS detected in all samples (fillets) and at the highest concentrations
- Downstream concentrations generally higher than upstream for most detected PFAS
- Predatory fish (yellow perch) had overall higher concentrations compared to bottom feeders (white suckers)

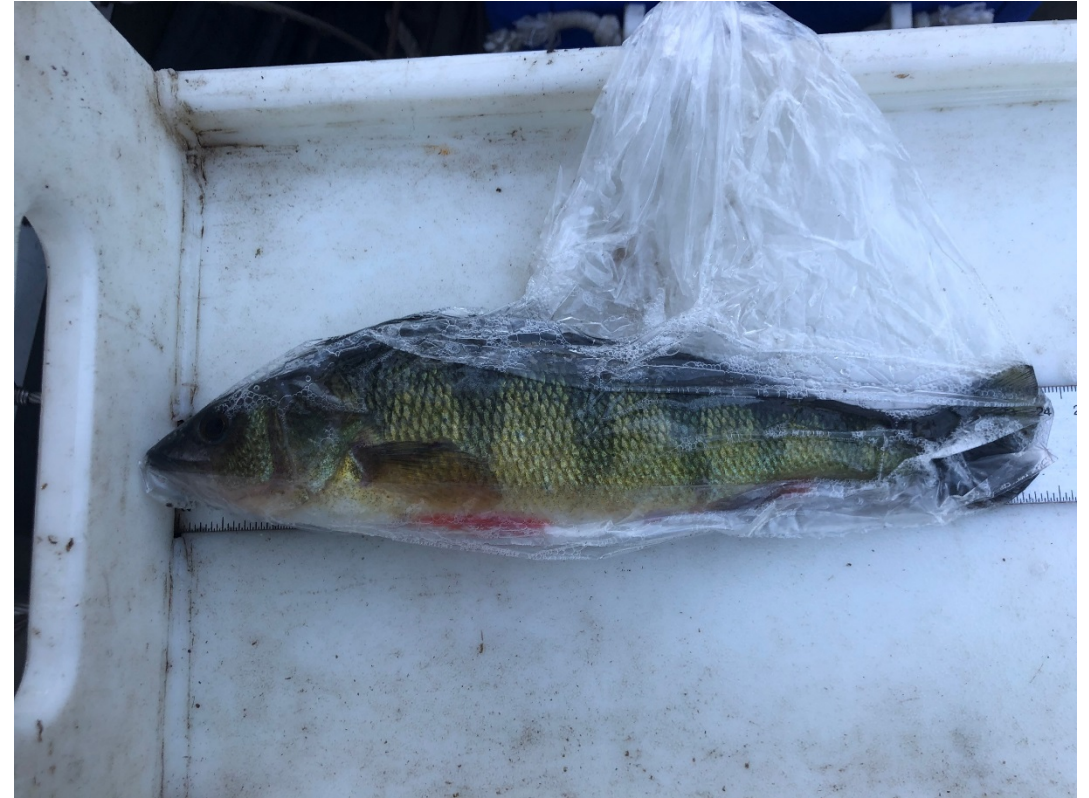
Historical Farmington River Fish Data

- PFOS detected in all samples (fillets) and at the highest concentrations
- Downstream concentrations generally higher than upstream
- No information available on AFFF releases at the time of the historic sampling events
- Sampling locations and some fish species differ from July 2019 sampling event

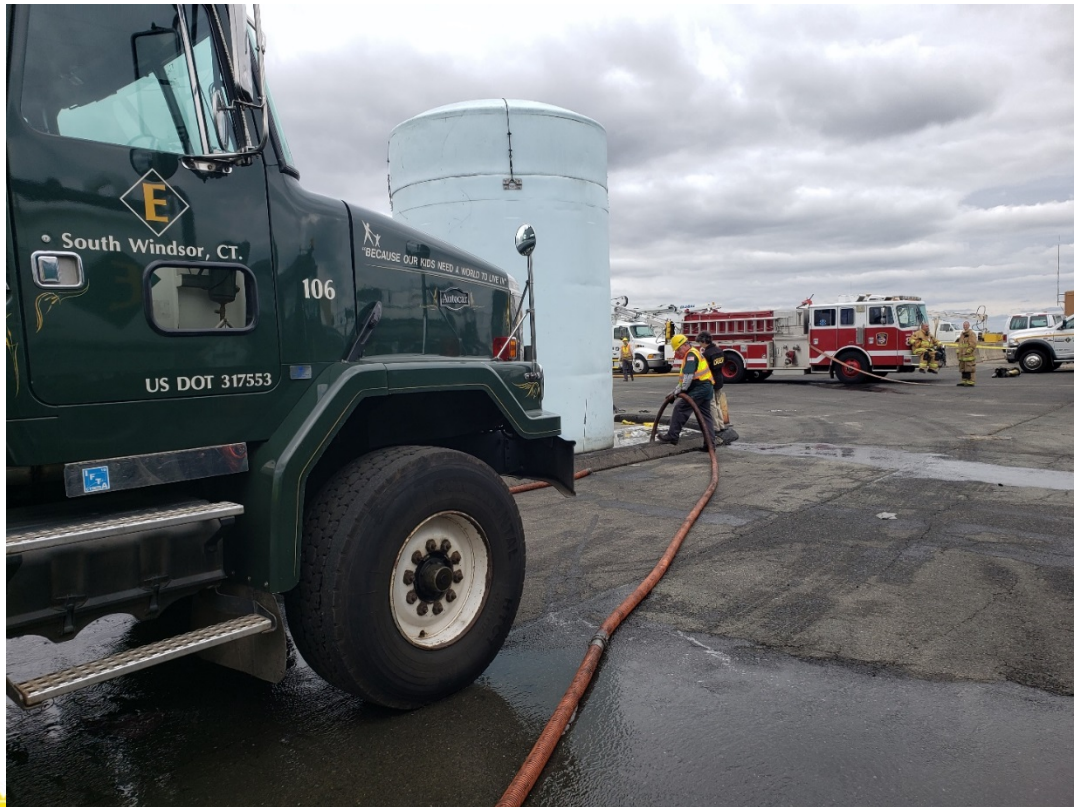
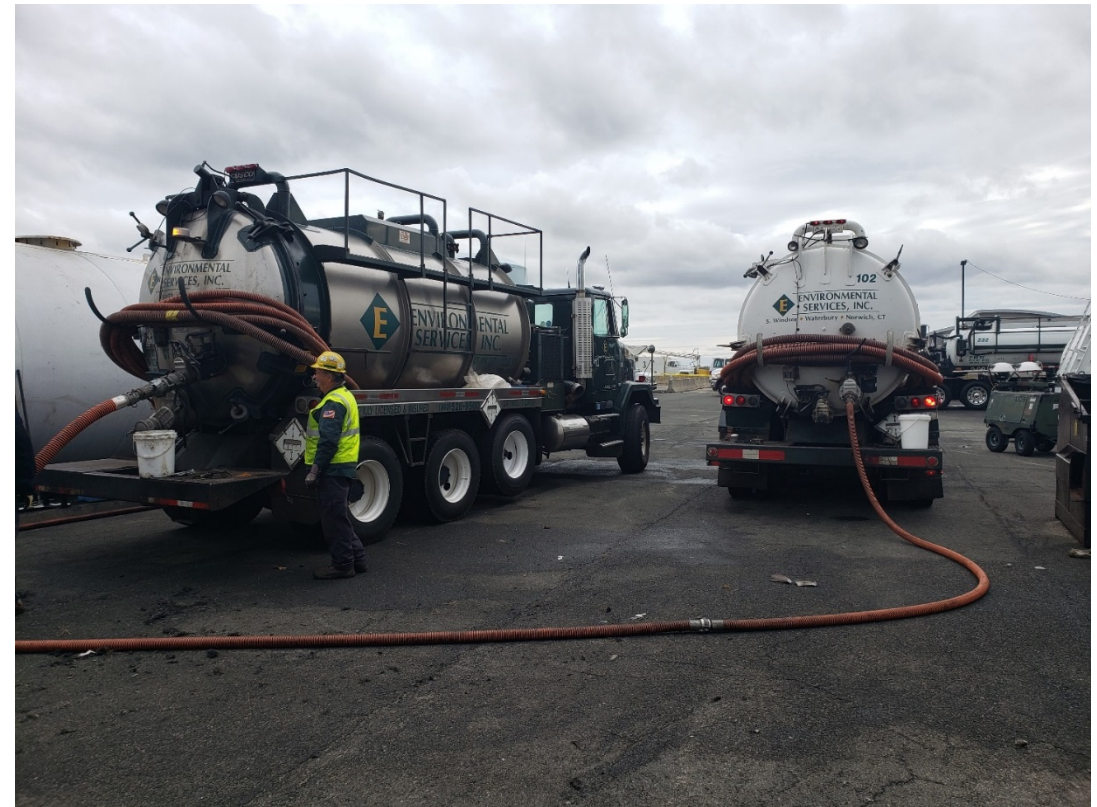
Fluids Containment and removal on-site

- Combination of Legacy PFOS AFFF and Modern C6 AFFF applied to fire
 - 700 – 800 gallons of AFFF concentrate, total
 - 22,000 – 25,000 gallons AFFF solution discharged
 - Visible foam never observed on the Farmington River
- De-icing fluids
 - 2 trucks and an above-ground storage tank damaged
 - 18,000 gallons of propylene glycol contaminated with AFFF

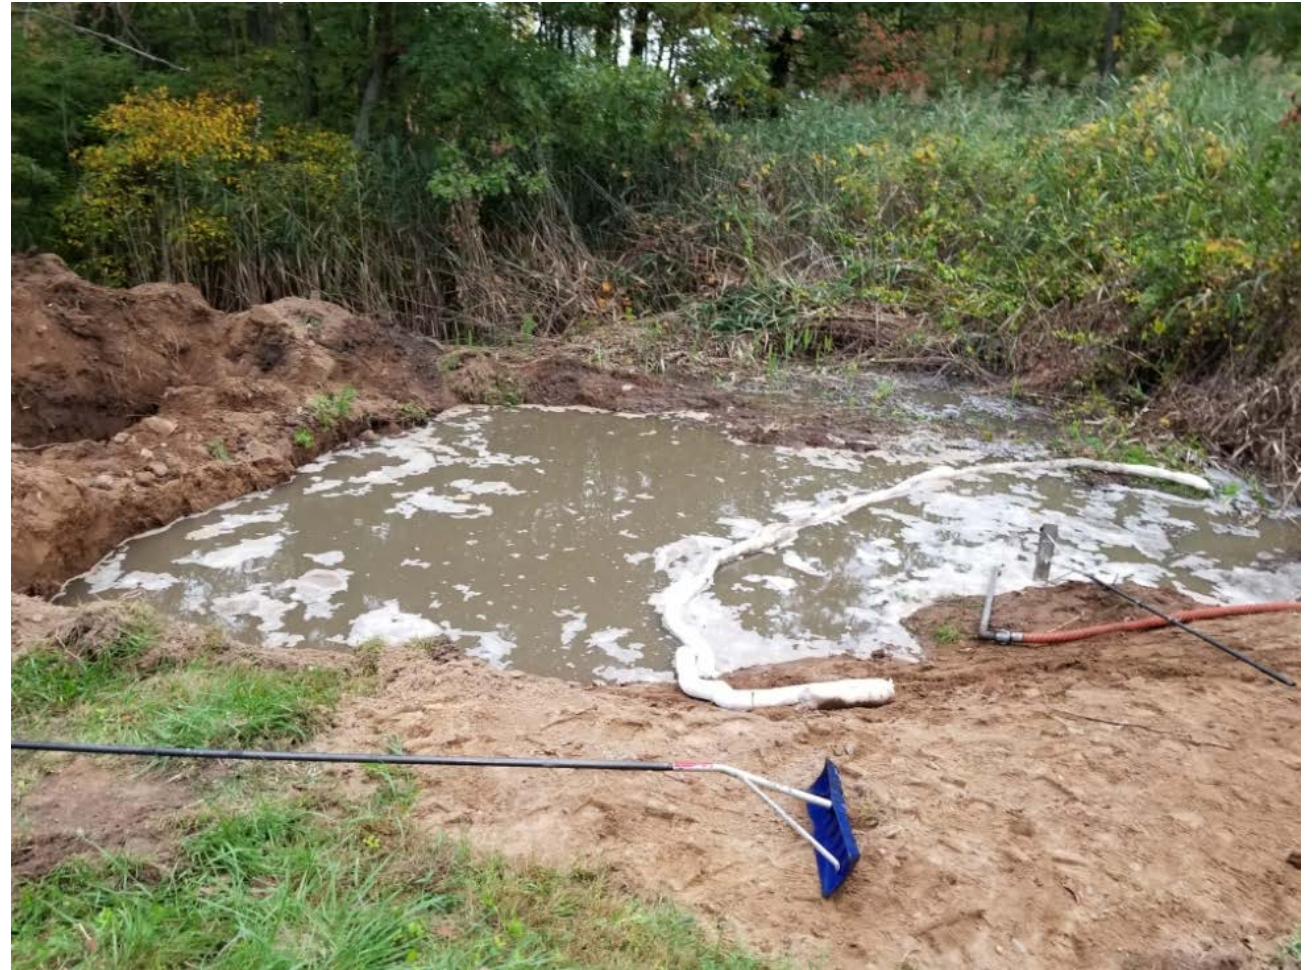
- Containment of surface water runoff from the Airport
 - Installed boom at drainage pipe outlet offsite
 - Installed berm ahead of drainage culvert along Rainbow Brook at Trap Rock Road, dismantled 10/3 prior to rain event

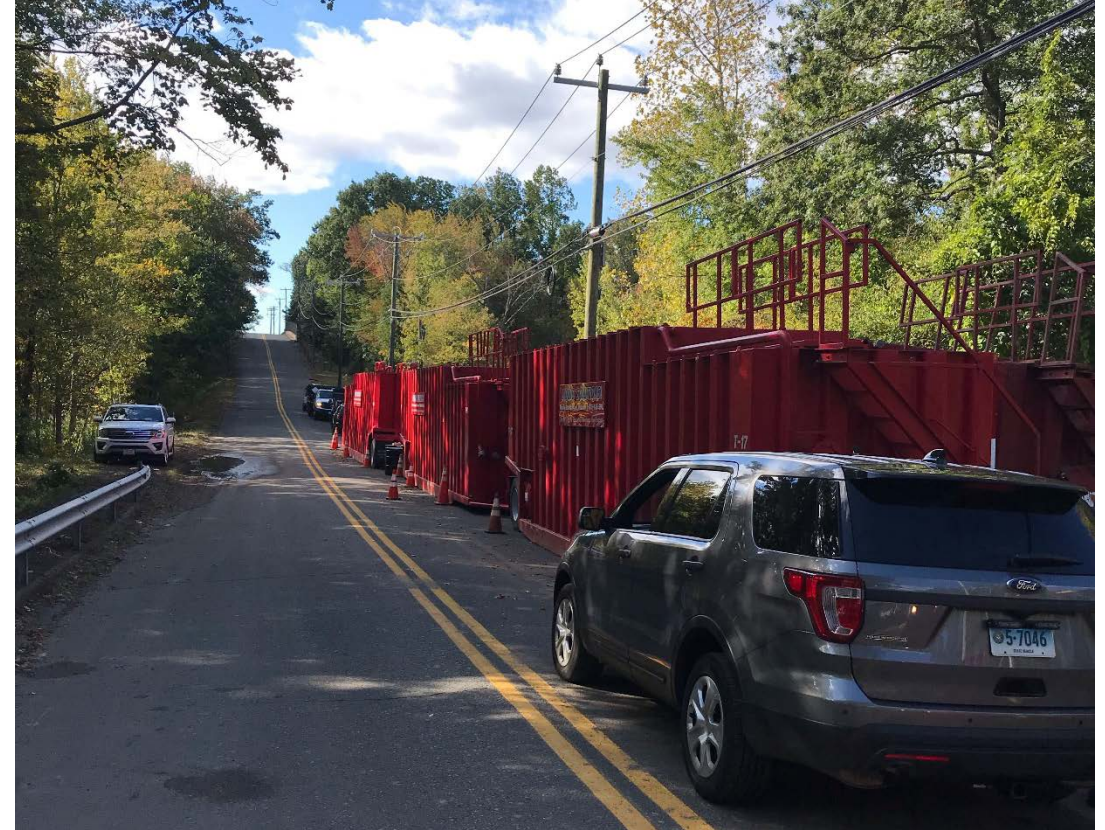
Liquid storage tanks along Trap Rock Road

- 117,976 gallons PFAS/Water combination collected. Still collecting and storing collected liquids.
- Approx. 18,055 gallons of Glycol/Water mixture recovered and stored in a tank at the Airport.

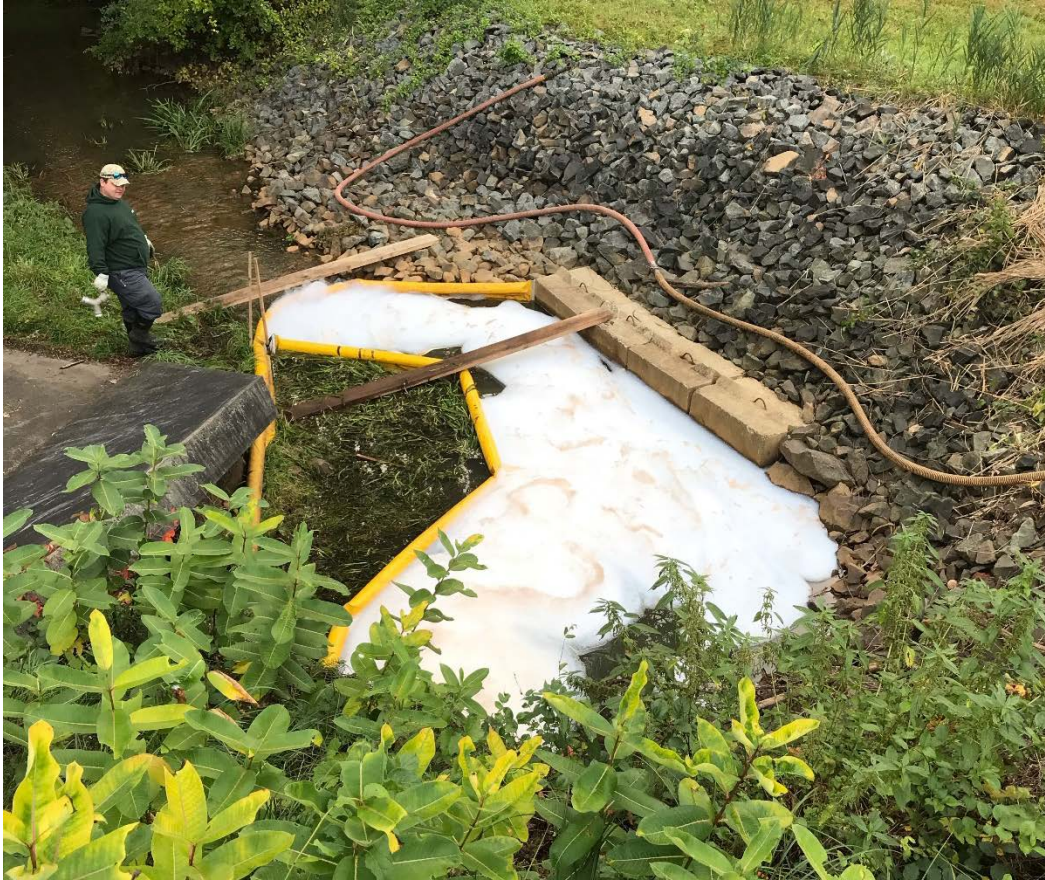
Downstream of Hamilton/Watts Pond Dam

Containment, Removal, and Sampling at Foam Collection Sites Downstream October 2-11

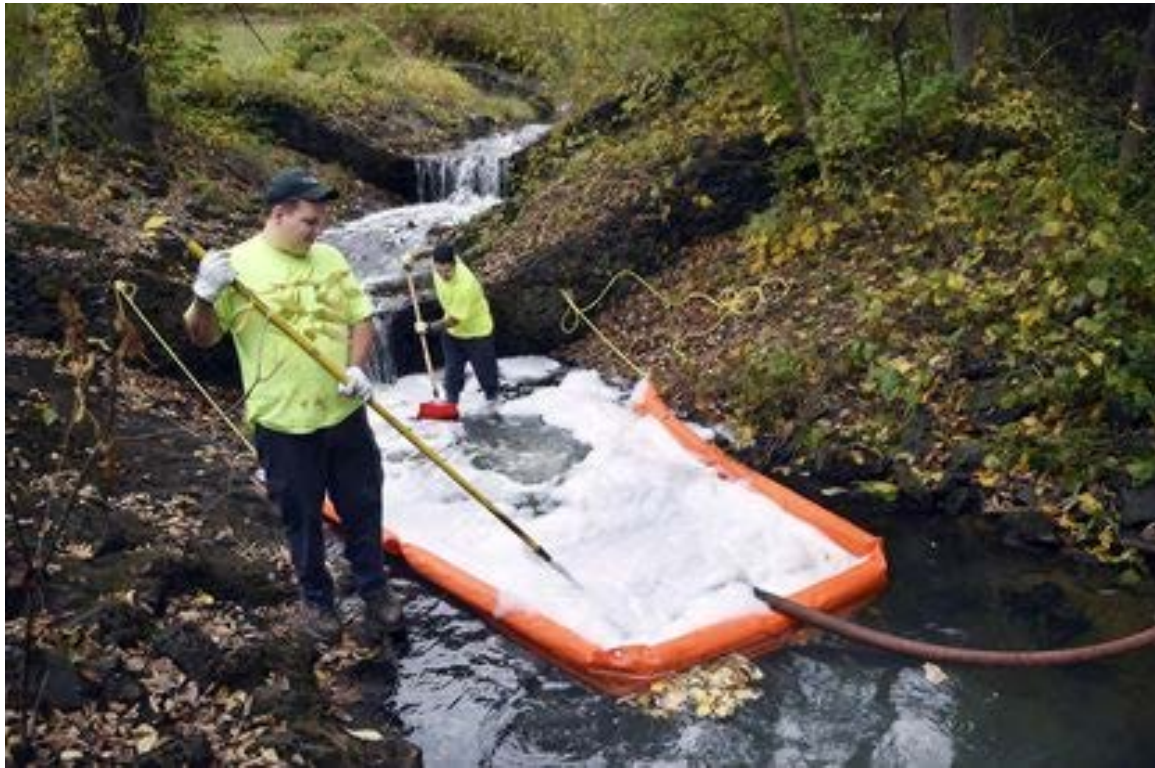
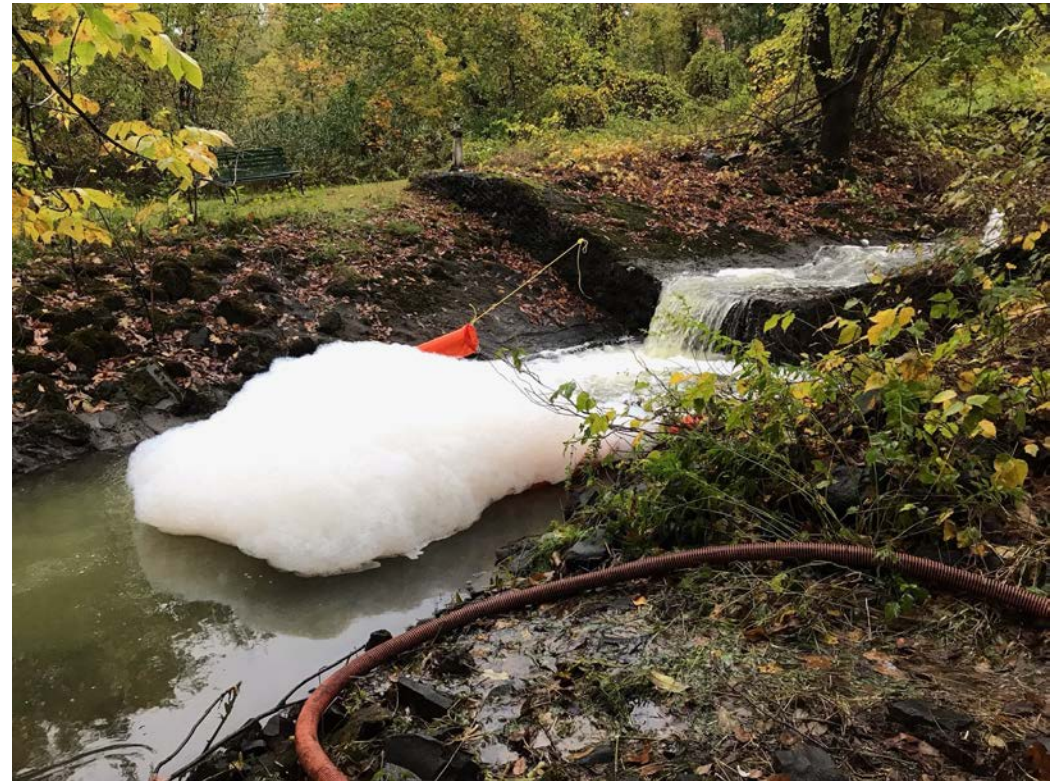
Rainbow Brook at Stevens Mill Road

Containment, Removal, and Sampling at Foam Collection Sites Downstream October 6-11

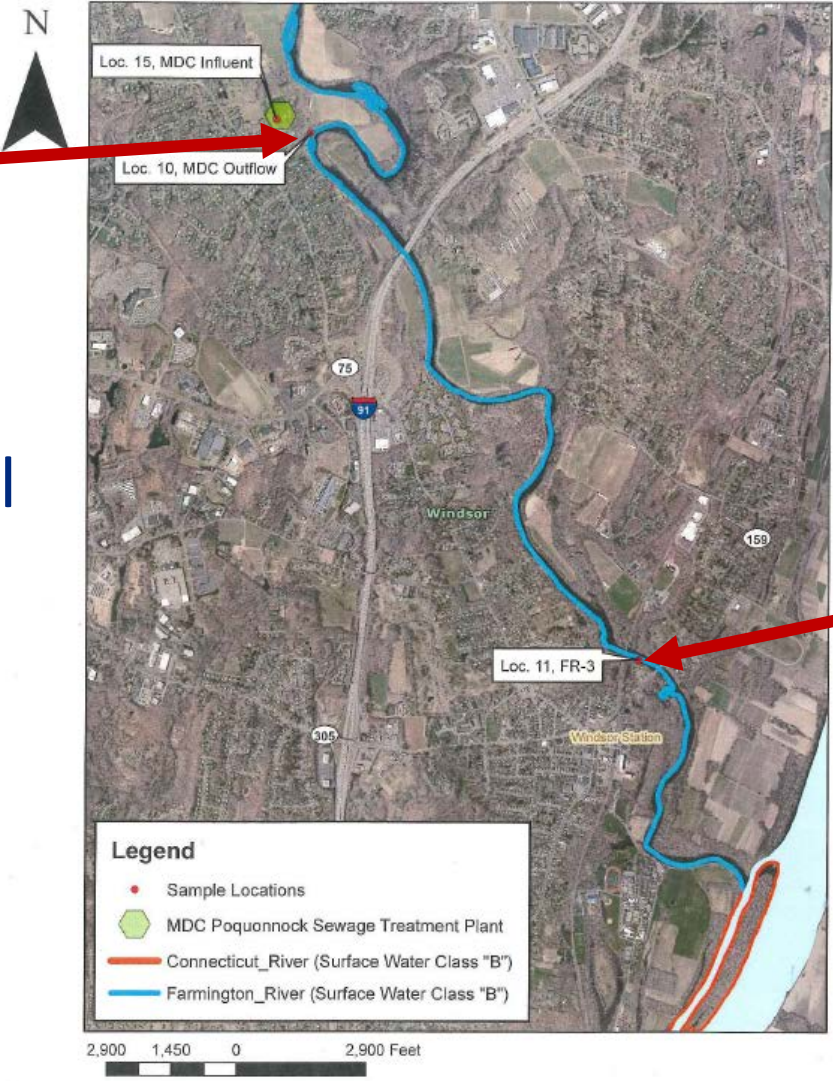
Figure 3: BDL, B17 Crash Incident, Lower Section Sample Locations
DRAFT

10/3 – 76 ppt

Farmington River –
Downstream of MDC Outfall

10/3 – 56 ppt
10/9 – 82 ppt

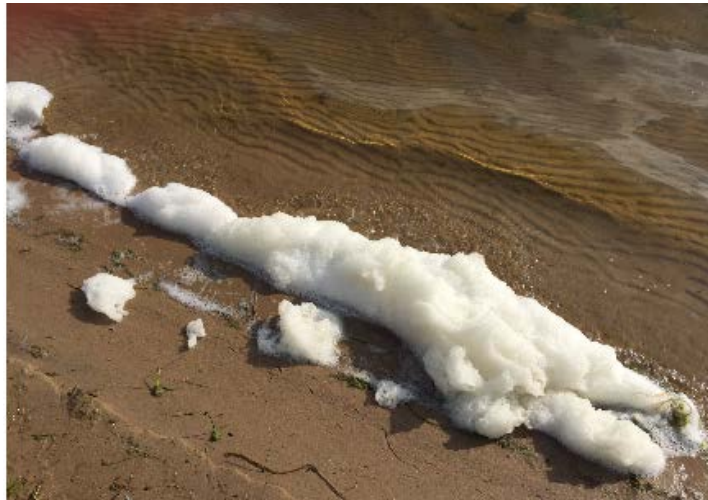
PFAS Foam

- Can be bright white
- Tends to pile up like shaving cream
- Usually lightweight
- May blow inland
- Can be sticky

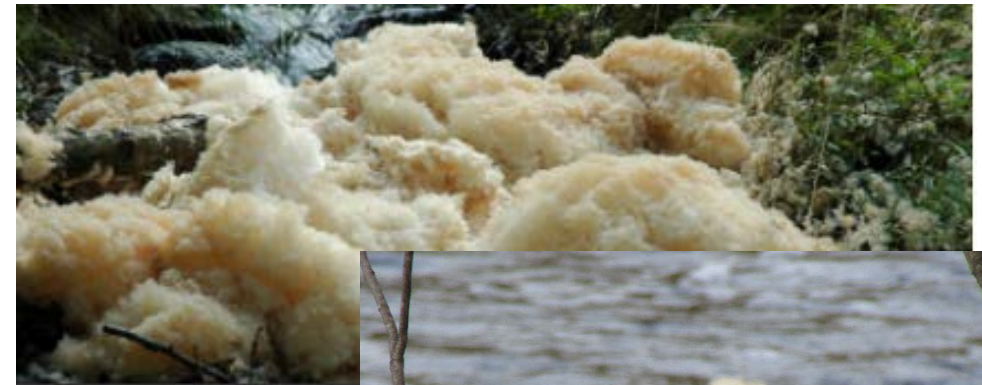
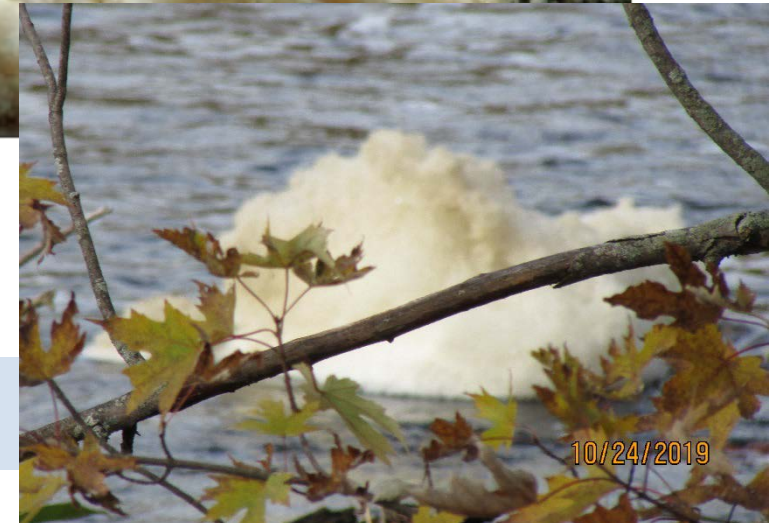
Naturally Occurring Foam

- Is off-white and/or brown
- Often accumulate in bays, eddies, or river blockages
- May have earthy or fishy aroma
