Hatch Pond Watershed Based Plan

South Kent School
South Kent, Connecticut

December 2014

FUSS & O'NEILL

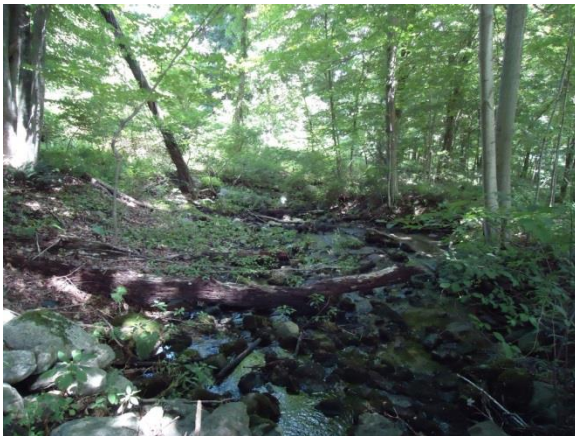
Photo 46: Excellent canopy cover and in-stream habitat along reach SP-02B

Stream reach SP-02B originates in a wetland on the Bull's Bridge Golf Club and flows easterly toward Bull's Bridge Road. The stream crosses under a utility roadway and then under Bull's Bridge Road. There are several outfalls along the roadway directing road runoff into the stream. A rock stilling basin is located within the stream downstream of the Bull's Bridge Road crossing. The stream segment has good

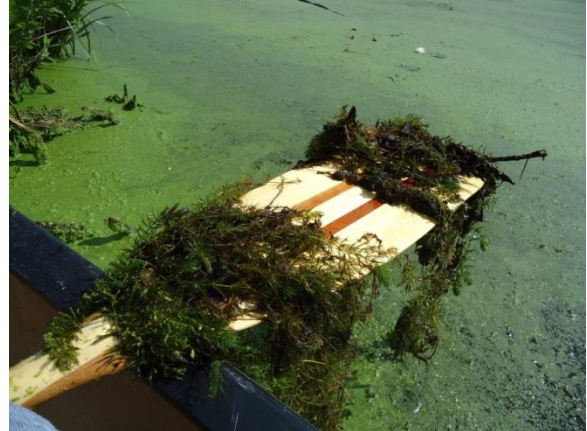
Photo 308: Eurasian milfoil is prevalent around the shoreline and dominates much of the lake bottom cover.

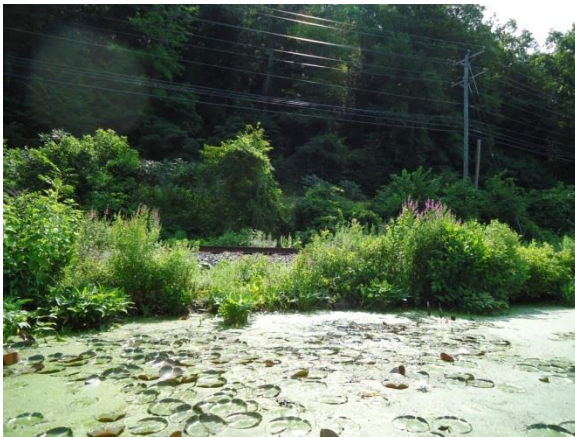
Photo 315: The shoreline is created by the railroad embankment in some locations along the eastern side of the pond.

Shoreline segment HP-07 and HP-08 were evaluated as one segment because their characteristics were similar. The segment is influenced by the presence of the railroad embankment. Several drainage outfalls from South Kent Road pass underneath the railroad and discharge to the pond (CTDOT, 1935); however, none were observed due to the heavy vegetation growth along the shore. A dock is located along this reach, which may be used by local residents (see Photo 317 below).

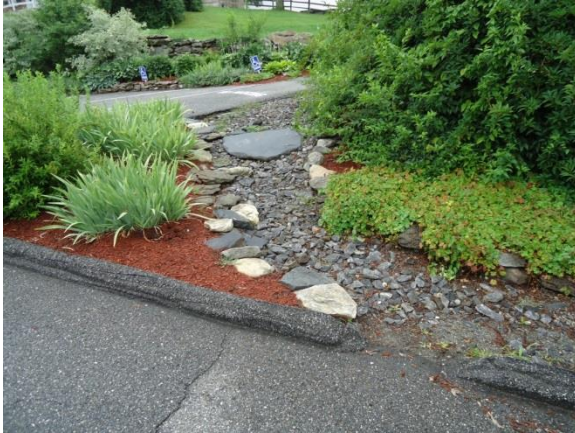
Photo 119: Rock-lined infiltration swale located off the main parking lot near the Old Building

Several Low Impact Development (LID) stormwater management practices exist on campus, including a rock-lined infiltration swale located off the main parking lot near the Old Building (Photo 119 below), grass pavers on a parking area in front of Gilder Hall Dormitory (Photo 143 below), and a rain garden behind the faculty housing buildings that receives runoff from the adjacent impervious areas. The plants are newly planted and will mature to fill in the garden (Photo 144 below).

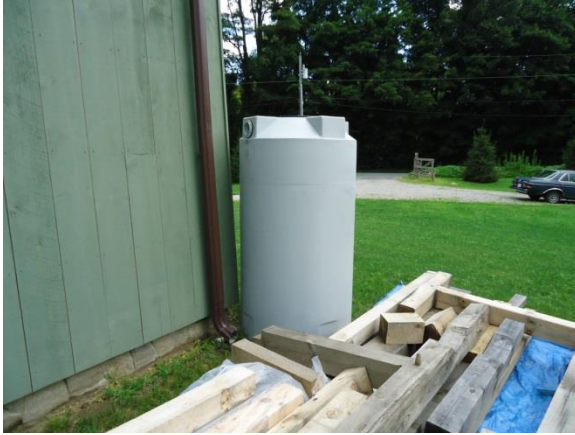
Photo 226: 250-gallon rain barrel at the Center for Innovation

Rainwater harvesting is planned for the barn/residential structure for use throughout the property. Several 250-gallon rain barrels will be connected to the roof leaders (Photo 226 below).

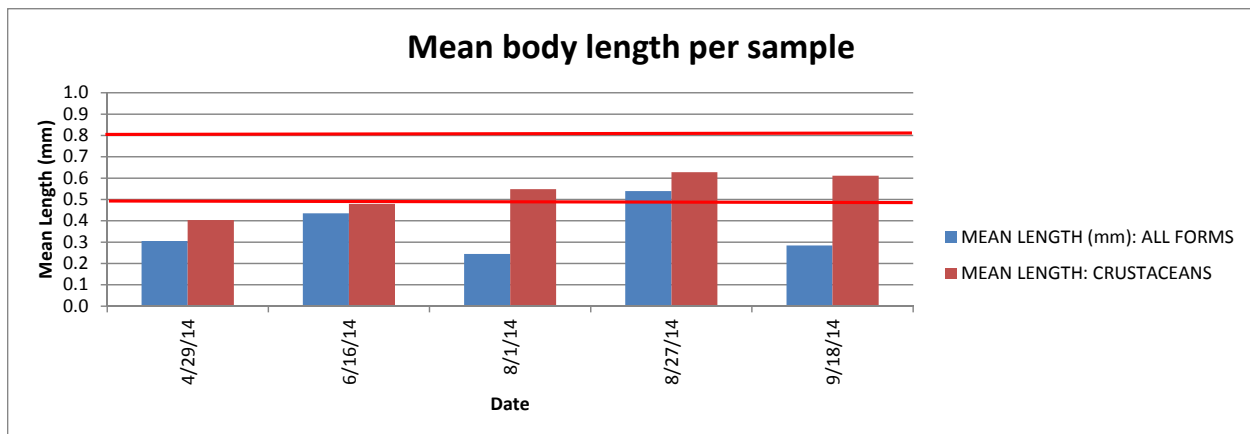
Figure 16. Hatch Pond zooplankton mean length in 2014
