SUMMARY OF THE NCHRP REPORT 350
CRASH TEST RESULTS FOR THE
CONNECTICUT TRUCK MOUNTED ATTENUATOR

June 1995

Report No.
2216-1-95-2

Research Project
SPR-2216

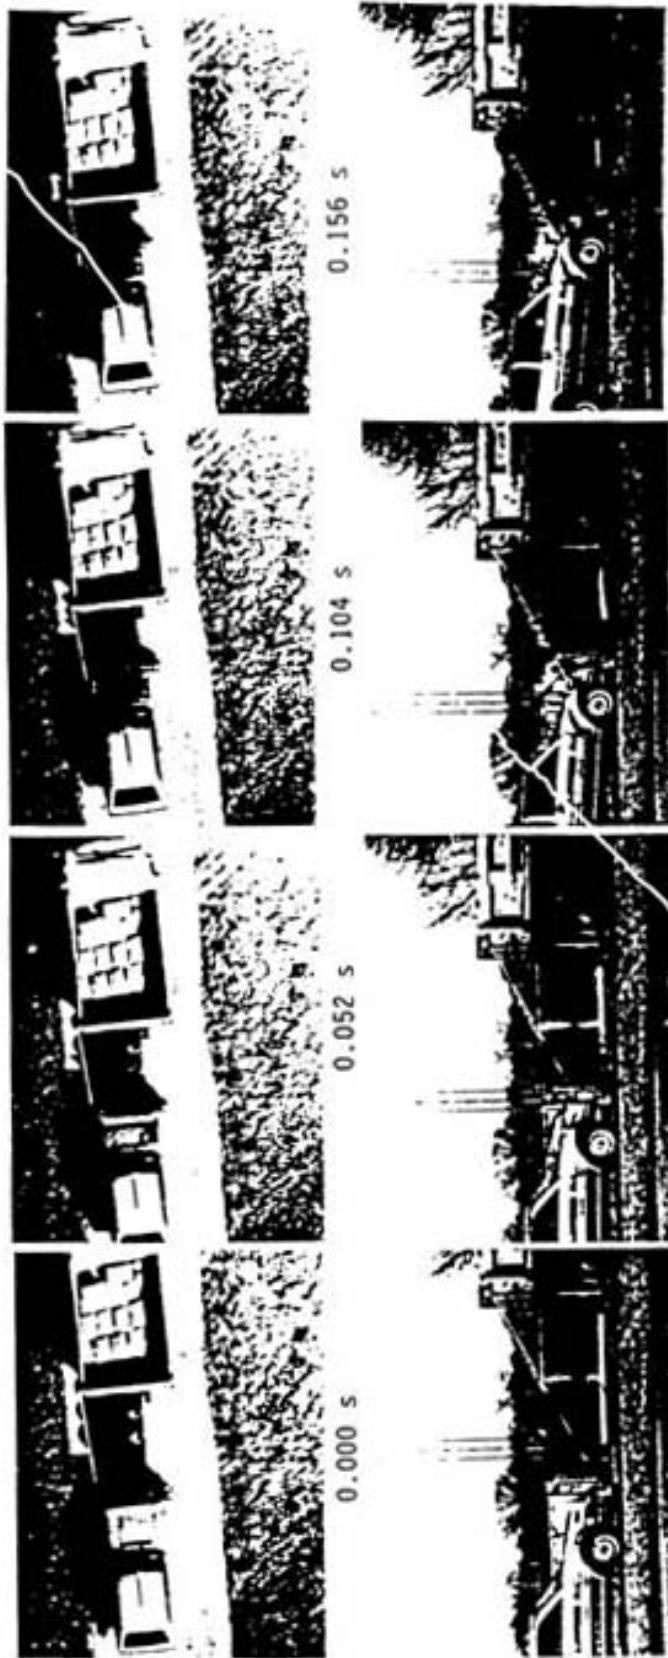
Figure 1-1 Summary of Results for NCHRP Test 2-50

Test No. 09910-9
 Date 01/25/90
 Test Article Truck Mounted Attenuator
 Manufacturer Connecticut
 TMA Truck 1950 Ford Dump Truck (#2)
 Weight without TMA 14,010 lb (6,361 kg)
 Weight with TMA 16,130 lb (7,323 kg)
 Test Vehicle 1982 Honda Civic
 Weight 1,800 lb (817 kg)
 Impact Speed 45.3 mi/h (72.9 km/h)
 Maximum Vehicle Crush 7.0 in (17.7 cm)
 Vehicle Damage Classification
 TAD 12FD3
 CDC 12FDEW3

Maximum Truck Displacement N/A (fixed position)
 Maximum TMA Crush 44.1 in (1.1 m)
 Vehicle Accelerations
 (Maximum 50 ms Average at c.g.)
 Vehicle Longitudinal -14.2 g
 Vehicle Lateral -1.5 g
 Truck Cab Longitudinal N/A
 Occupant Impact Velocity
 Longitudinal 37.8 ft/s (11.5 m/s)
 Lateral 4.8 ft/s (1.5 m/s)
 Occupant Ridedown Accelerations
 Longitudinal -14.0 g
 Lateral -0.9 g

This test involves a 820 kg automobile impacting the TMA head-on with no offset at 70 km/h. It is a difficult test to pass because of the added requirement that the service vehicle not be allowed to move forward during the test. This is accomplished by butting the front end of the service vehicle against a rigid barrier. This test was conducted as part of a TTI project entitled "Comparative Crash Test Conducted on Seven Different Makes and Models of Truck Mounted Attenuators /6/. The crash test details are shown in Figures 1-1 through 1-5 in the Appendix. Although the impact speed of 72.9 km/h resulted in a kinetic energy overload of 8.5 percent all test requirements were met. The occupant impact velocity was 11.50 m/s (the maximum allowable value is 12 m/s), and the ridedown acceleration was 14.00 g's (below the preferred value of 15 g's).

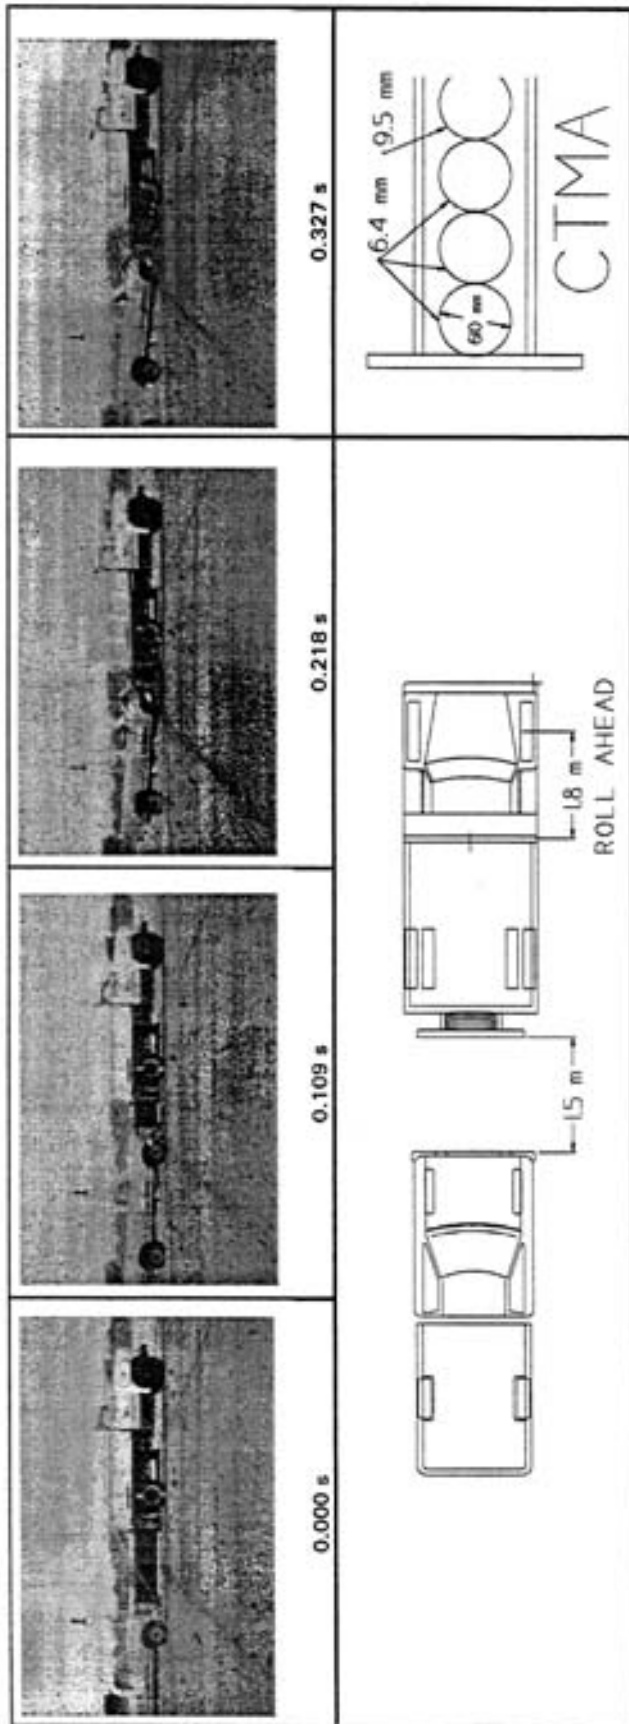
Figure 2-1 Summary of Results for NCHRP 350 Test 2-51

General Information		Texas Transportation Institute		Impact Conditions		Test Article Deflections (m)	
Test Agency	405241-1	Speed (km/h)	Dynamic
Test No.	11/2/94	Angle (deg)	Permanent
Date	Truck Mounted Attenuator	Exit Conditions	Vehicle Damage
Test Article	Connecticut	Speed (km/h)	0	Exterior
Type	2.40 m (7.88 ft)	Angle (deg)	N/A	VDS
Name or Manufacturer	6.4 & 9.5 mm Thick wall	Occupant Risk Values	CDC
Installation Length (m)	0.70 m Diameter Cylinders	Impact Velocity (m/s)	Interior
Size and/or dimension	N/A	x-direction	OCDI
and material of key	Production	y-direction	Maximum Exterior
elements	2000P	Roll-down Accelerations (g's)	Vehicle Crush (mm)
Test Vehicle	1988 Ford F250 Custom	x-direction	-15.65	Max. Occ. Compart.
Type	2068 (4559 lb)	y-direction	1.56	Deformation (mm)
Designation	2000 (4409 lb)	Support x-direction	8.37	Post-Impact Behavior
Model	N/A	ASI (optional)	Max. Roll Angle (deg)
Mass (kg) Curb	2000 (4409 lb)	Max. 0.050-sec Average (g's)	Max. Pitch Angle (deg)

Test Inertial	N/A	x-direction	-13.23	Max. Yaw Angle (deg)
Dummy	2000 (4409 lb)	y-direction	-1.13		
Gross Static	2000 (4409 lb)	z-direction	4.73

In test 2-51, a 2000 kg pick-up truck impacts the TMA head-on with zero offset. This impact condition is the same as in test 3-50 except for the fact that the service vehicle is allowed to move forward during this test. The pre-test configuration and post-test details are presented in Figures 2-1 through 2-5 in the Appendix. The impact velocity was 70.9 km/h and all the test requirements were again satisfied. The occupant impact velocity was 8.38 m/s (below the preferred value of 9 m/s), and the occupant ridedown deceleration was 15.65 g's.
