**The Connecticut
Agricultural
Experiment
Station**

*Bulletin 1093
June 2, 2023*

Pachaug Pond
Griswold, CT
Aquatic Vegetation Survey
Water Chemistry
Aquatic Plant Management Options
2022

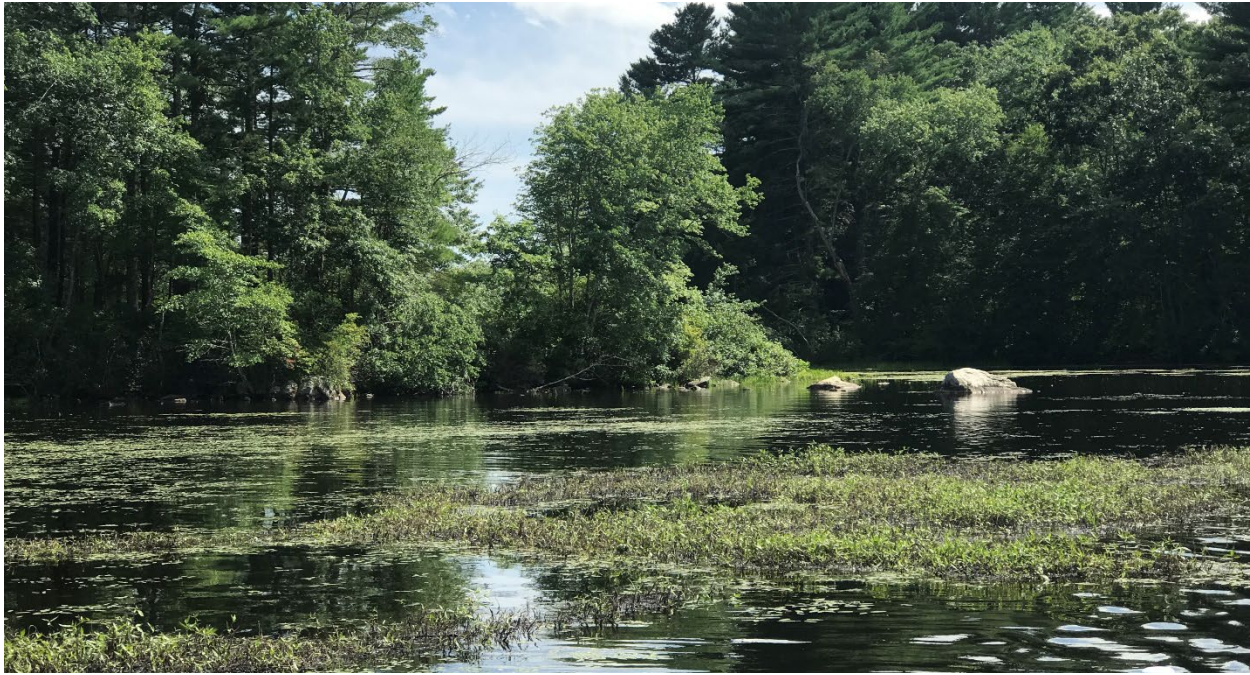
Figure 3. Water smartweed and water lilies in the southwestern cove of the lake.

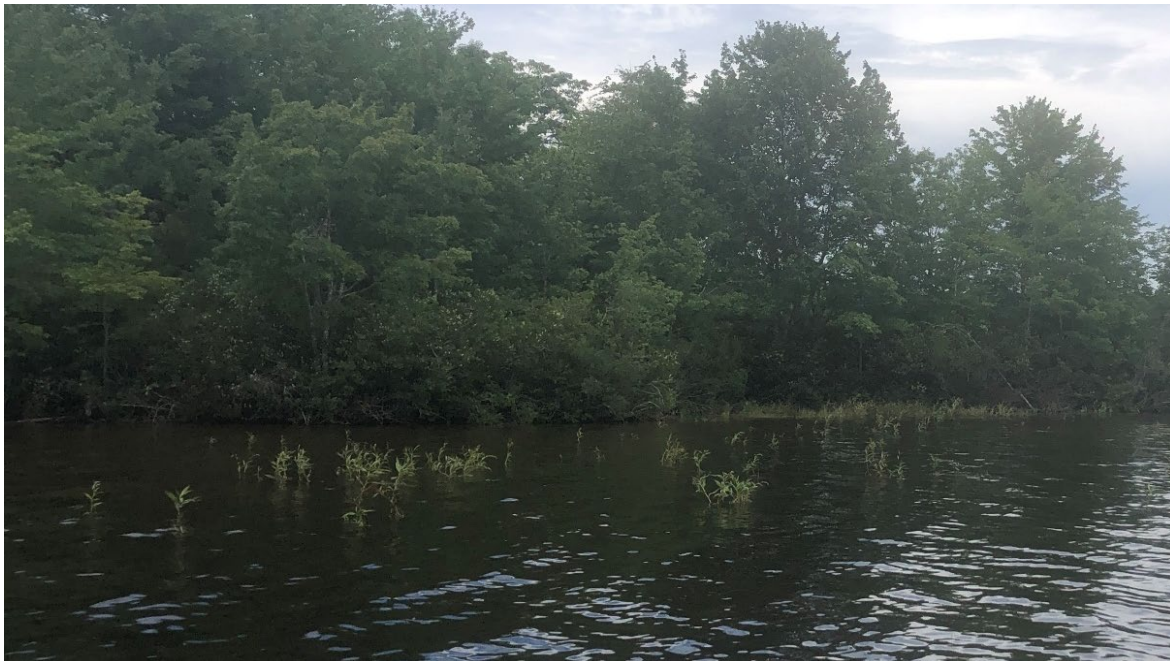
Figure 4. Terrestrial and wetland plants growing in one to three feet of water as a result of the drawdown for dam repairs.

capacity until just prior to our July 2022 survey. Since sediment was exposed for an extended period, wetland and terrestrial species such as phragmites, cattail, and tree saplings became established and were found frequently along the shoreline in up to three feet of water (Figure 4). Typically, these plants will return to less saturated shoreline locations with time. Aquatic vegetation abundance in 2022 was most like 2018 (Figure 5, see appendix for closeup maps and previous years' maps). Many coves had nuisance emergent vegetation such as white and yellow water lily, and water smartweed. The CAES IAPP website contains digitized survey maps where individual plant layers can be viewed separately (portal.ct.gov/caes-iapp). Water smartweed, fanwort, and water lilies often occurred in patches dense enough to restrict navigation, but fewer patches were found compared to previous years. Similar to 2021, the northwestern cove and the southwestern cove near Transect 3 each had a boat path through the vegetation. These paths seem to be actively managed.

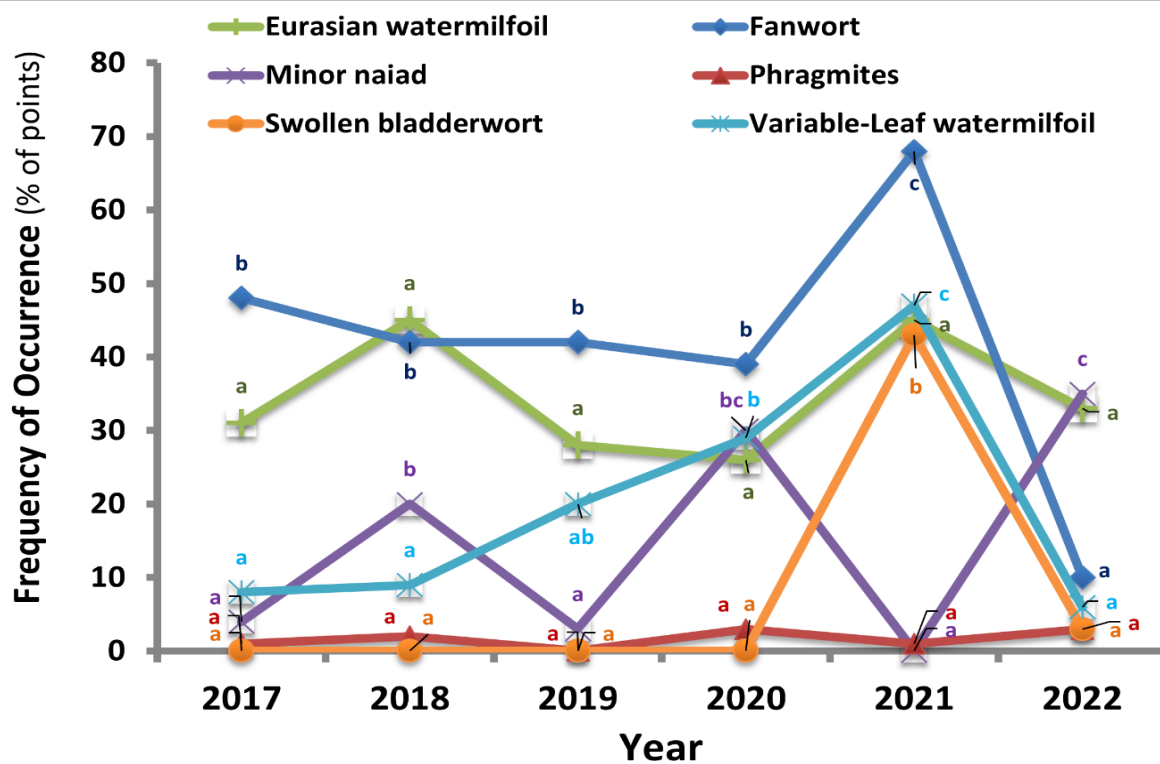
Figure 7. Frequency of occurrence (FOQ) of individual invasive aquatic plant species on transects in Pachaug Pond from 2017 - 2022.

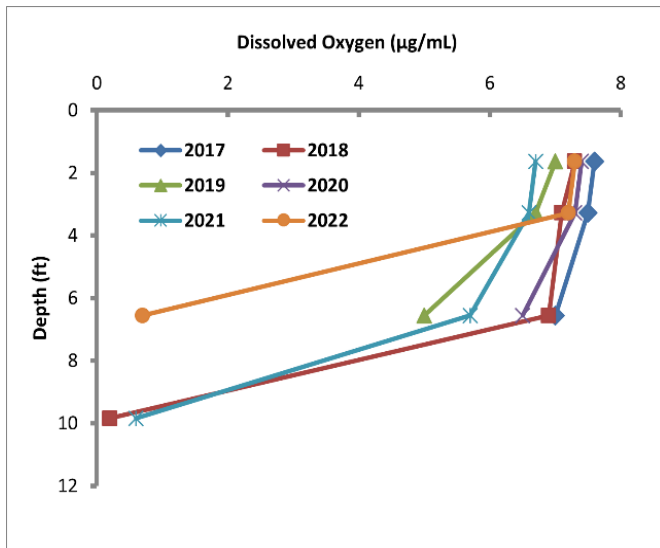
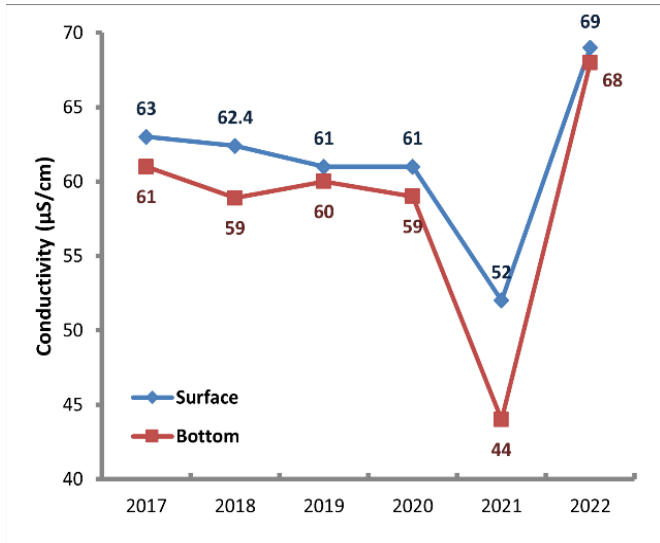
Figure 9. Water chemistry data for Pachaug Pond from 2017 - 2022.

The shallow nature of Pachaug Pond resulted in little stratification of temperature in all years and the presence of anaerobic bottom water at depths below 2 m (Figure

9). Water pH was near neutral (6.2 – 7.0) with an alkalinity of 5 - 14 mg/L CaCO₃ which is low for Connecticut lakes which range from near 0 to >170 (CAES IAPP, 2021). Low alkalinity waterbodies are more prone to pH change due to outside influences such as watershed activities and acid rain. Conductivity is an indicator of dissolved ions that come from natural and man-made sources (mineral weathering, organic matter decomposition, fertilizers, septic systems, road salts, etc.). Connecticut waterbodies have conductivities that range from 50 - 250 µS/cm. Pachaug Pond’s conductivity of 69 µS/cm at the surface and 68 µS/cm at the bottom in 2022 was higher than in our previous surveys. This may be related to the concentration of ions during the drawdown, decreased uptake by vegetation, road salts, or other factors.

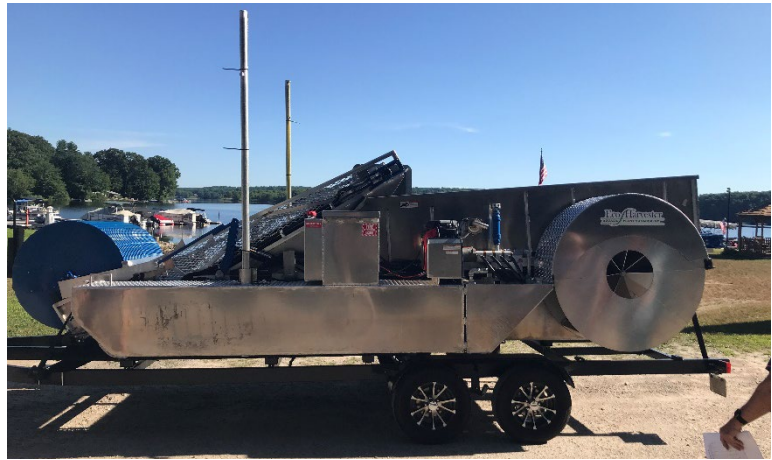
In July 2022, the eco-harvester purchased by the PPWCA arrived and was in full use through the rest of the season (Figure 10). The harvester arrived during our 2022 survey but was not utilized until after our survey was completed. Major benefits of mechanical harvesting include quick results, the ability to target areas and avoid damage to species needing protection, avoidance of aquatic herbicides, and removal of nutrients contained in the harvested vegetation. Drawbacks include the initial expense of the harvesting machine, maintenance costs, rapid regrowth, the need for follow-up work, and costs for vegetation removal and disposal. Results of the Pachaug Pond harvesting program will provide important information for others considering a similar weed management approach.

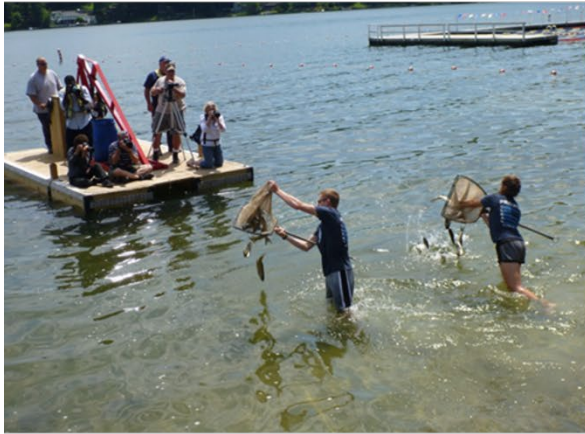
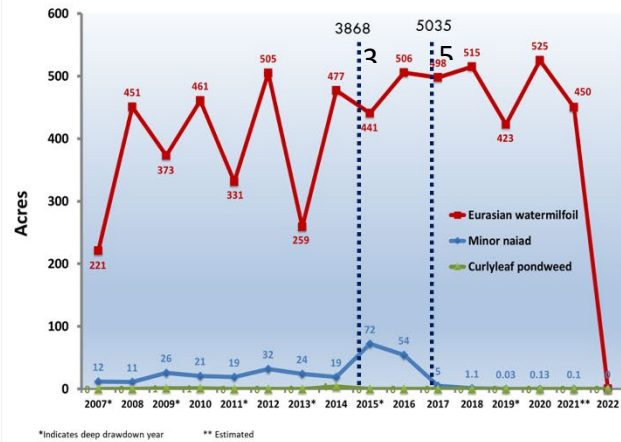
Figure 11. Grass carp introduction into Candlewood Lake in 2015 (left). Near complete elimination of invasive and native (not shown) in Candlewood Lake after seven years (right).

Although efforts are underway to find biological controls for nuisance aquatic vegetation, breakthroughs have been limited. To date the only biological control used in Connecticut is grass carp (*Ctenopharyngodon idella*, Figure 11 left). Grass carp are herbivorous fish that feed on most submersed aquatic plants. The introduction of grass carp into Connecticut lakes requires approval by CT DEEP. In Connecticut, only sterile (triploid) grass carp are permitted. Introducing grass carp in Pachaug Pond could cause damage to non-target plants necessary to maintain the current fishery. Grass carp primarily feed on submergent vegetation, so the water lilies and water smartweed impacting many of the coves will be unaffected. Overstocking in some waterbodies has led to an undesirable reduction in plants needed for fish and other wildlife (Figure 11 right). CAES has worked with officials from the United States Department of Agriculture to find new plant pathogens and insects that control nuisance aquatic plants with little success.

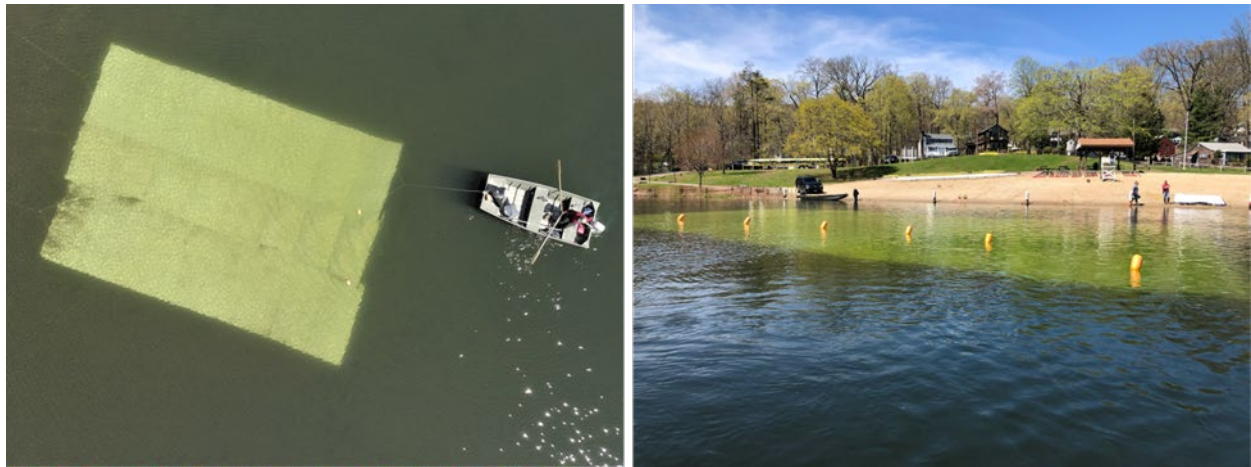
Figure 12. CAES IAPP testing of short-term benthic barriers in Lake Beseck.

CAES IAPP has tested short-term placement (<30 days) of the barriers in Lake Quonipaug, Bashan Lake, and Lake Beseck (Figure 12). Season-long control for Eurasian watermilfoil and fanwort was achieved. Although labor intensive, benthic barriers may be able to be moved from place to place during a season for effective control. They can also be used over multiple years, reducing cost of materials.
